Name Of Dam: SMITH RIVER DAM
Location: HENRY COUNTY, VIRGINIA
Inventory Number: VA. NO. 08913

PHASE I INSPECTION REPORT

NATIONAL DAM SAFETY PROGRAM

Date of Inspection: May 1, 1979

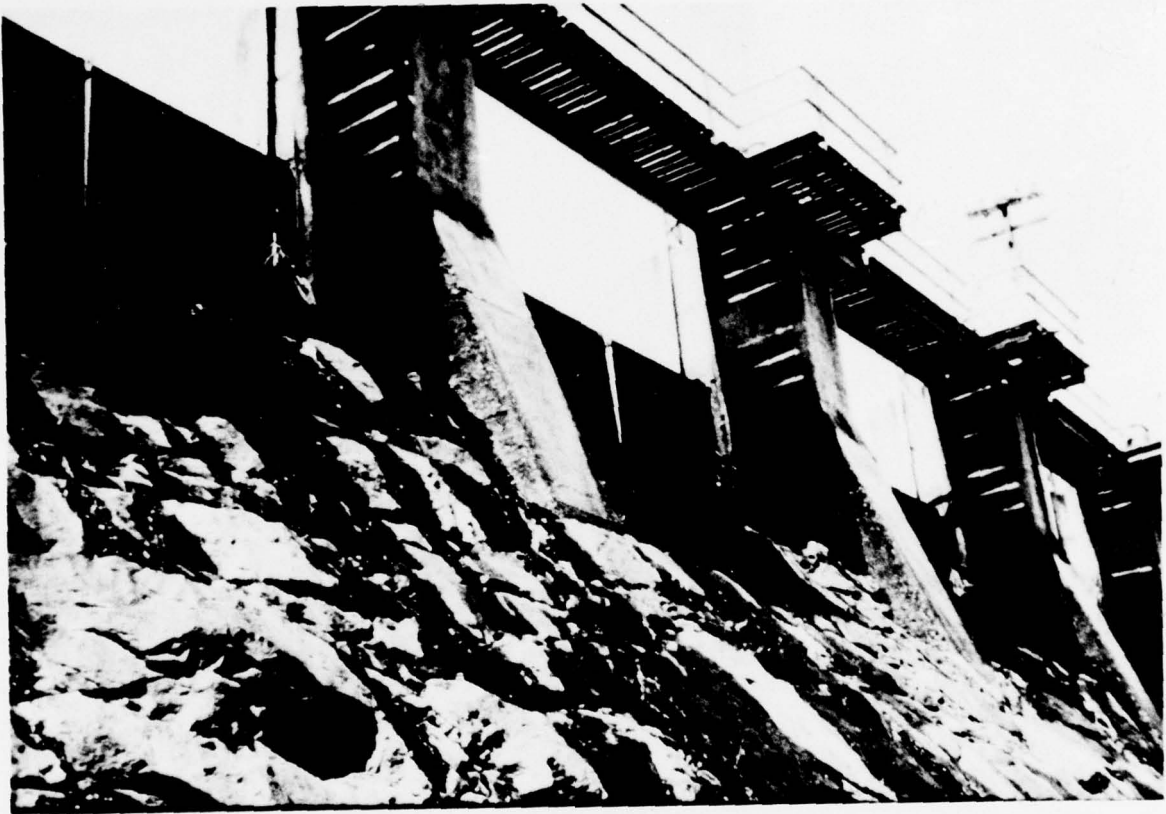
CLOSE-UP CATWALK AND GATE SECTION

Leakage was passing below the spillway crest gates, particularly between Gates No. 7 through 14 numbered from the right abutment. The estimated leakage flow ranged from less than 1 gpm to more than 100 gpm. The greatest flow appeared to occur at Gates No. 8 and 11.

7.2.3 The concrete sill along the spillway crest should be repaired to minimize leakage through the crest gates and protect the crest from further deterioration.

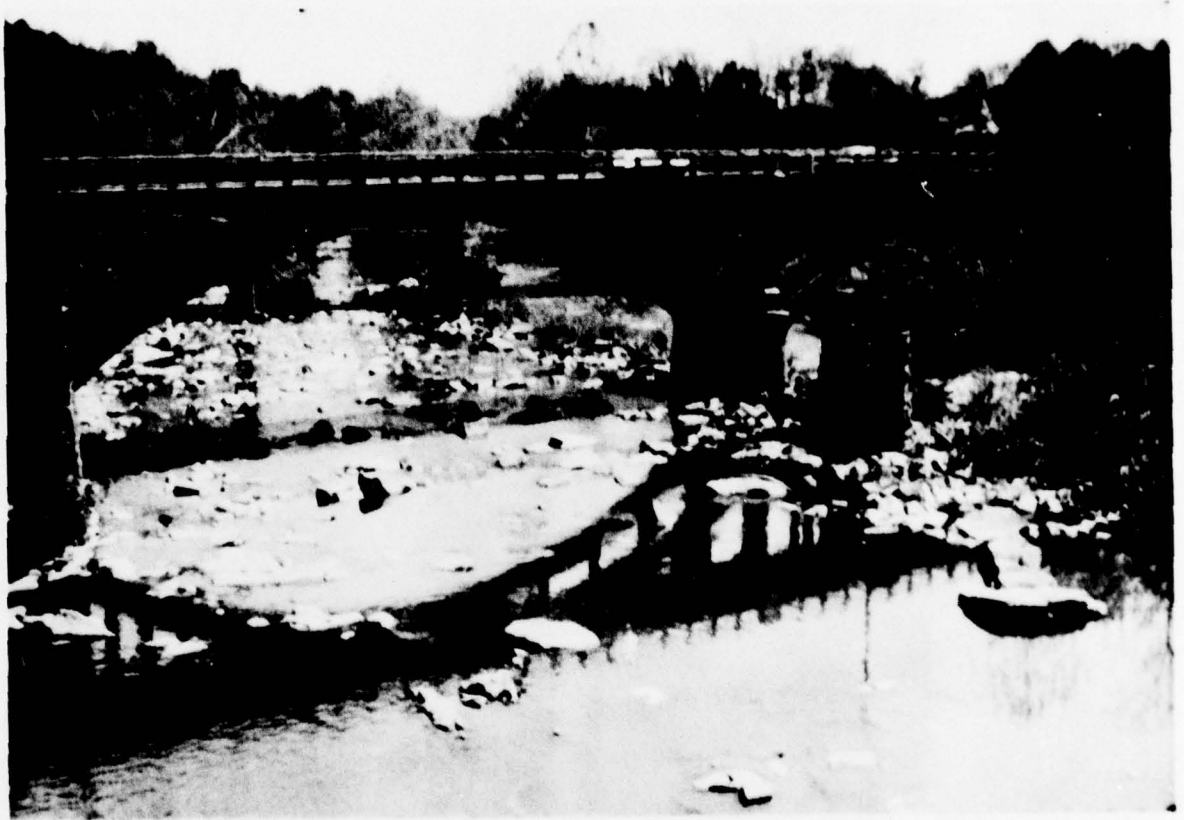
3.2.3 Downstream Area: The stream is stable with a rock bottom showing essentially no signs of erosion or scouring. A highway bridge crosses the river some 100 ft to 150 ft downstream. The bridge decking is at the approximate height of the top of impoundment. The downstream slopes are approximately 2:1 and the stream width is constant for some distance downstream. The only debris noted downstream were rocks, as can be seen in pictures in Appendix II. It was also noted

DOWNSTREAM VIEW
