MOSS NO. 1 FRESH WATER SUPPLY DAM

DICKENSON COUNTY, VIRGINIA

VA. NO. 05103

PHASE I INSPECTION REPORT NATIONAL DAM SAFETY PROGRAM

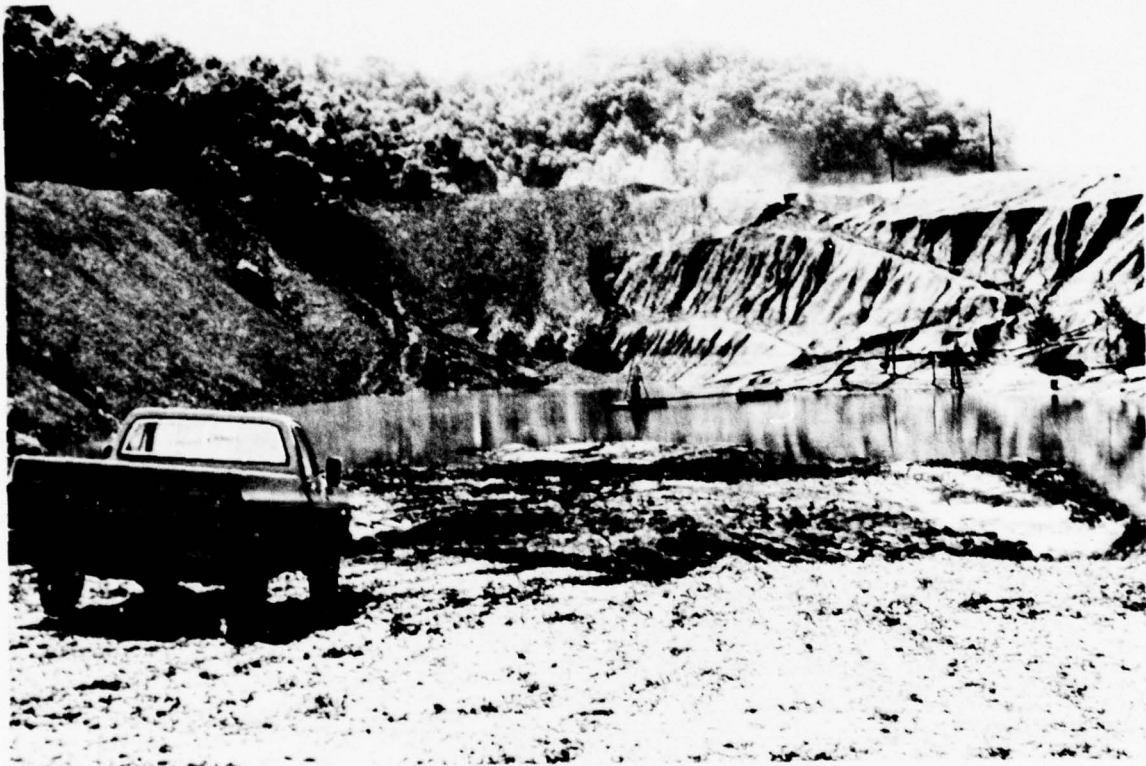
OVERVIEW PHOTO

(View looking at upstream face of berm
and arrow denoting principal spillway.)

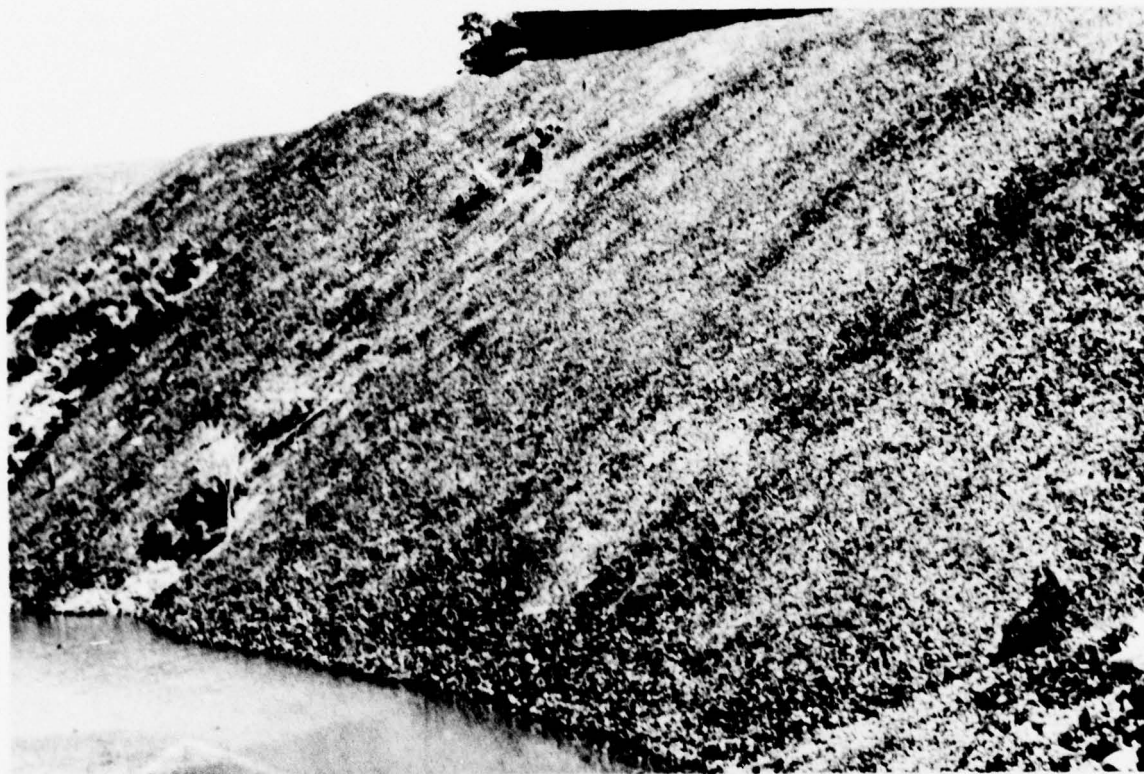
VIEW OF DAM SLOPE
FRESH WATER POND

AT UPSTREAM FACE OF MOSS MINE #1

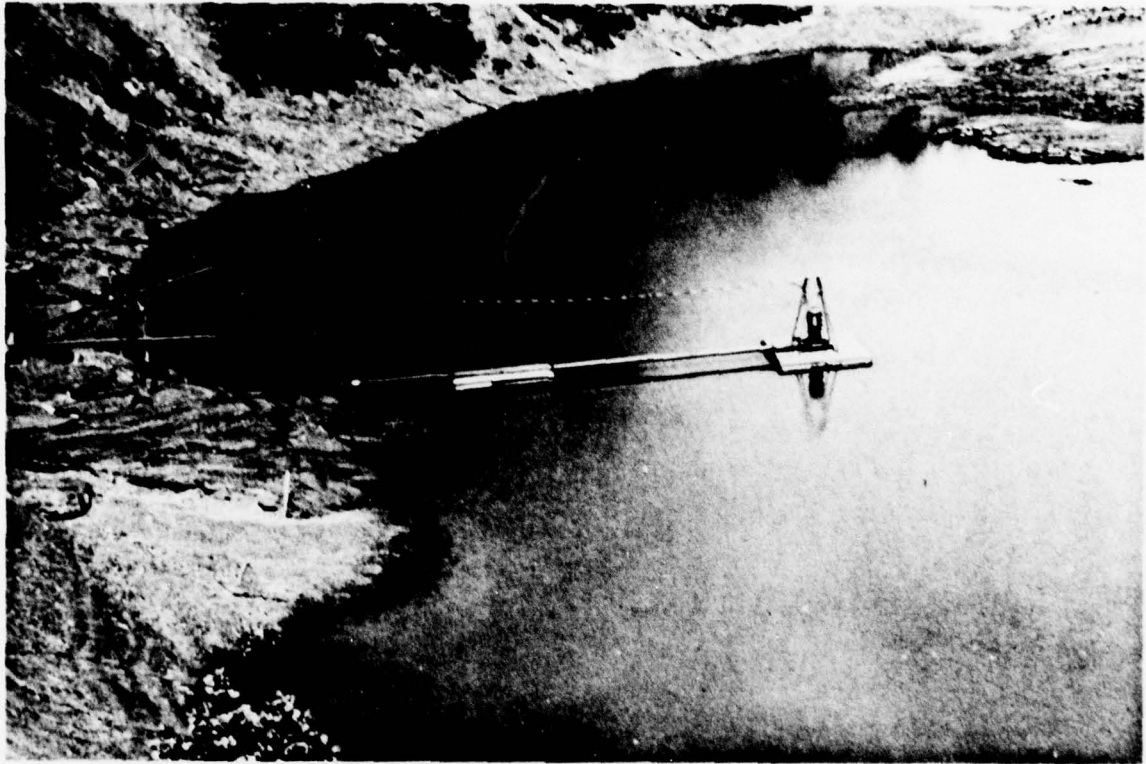
VIEW OF PUMP FROM TOP OF DAM AT MOSS MINE #1
FRESH WATER POND

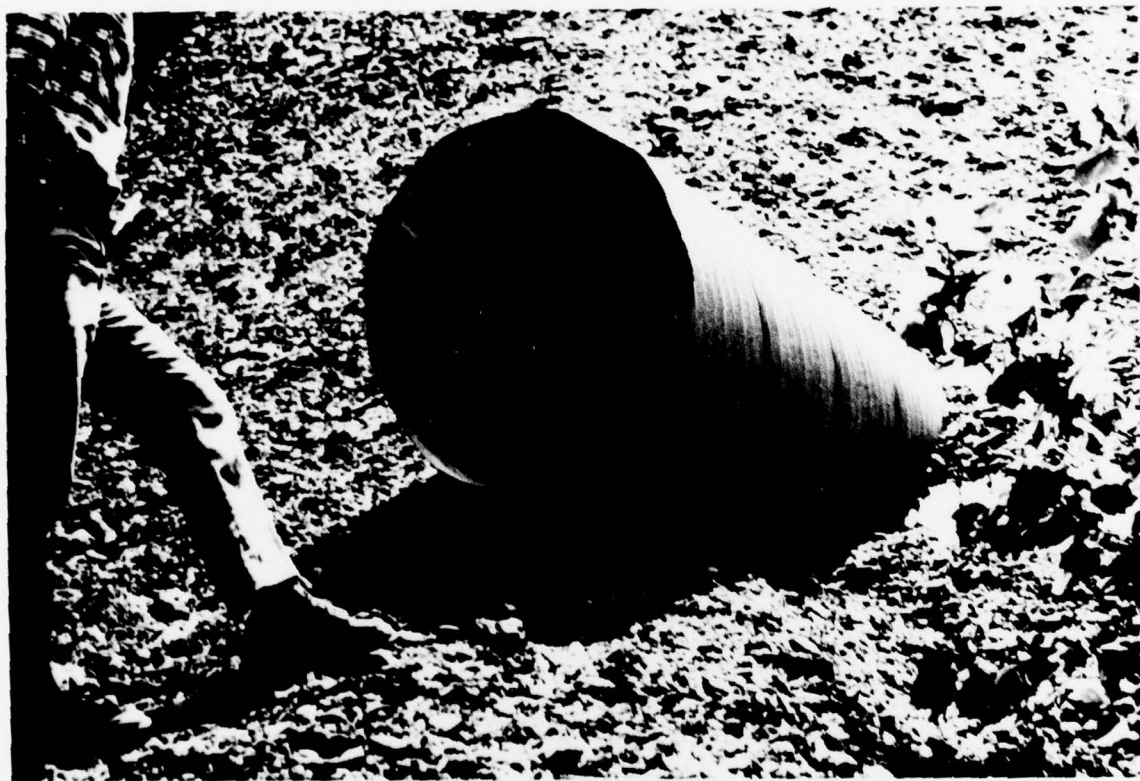
3.1.2 Dam and Spillway: The spillway consists of an ungated 36" CMP located 16 feet above normal pool elevation. The pipe is in good condition but is blocked by mine waste at the outlet.

3.2.1 Dam and Spillway: The spillway was blocked on the outlet side by mine waste and this should be removed. The pipe is reportedly in good condition. The severe embankment erosion encountered on the left downstream slope was not considered hazardous at the time of inspection and it need not be corrected if the pond is abandoned in 1980. Otherwise, it is recommended that areas be backfilled and compacted since continued erosion over a long period of years could create a condition detrimental to the integrity of the dam. Seepage observed near the left downstream abutment is not believed to be related

PRINCIPAL SPILLWAY MOSES MINE #1 FRESH WATER POND

7.3 Maintenance Measures: The downstream end of the spillway pipe should be uncovered.

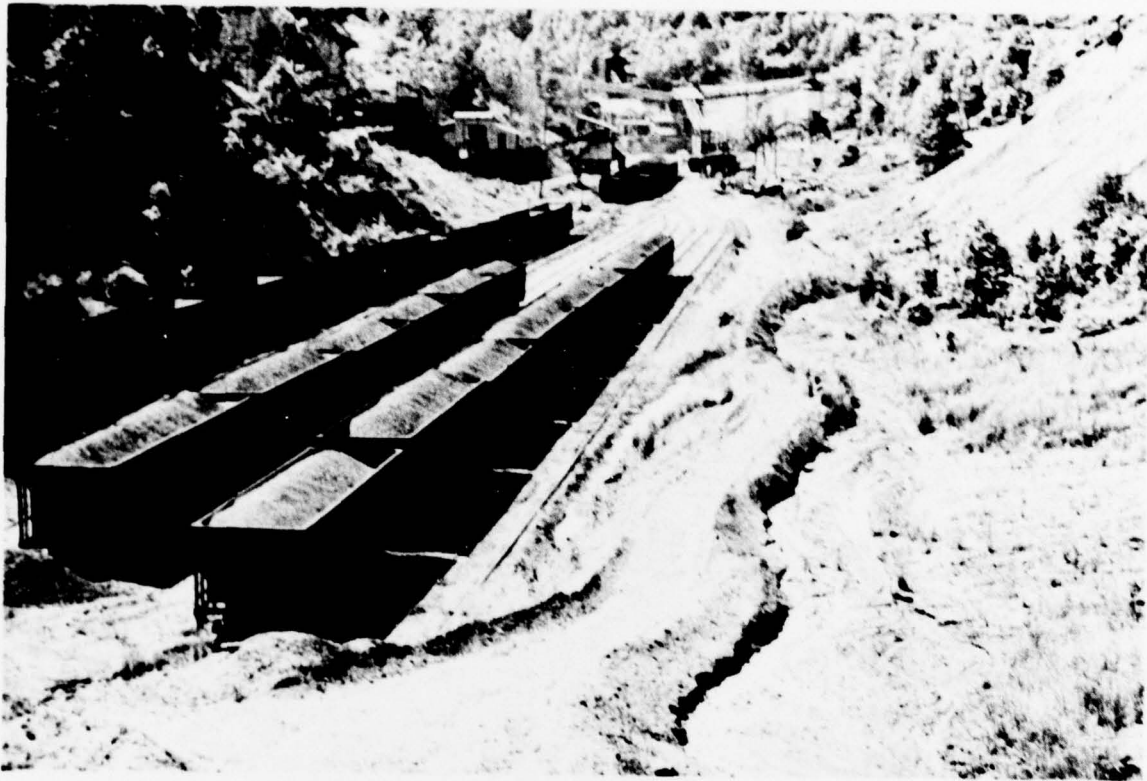
DOWNSTREAM VIEW MOSS MINE #1 FRESH WATER POND
