LONG BOTTOM BRANCH DAM

BUCHANAN COUNTY, VIRGINIA

VA. NO. 02702

PHASE I INSPECTION REPORT

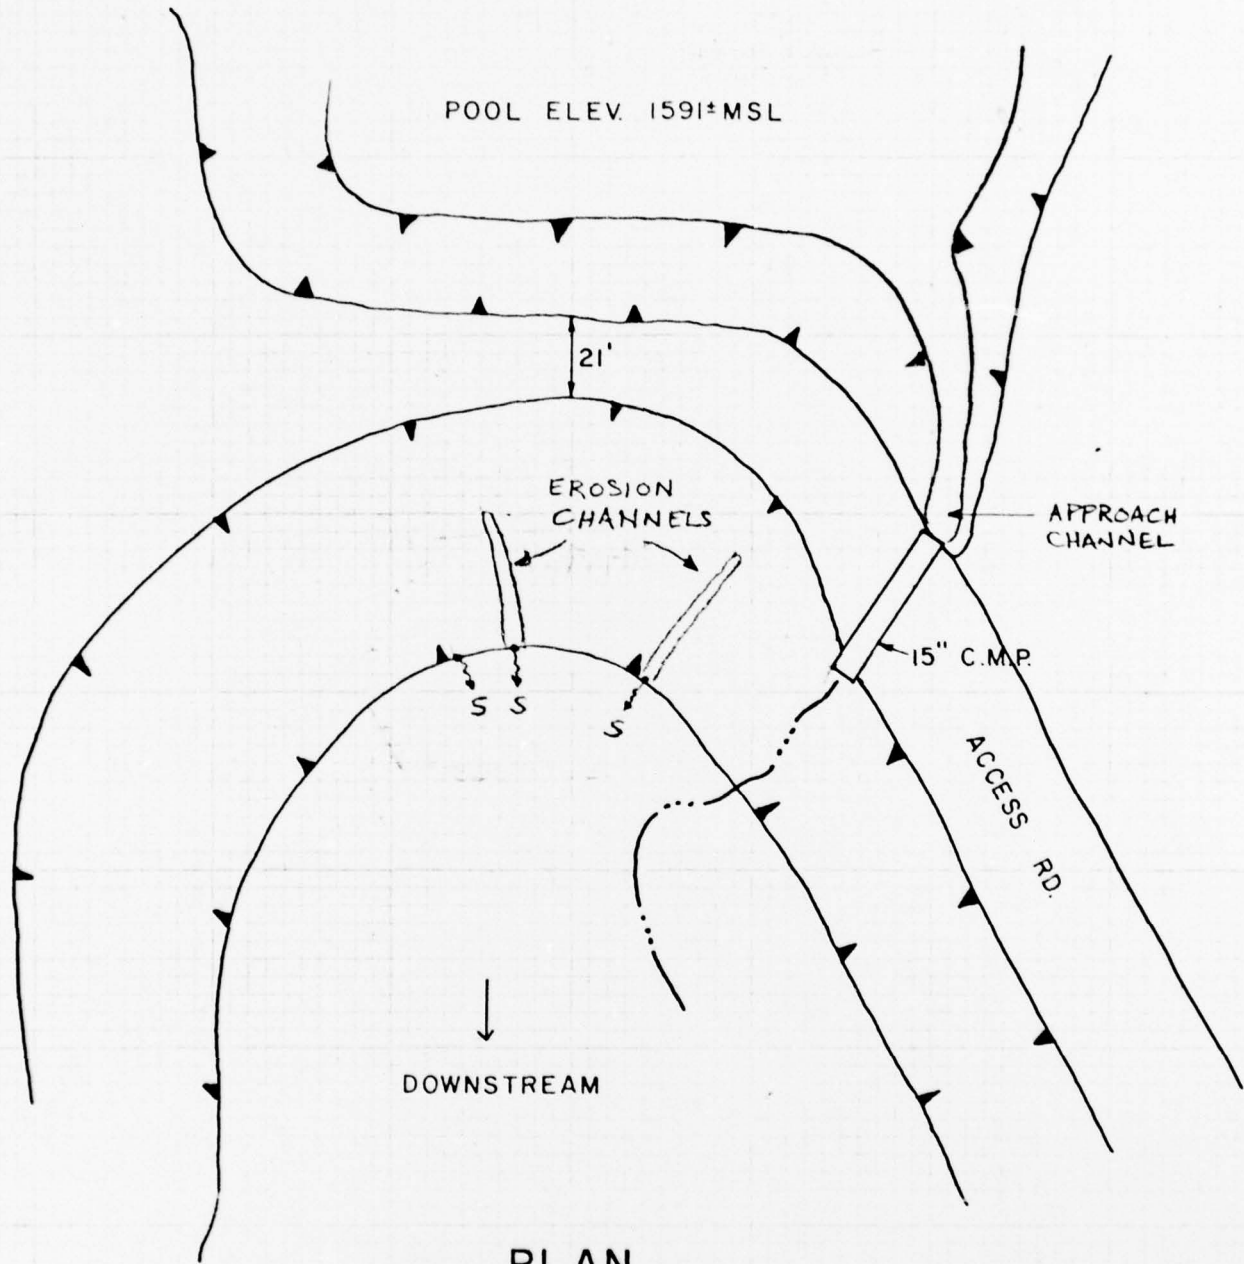
PLAN
(NO SCALE)

encountered on the downstream slope along the left abutment and to the right of the dam center where the dam curves into the right abutment. These eroded areas were up to 3 ft wide, 1 to 2 ft deep, and extended from about halfway down the slope to the toe. Three seeps, each flowing at 2 gpm[±] were encountered. Two occur along the toe of the eroded channels or washes and the third was approximately 10 ft right of the right erosion channel along the toe of the slope. Heavy iron staining was associated with the three seeps. Erosion and seepage features are illustrated on Plate 2, Appendix I.

1.7 Seepage: Three seeps were encountered during the inspection. Two were located along the toe of the two eroded channels or washes and the third was approximately 20 ft right of the right erosion channel along the toe of slope. Seepage from all three areas was estimated as 2 gpm[±]. Heavy iron staining was generally present along seepage paths.

Eroded areas and excavations created by removal of trees should be backfilled with compacted fill. The embankment should be reseeded and all surface drainage should be diverted to prevent further erosion.

7.3.1 Seepage observed along the downstream toe of the embankment should be monitored quarterly to detect any increase in flow rates which may cause piping within the embankment.

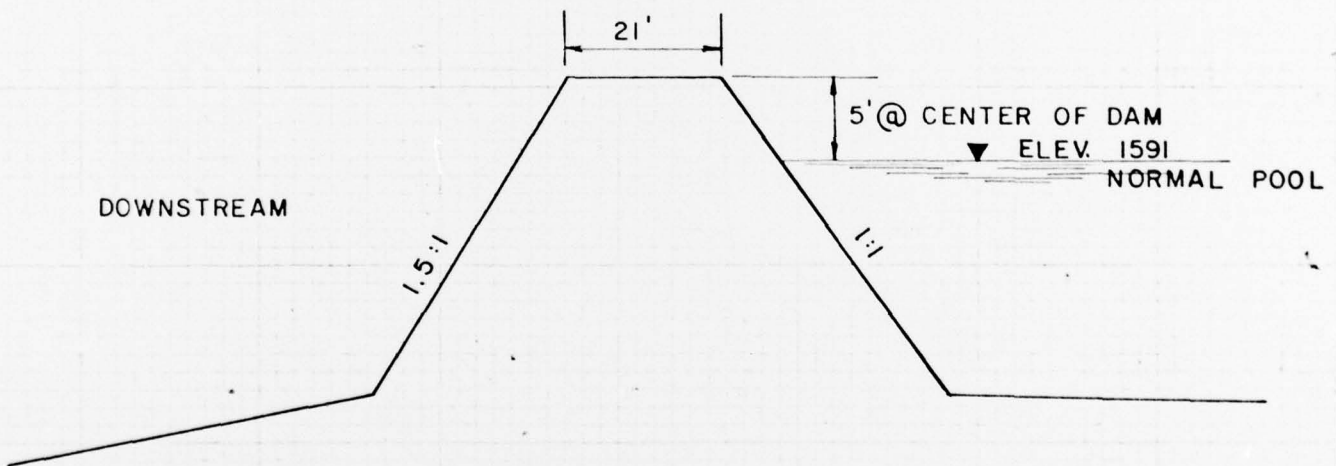
SECTION

6.3.2 Embankment: The embankment slopes do not meet the requirement recommended by the U.S. Bureau of Reclamation for small homogeneous earthfill dams on stable foundation.

The embankment is not constructed according to any conventional standards and no construction records are available. Without design data and construction records, the stability of the structure cannot be assessed. Furthermore, the embankment slopes are much steeper than the slopes recommended by the U. S. Bureau of Reclamation, Reference 2, Appendix IV, for small homogeneous earthfill dams on stable foundations.

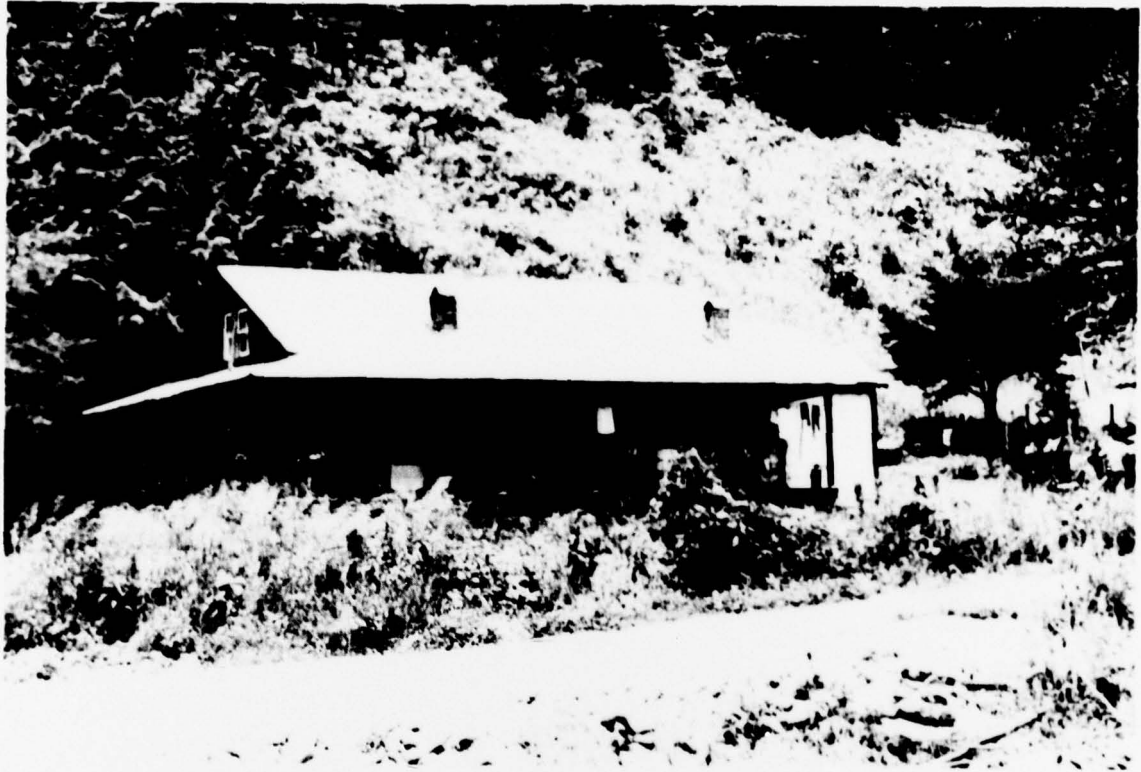
HOUSE LOCATED DOWNSTREAM IN FLOODPLAIN. THE SLOPE IN BACKGROUND IS TYPICAL OF SIDE SLOPES BETWEEN IMPOUNDMENT AND THIS HOME.

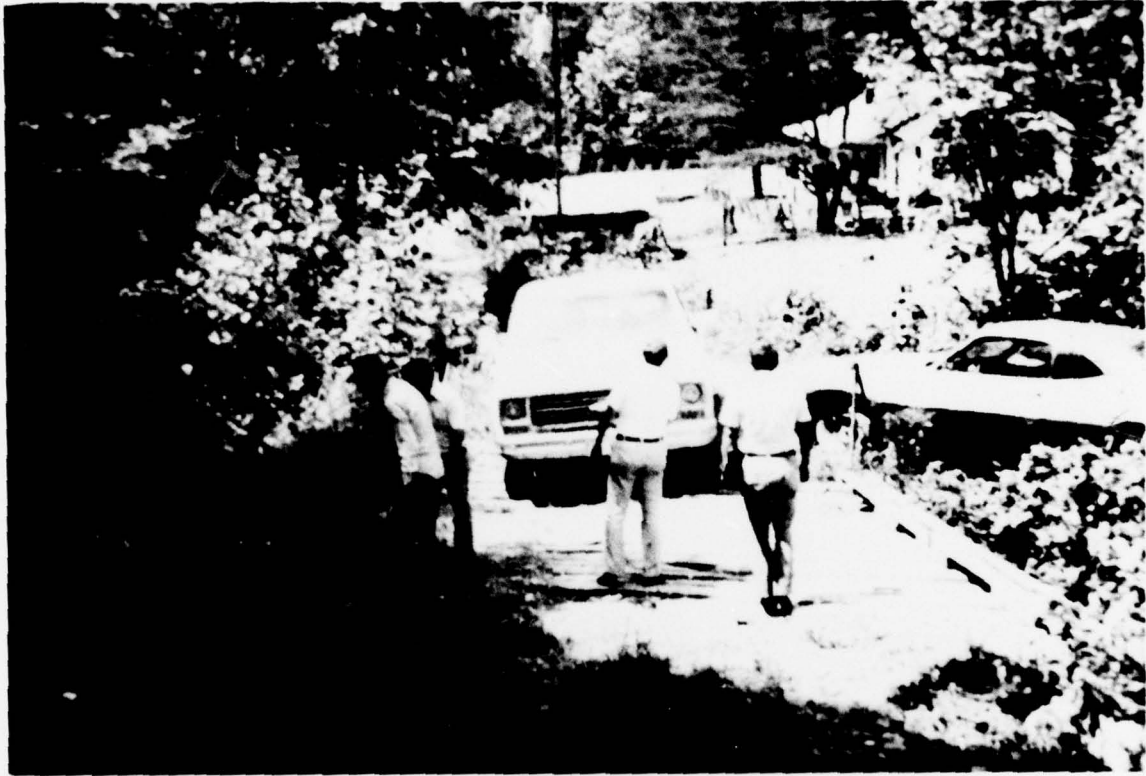
VIEW SHOWING WOODEN ACCESS BRIDGE APPROXIMATELY 2½ MILES
DOWNSTREAM AND THE FIRST HOUSE IN FLOODPLAIN DOWNSTREAM

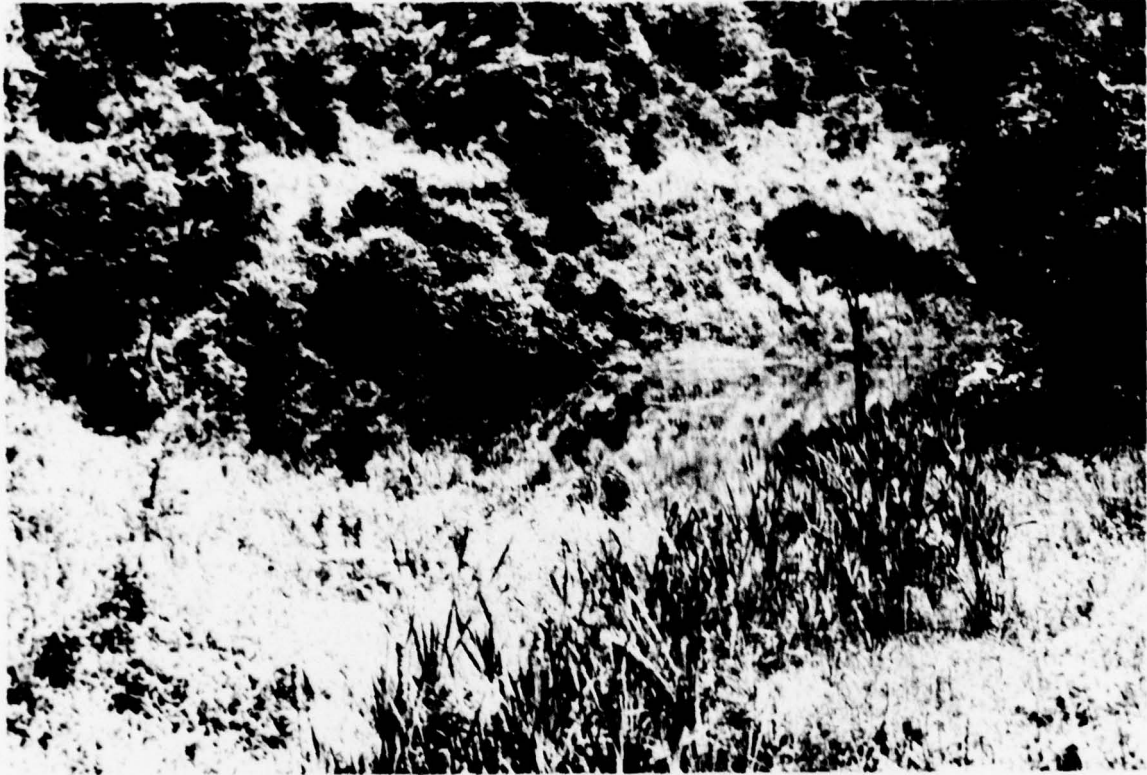
VIEW LOOKING UPSTREAM FROM IMPOUNDMENT. NOTE: GRASS
SPILLWAY IN FOREGROUND AND TYPICAL SIDE SLOPES IN BACKGROUND.
