HLH ROTOR BOX BEAM FATIGUE TEST

M. Hanson

September 1979

APPLIED TECHNOLOGY LABORATORY  
U. S. ARMY RESEARCH AND TECHNOLOGY LABORATORIES (AVRADCOM)  
Fort Eustis, Va. 23604

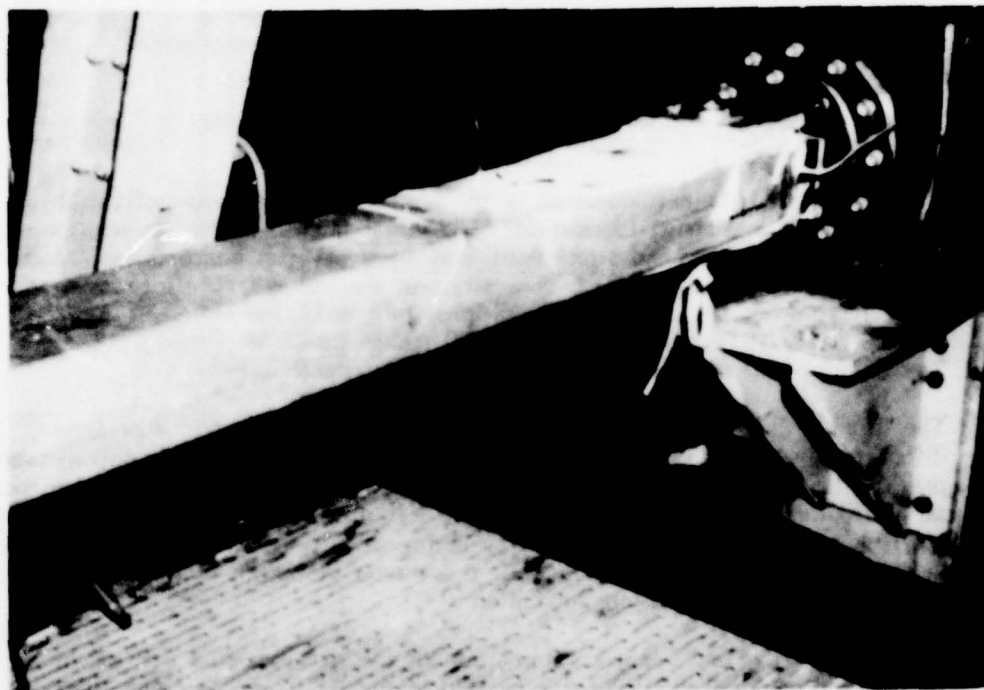
After replacement of the failed bolt, testing resumed. A strain of 3500 microinches per inch peak to peak was achieved in the test section when an axial deflection limit detector again shut down the machine. The maximum strain had shifted away from midspan (see Figure 14). After several more shutdowns and inspections, the limit detector was removed and testing resumed. The frequency was increased gradually to find the peak of the resonance curve. The amplitude of the strains increased as frequency increased. At 20 Hertz and 22,000 cycles the beam failed catastrophically in the grip area at the reaction end where smoke had been previously observed. The fiberglass beam failed in shear at the adapter pin connections of each flange (see Figure 15). The doublers on one flange debonded and, in turn, sheared the bolts that were used to secure the doublers to the beam (see Figure 16). The doubler assembly on the other flange failed in tension (see Figure 15).

Figure 16. Shear failure of doubler assembly.

4. Fatigue testing was terminated after 22,000 cycles when a shear failure occurred in the grip area. Smoke was emanating from the root end just prior to failure. Interlaminar charring was evident between the plies of the unidirectional material in the bearing failure area. The beam had been designed to react to bearing loads without the use of doublers. It was decided to install aluminum doublers to reduce the possibility of grip failure. Even with the use of doublers the combined strength of the unidirectional material and doubler was inadequate to react the loads.
