THE NUCLEAR THERMAL EFFECTS ON HUMIDITY SATURATED COMPOSITE MATERIALS

Rockwell International Corporation
Los Angeles Division
P.O. Box 92098
Los Angeles, California 90009

February 1979

Final Report for Period December 1977-February 1979

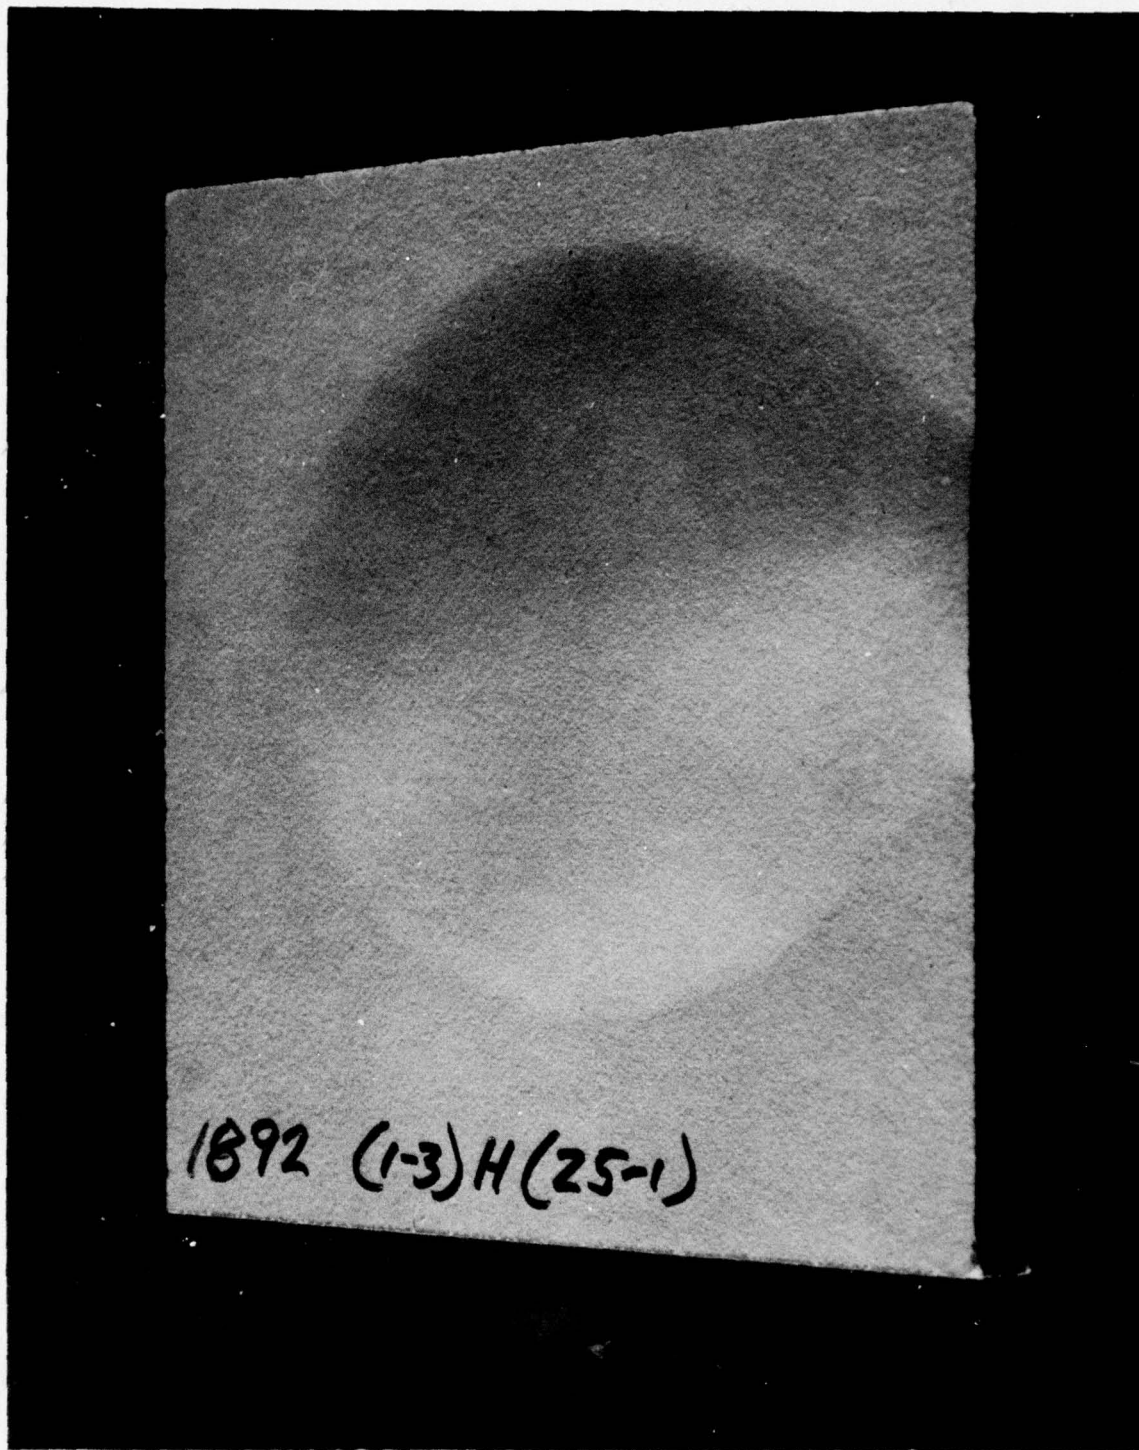
System 1, three-ply laminates all failed at 25 cal/cm². The system 1 damage threshold is evident in Figure 1. The panel had one flash at 25 cal/cm². The failure mechanism was interlaminar face sheet delamination. All four-, five-, and six-ply laminates had sufficient mass to absorb this energy level without visual damage or structural degradation. Humidity saturation amplified the damage on a three-ply laminate. (See Figure 2.) The right-hand specimen was dry; the left-hand specimen was saturated.

Figure 1. System 1 - material with threshold damage.

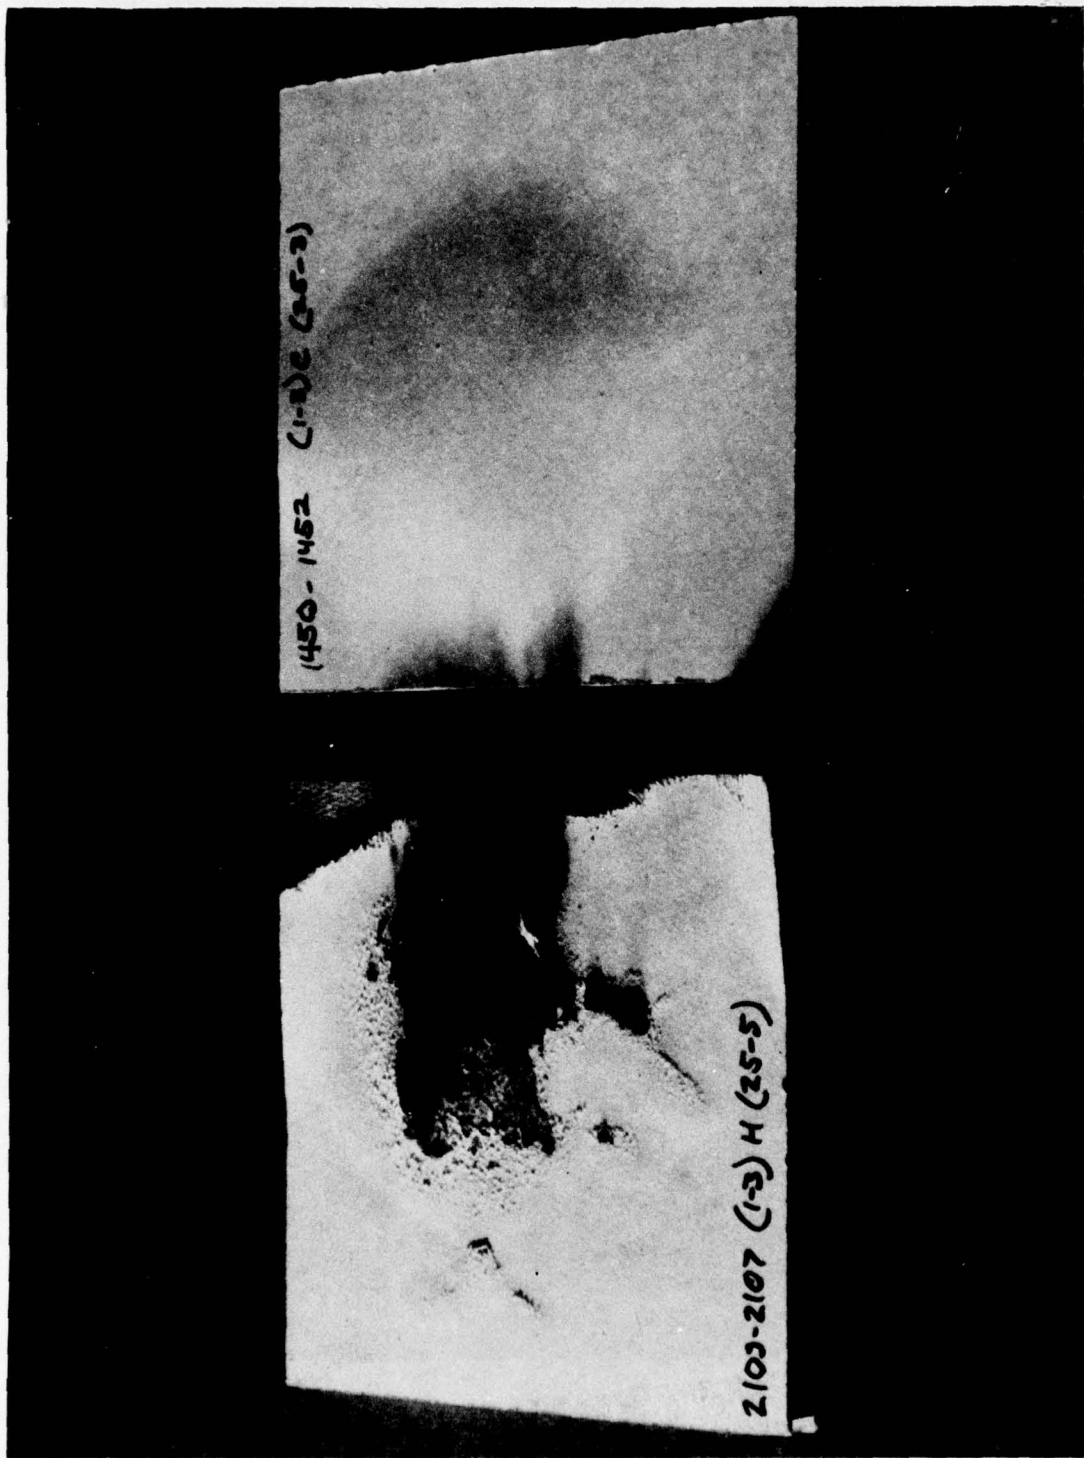
Figure 2. Humidity saturation vs dry specimen.

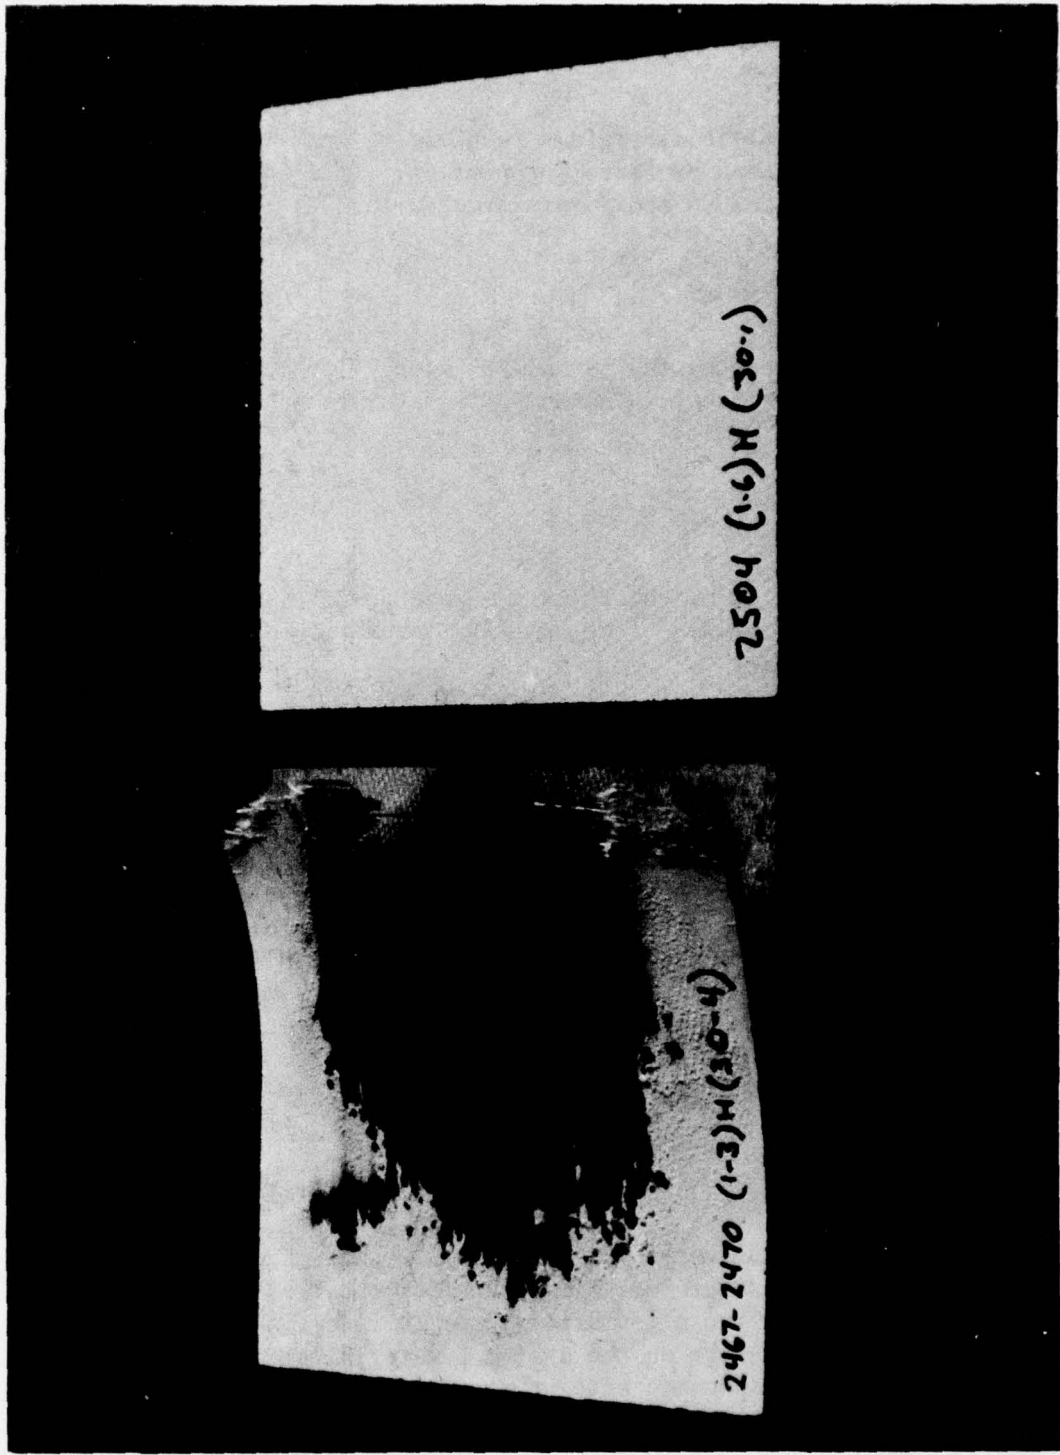
System 1 three- and four-ply laminates all failed at 30 cal/cm². The failure mechanism was interlaminar face sheet delamination. The five- and six-ply face sheets were unaffected at either one or three flashes but suffered severe paint discoloration after five flashes. (Figure 3 illustrates the difference between a three- and six-ply laminate of system 1 material at

Figure 3. System 1 - 3- vs 6-ply at 30 cal/cm².

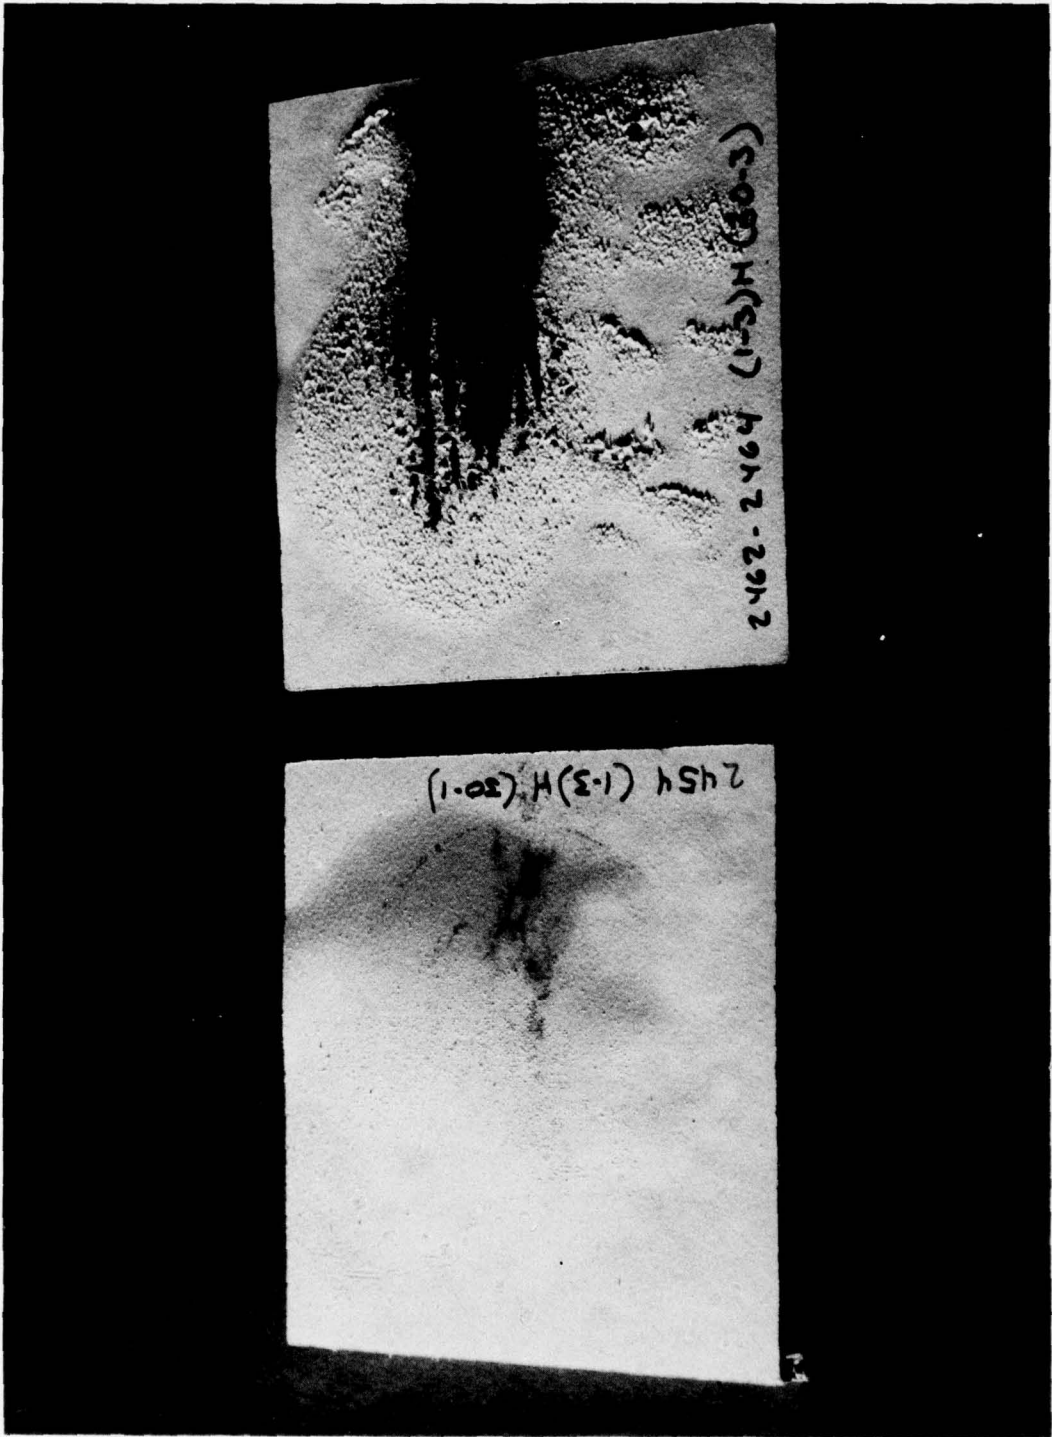
30 cal/cm².) Multiple flash damage is shown in Figure 4. The specimen on the left saw one flash, while the right specimen saw three flashes.

Figure 4. System 1 - one vs three flashes.

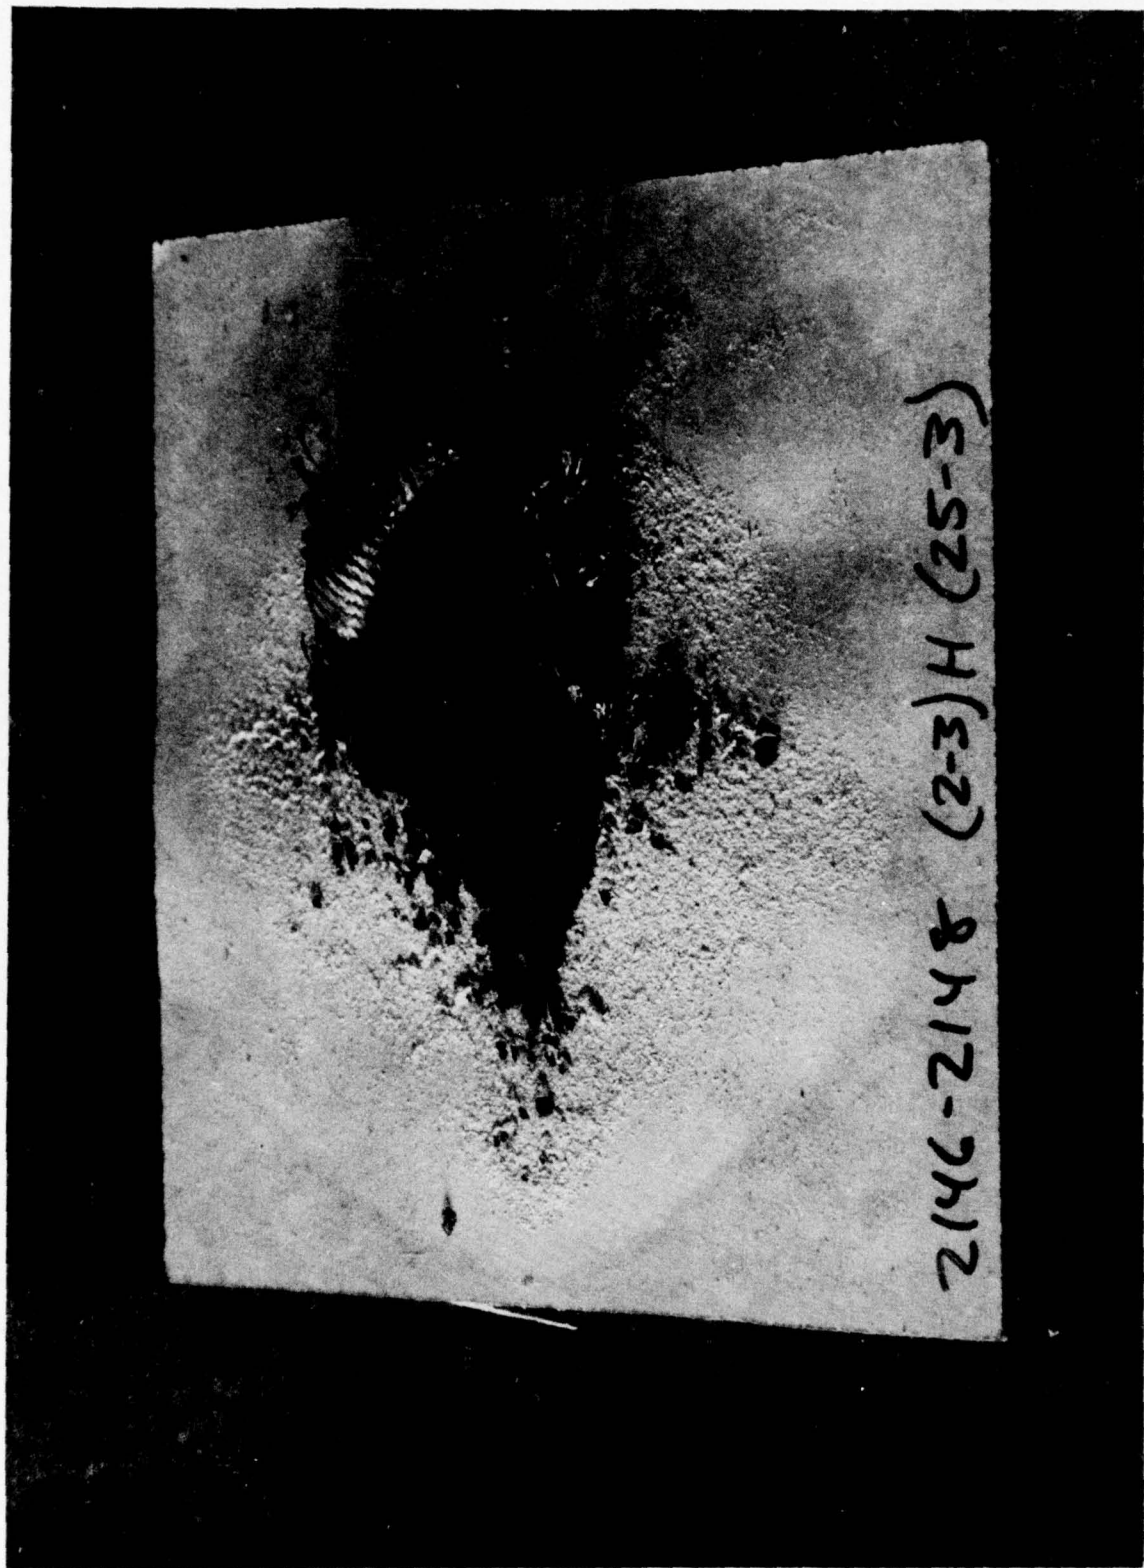
System 2 three-, four-, and five-ply laminates all failed at 25 cal/cm² after only one flash. The failure mechanism was blistering and yellowing of the paint after one shot and a severe interlaminar delamination after two or more flashes. Figure 5 shows a system 2 laminate after three flashes at 25 cal/cm². The six-ply laminates were unaffected by up to five flashes in a dry condition. In a humidity saturated condition, the six-ply laminates were unaffected by one flash but suffered paint discoloration after three flashes and severe paint discoloration and blistering after five flashes. (Figure 6 illustrates the difference between three and five flashes.)

Figure 5. System 2 - three flashes at 25 cal/cm².

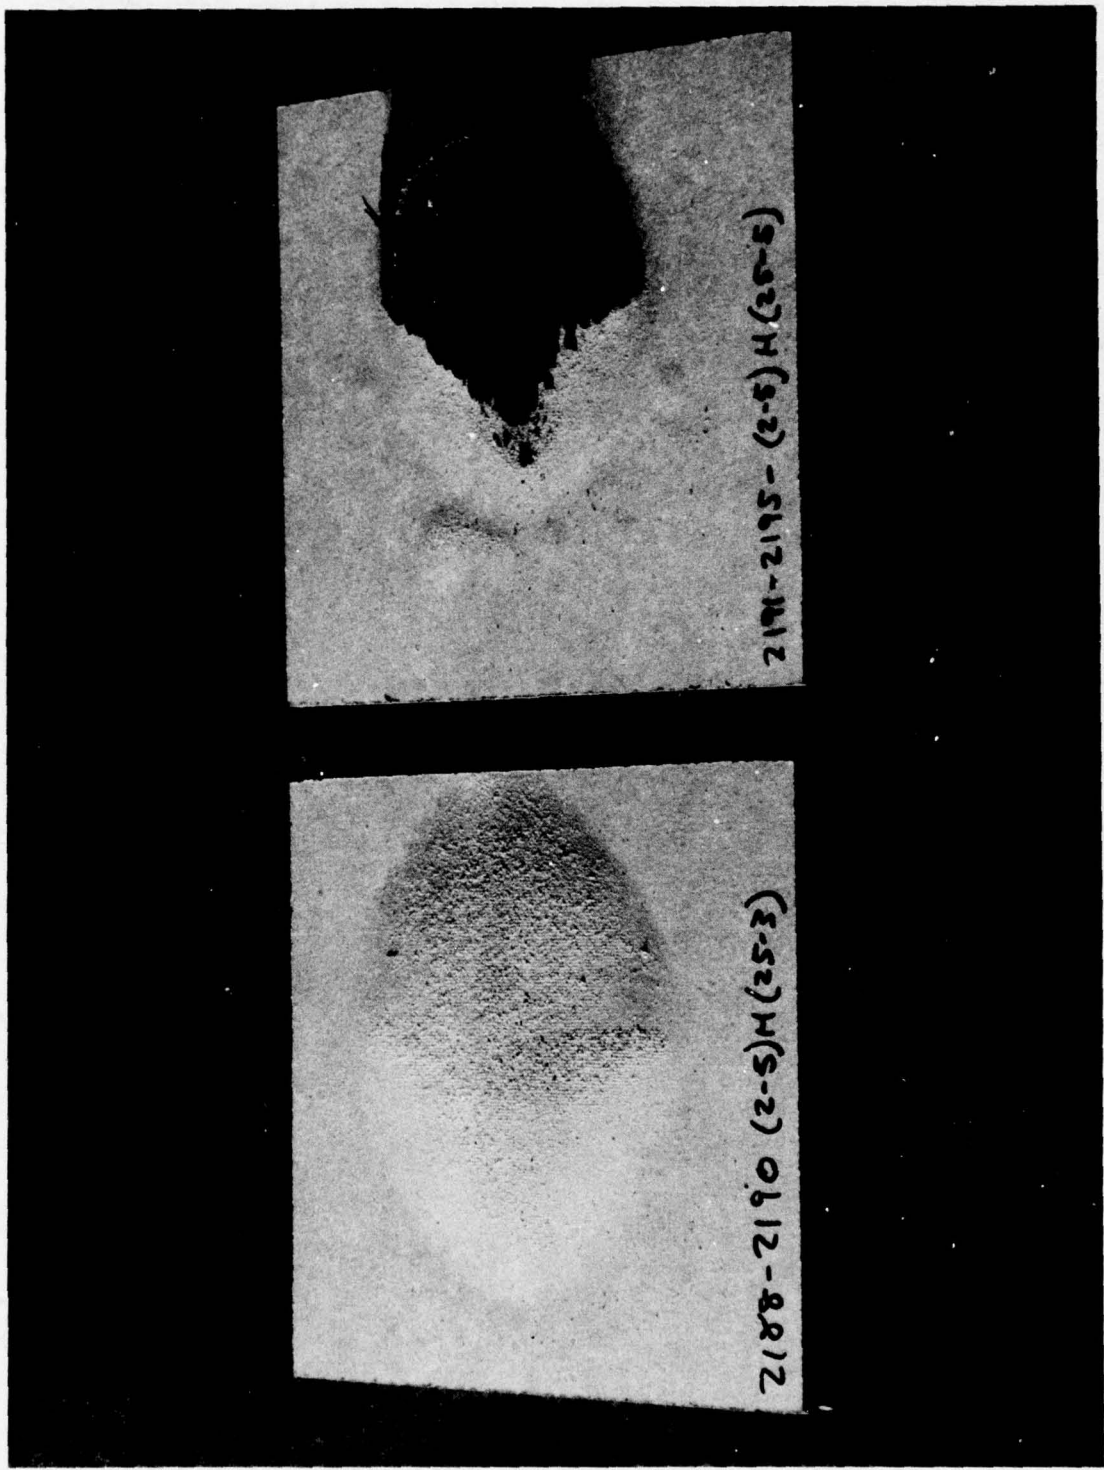
Figure 6. System 2 - three vs five flashes at 25 cal/cm².

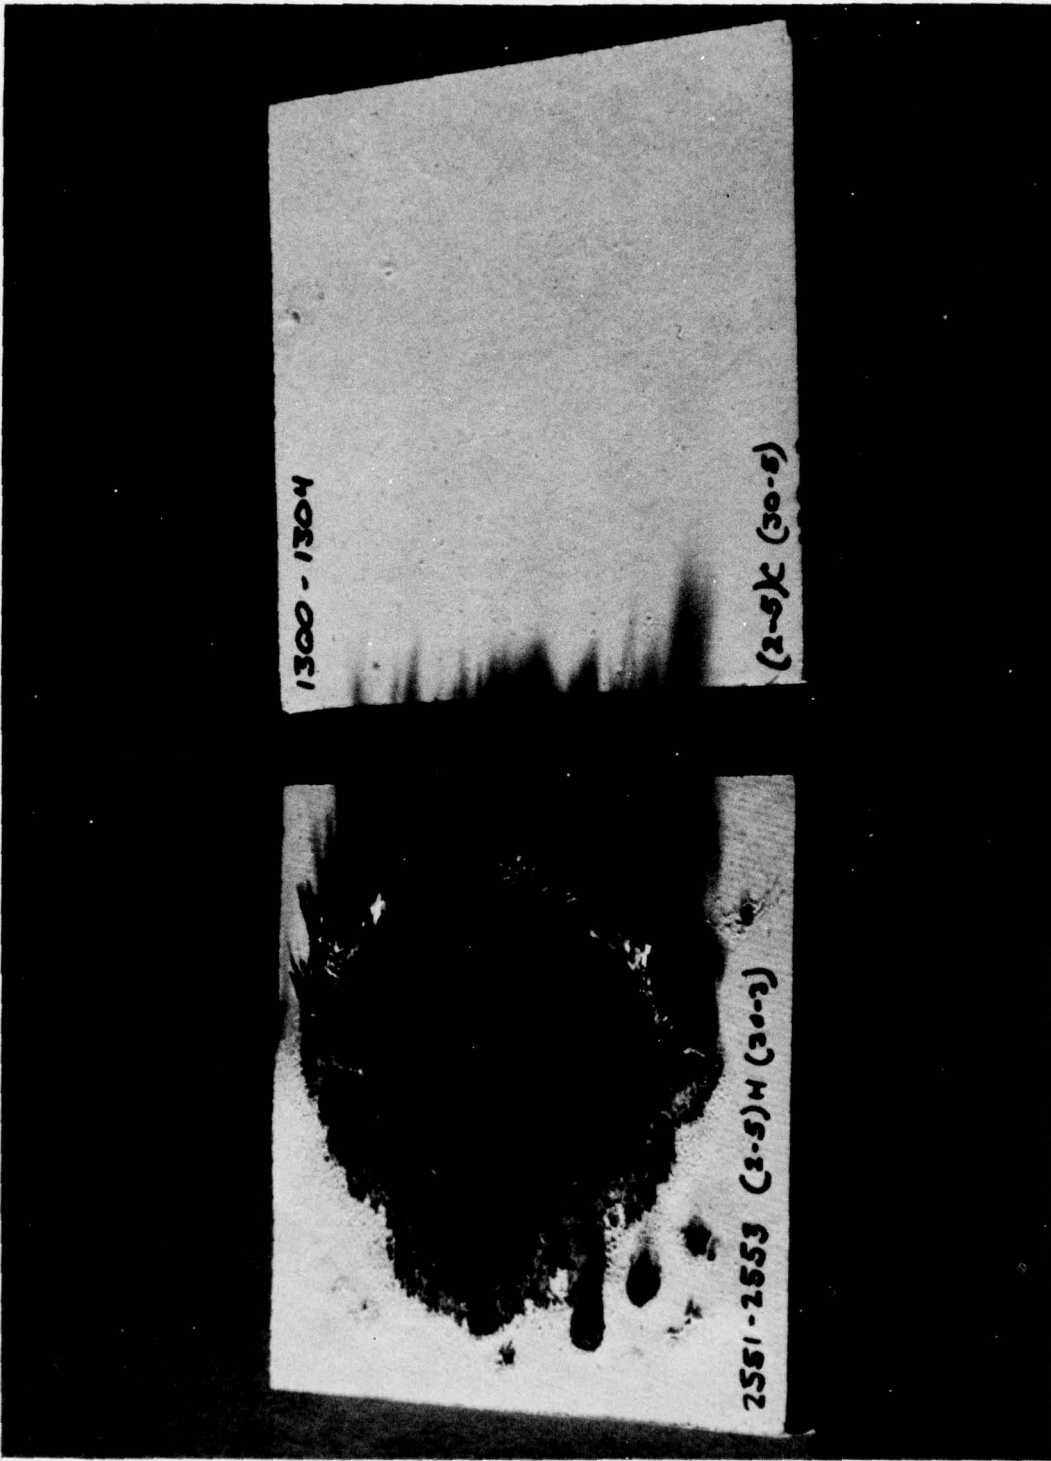
All of the system 2 laminates failed at the 30 cal/cm² energy level. The failure mechanism was severe delamination after one flash and charring and burning through one or two plies after three to five flashes. Humidity saturation amplified the damage on the system 2 material at 30 cal/cm². Figure 7 shows a five-ply specimen after three flashes. The left specimen was humidity saturated, while the right specimen was dry.

Figure 7. System 2 - saturated vs dry.

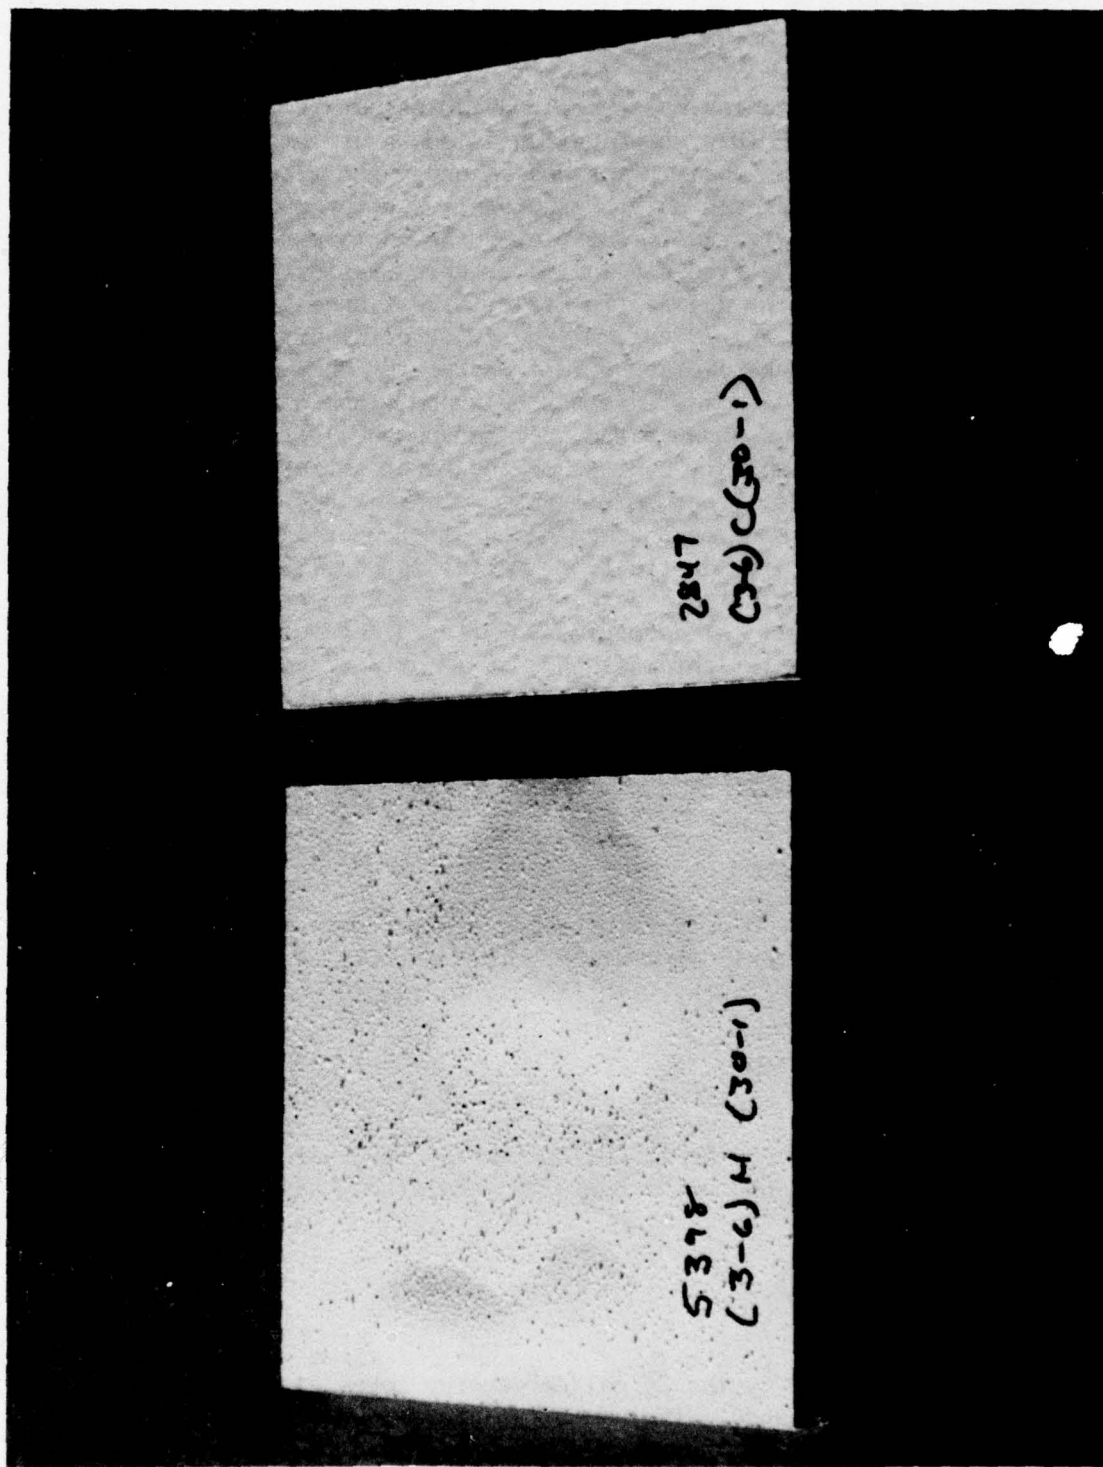
Figure 8. System 3 - humidity saturation vs dry.

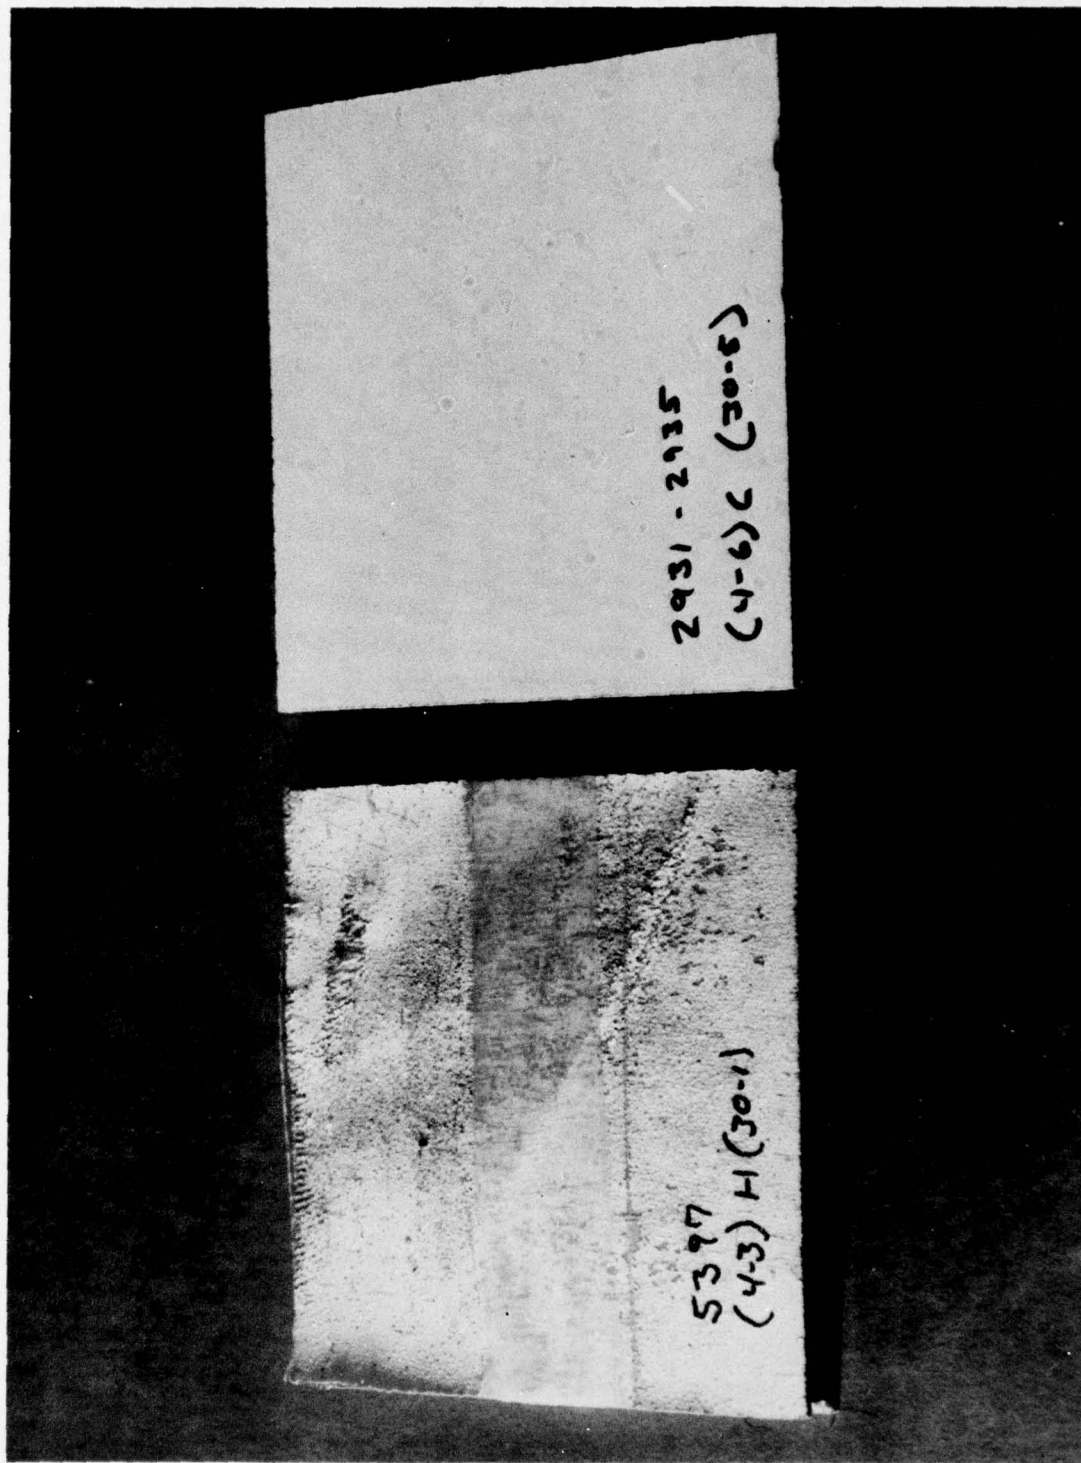
System 4 dry three-ply laminates severely delaminated after one flash at the 30 cal/cm² energy level. This delamination is shown as left specimen in Figure 9. The right specimen is six plies and is undamaged after five flashes. The dry four-ply laminate suffered paint discoloration after one flash. The paint degradation became progressively worse over the next four flashes, but no delamination occurred. The five-ply laminates were unaffected by three flashes but suffered some paint degradation after five flashes. The six-ply laminates were unaffected by the 30 cal cm² energy level at any structural thickness and up to five flashes. The humidity-saturated three-, four-, and five-ply laminates severely delaminated after only one flash at the 30 cal/cm² energy level. Figure 10 shows a saturated specimen on the left which delaminated after one flash, while the dry control on the right suffered paint discoloration after five flashes. The humidity-saturated six-ply laminate was marginal. One out of three specimens delaminated after one flash, with the other two suffering severe paint degradation. After three flashes, two out of three specimens were delaminated and the third had severe paint degradation. After five flashes, all three specimens suffered severe delamination. Figure 11 shows the damage after three flashes at 30 cal/cm² versus the damage after five flashes. One can readily see that after three flashes there is paint discoloration and blistering but no delamination; after five flashes there is severe charring and delamination of the laminate.

Figure 9. System 4 - 3 vs 6 ply.

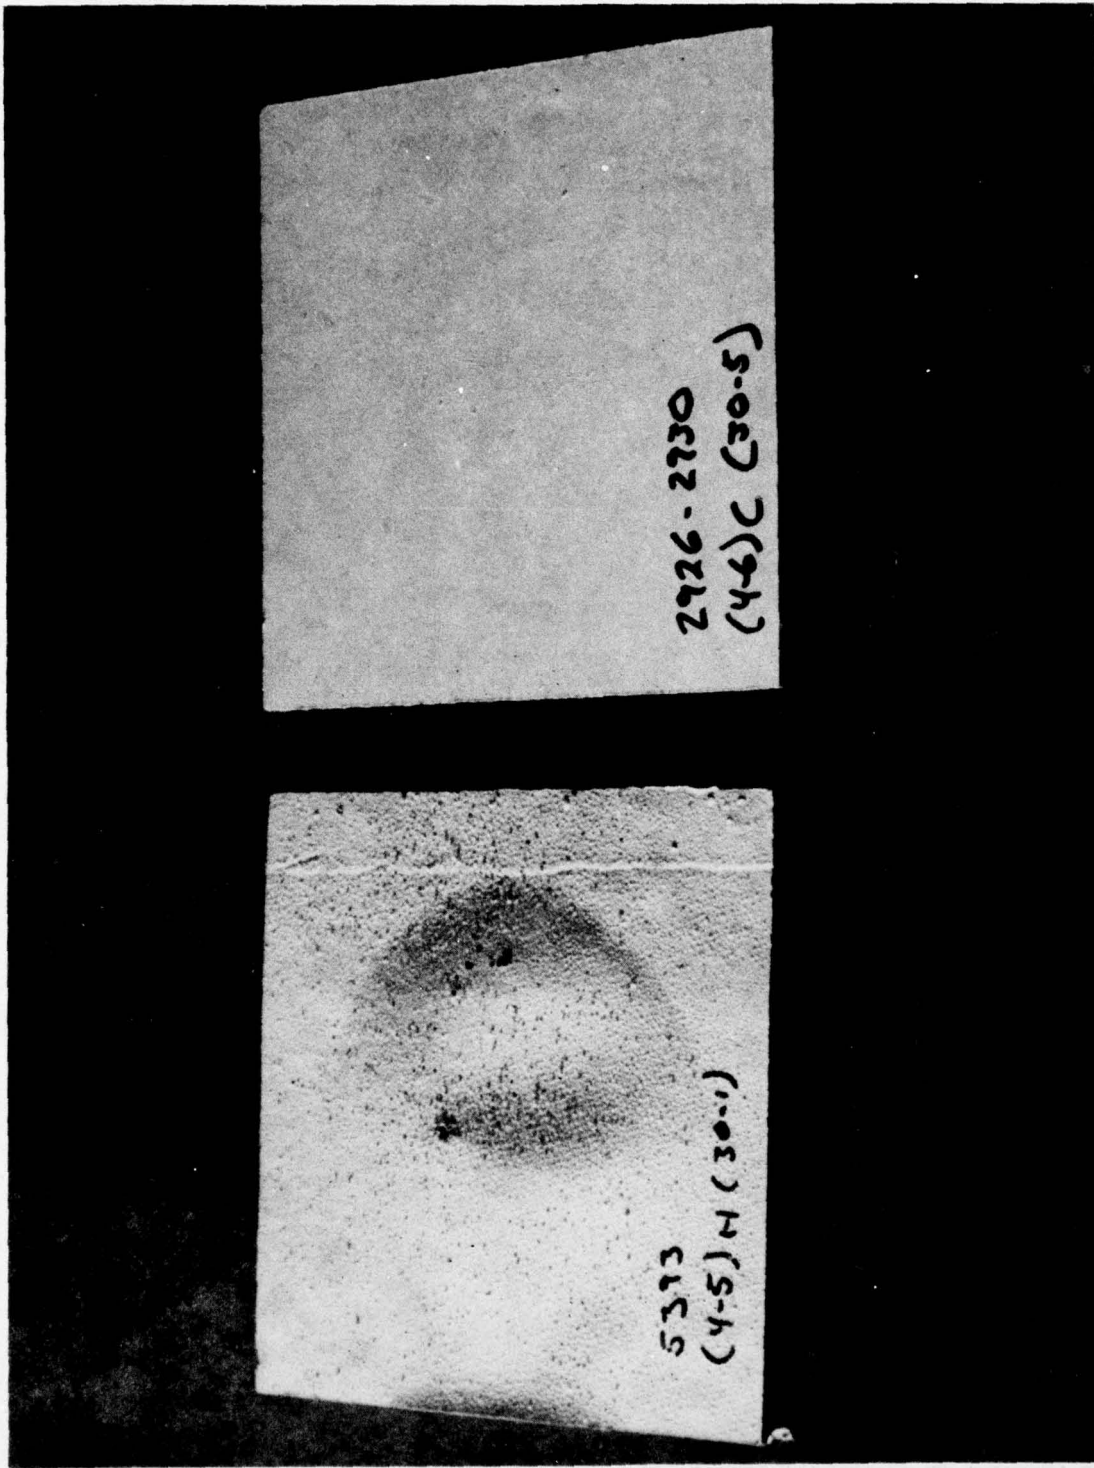
Figure 10. System 4 - humidity saturated vs dry specimens.

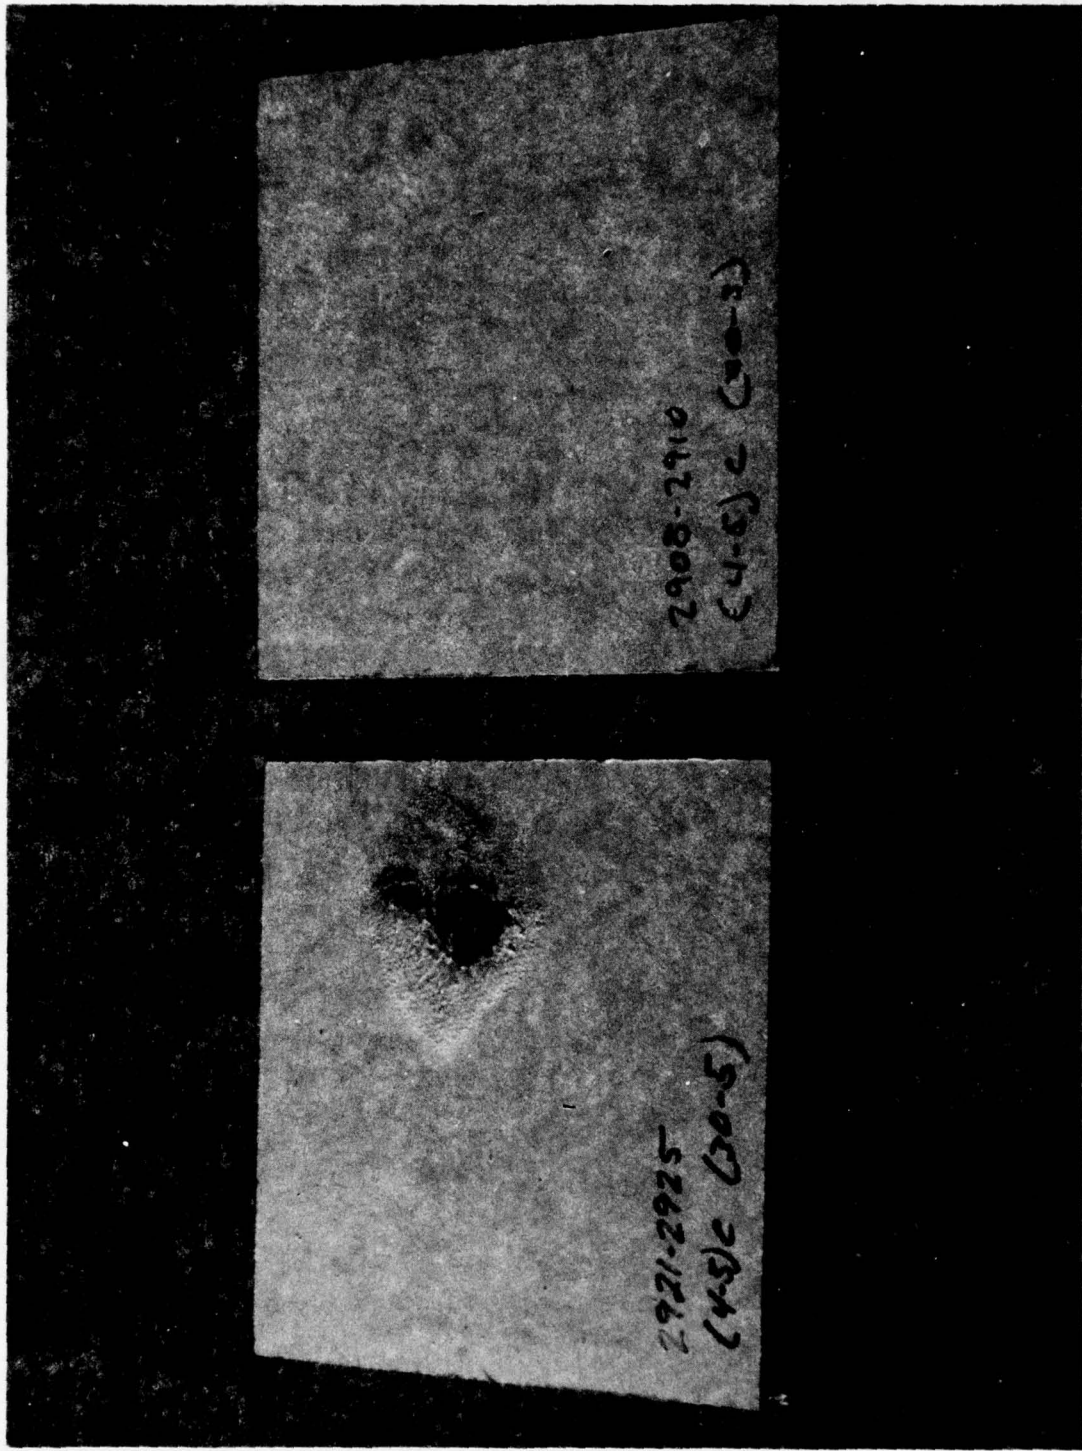
Figure II. System 4 - five vs three flashes at 30 cal/cm^2 .

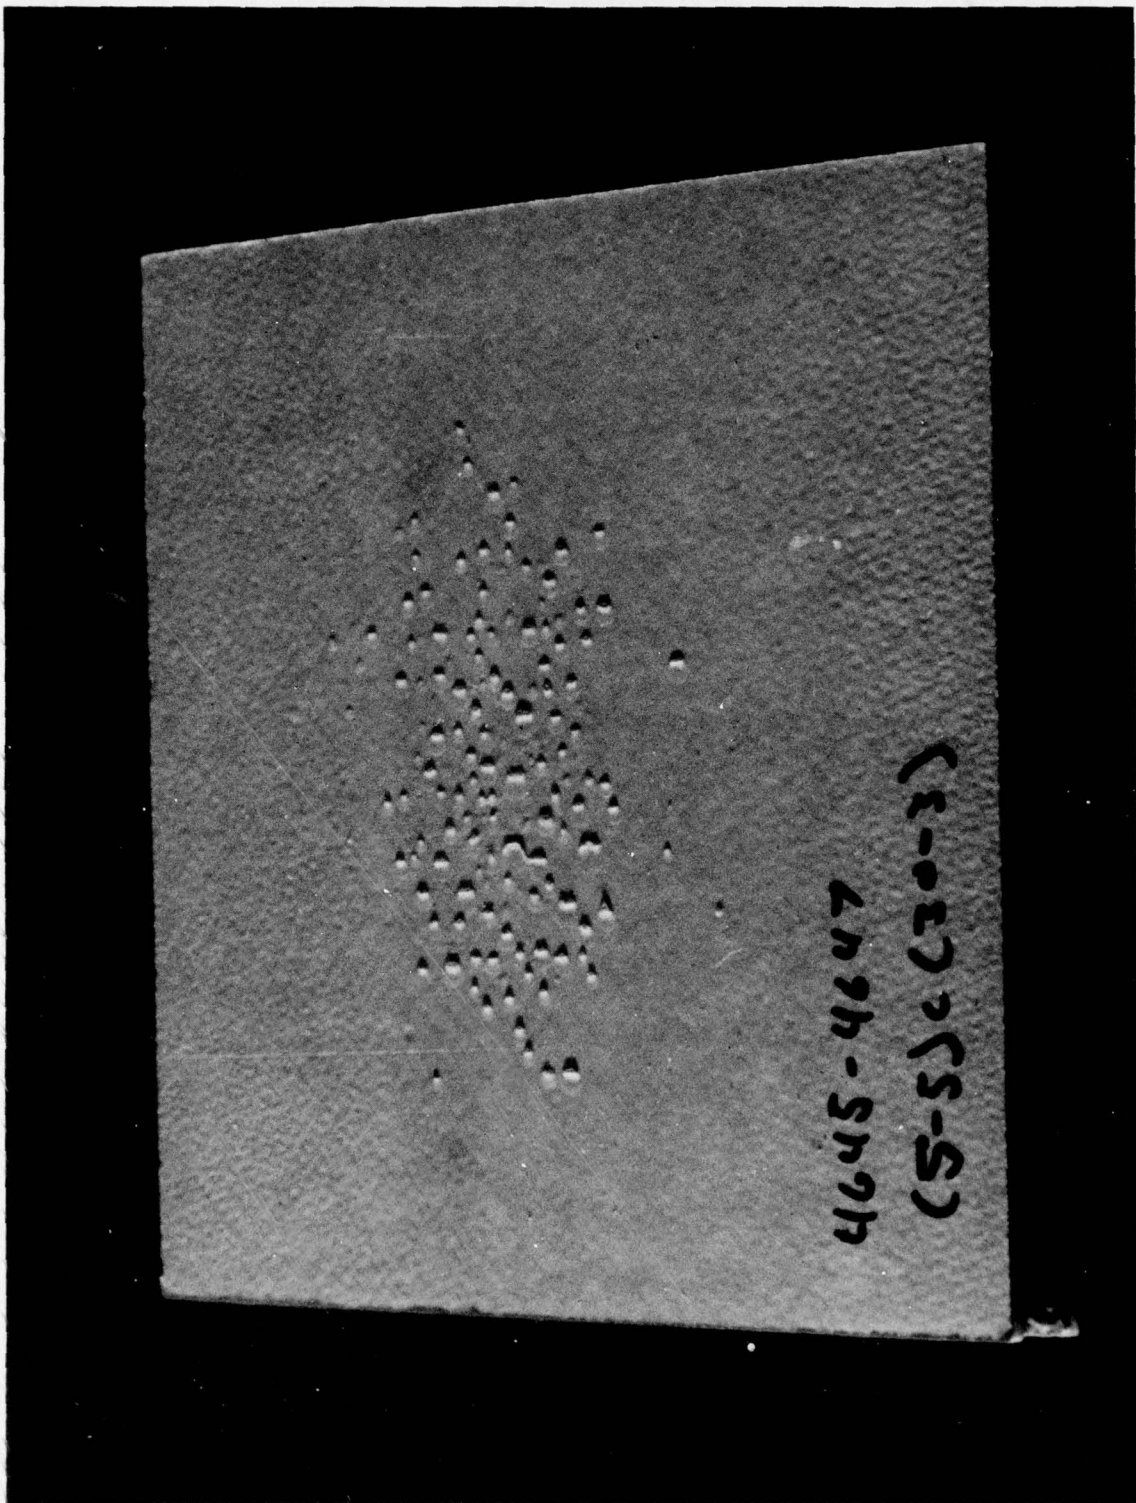
Figure 12. System 4 - paint blistering at 50 cal/cm^2 .

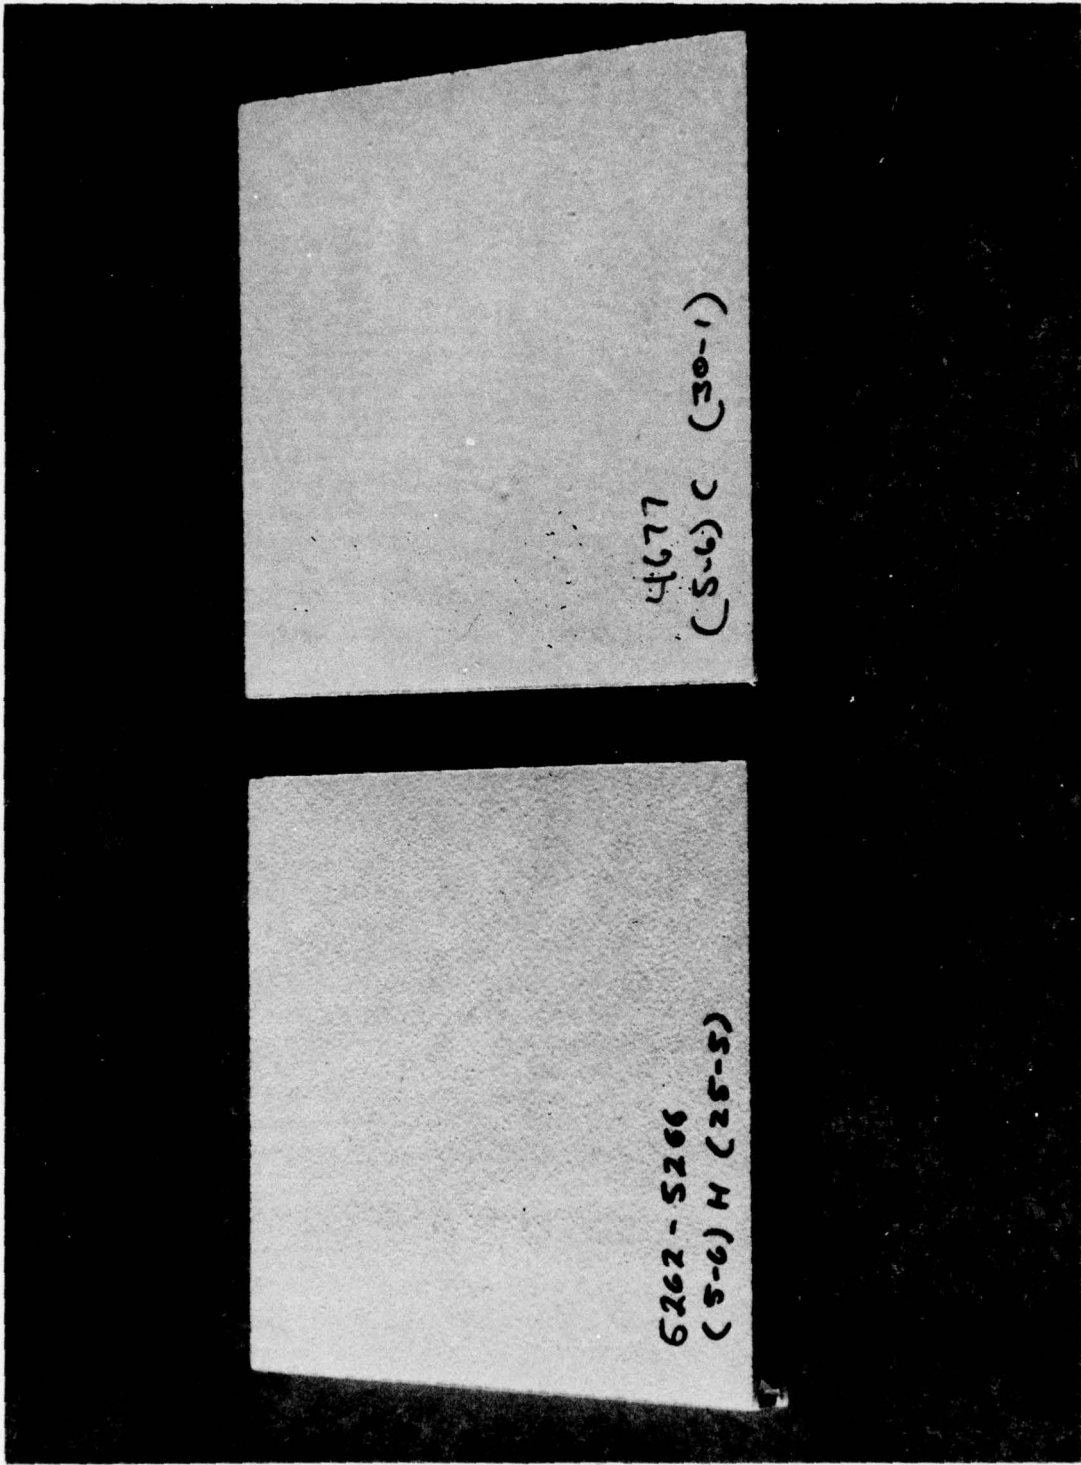
Figure 13. System 5 - coating after 25 and 30 cal/cm² exposure.
