THE NUCLEAR THERMAL EFFECTS ON HUMIDITY SATURATED COMPOSITE MATERIALS

Rockwell International Corporation
Los Angeles Division
P.O. Box 92098
Los Angeles, California 90009

February 1979

Final Report for Period December 1977-February 1979

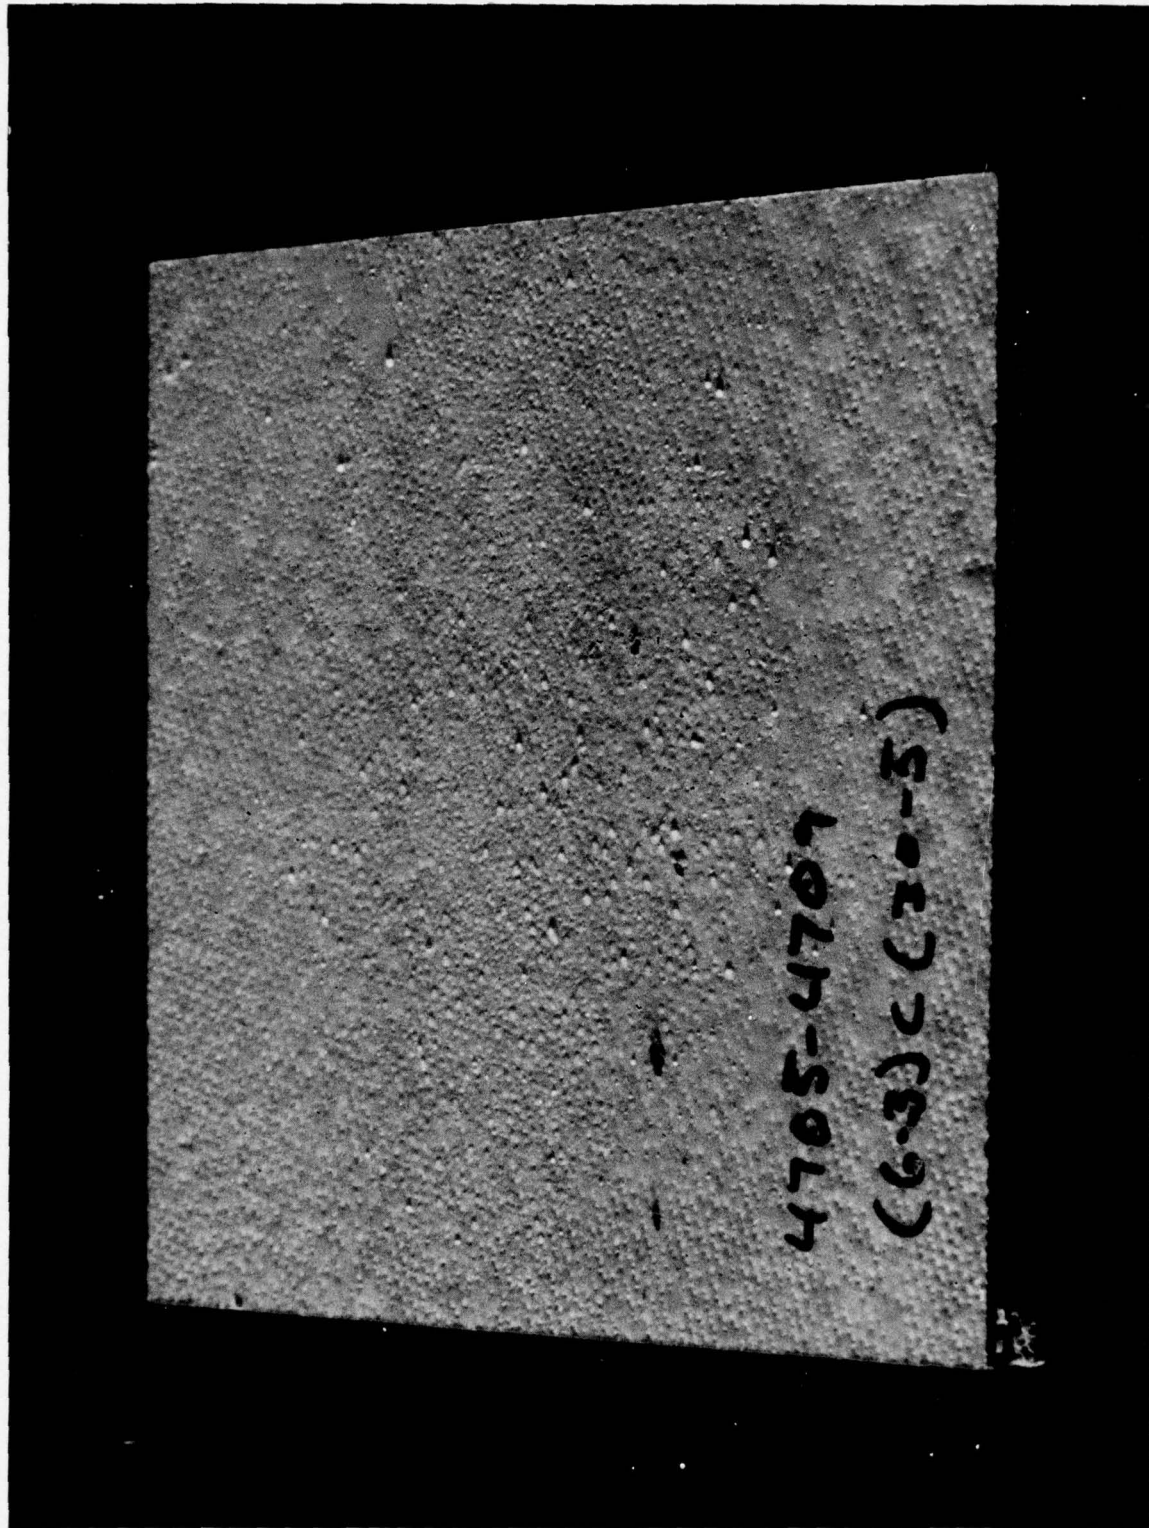
System 6 dry composites suffered paint discoloration and blistering at all structural thicknesses at the 30 cal/cm² energy level. (See Figure 14.) The paint degradation became progressively worse through five flashes, but no composite delamination occurred. The humidity-saturated composite severely delaminated after one flash at all structural thicknesses when exposed to the 30 cal/cm² energy level. This damage can be seen in Figure 15. The sample on the right was dry, while the left sample was saturated. The blistering and delamination is readily visible in the saturated specimen.

Figure 14. System 6 - threshold damage.

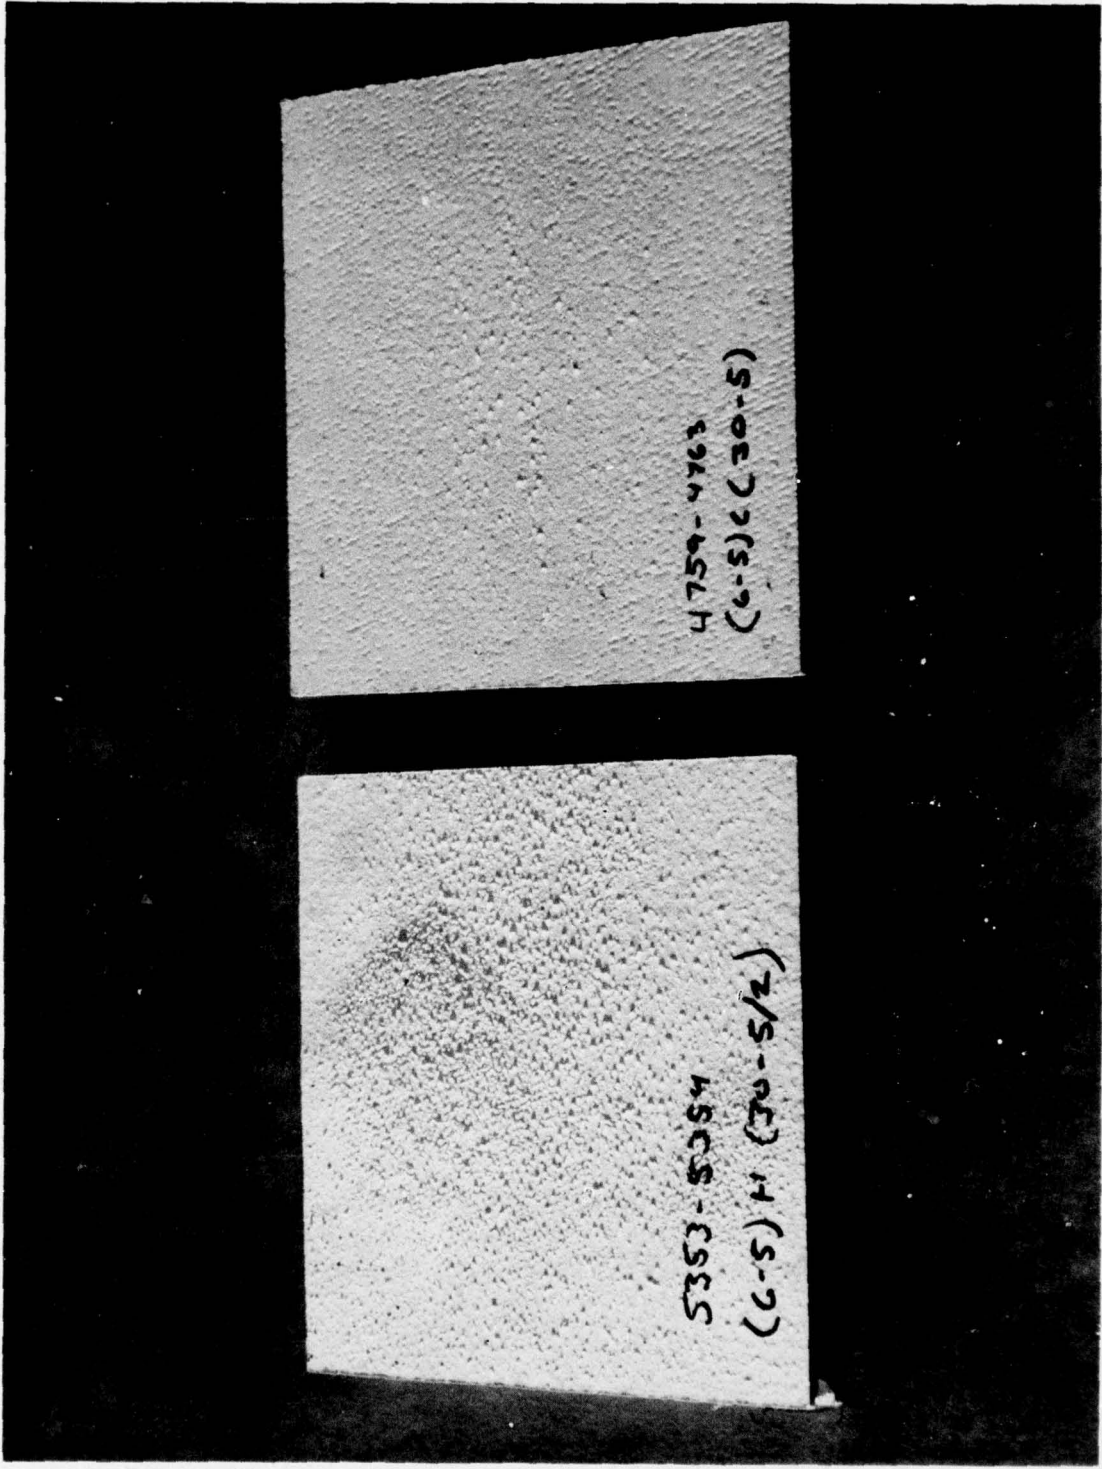
Figure 15. System 6 - humidity saturation vs dry specimens.

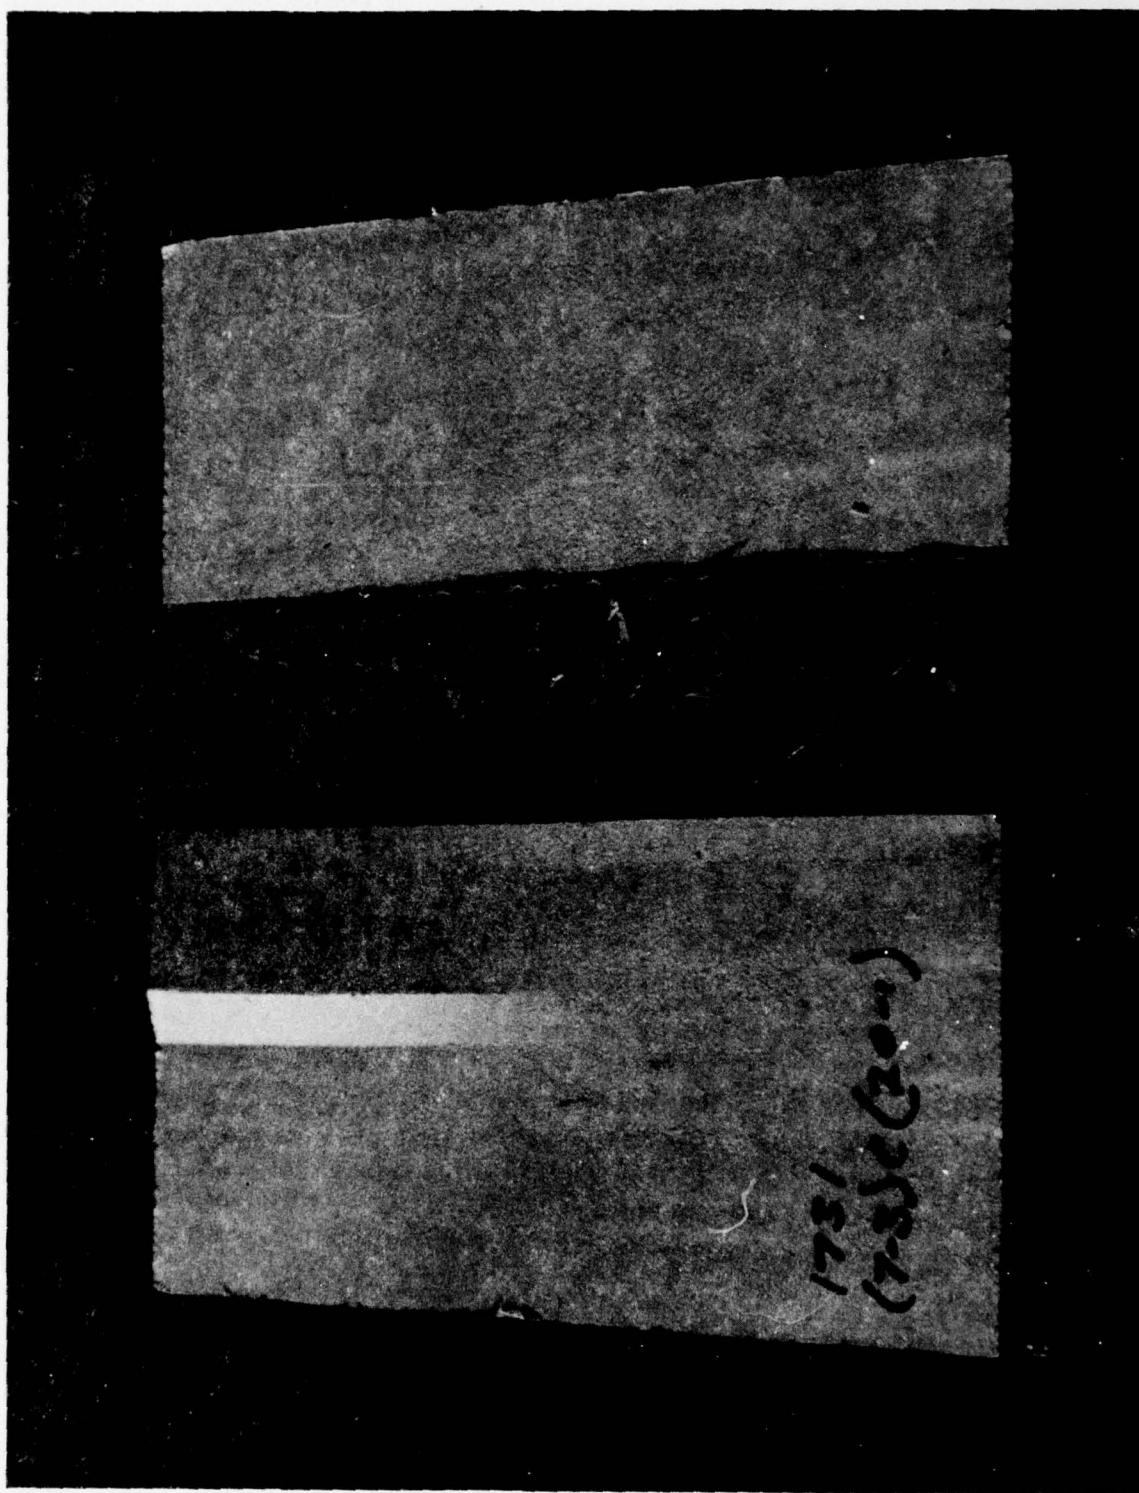
System 7 three-ply material, both dry and humidity-saturated, suffered severe coating and laminate surface charring and delamination after only one flash. Figure 16 shows the one flash damage to a three-ply laminate at 20 cal/cm². The four-, five-, and six-ply laminates, both dry and humidity-saturated, suffered paint degradation after one flash. After each subsequent flash, the degradation became more severe, with blistering and charring after five flashes.

Figure 16. System 7 - damage to 5-ply specimen at 20 cal/cm^2 .

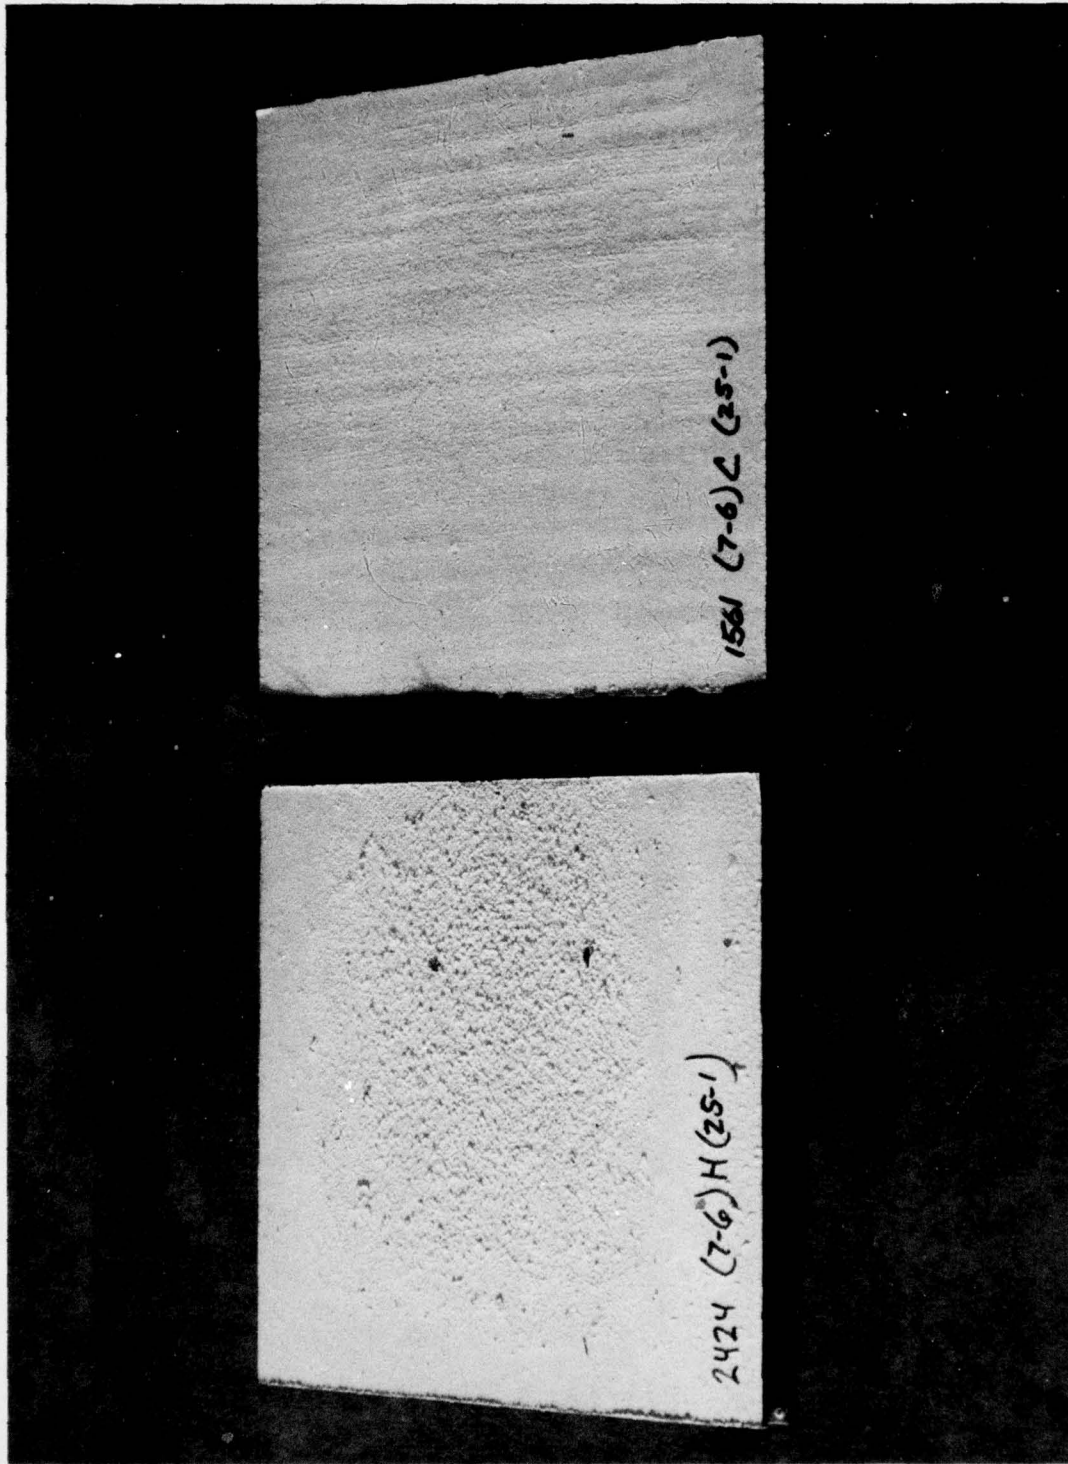
Figure 17. System 7 - humidity saturated as dry specimen at 25 cal/cm².

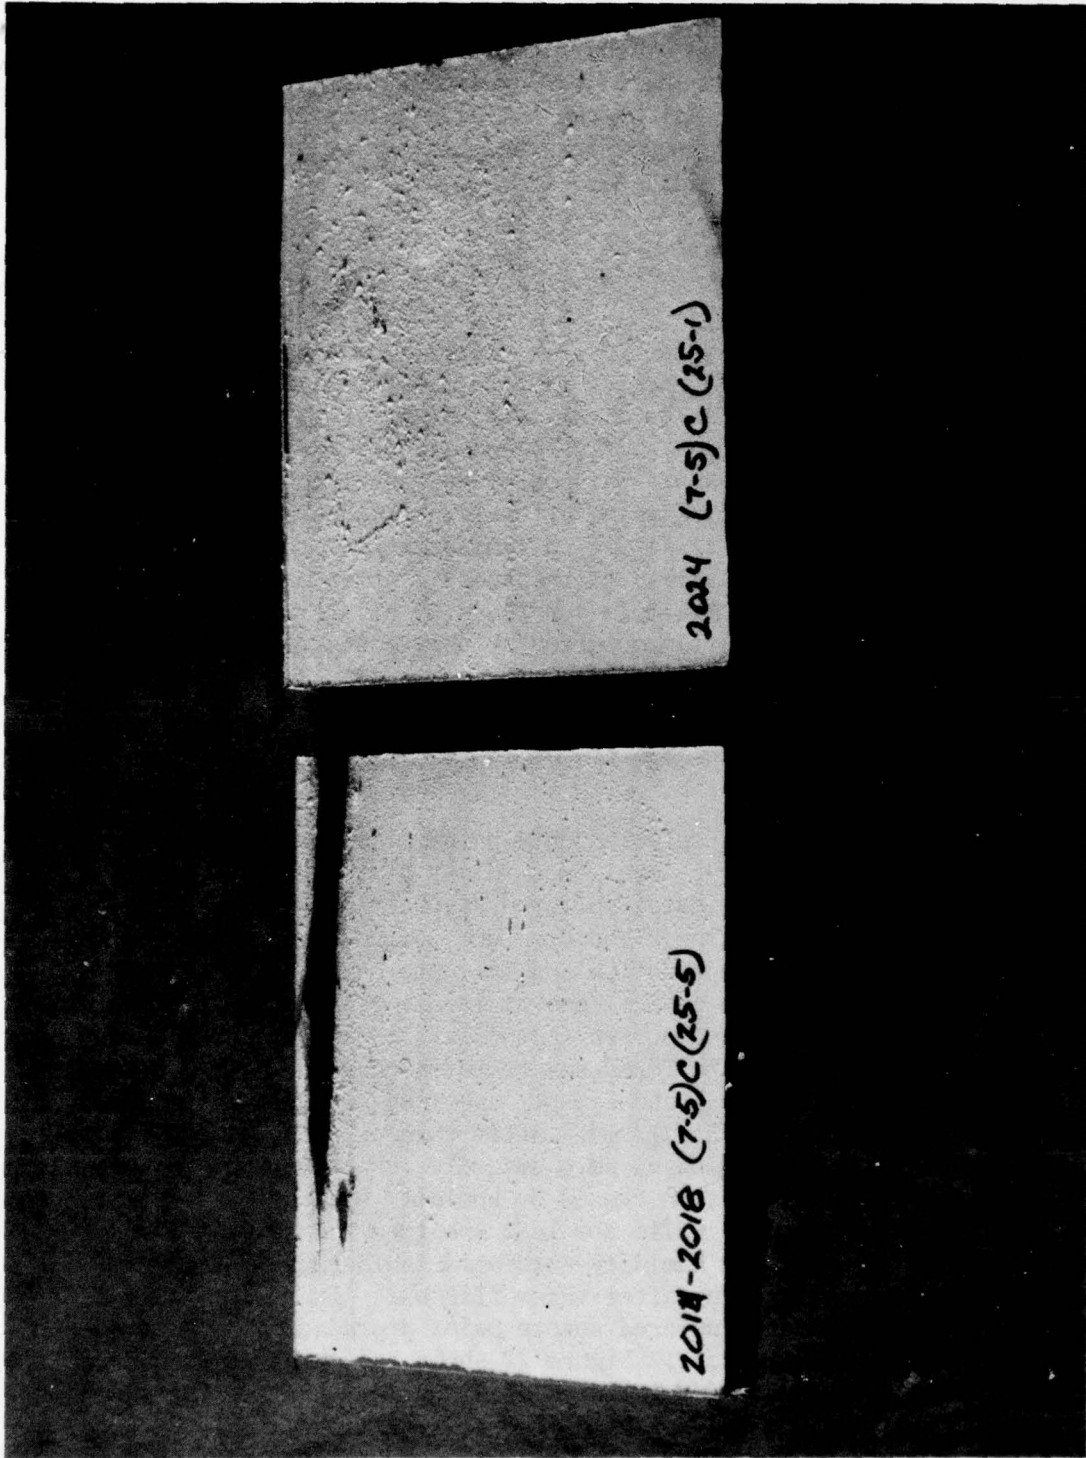
System 7 dry and humidity saturated, 3- and 4-ply composite suffered severe coating and composite charring after one flash at the 25 cal/cm² energy level. The dry, 5- and 6-ply material suffered only paint degradation after up to five flashes at the 25 cal/cm² energy level. The humidity saturated 5- and 6-ply laminates suffered some surface charring of the resin matrix and some removal of the reflective coating after only one flash. Figure 17 is a comparison of a dry 6-ply laminate after one flash at 25 cal/cm², and a saturated 6-ply laminate tested at the same level. Note the increased paint damage in the saturated specimen. Figure 18 illustrates the effect of multiple flashes on a five-ply laminate at 25 cal/cm². After one flash, the right specimen has coating damage; after five flashes, the left specimen shows charring of the laminate.

Figure 18. System 7 - one flash vs five flashes at 25 cal/cm².

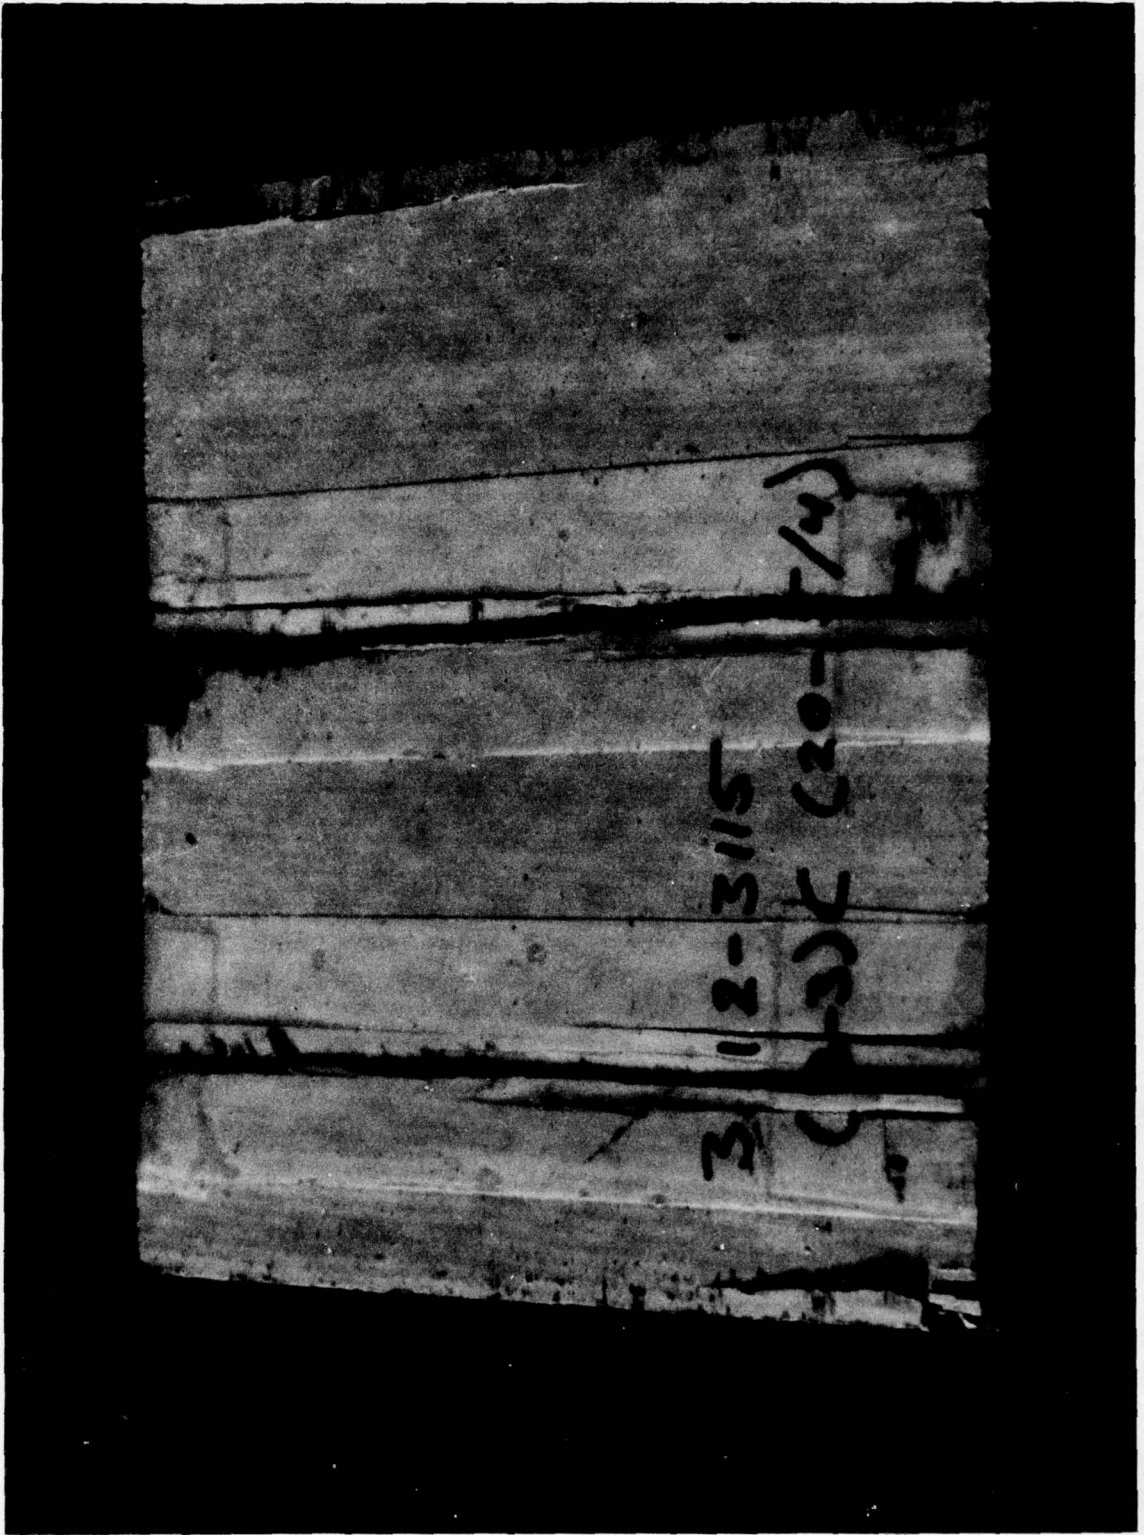
The dry three-ply laminate suffered paint discoloration after one flash, paint blistering and charring after three flashes, and severe resin-matrix degradation and laminate delamination after four flashes. This degradation is shown in Figure 19. The dry four-, five-, and six-ply laminates suffered paint discoloration after one flash. This paint degradation progressed after each flash to blisters and charring after five flashes at the 20 cal/cm² energy level. All of the humidity-saturated laminates suffered paint discoloration after one flash, regardless of thickness. After each subsequent flash, the paint degradation became more severe, with blisters and charring after five flashes. No delamination occurred at this energy level on the humidity saturated laminates.

Figure 19. System 8 - damage after four flashes at 20 cal/cm^2 .

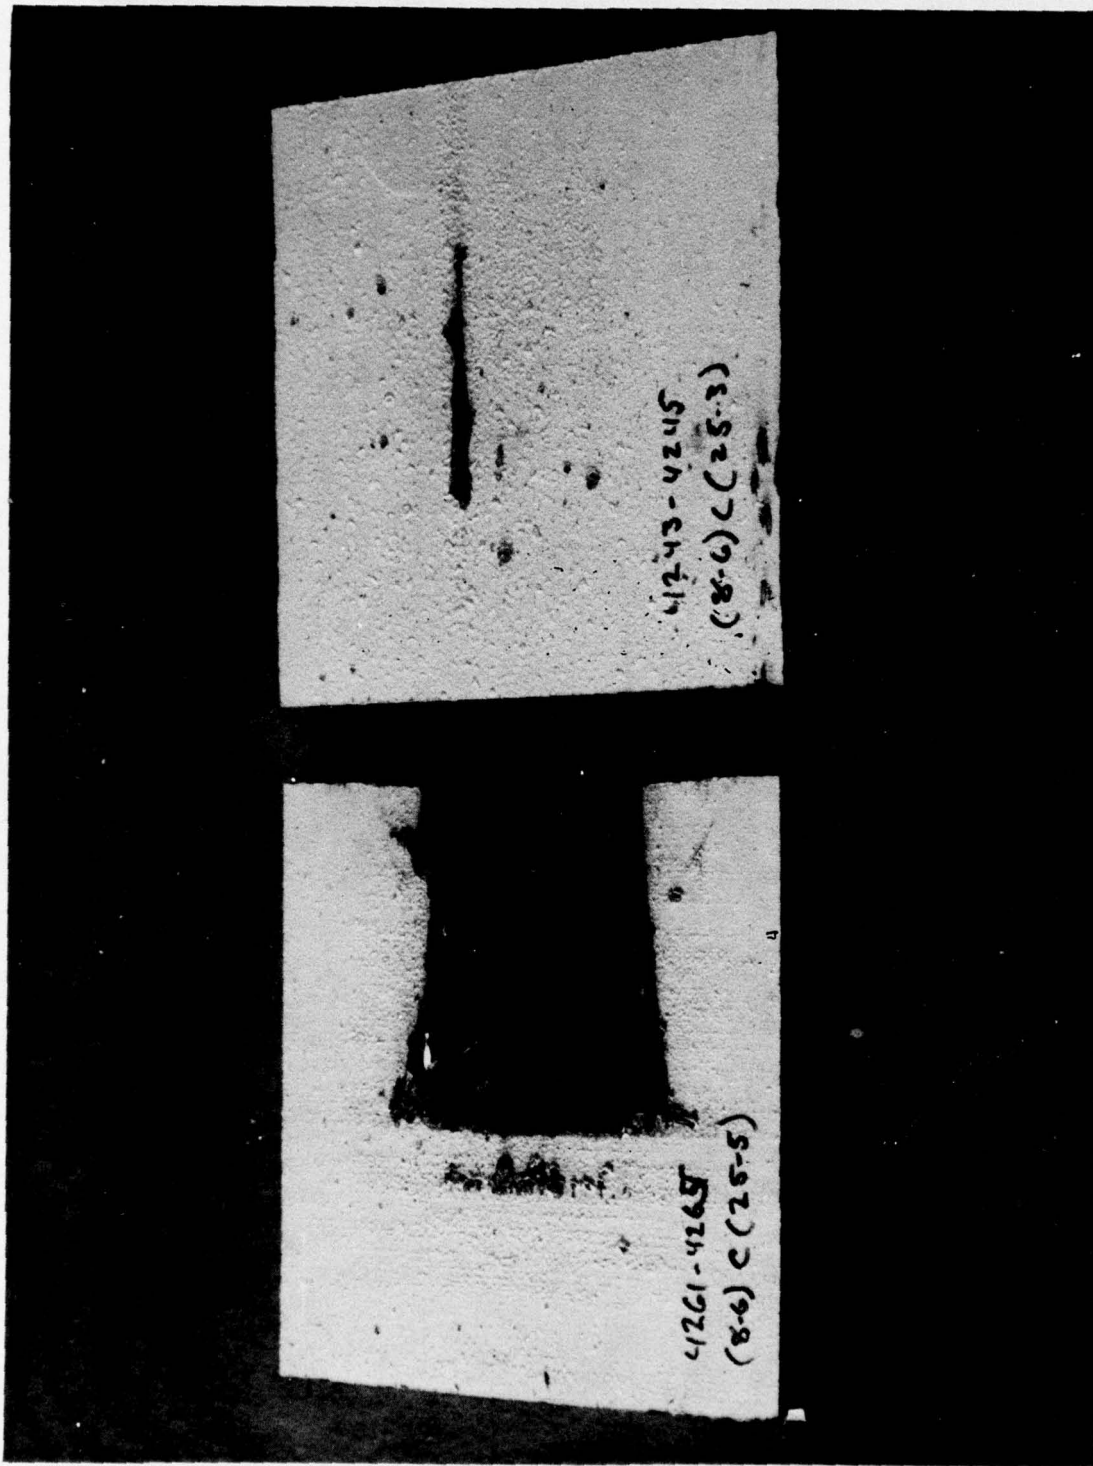
Figure 20. System 8 - progressive damage, three to five flashes at 25 cal/cm².

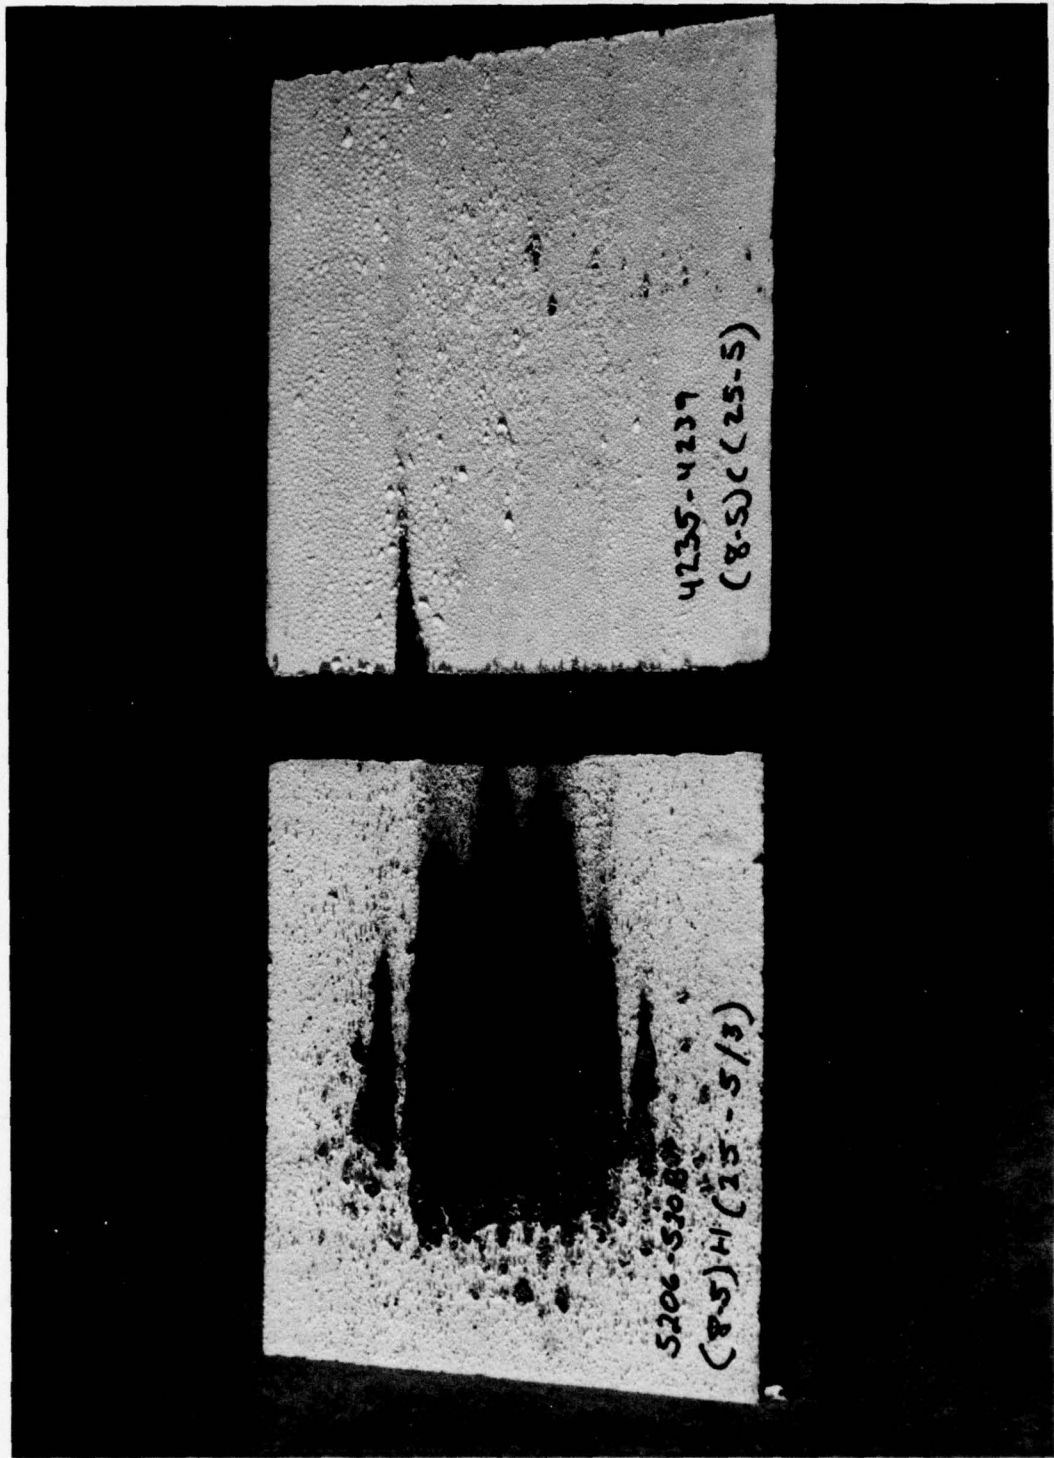
Figure 21. System 8 - humidity saturated vs dry specimen at 25 cal/cm².

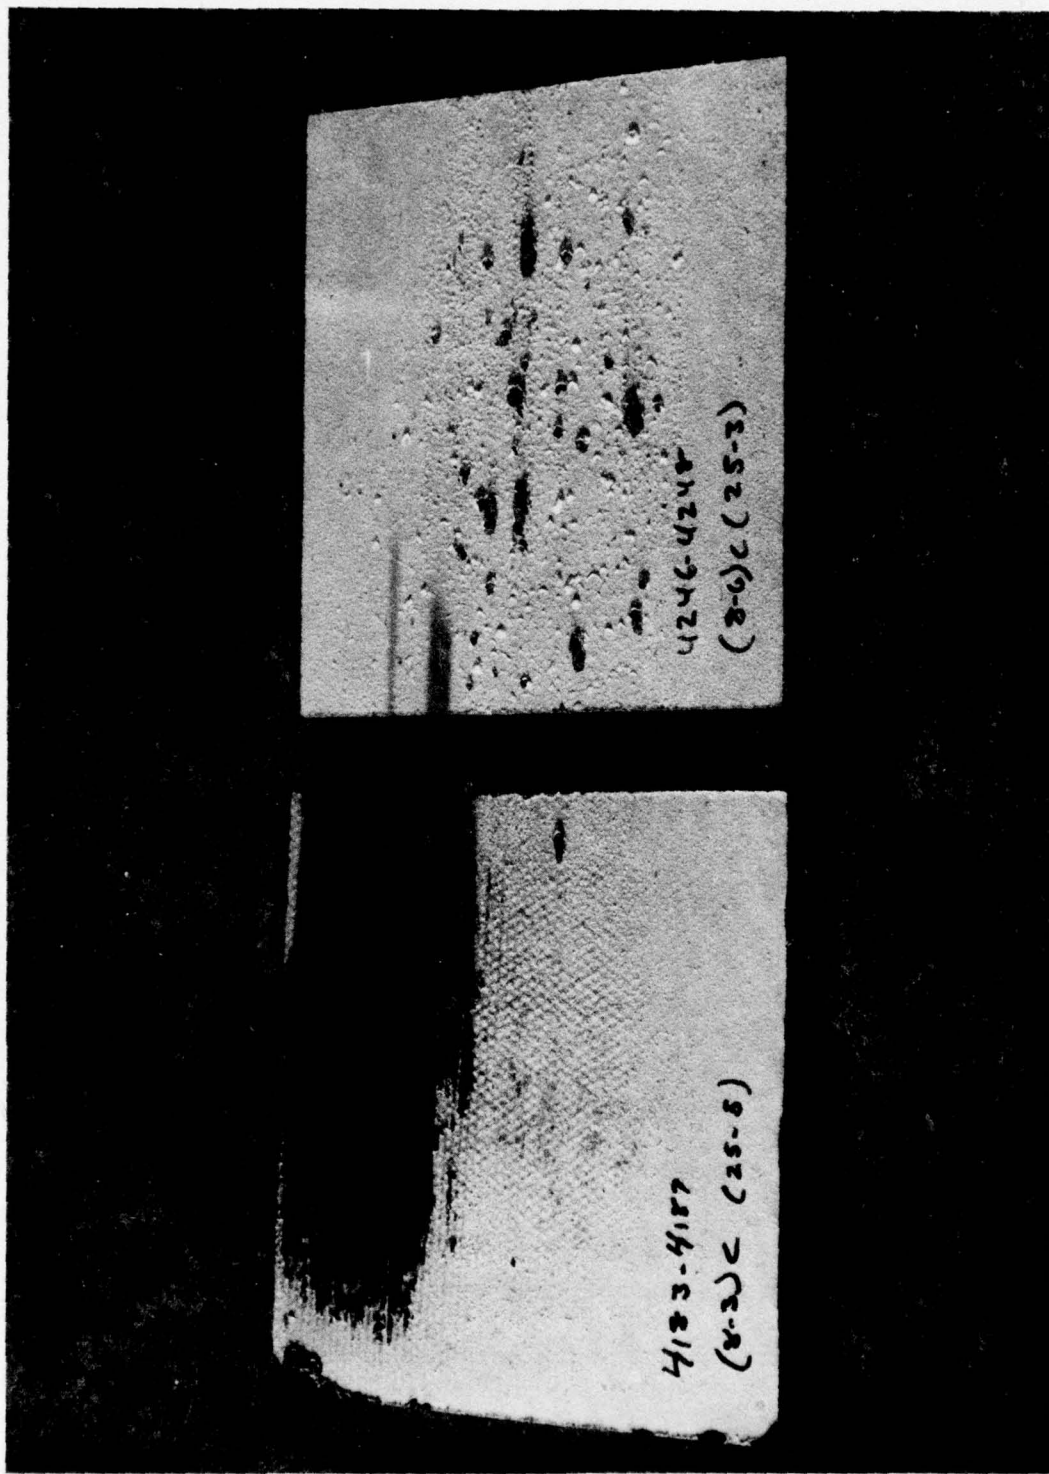
Figure 22. System 8 - 3 vs 6 ply at 25 cal/cm².

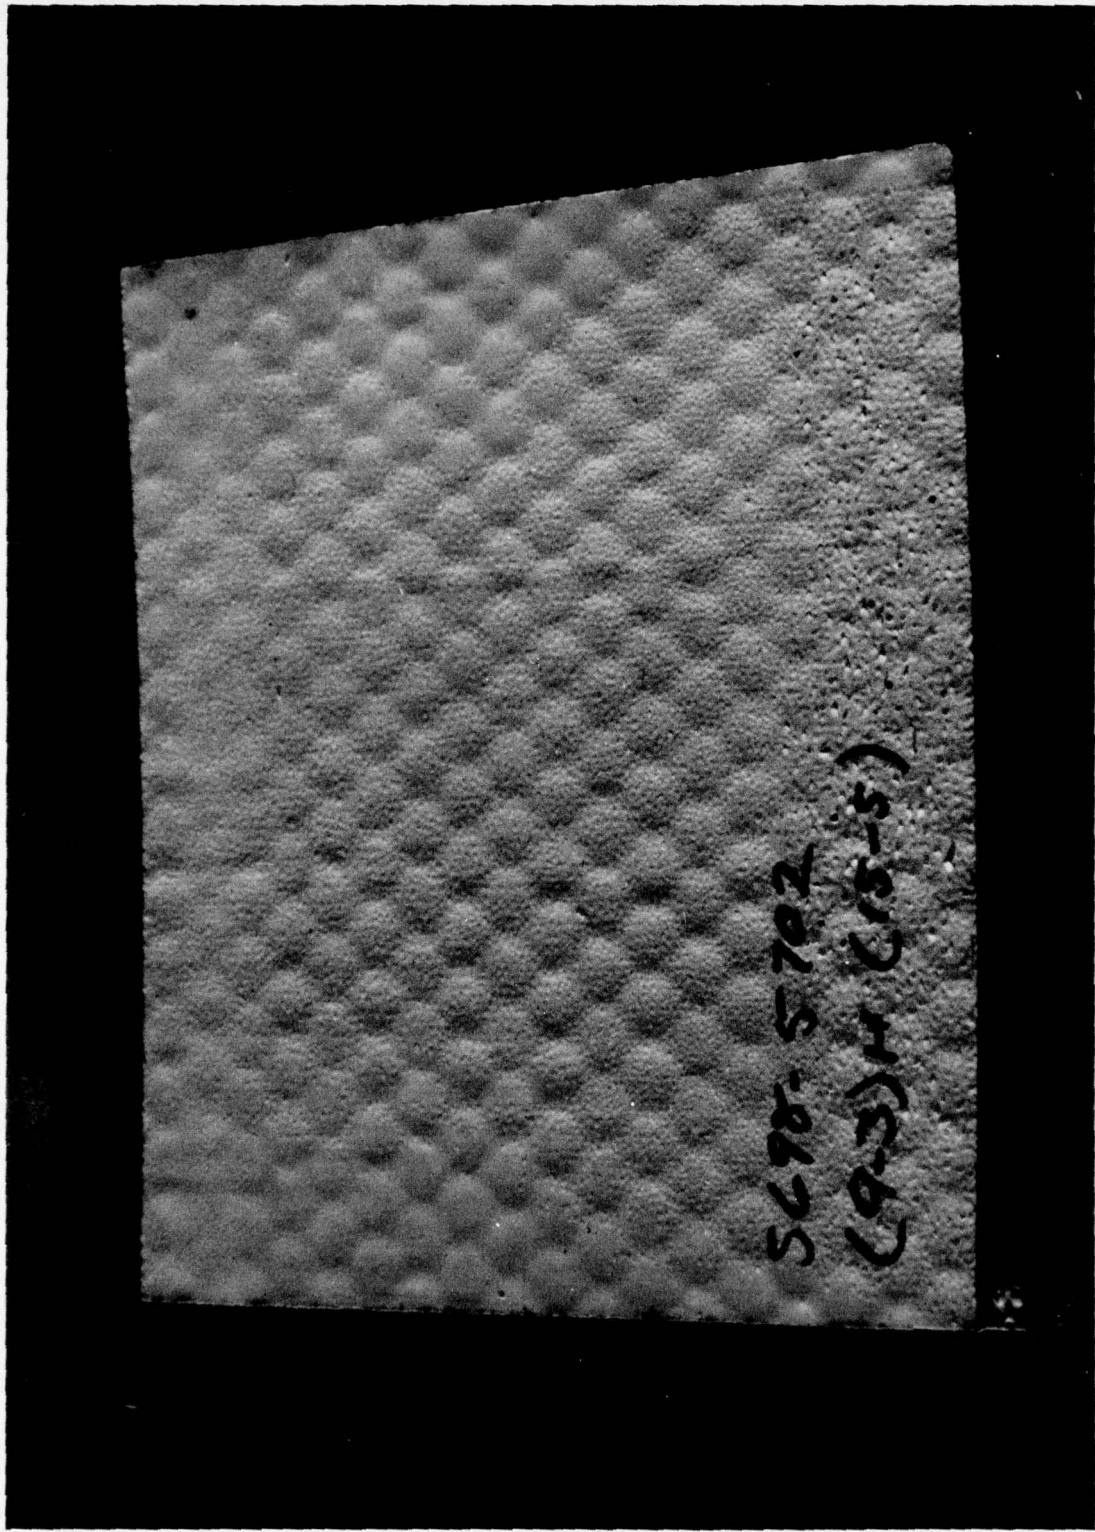
System 9 was unaffected by one flash at the 15 cal/cm² energy level at any structural thickness when dry. After three flashes, the dry three-ply laminate was discolored. The dry four-, five-, and six-ply laminates were unaffected after three flashes at the 15 cal/cm² energy level. After five flashes the three-, four-, and five-ply dry laminates were discolored. The dry six-ply laminate was unaffected by five flashes at the 15 cal/cm² energy level. After humidity saturation, all system 9 laminates suffered paint discoloration and blistering after one flash. Each subsequent flash caused further paint degradation but no laminate charring or delamination. (See Figure 23.)

Figure 25. System 9 - 15 cal/cm² paint degradation.

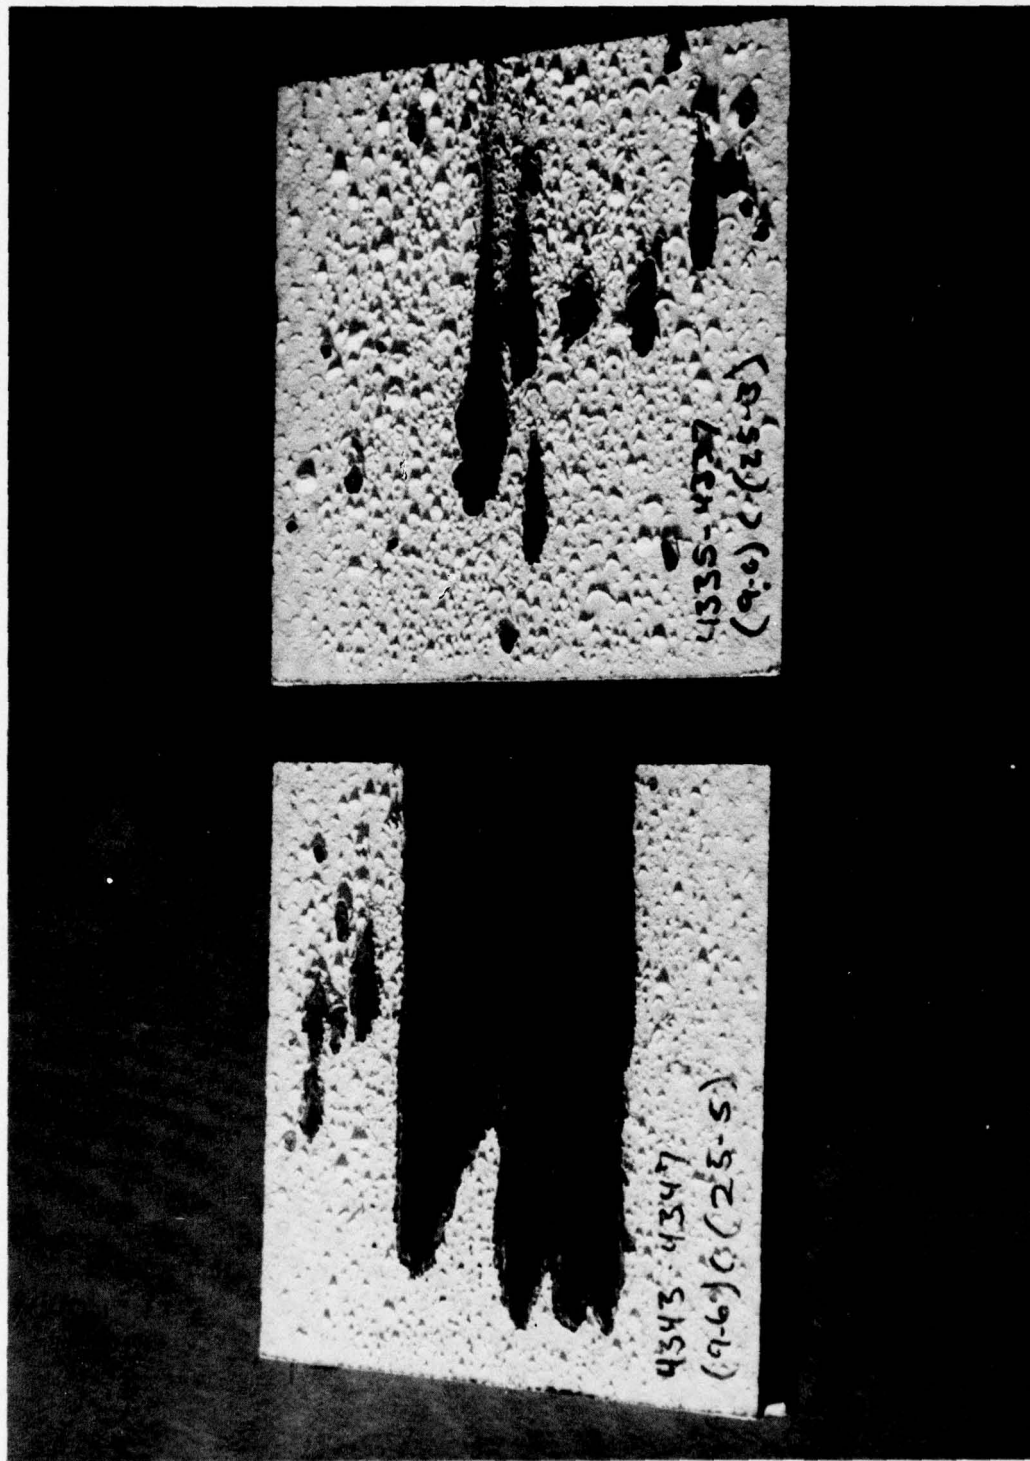
Figure 24. System 9 - progressive degradation from three to five flashes at 25 cal/cm².

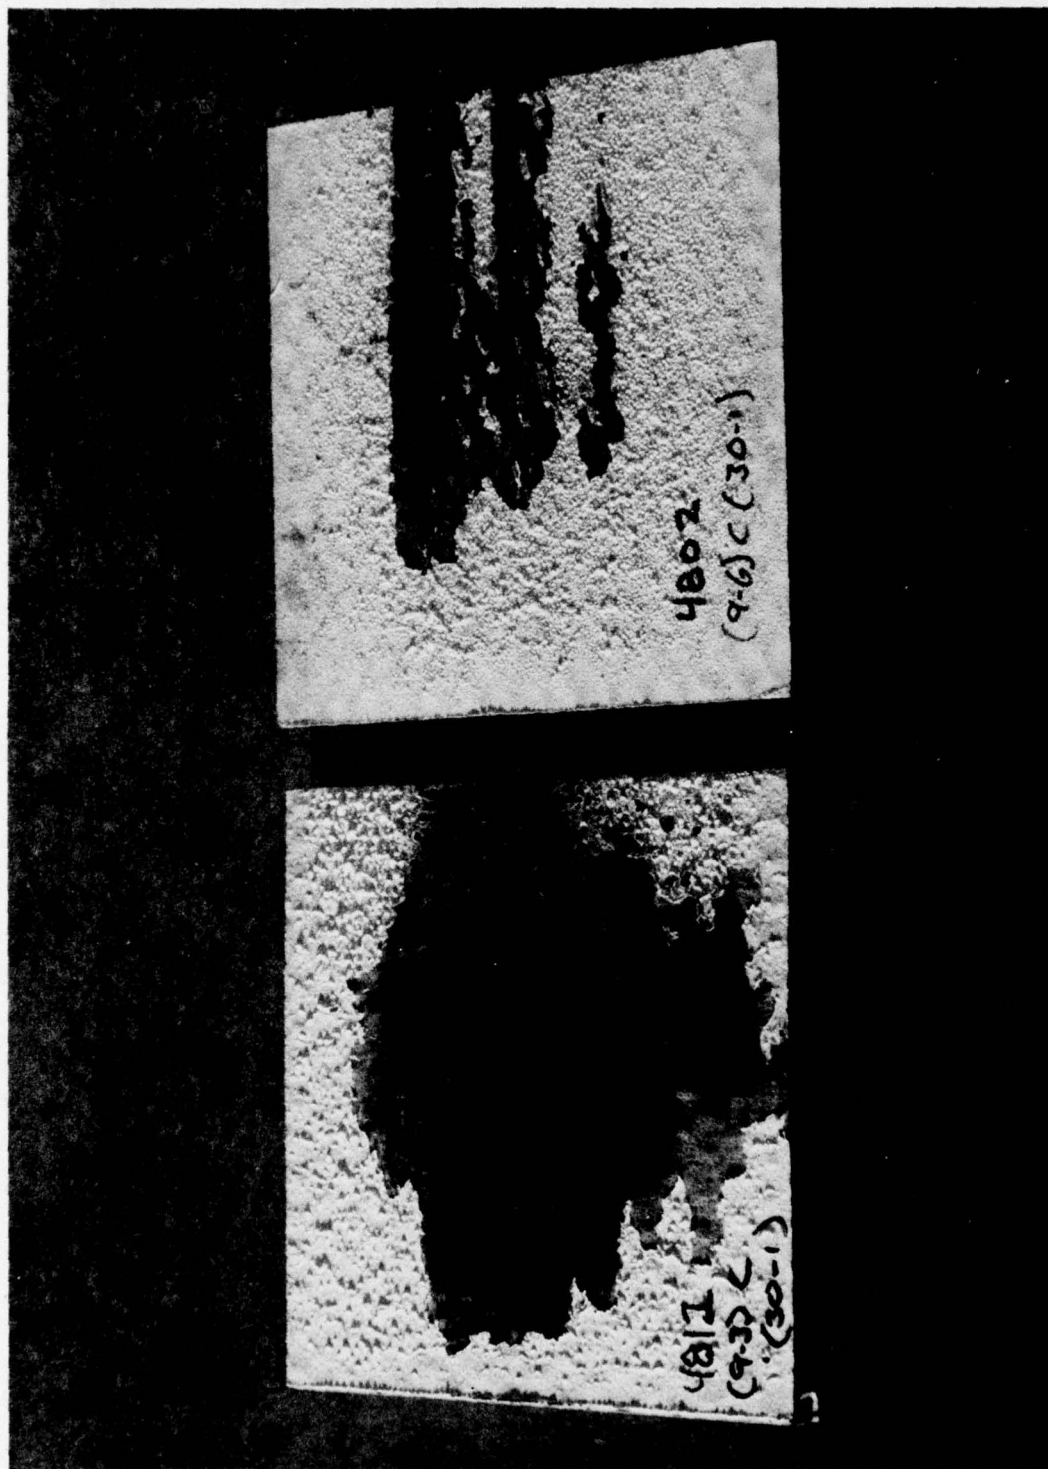
Figure 25. System 9 - 3- vs 6-ply specimen at 30 cal/cm² (one flash).

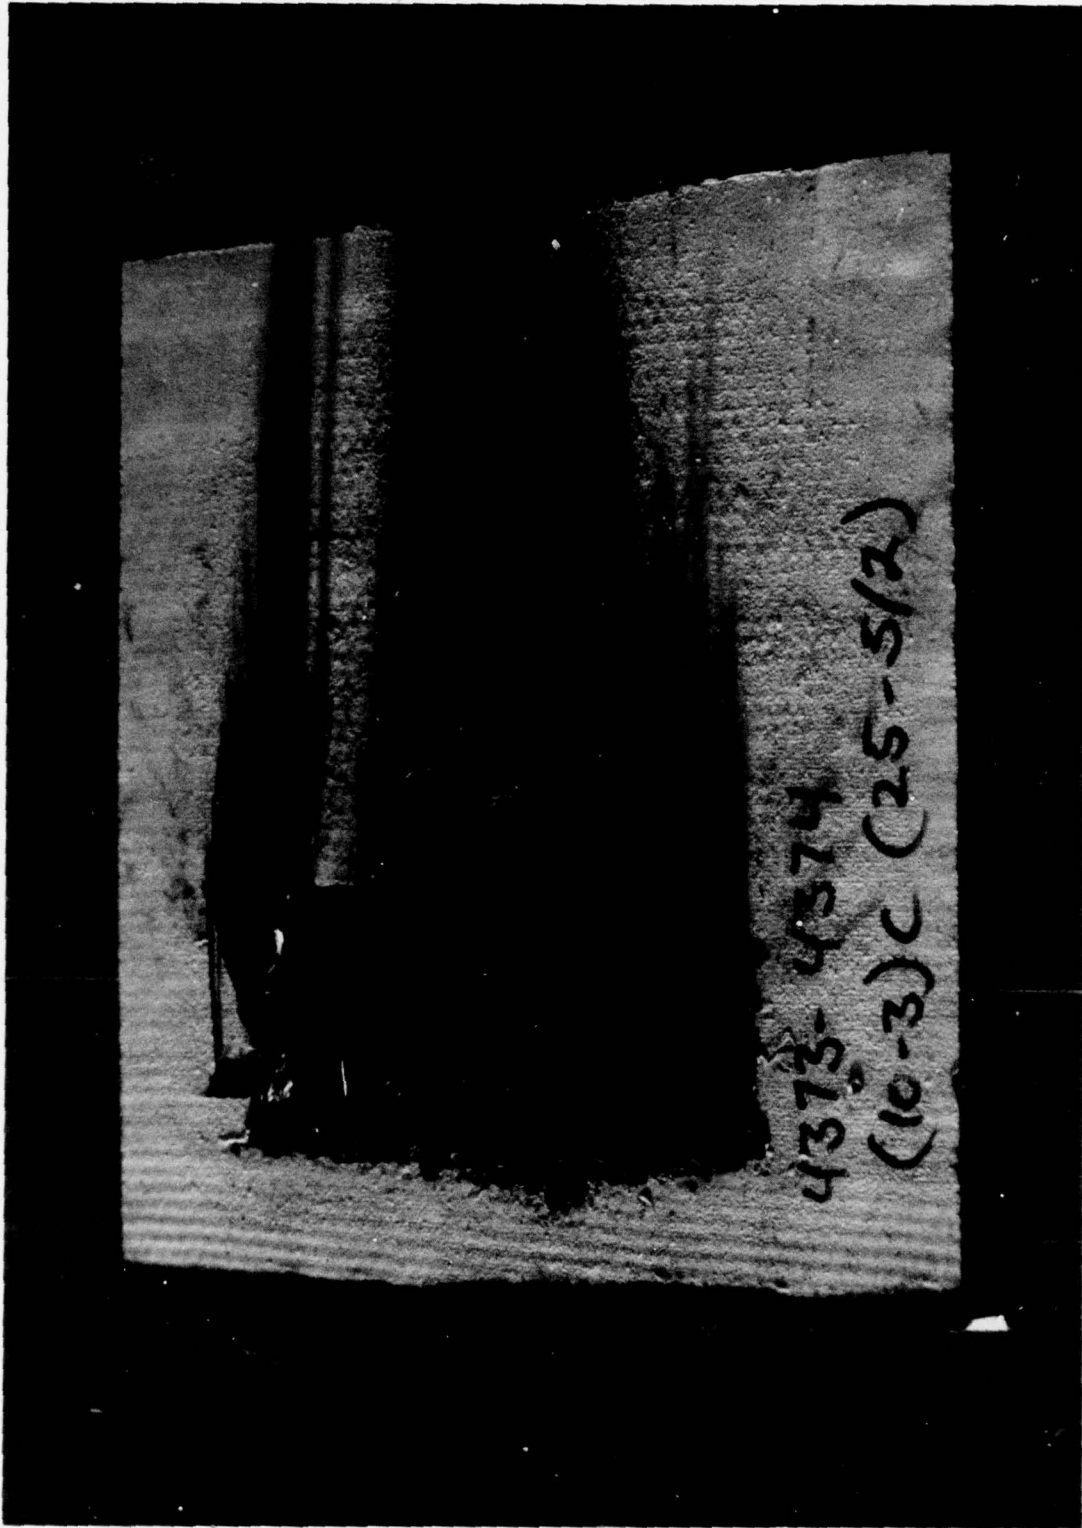
Figure 26. System 10 - specimen degradation after two flashes at 25 cal/cm^2 .
