THE NUCLEAR THERMAL EFFECTS ON HUMIDITY SATURATED COMPOSITE MATERIALS

Rockwell International Corporation
Los Angeles Division
P.O. Box 92098
Los Angeles, California 90009

February 1979

Final Report for Period December 1977-February 1979

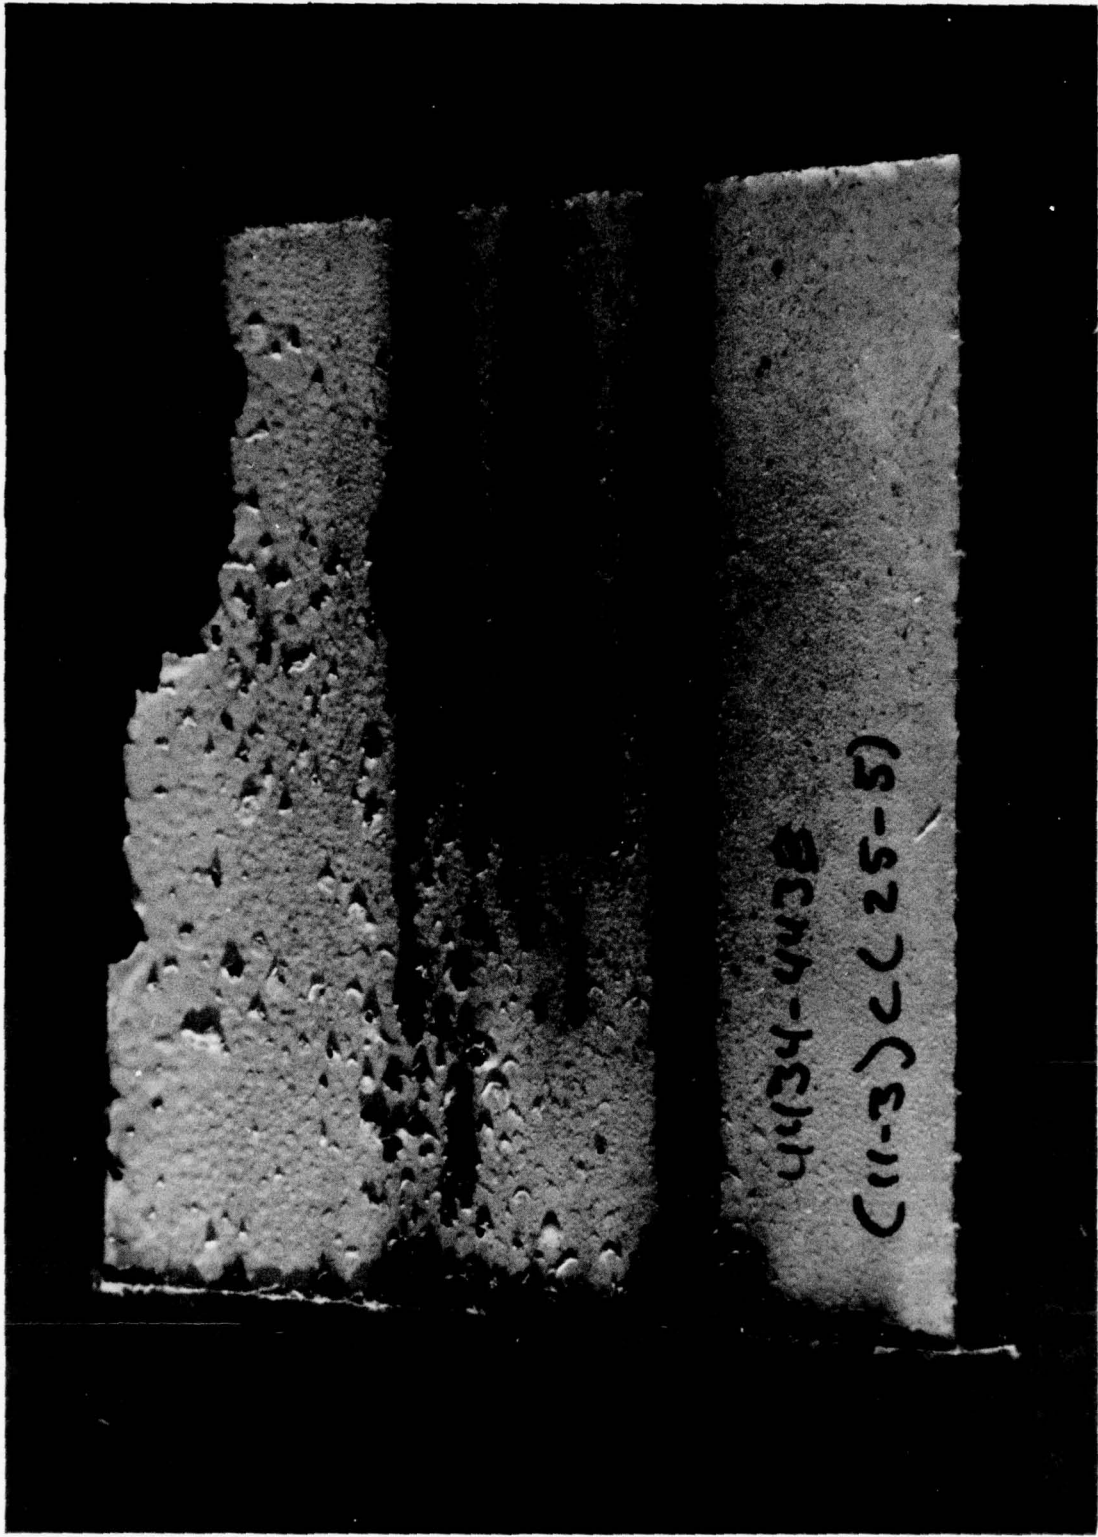
Figure 28. System II - specimen degradation at 25 cal/cm^2 (five flashes).

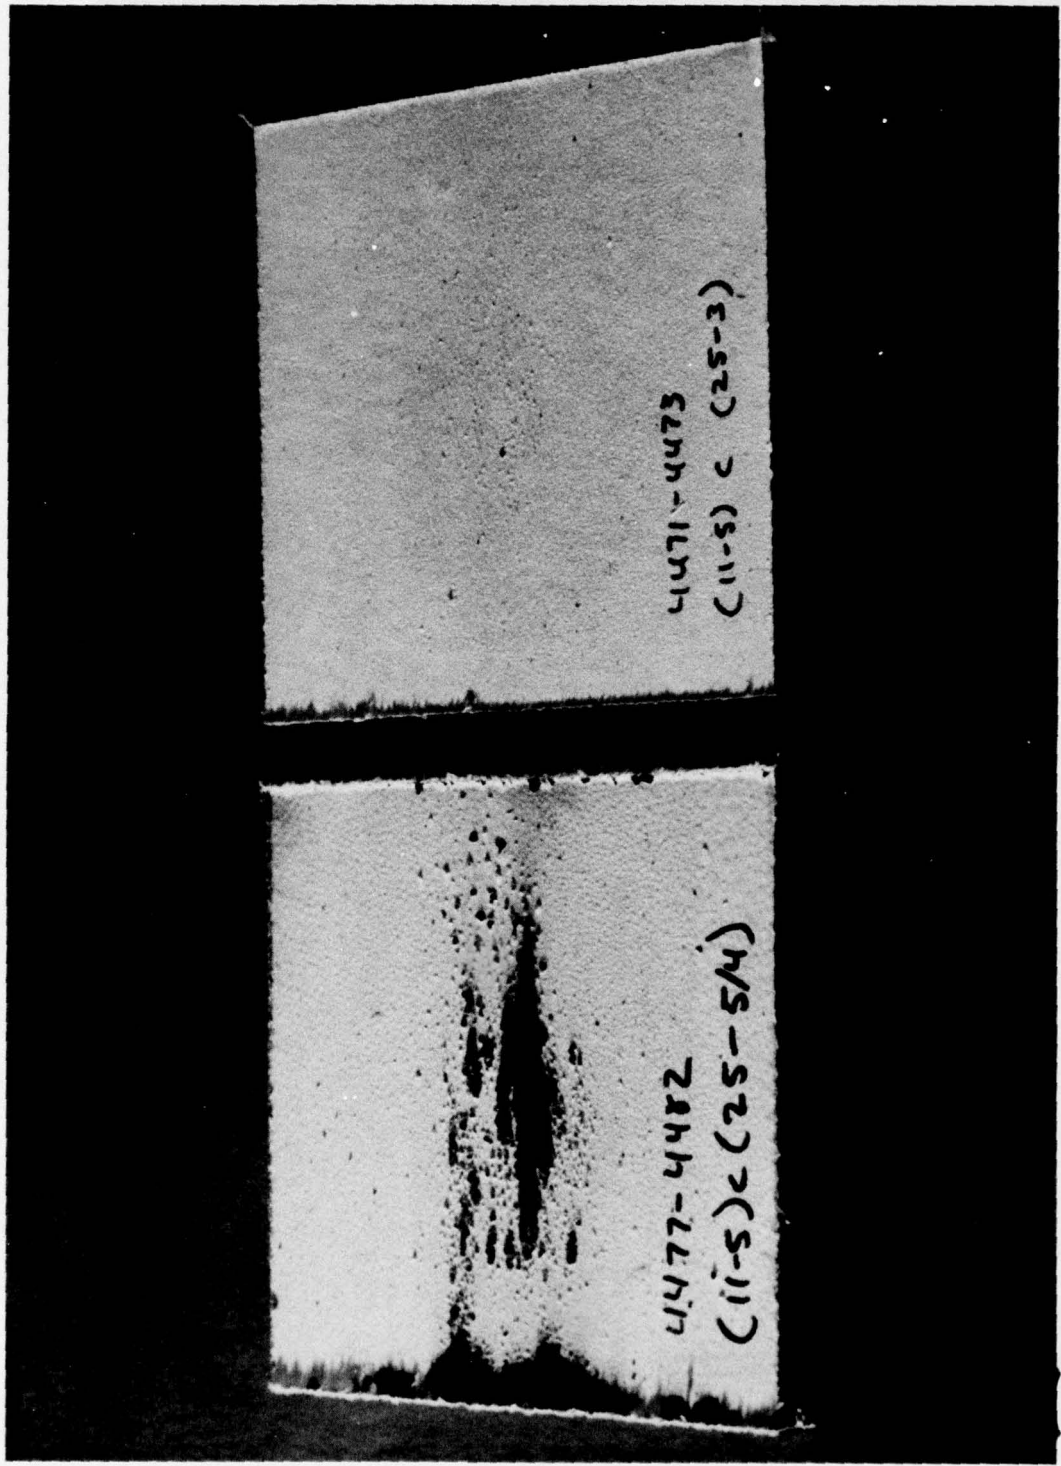
Figure 29. System 11 - three vs four flashes at 25 cal/cm².

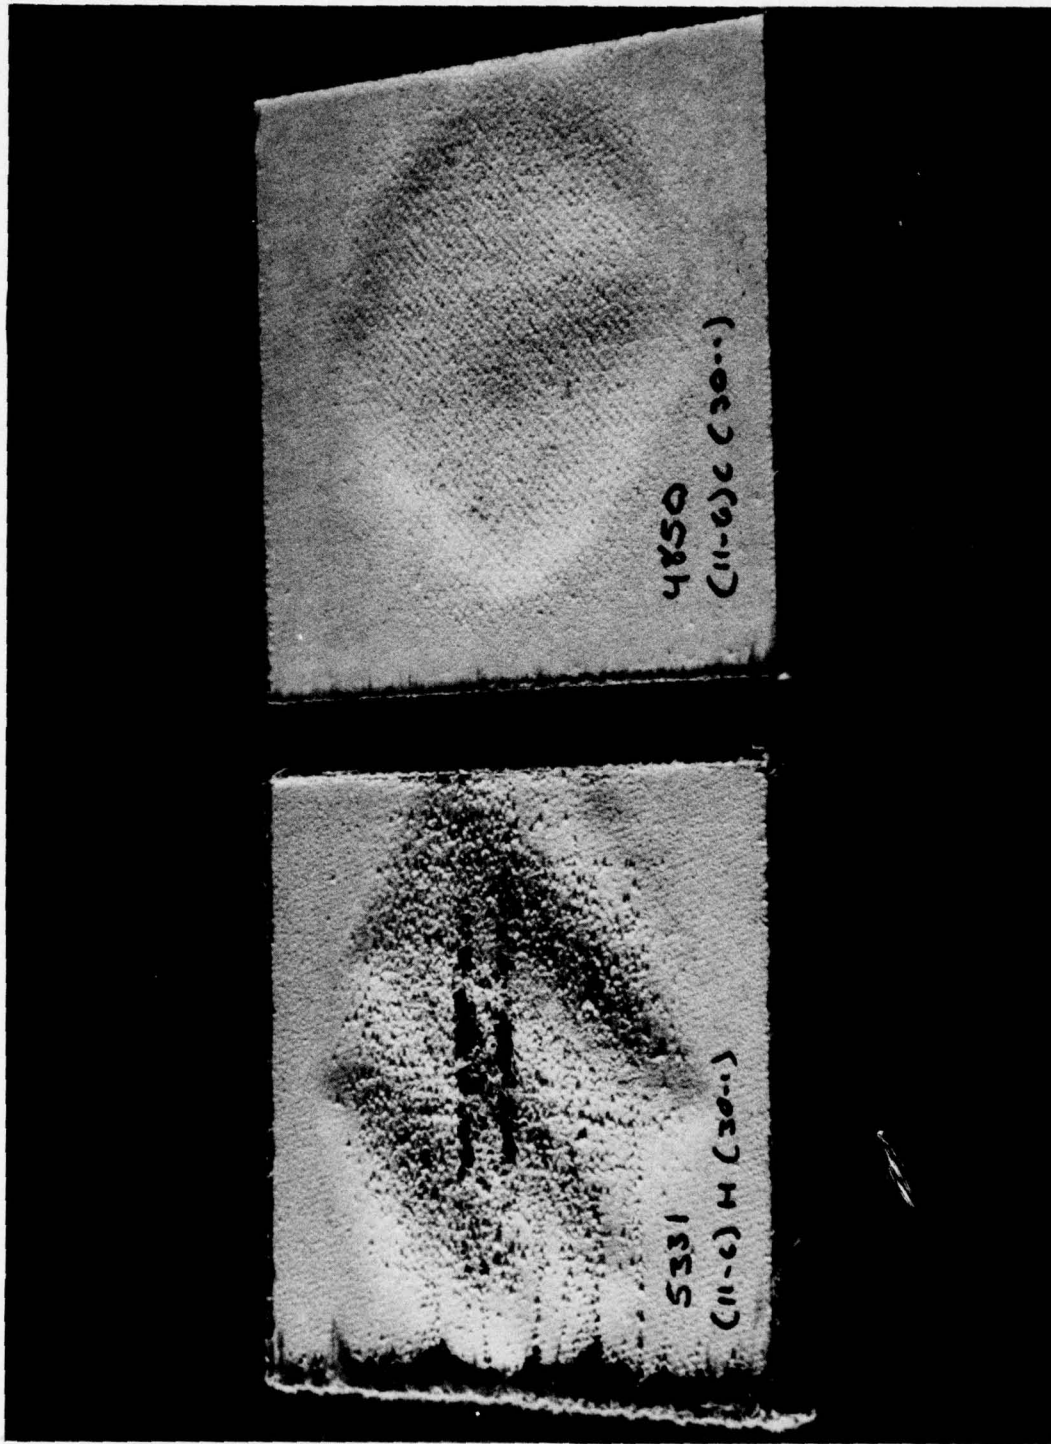
Figure 30. System 11 - resin charring and delamination of 6-ply specimen.

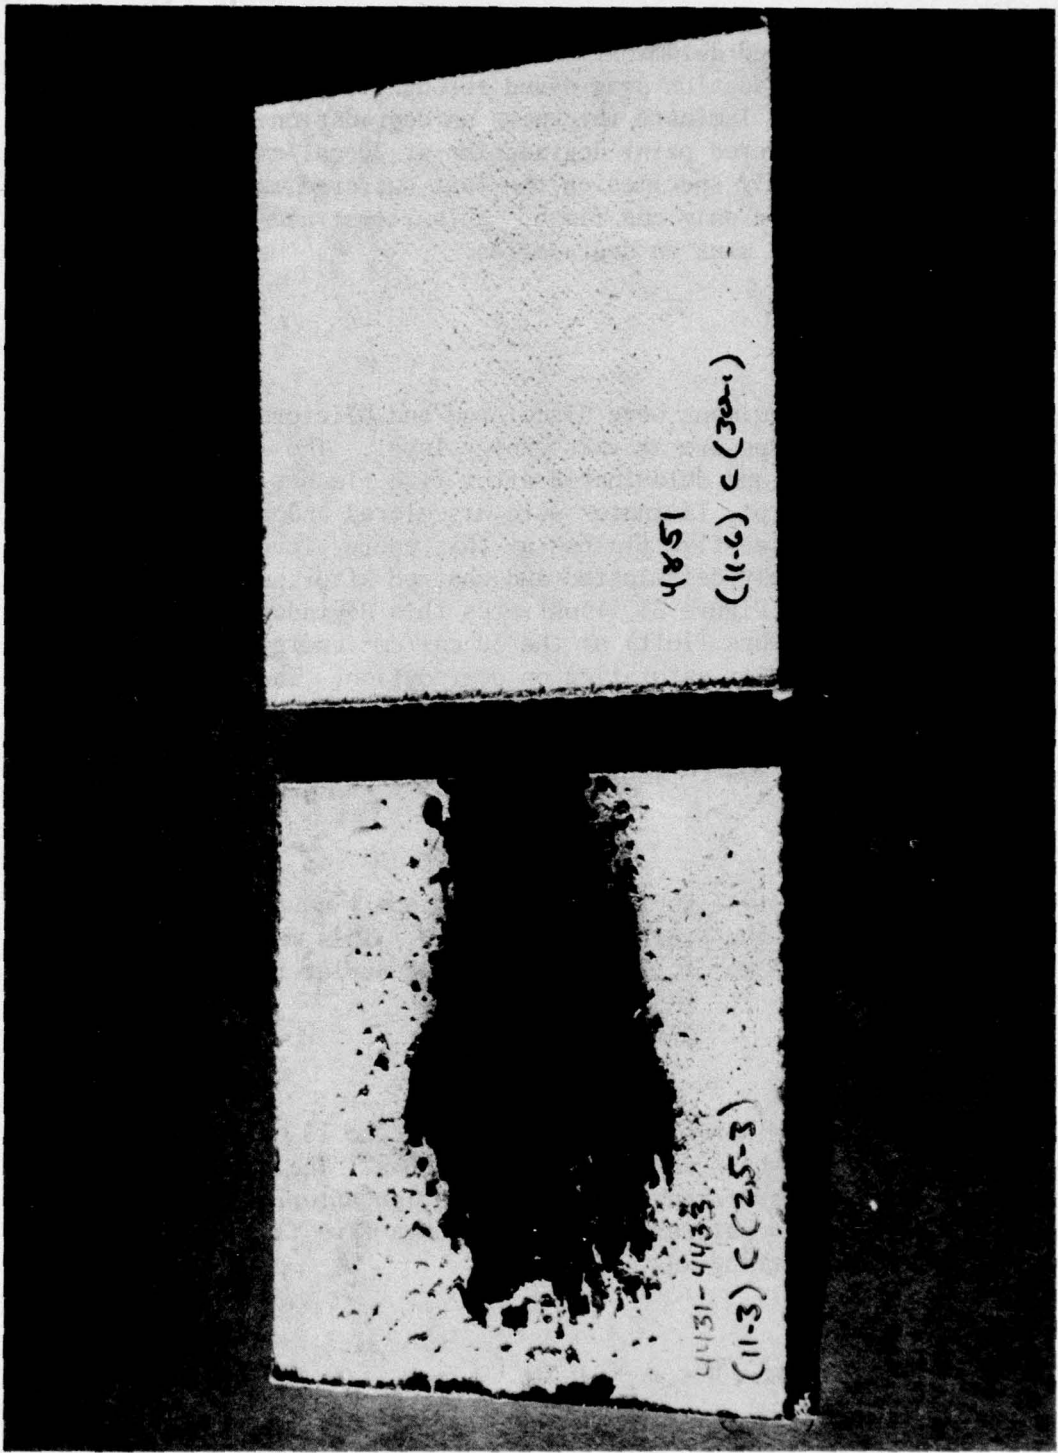
Figure 31. System 11 - 6- vs 3-ply specimen damage.

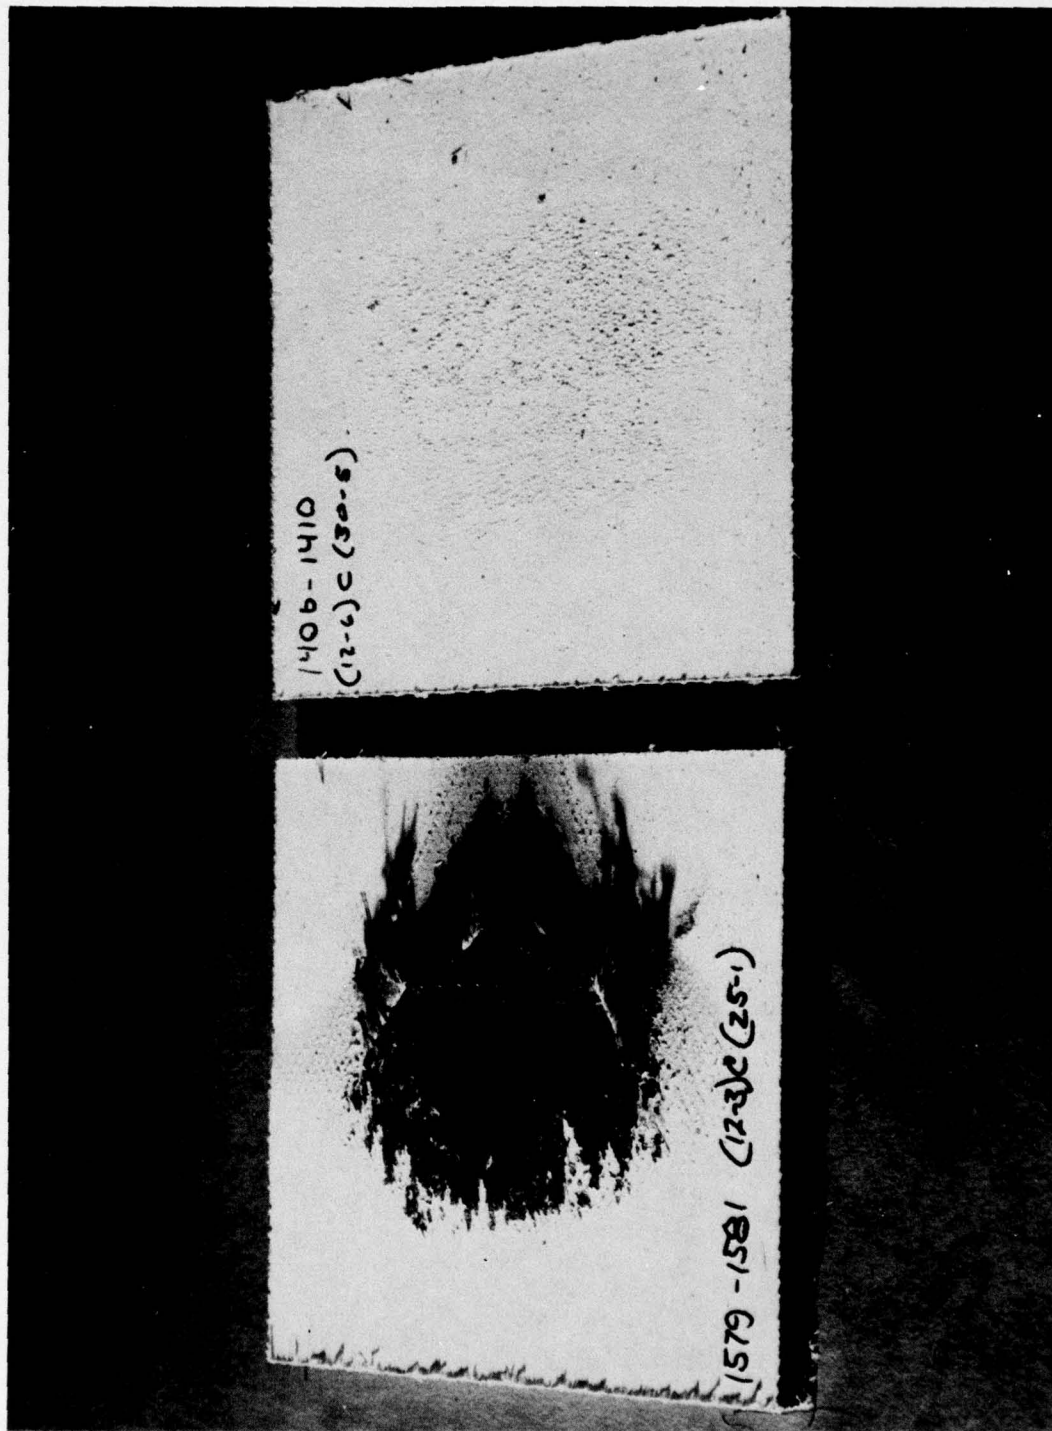
Figure 32. System 12 - 3- vs 6-ply specimen.

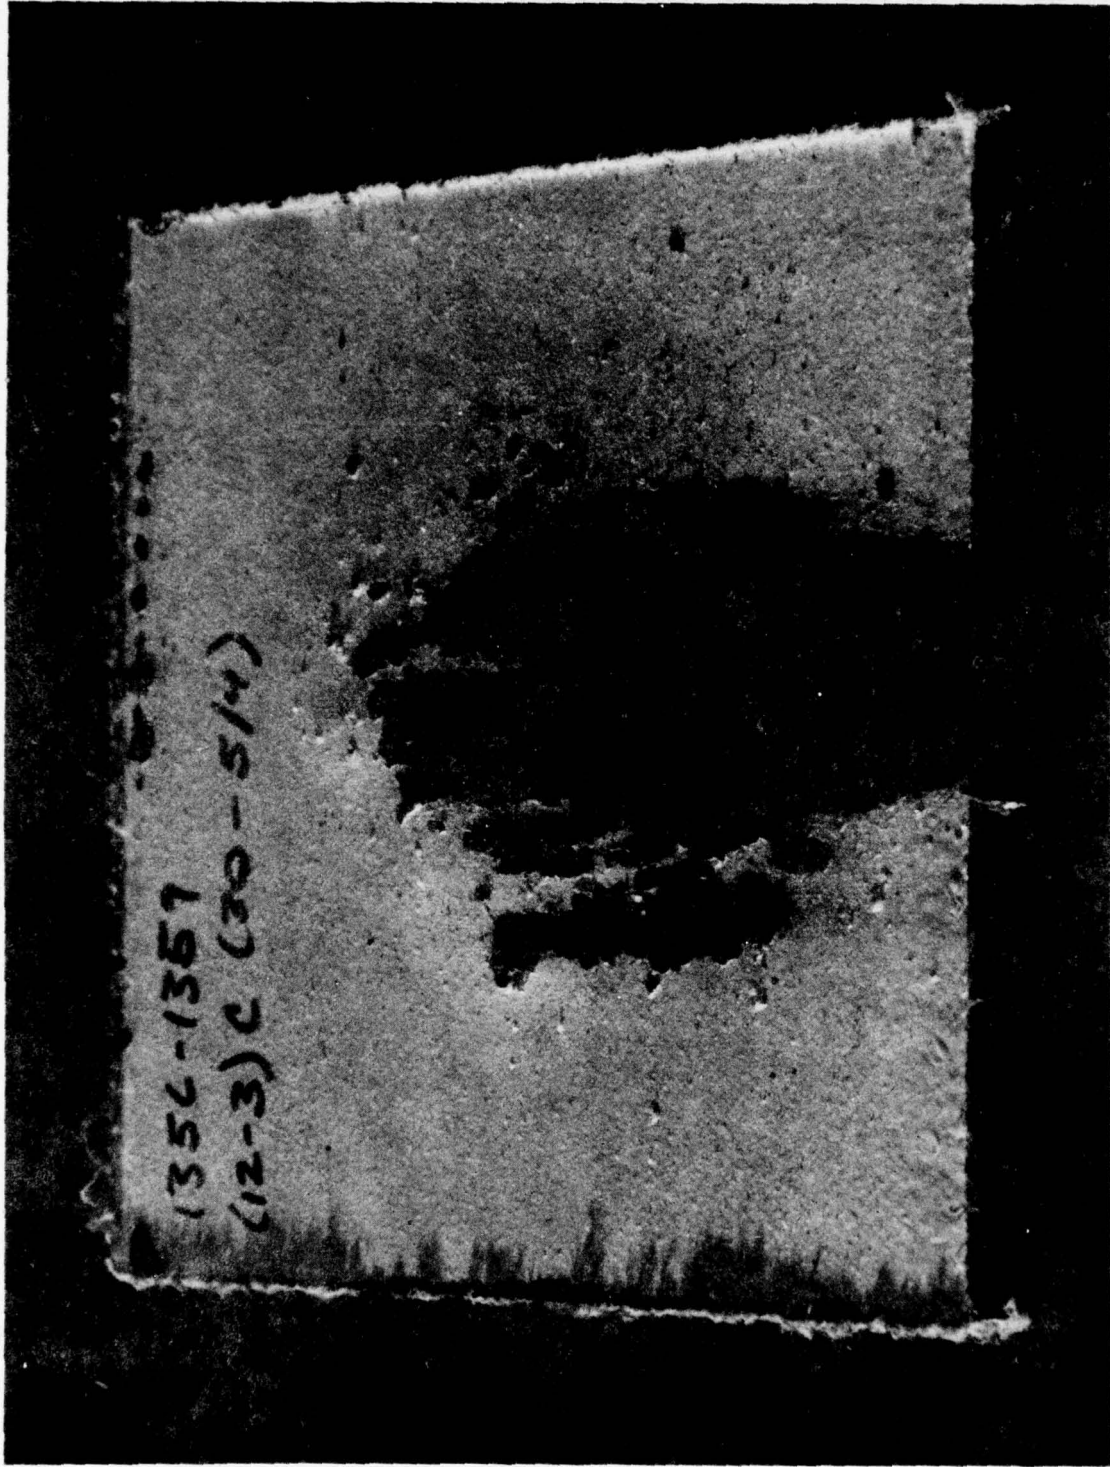
Figure 53. System 12 - damage at 50 cal/cm².

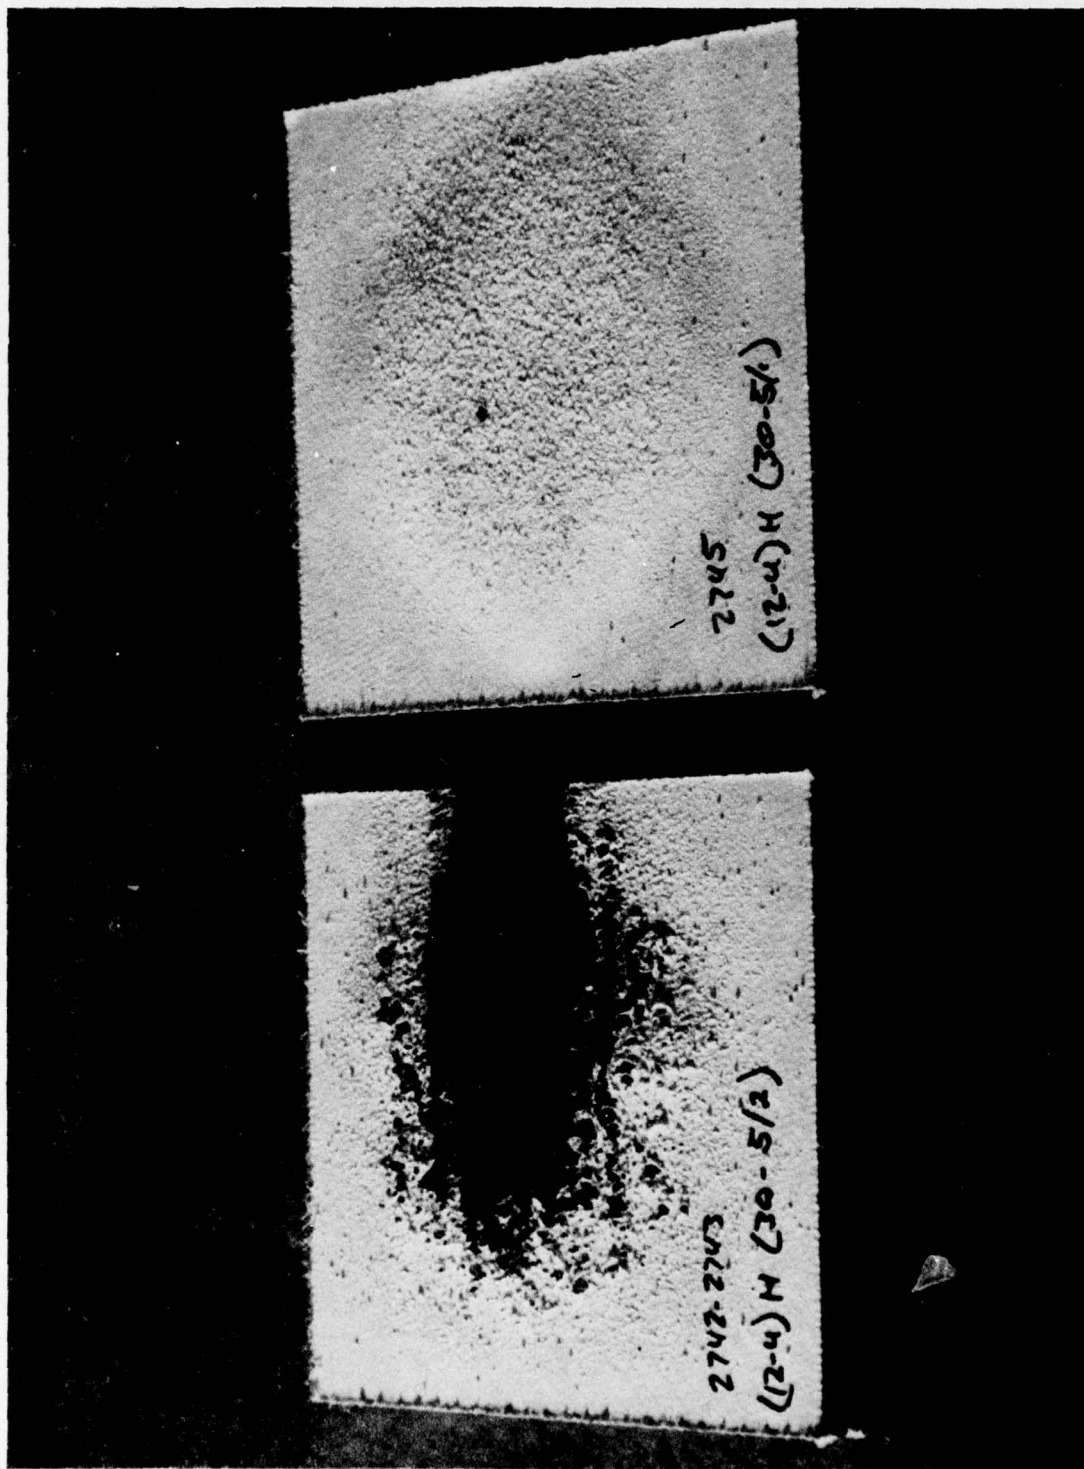
Figure 34. System 12 - one vs two flashes at 50 cal/cm².

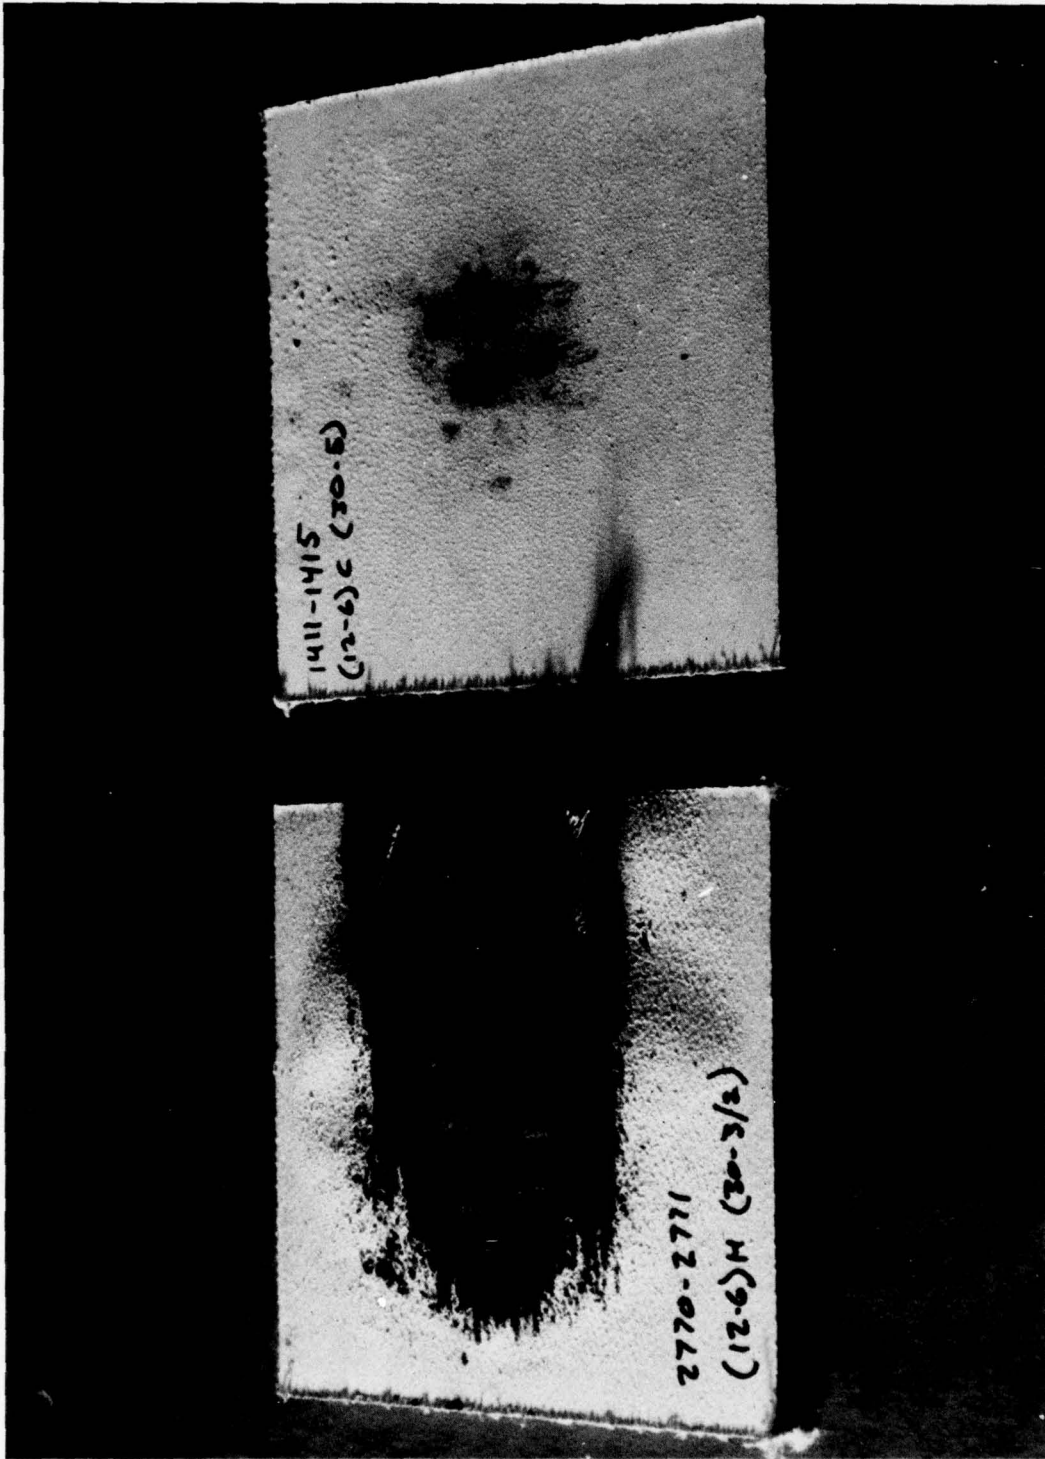
Figure 35. System 12 - humidity saturated vs dry specimen at 50 cal/cm².

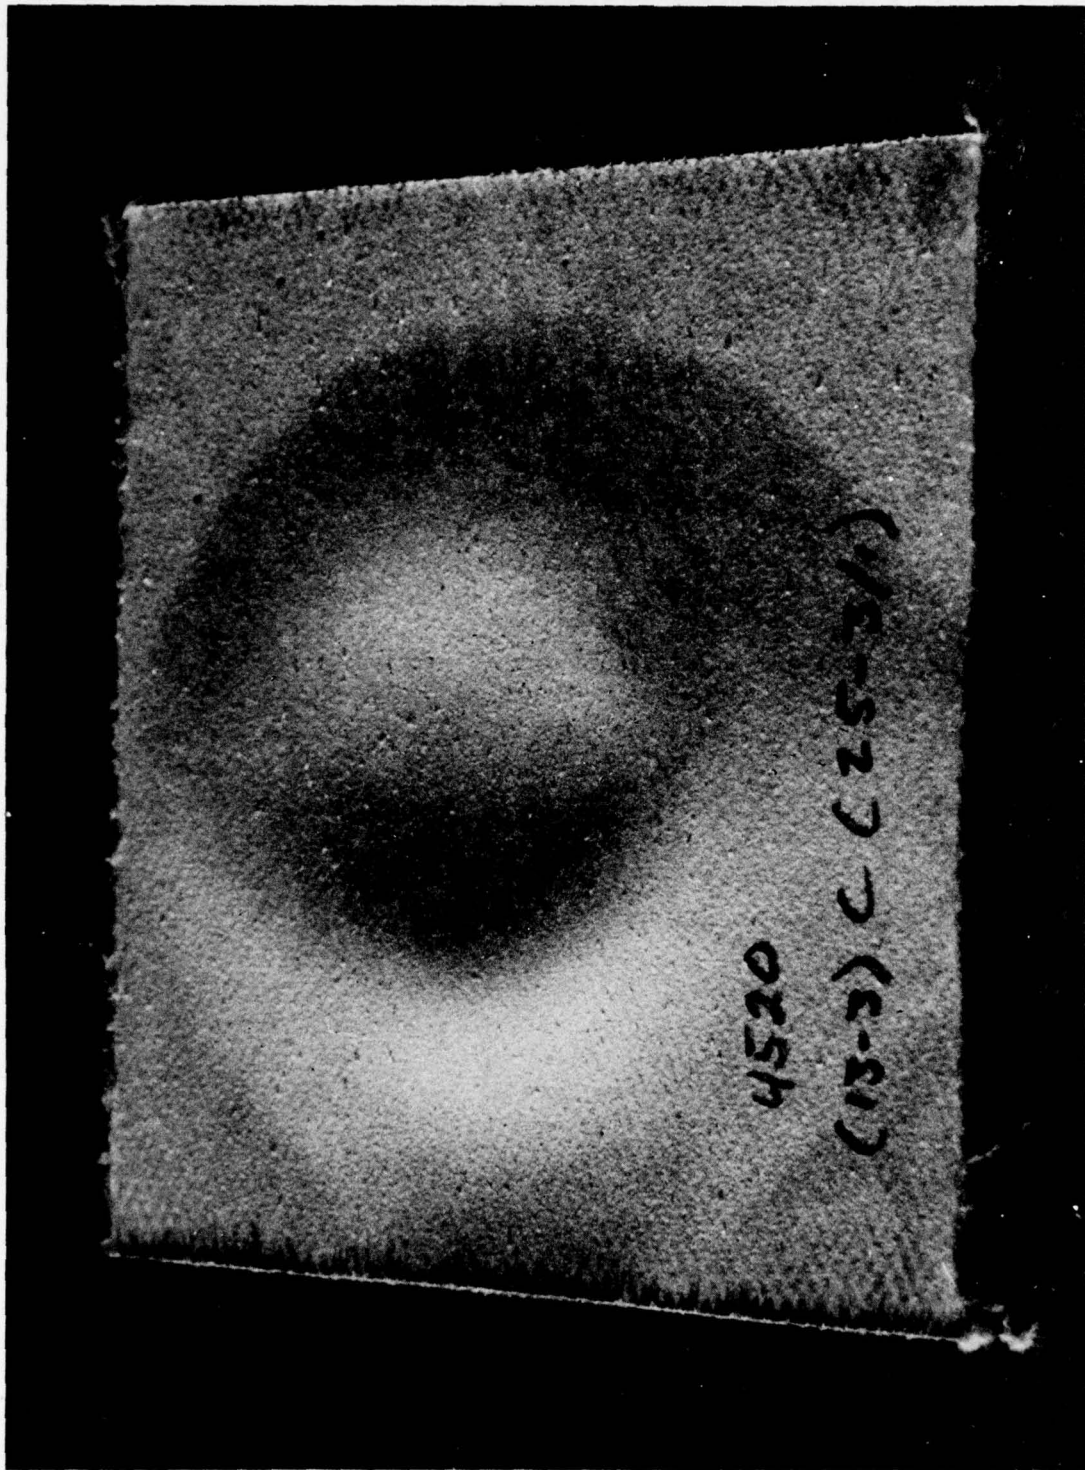
Figure 36. System I3 - delamination at 25 cal/cm².

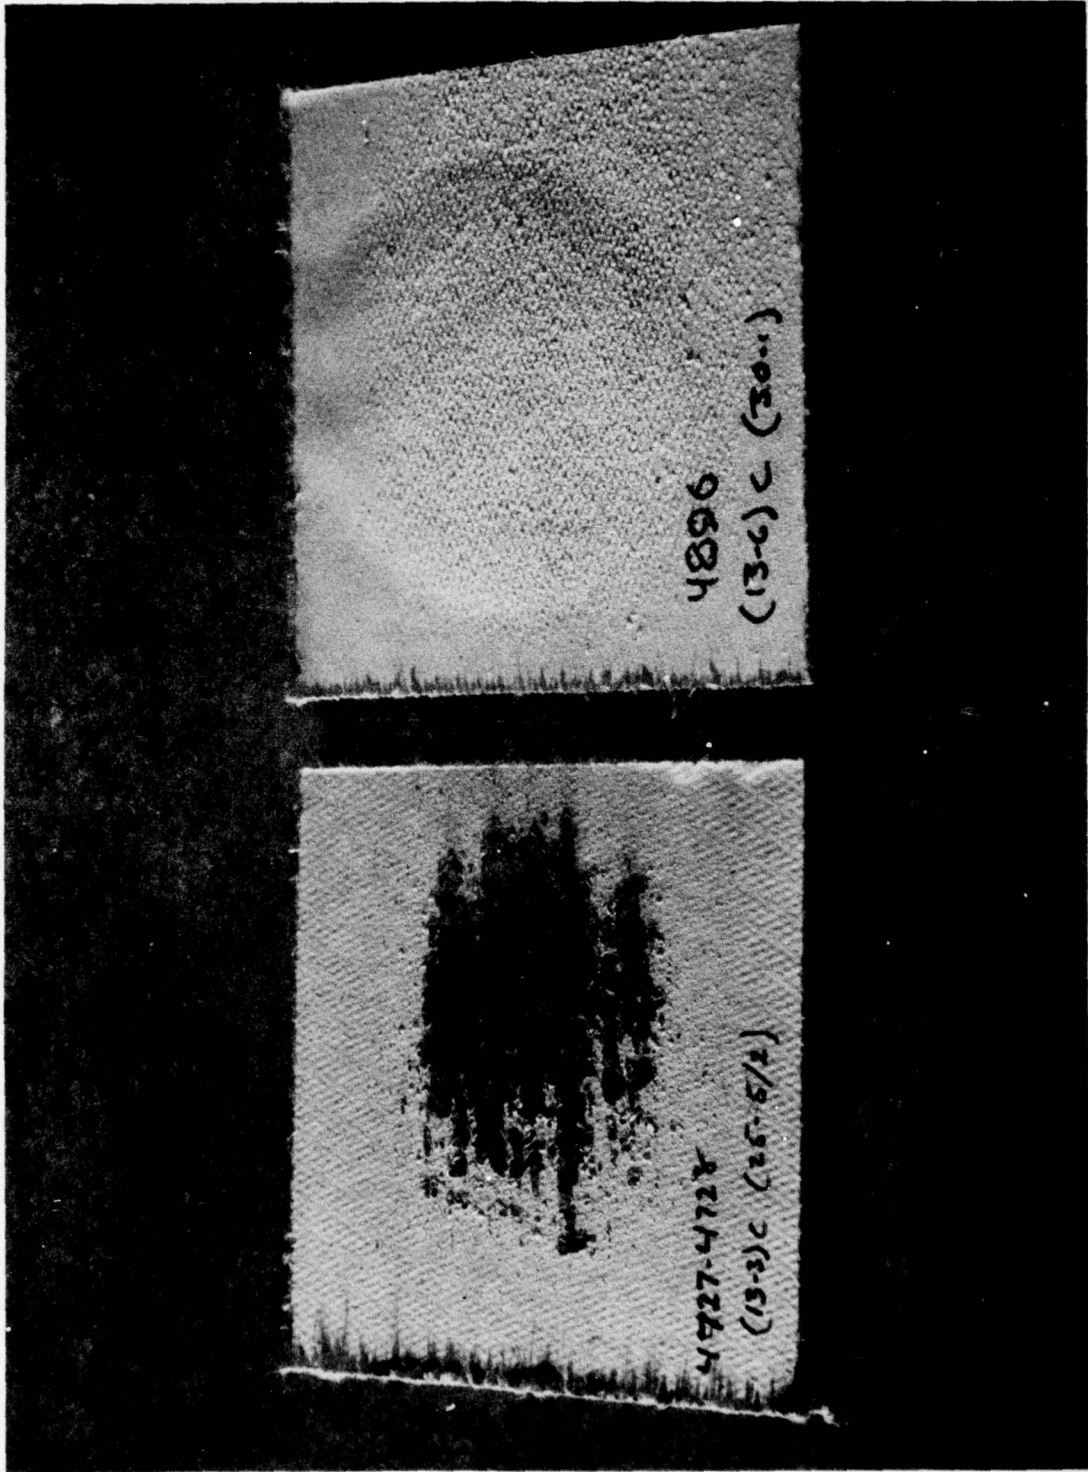
Figure 57. System 13 - 3- vs 6-ply damage.

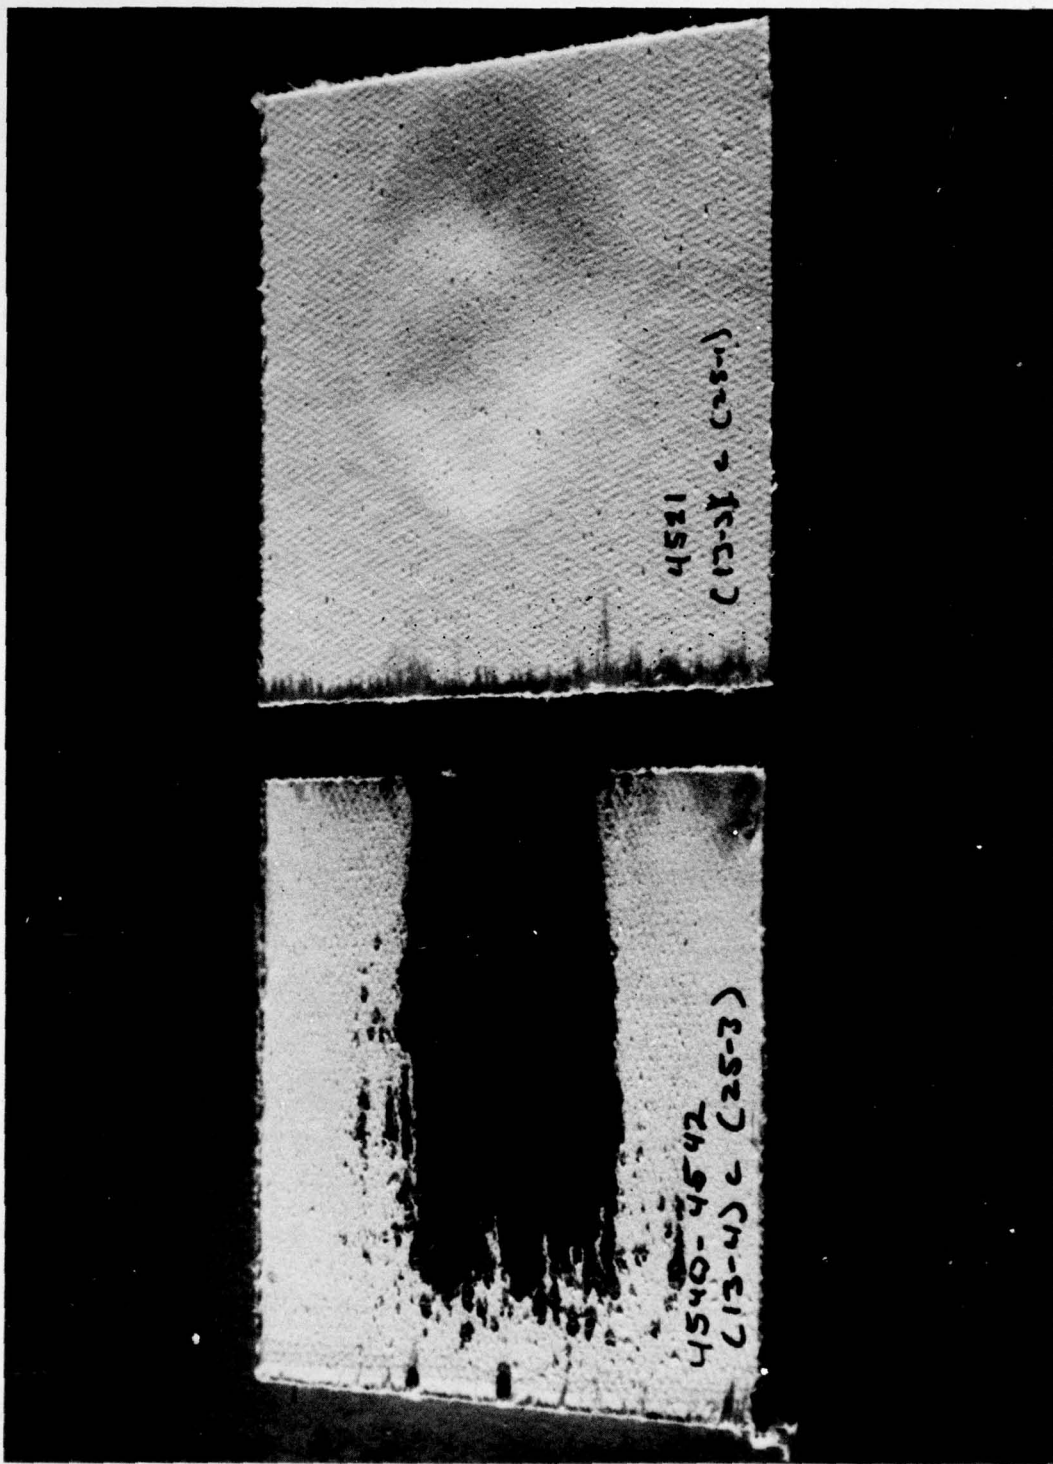
Figure 58. System 13 - one vs three flashes at 25 cal/cm².

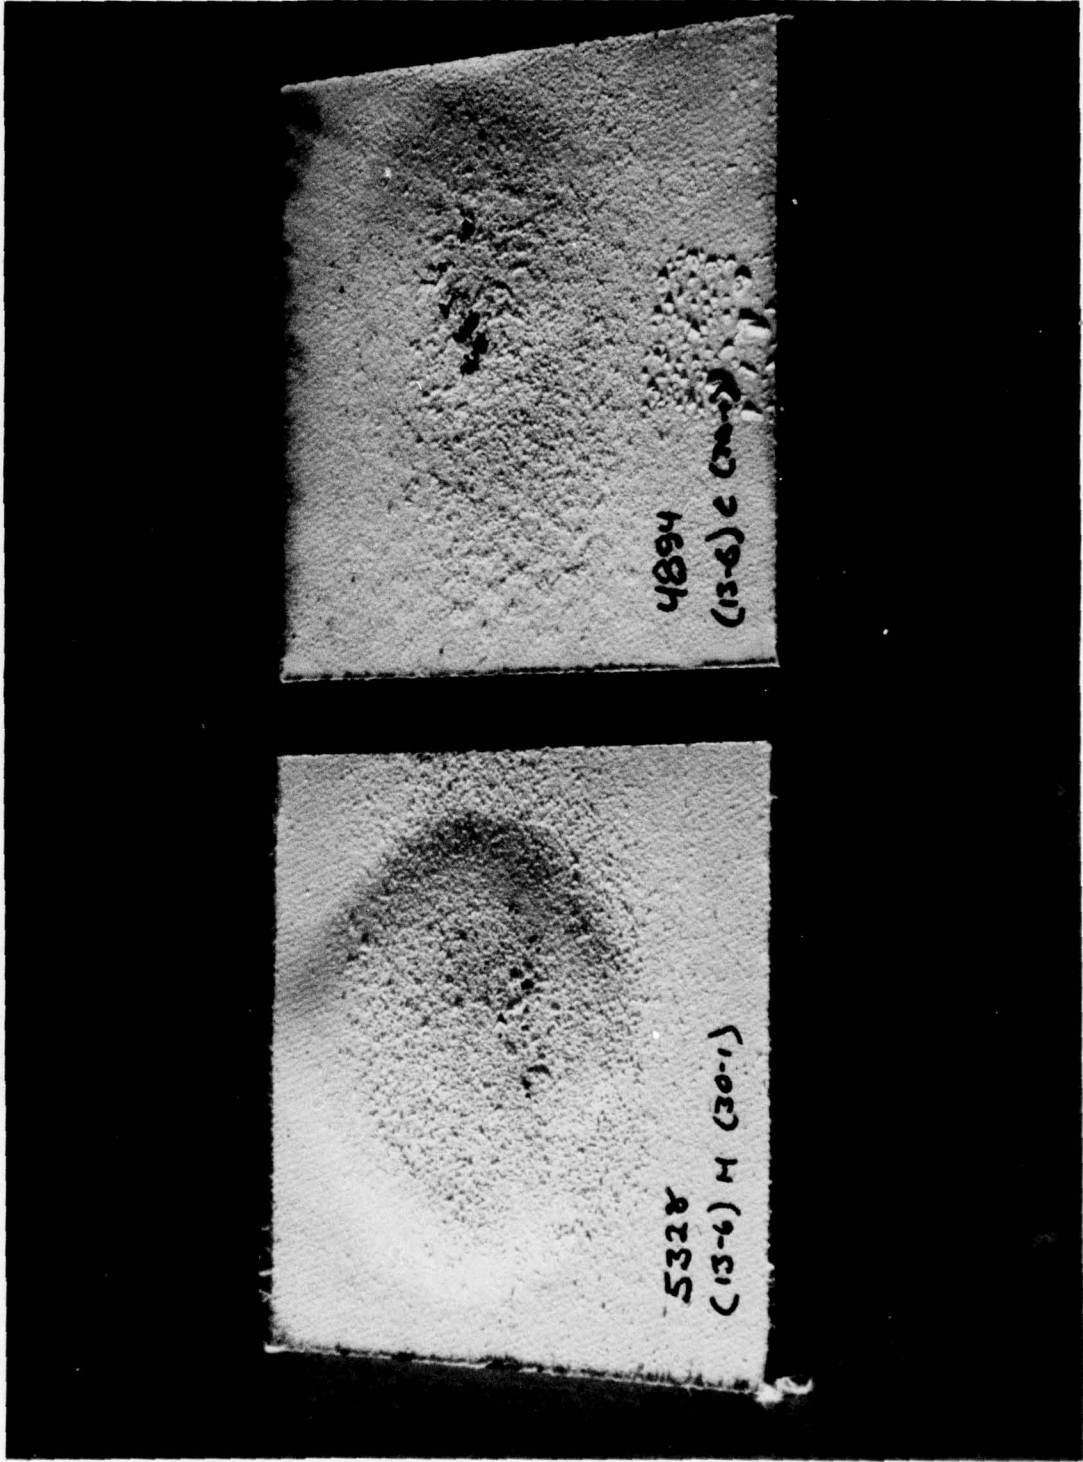
Figure 39. System 13 - humidity vs dry specimen at 30 cal/cm².

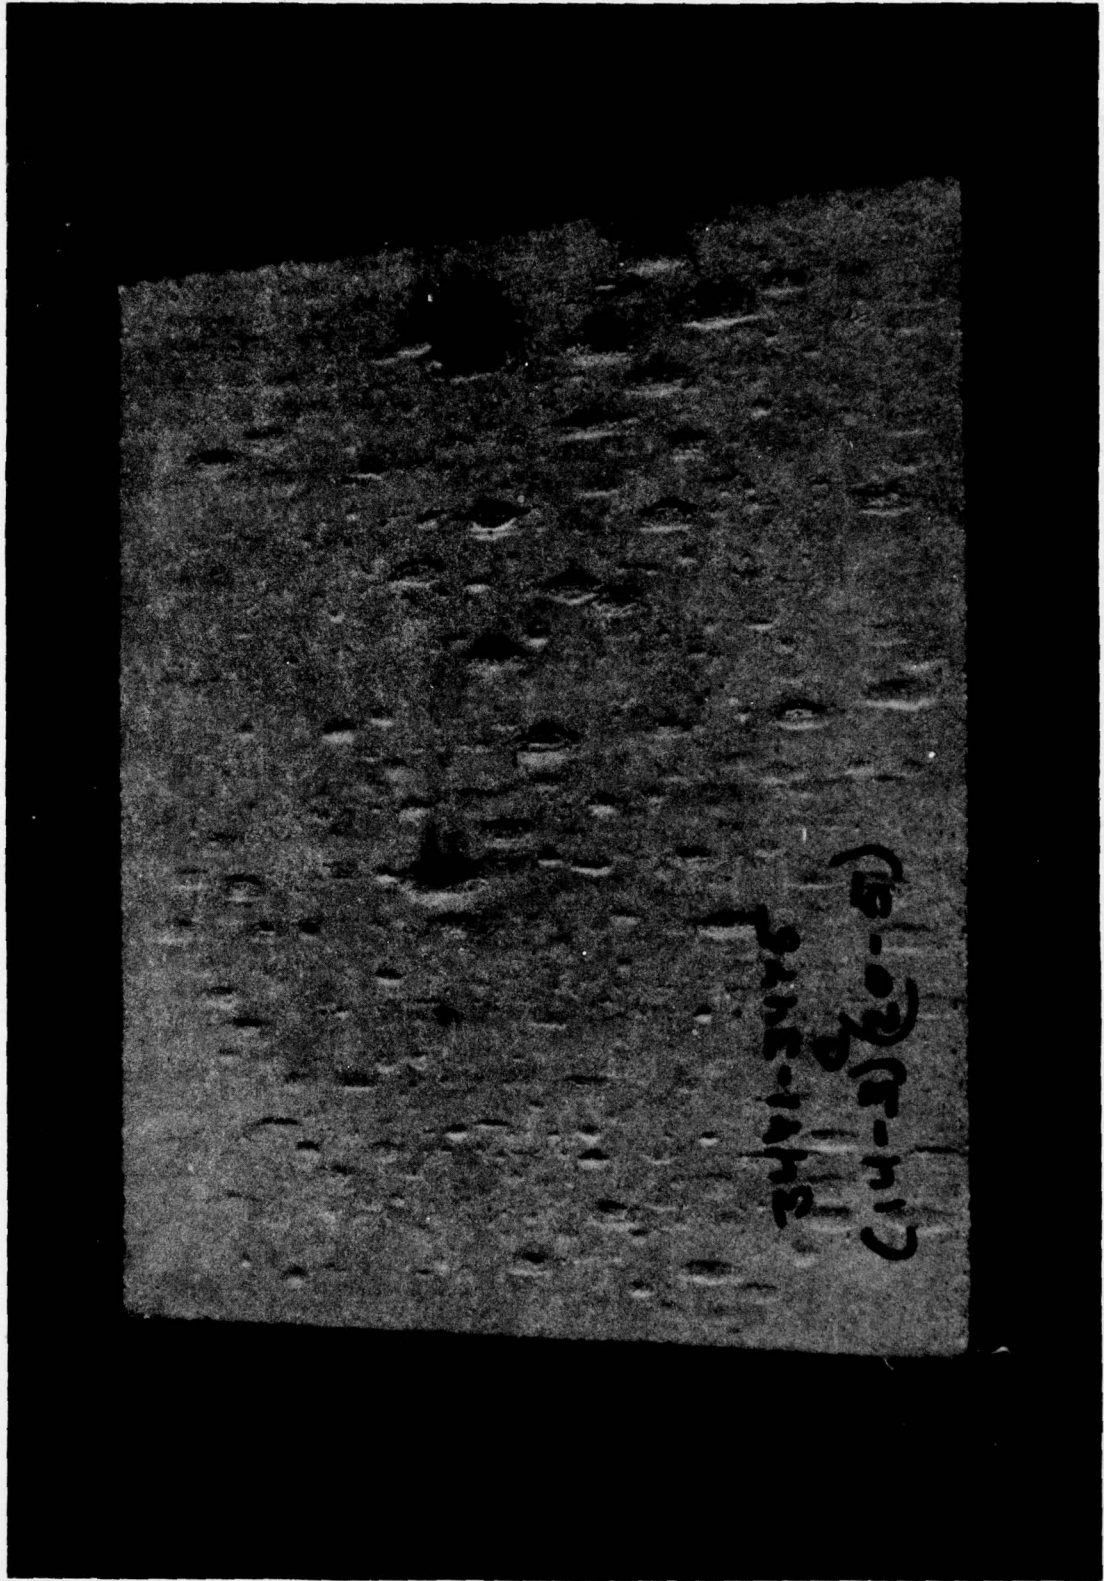
Figure 40. System 14 - threshold damage at 20 cal/cm².

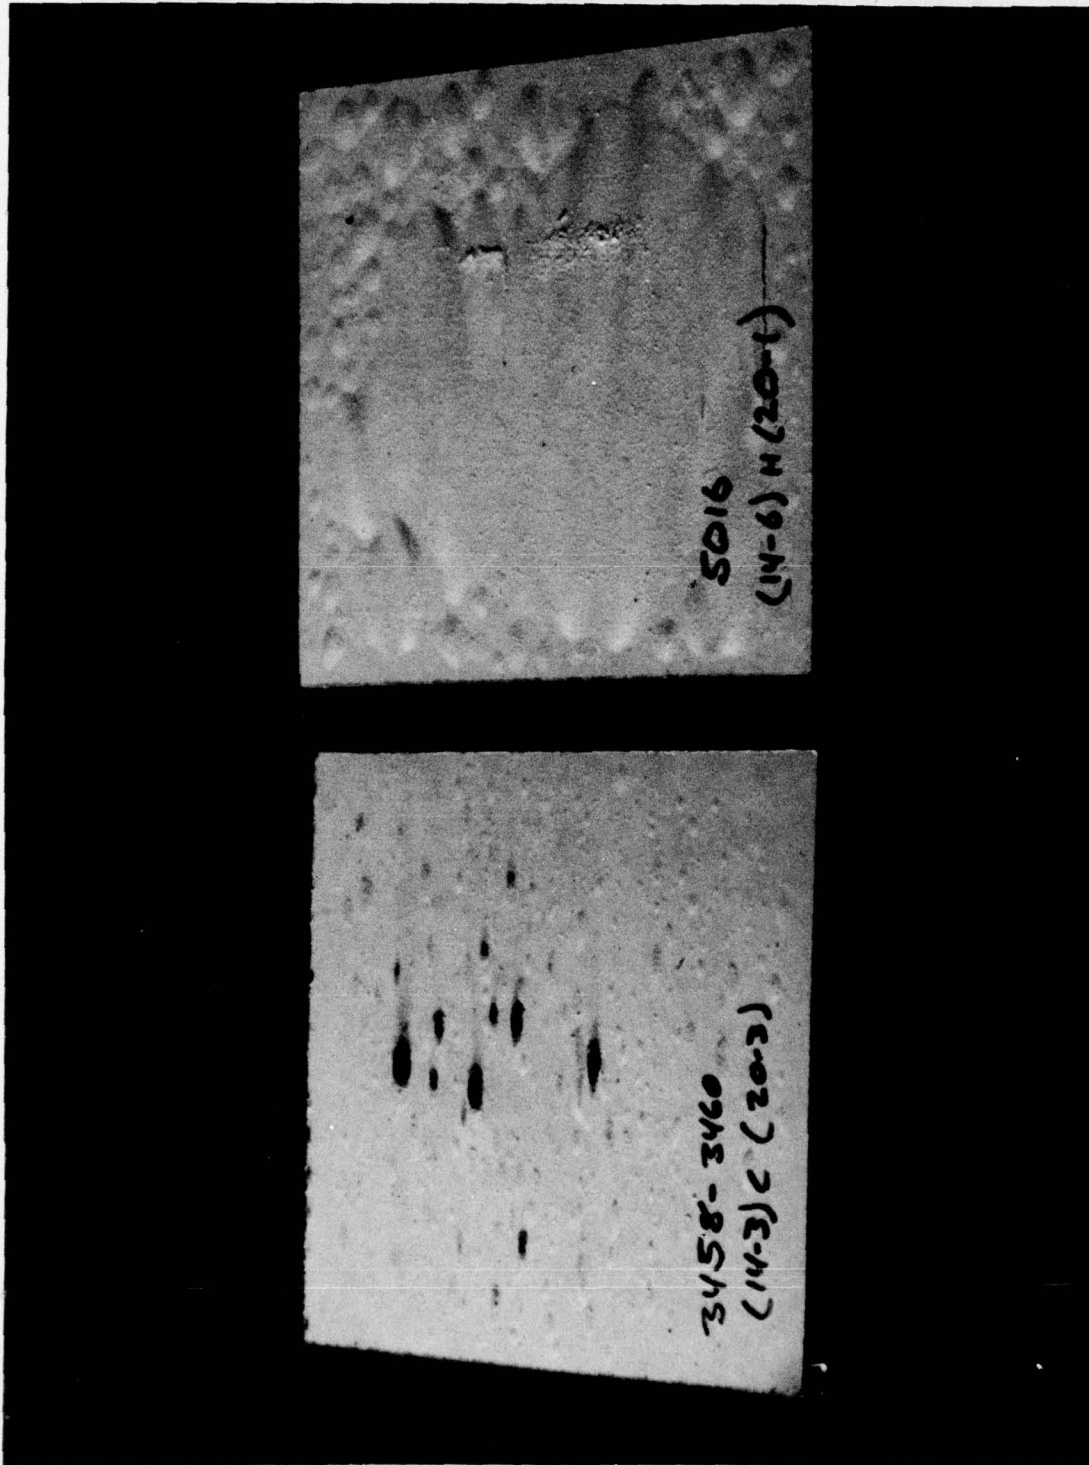
Figure 41. System 14 - humidity saturated vs dry specimen at 20 cal/cm².
