THE NUCLEAR THERMAL EFFECTS ON HUMIDITY SATURATED COMPOSITE MATERIALS

Rockwell International Corporation
Los Angeles Division
P.O. Box 92098
Los Angeles, California 90009

February 1979

Final Report for Period December 1977-February 1979

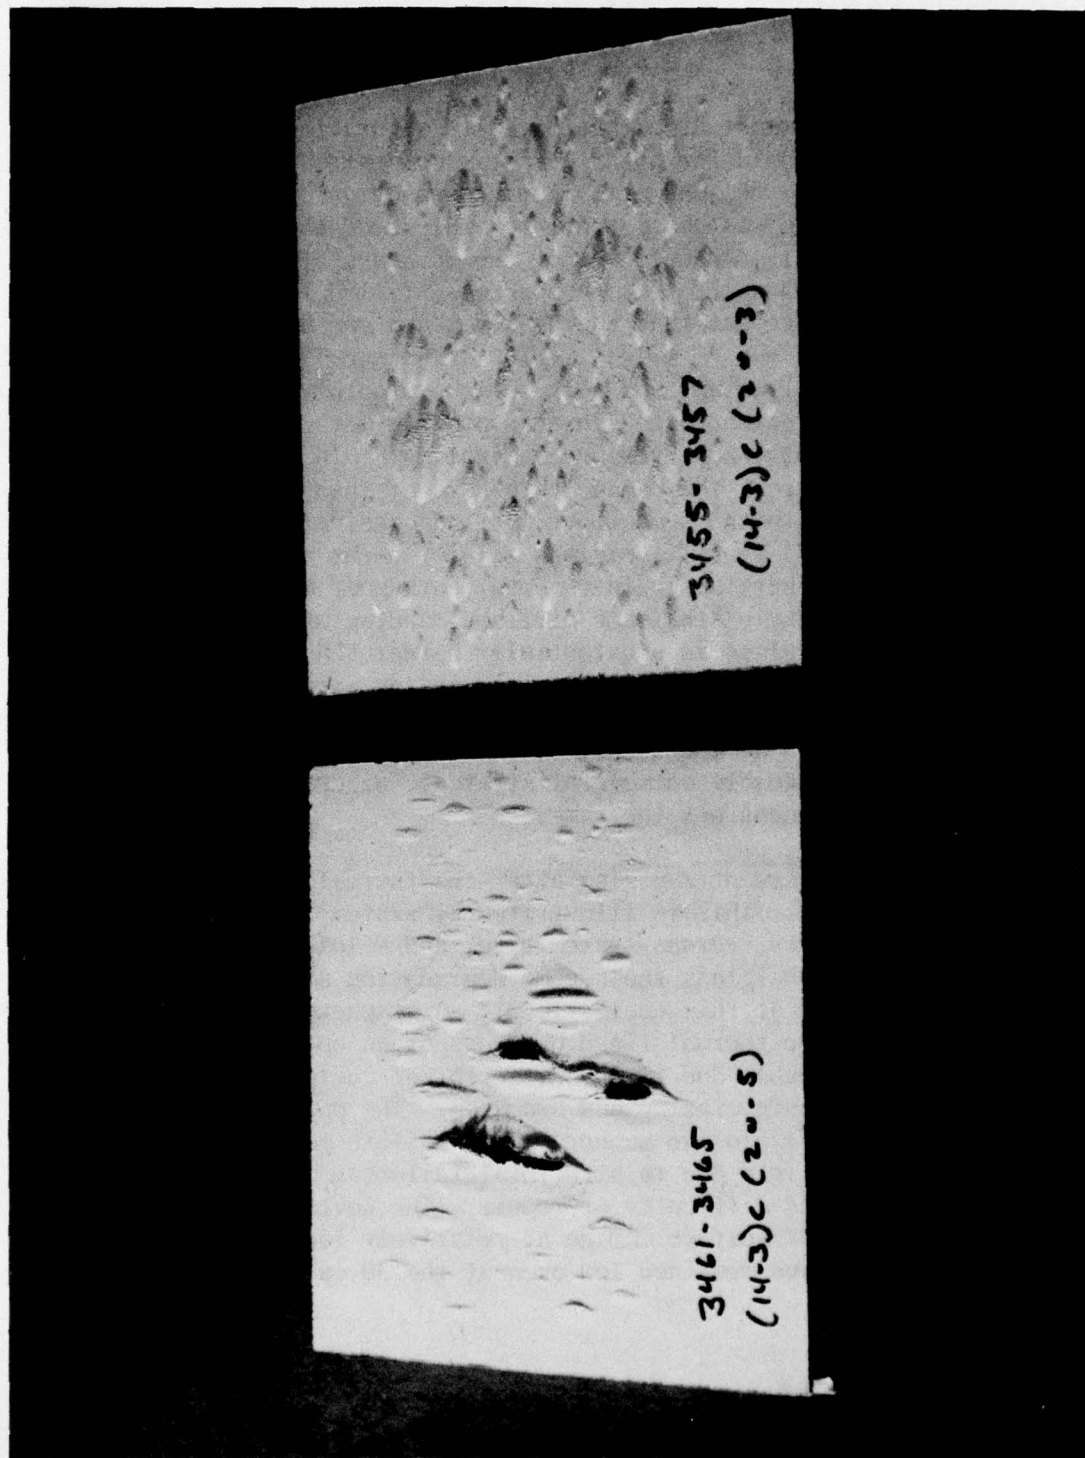
Figure 42. System 14 - three vs five flashes at 20 cal/cm².
