# CONCRETE AND ROCK TESTS, REHABILITATION WORK, MARSEILLES DAM, ILLINOIS WATERWAY CHICAGO DISTRICT

Richard L. Stowe

Structures Laboratory  
U. S. Army Engineer Waterways Experiment Station  
P. O. Box 631, Vicksburg, Miss. 39180

September 1979

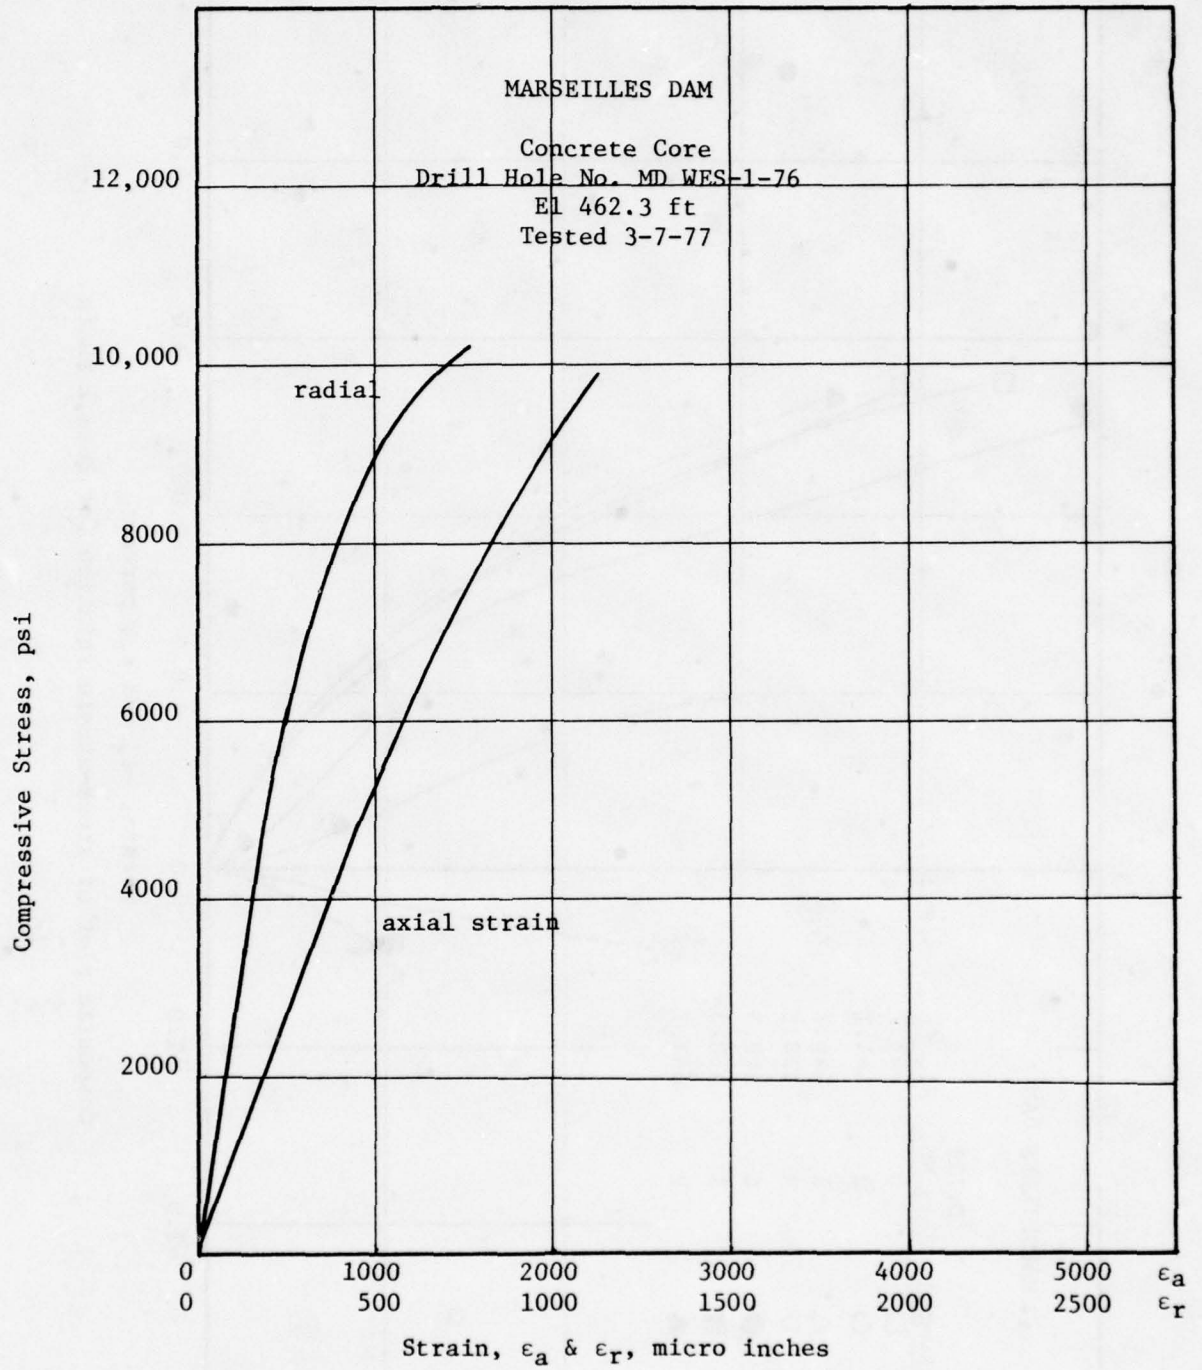
Typical stress-strain relation for concrete

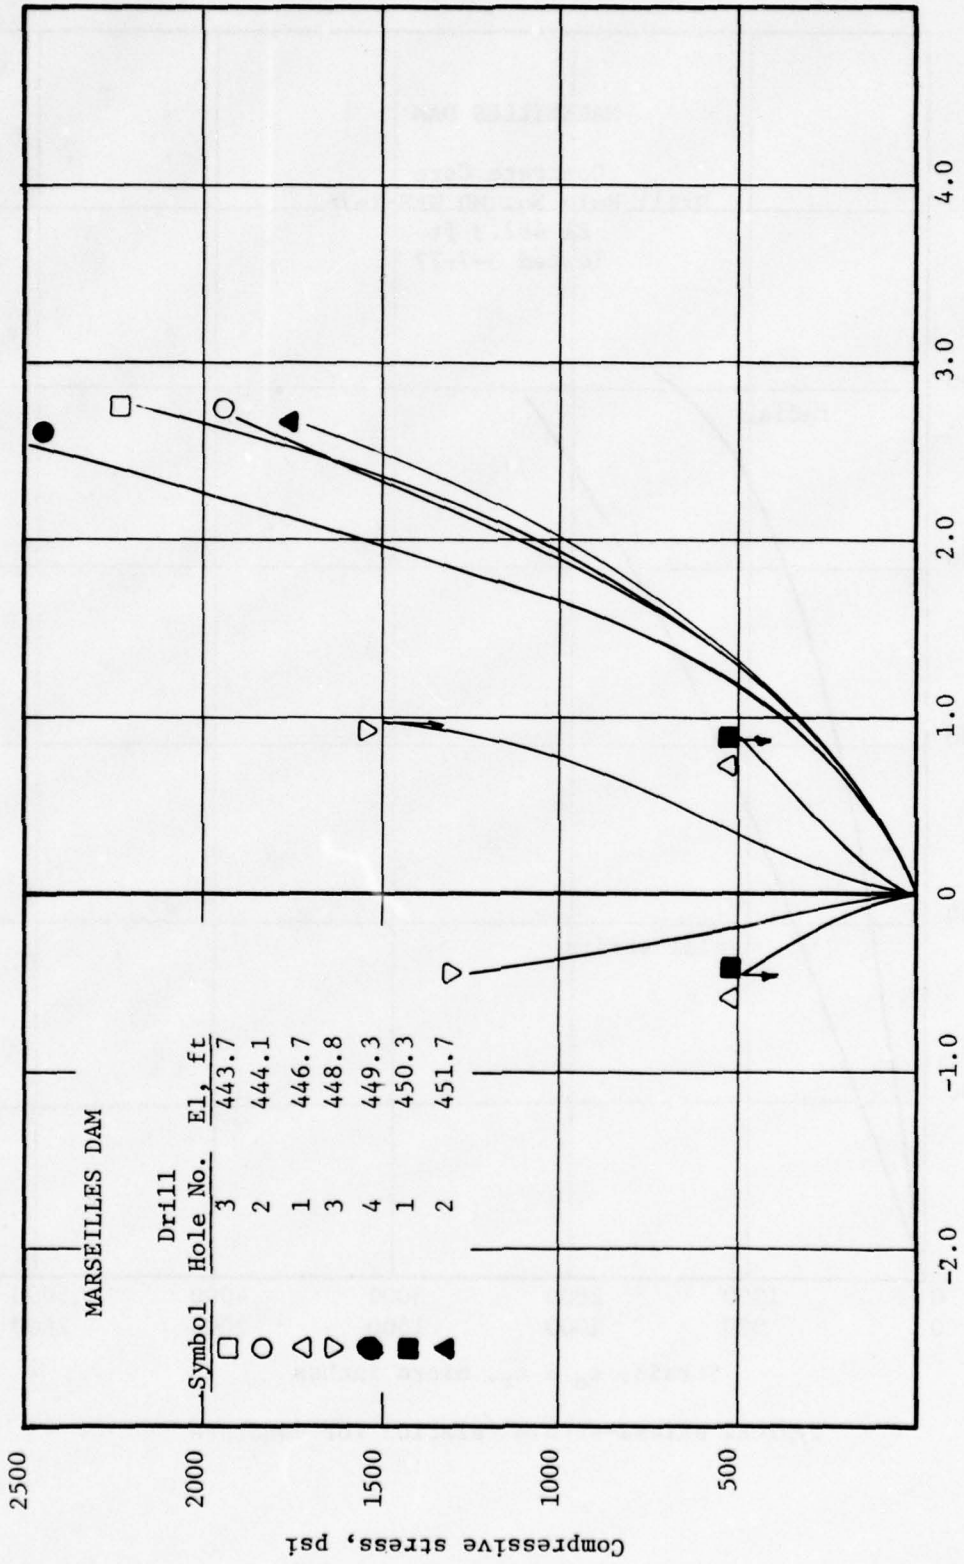
Strain,  $-\epsilon_r$  and  $\epsilon_a$ , percent  
 Composite plot of stress-strain relation for Zone 1 shale

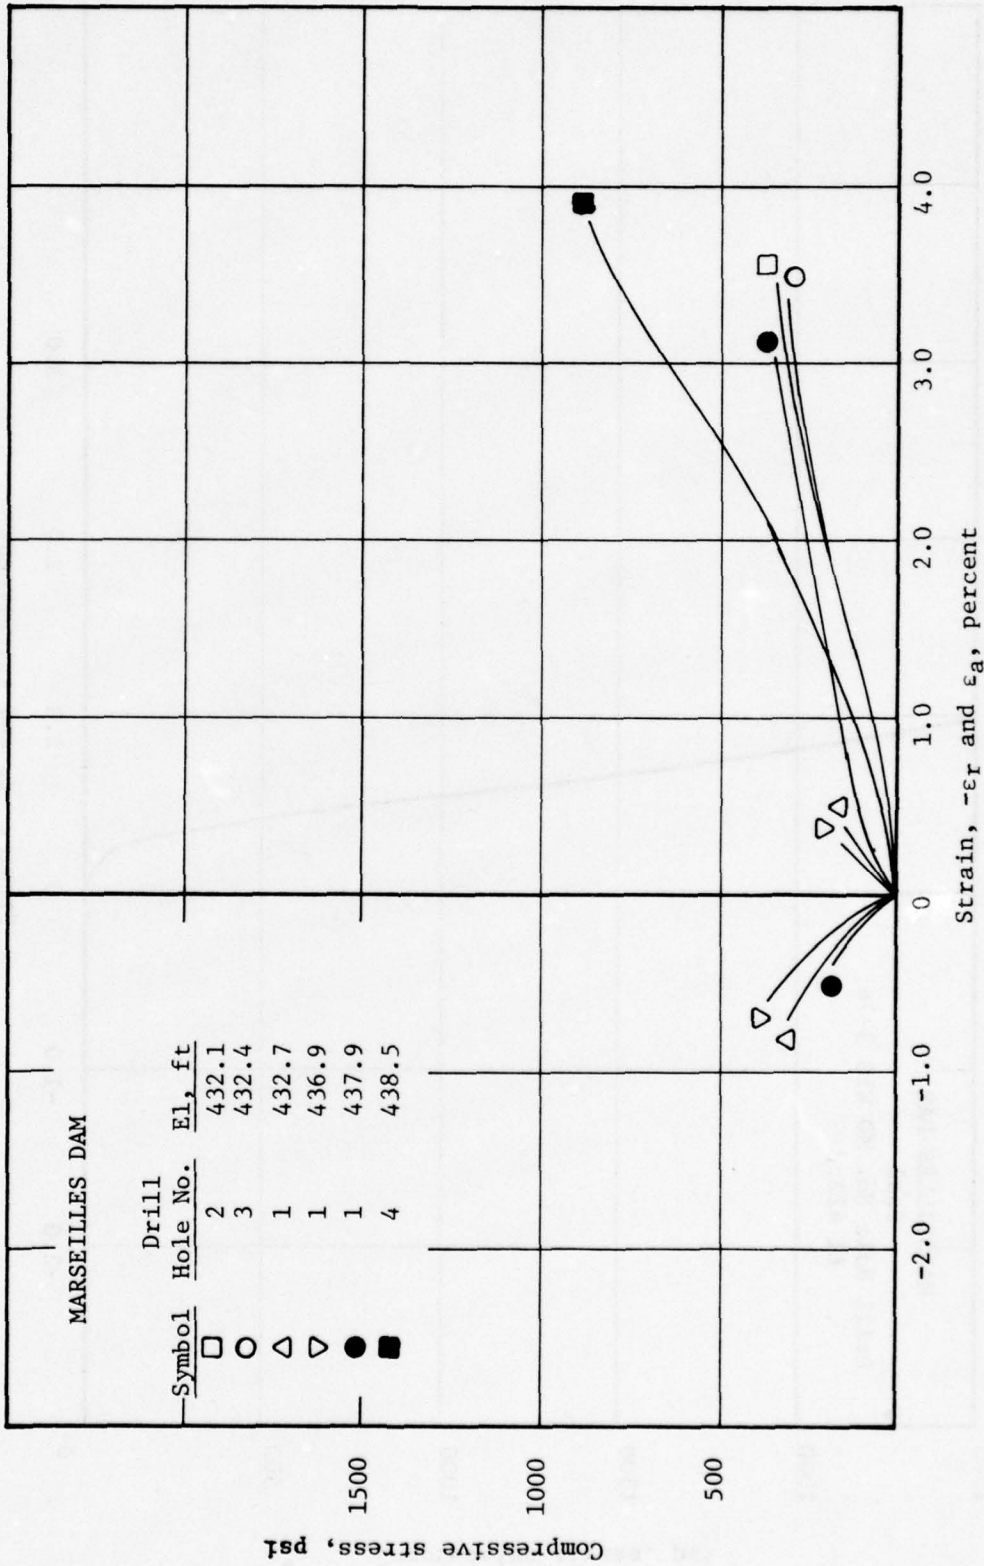
Composite plot of stress-strain relation for Zone 2 shale

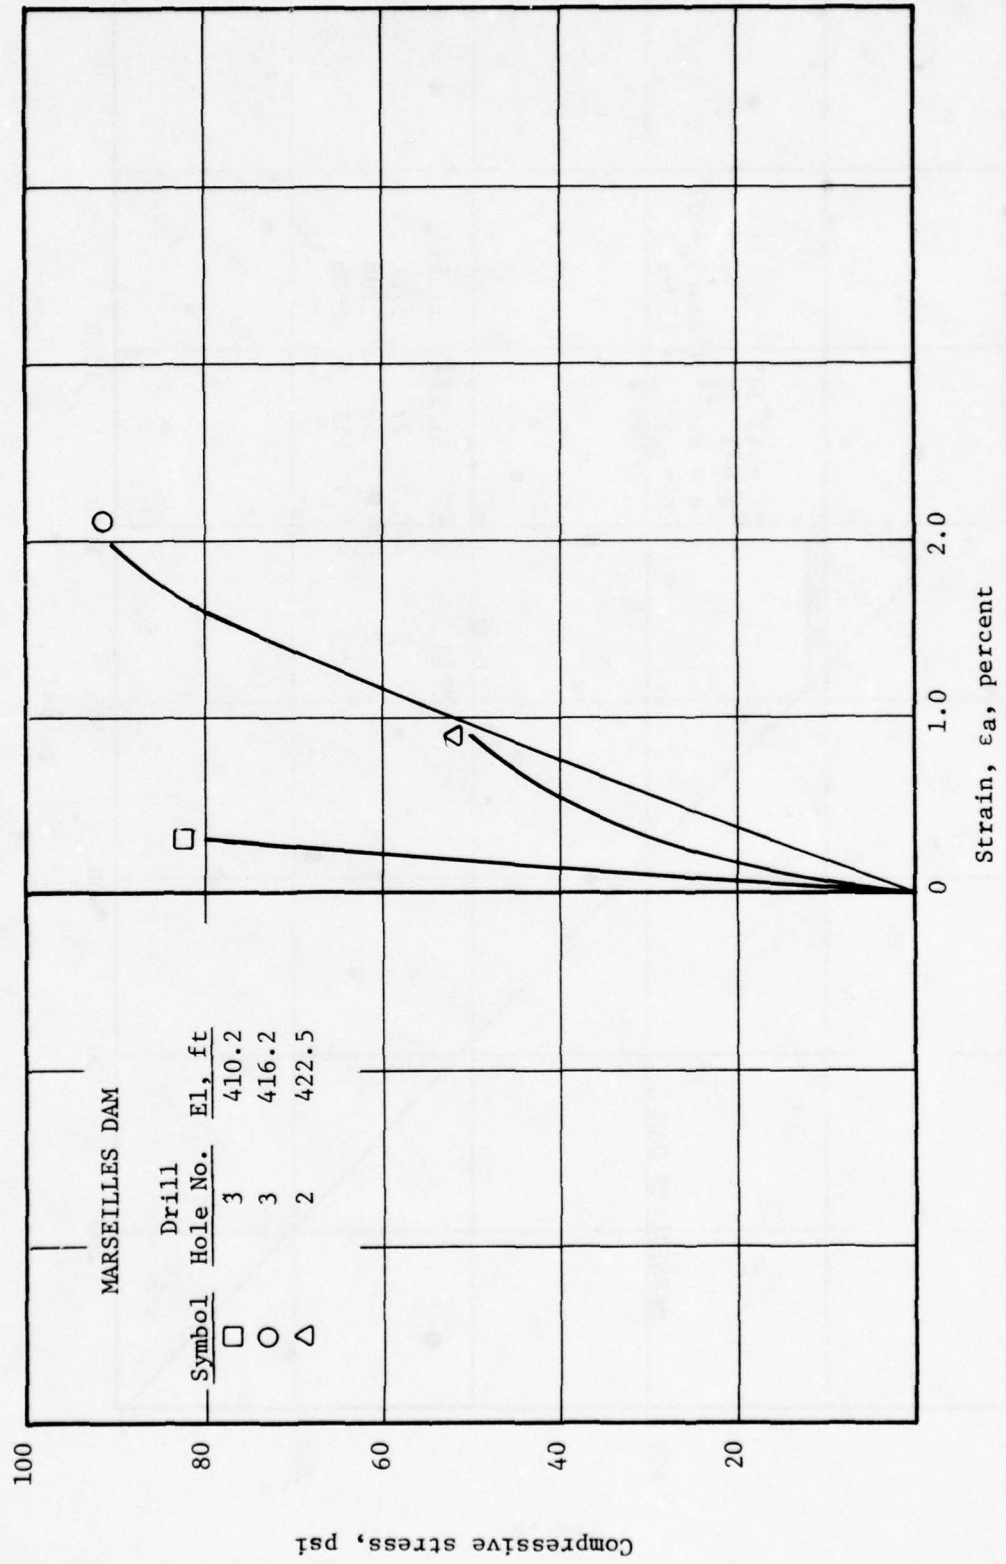
Composite plot of stress-strain relation for claystone

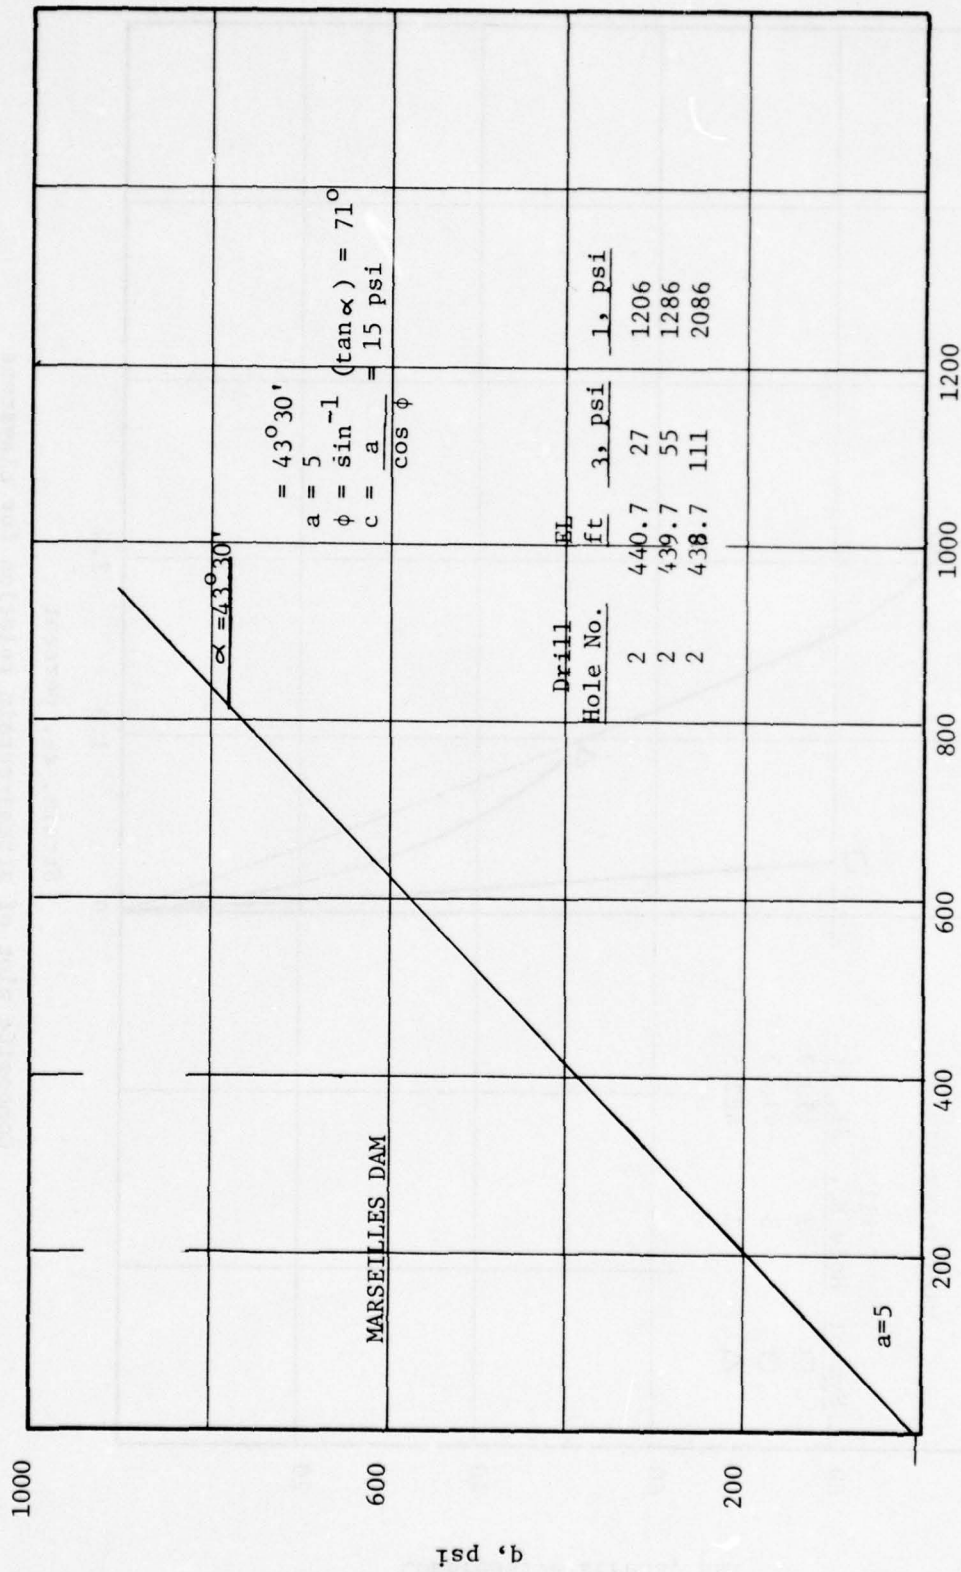
65. The strength results from these tests do not appear reasonable; the  $c = 15$  psi (1.1 tsf) and  $\phi$  is 71 degrees. The  $\phi$  is much higher than expected for a medium hard shale (compressive strength about 2100 psi). A plausible explanation for the high phi value is that the specimen tested at  $\sigma_3 = 111$  psi was composed of a much harder shale than were the other two specimens (tested at  $\sigma_3 = 27$  and 55 psi). Upon reexamination of all the core, the harder shale was found to occur only locally. Another test on a representative specimen was not run because the triaxial series was conducted for comparison purposes. The comparison, therefore, between the triaxial and the direct shear tests was not made.

Results of triaxial tests on shale.

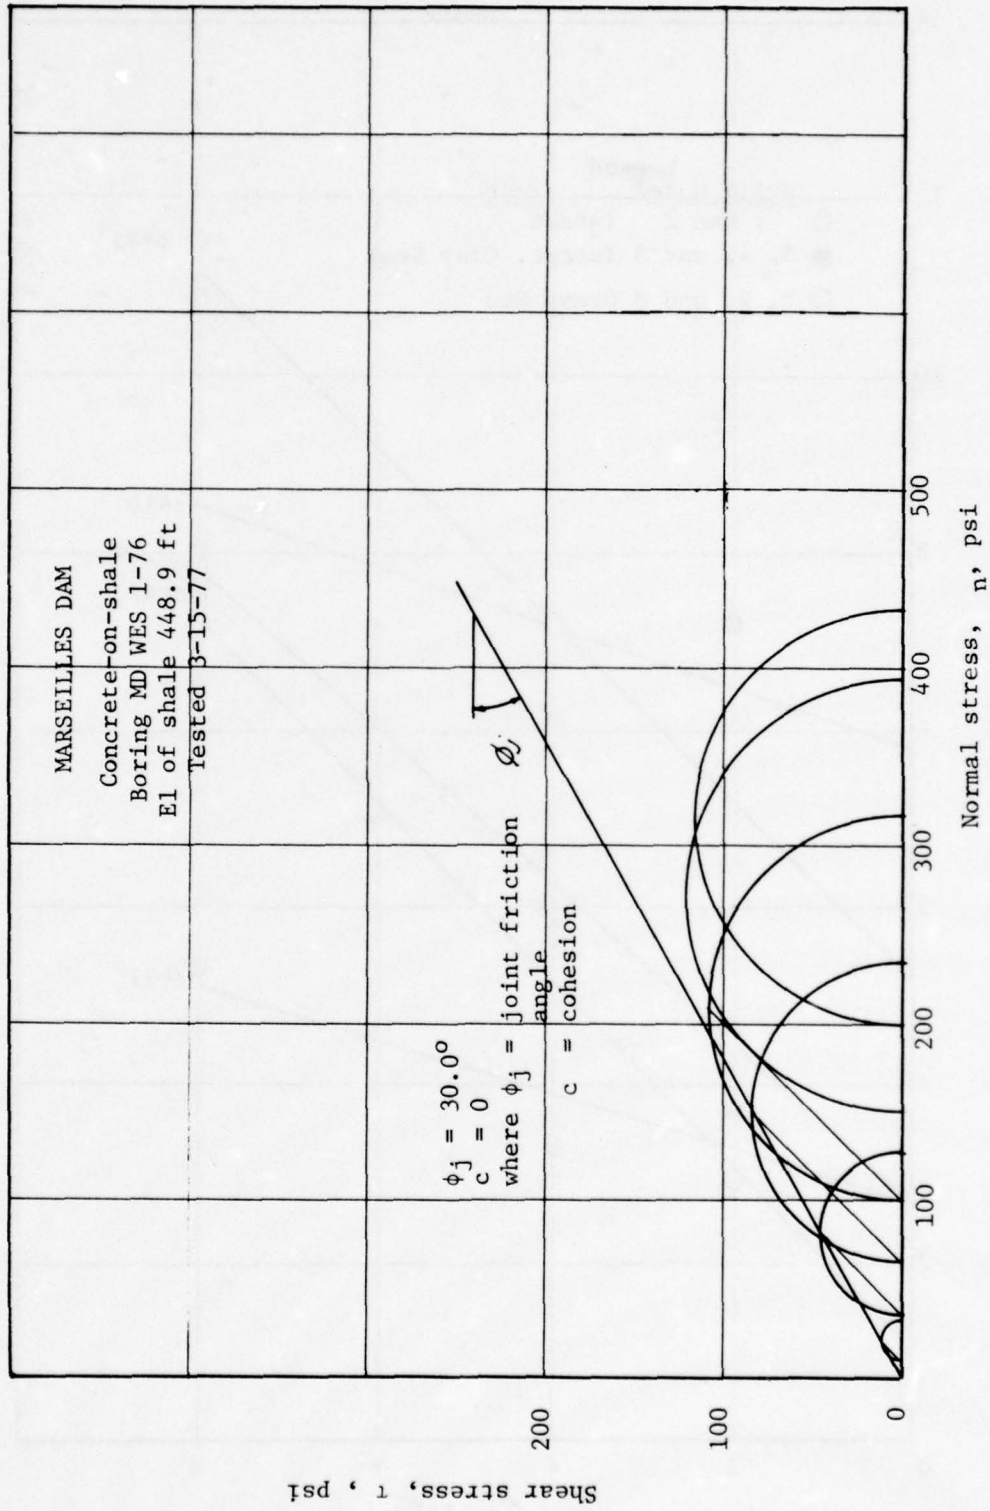
The equation yields an angle of shearing resistance of 30.0 degrees and a zero cohesion. Due to the loose contact between the concrete and rock described earlier, the *sliding friction* value from the multistage triaxial test is recommended for computing structural stability for that portion directly under the dam.

Mohr diagram for locating stresses on failure plane; multistage results.

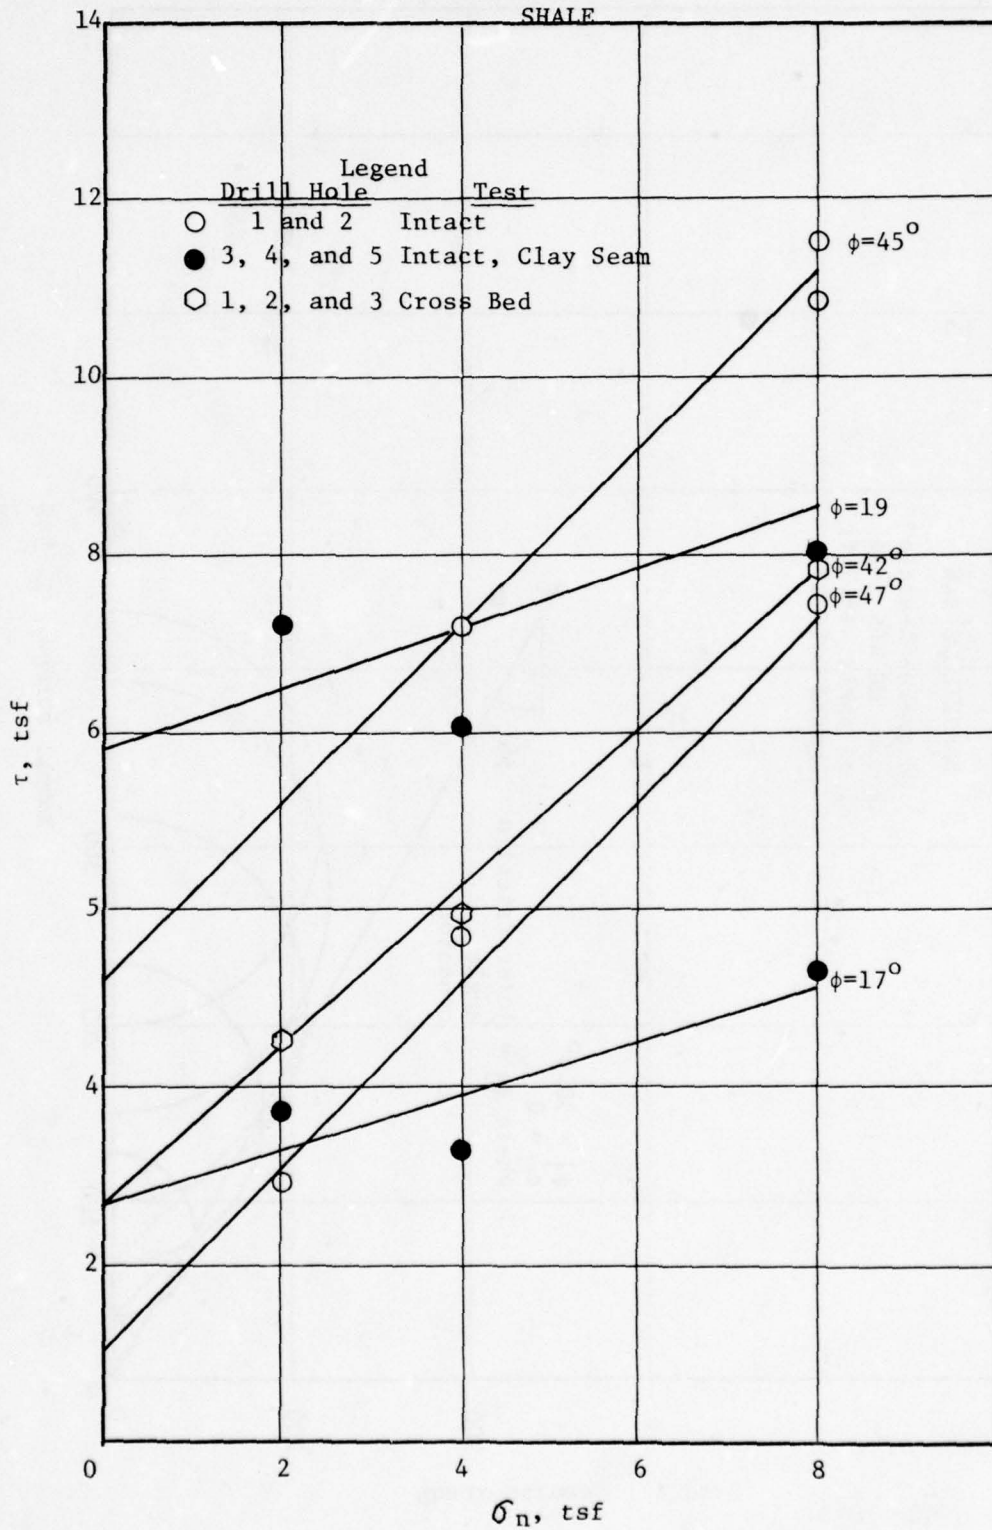
Failure envelope for shale tested in direct shear

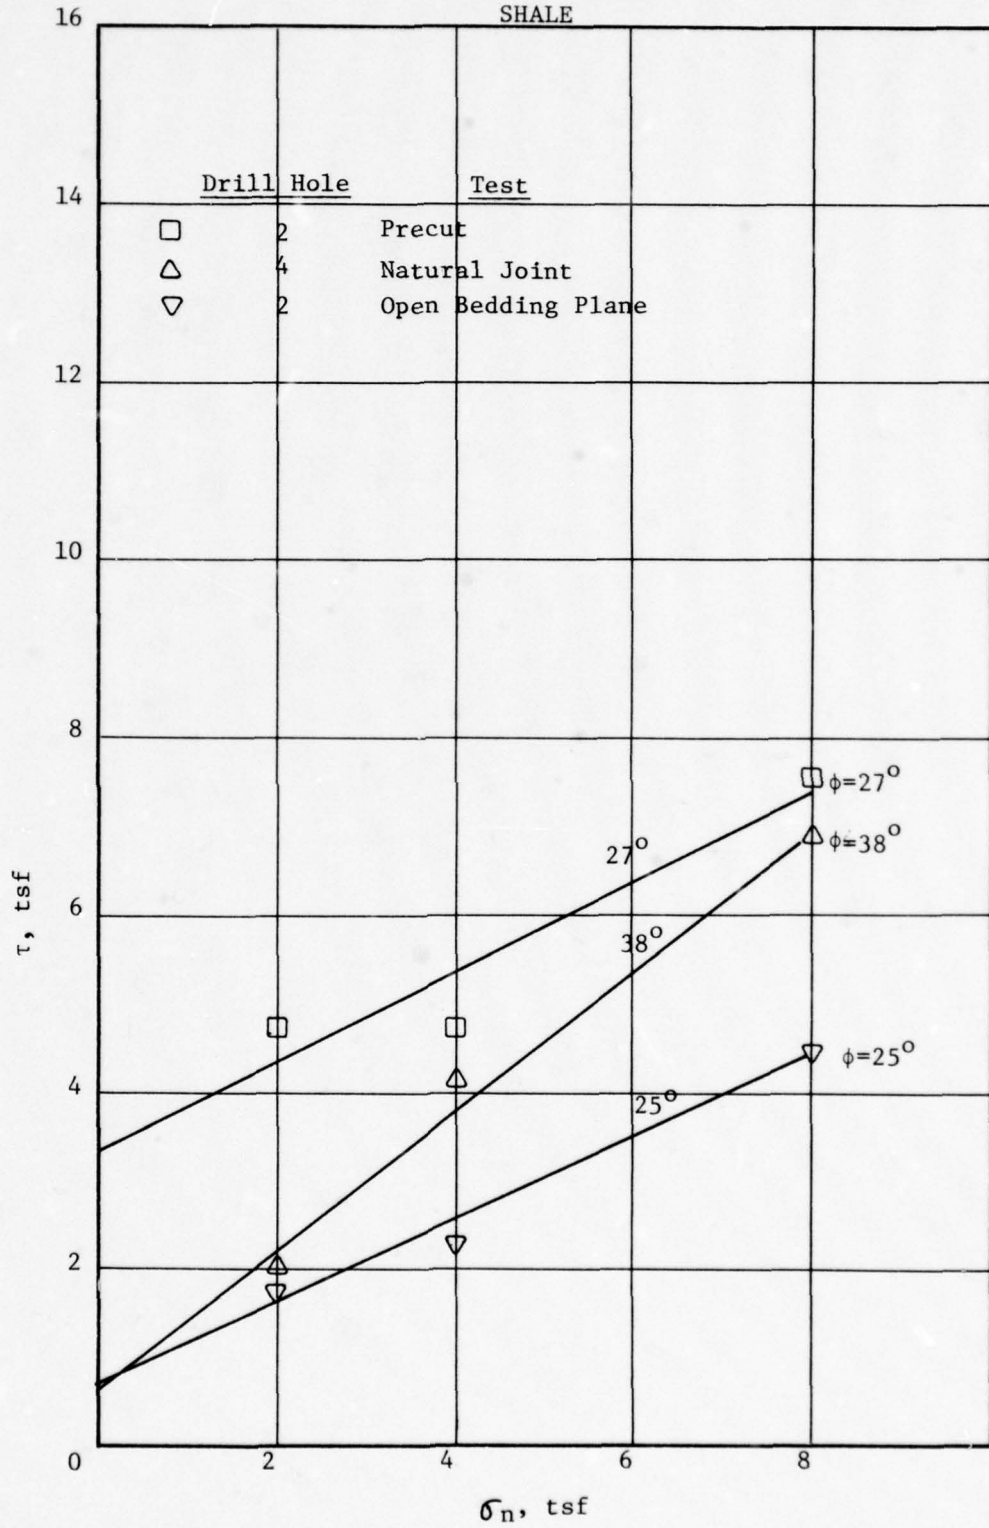
75. The  $c$  and  $\phi$  for the natural jointed features are 0.64 tsf and 38 degrees. The jointed surfaces were not smooth like the open bedding plane surfaces, but slightly irregular in that they were gently undulating. As mentioned in paragraph 45, the joints observed in the shale strata beneath the dam could participate in a failure by acting as an inclined plane, therefore, it is recommended that the shear strength parameters on natural joints be considered when making a stability analysis.

Failure envelopes for shale tested in direct shear

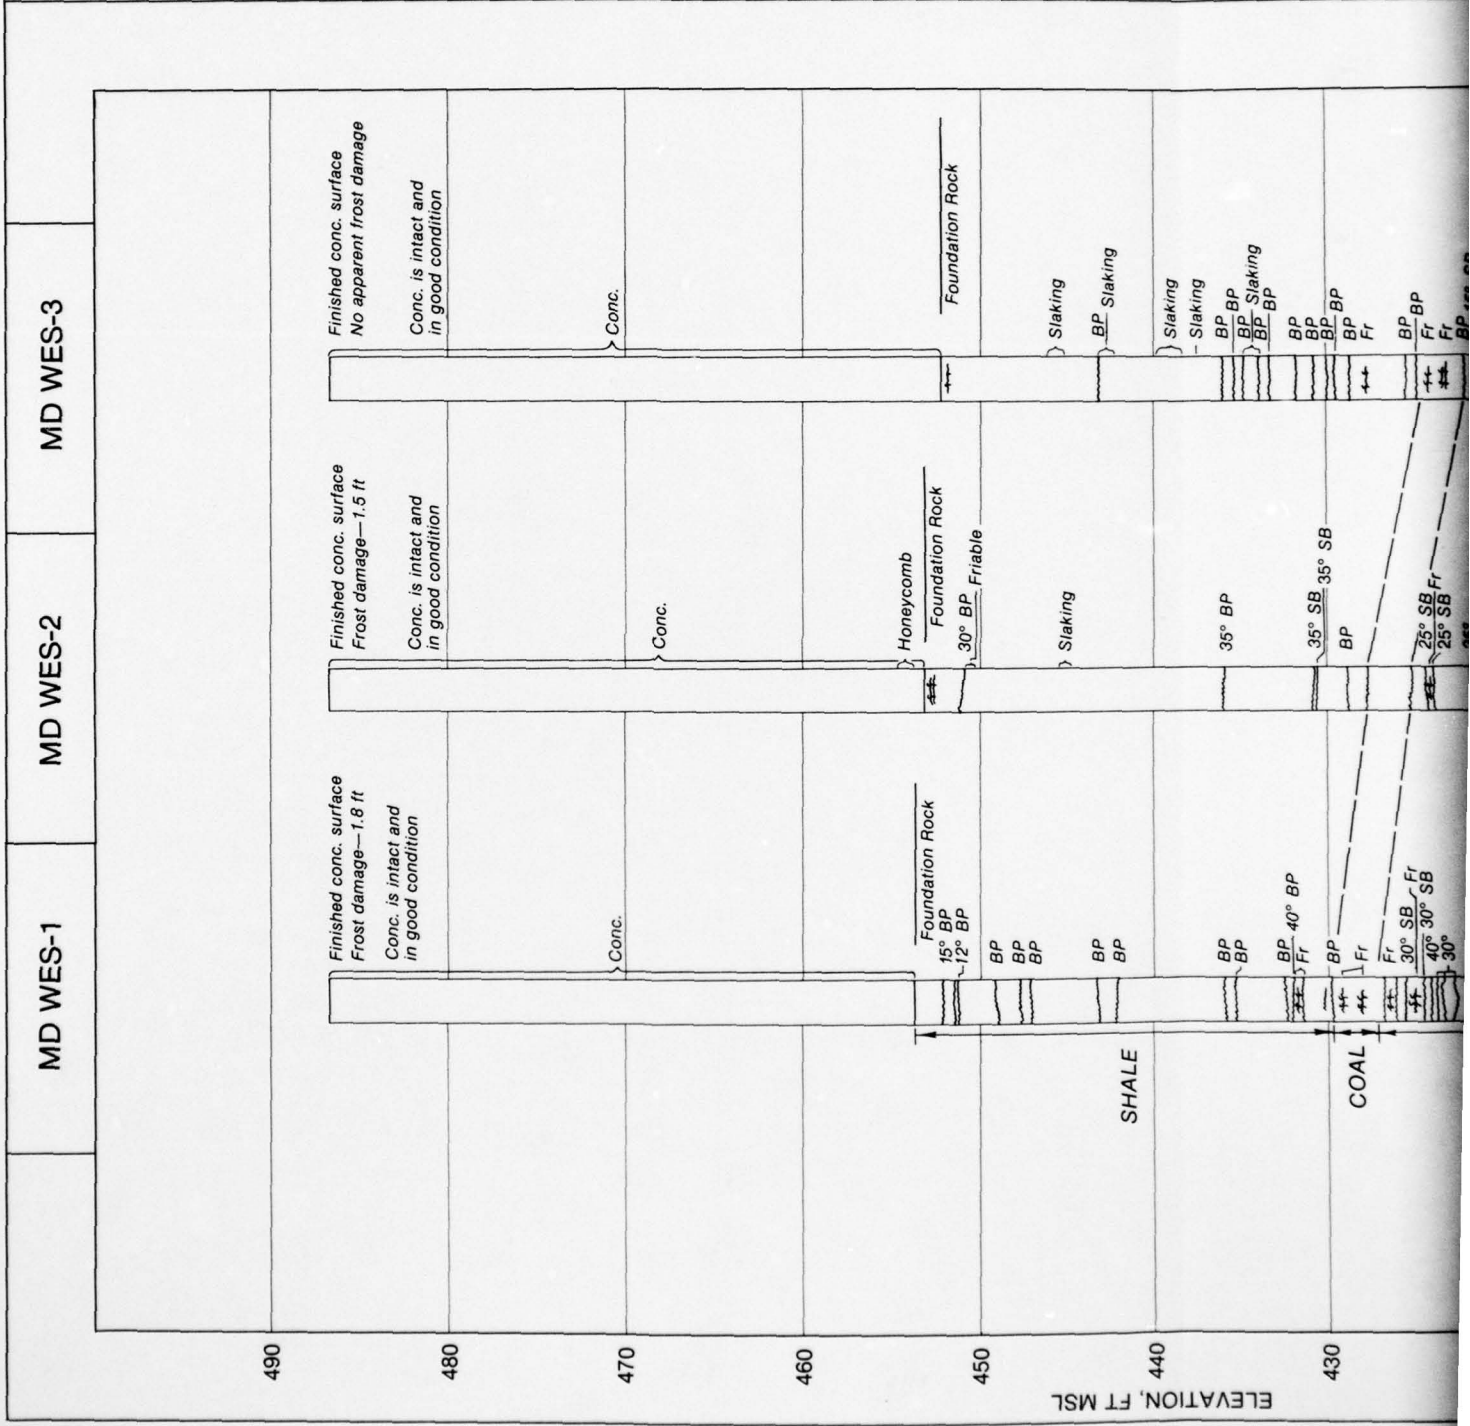
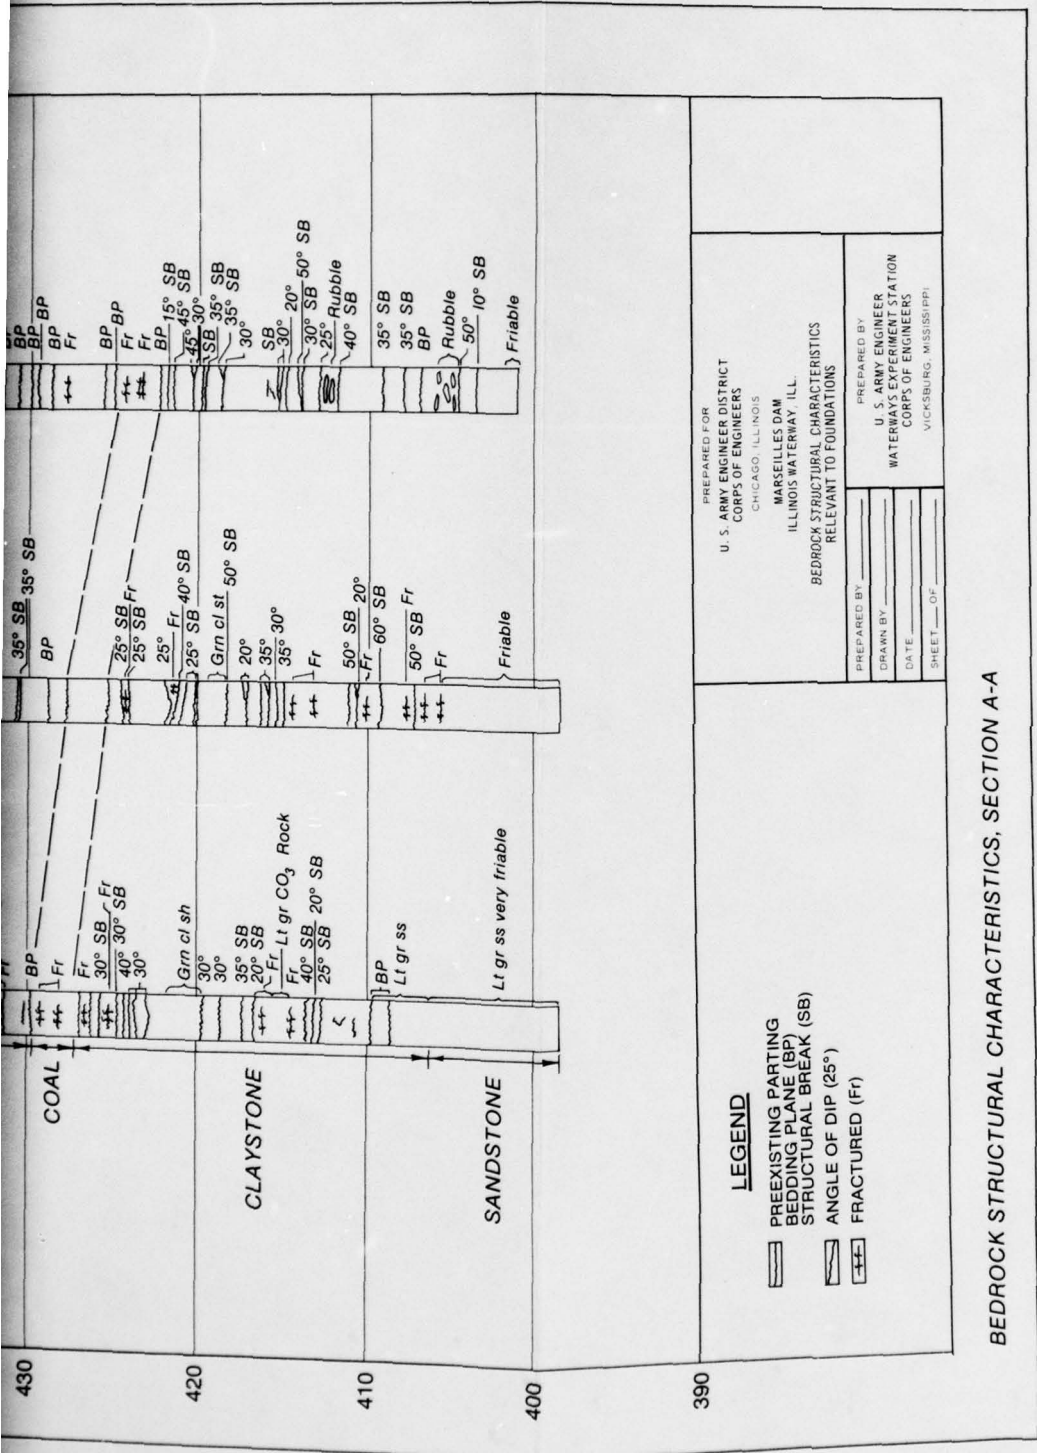
PLATE A1

32. A total of seven fractures that were considered as joints occur in the top shale stratum. The joints are widely spaced and were considered not to be continuous between borings. The inclination of these joints is shown in Appendix A, Plate A1. The 12 to 18 ft of claystone below the coal is highly fractured and contains at least three sets of joints with slickensided surfaces produced by possibly contemporaneous deformation;

the term contemporaneous deformation is used to describe the physical character of the claystone because the inclined jointing did not extend into the coal above nor the sandstone below. The highly fractured and jointed character of the claystone should not effect the stability of the dam.

BEDROCK STRUCTURAL CHARACTERISTICS, SECTION A-A
