Failure Analysis and Resin Evaluation of IUS SRM-1 92-inch Prototype Motor Case

Prepared by R. W. FILLERS, J. F. WARD, and P. K. GRANT
Materials Sciences Laboratory
The Aerospace Corporation
El Segundo, Calif. 90245

28 September 1979

Interim Report

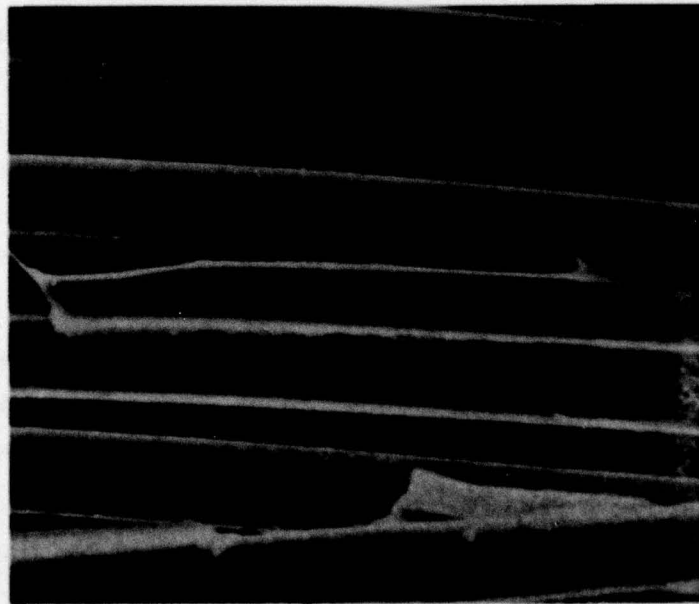
Fig. 1. SRM-1 Subscale 18-in. Vessel

Figures 1 and 2 show typical cross sections of the SRM-1 and SRM-2 subscale 18-in. vessels, which were wound as part of the case development program. (The SRM-1 vessel was fabricated using wet winding procedures, and the SRM-2 vessel was fabricated using a wet "pre-preg" version of the same system.) The clean separation between fiber and resin evidenced in both figures indicates poor wetting, or adhesion, between the Kevlar fibers and the epoxy resin. Small pieces of poorly bonded resin are present in both figures, but particularly in Fig. 2.

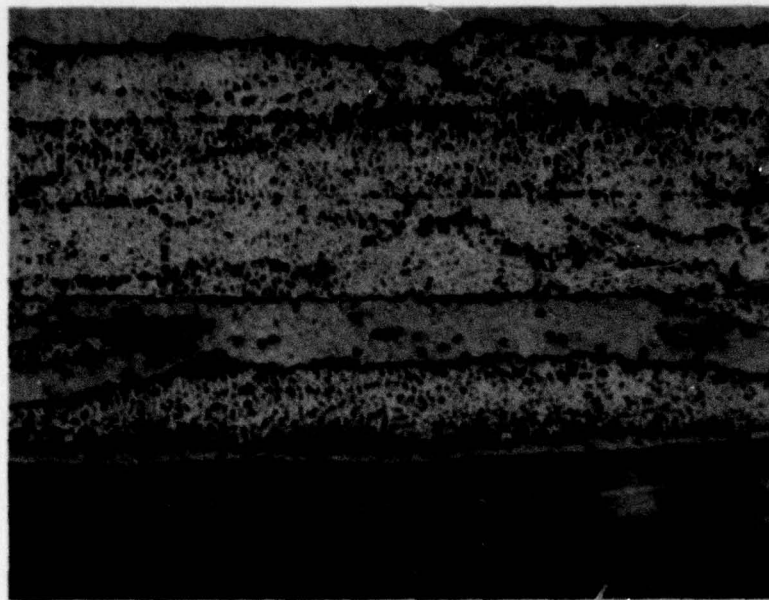
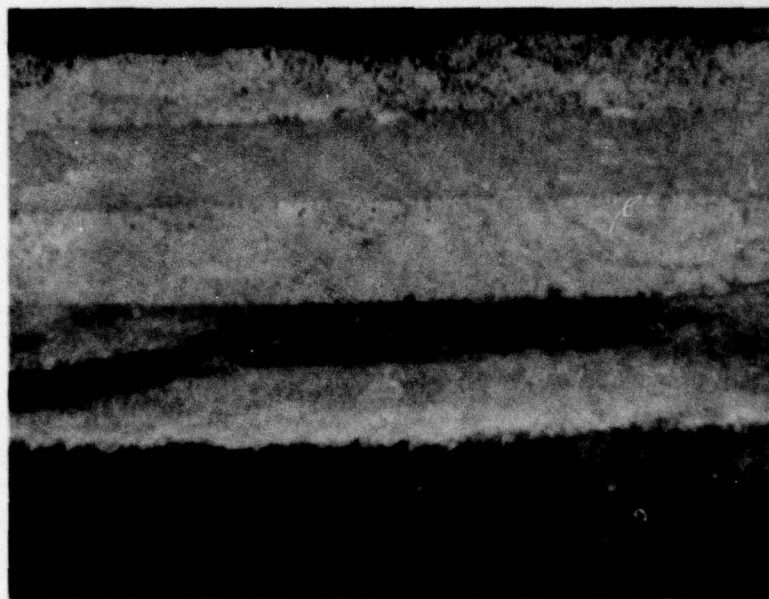
Fig. 3. SRM-2 Subscale Vessel: Polished Cross Sections

Figure 3 shows polished cross sections of the SRM-2 subscale vessel, taken at 50 \times (with the optical microscope). The two cracks running across the bottom of the pictures are delaminations, which occurred when the case burst. Note the poor distribution of fibers in the various wraps, or layers, and the resulting voids. The thickness of the inner wrap is approximately 0.010 in., whereas the outer wrap varies between 0.006 and 0.014 in. Also note that no fibers are split along the length of the crack.

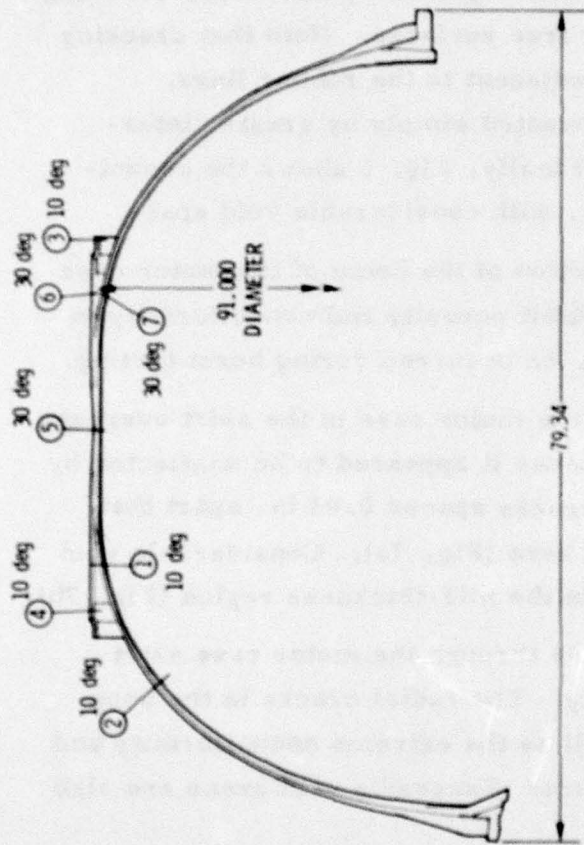
Fig. 4. SRM-1 92-in. Prototype

Figure 4 is a schematic of the SRM-1 92-in. prototype motor case, showing the regions from which the specimens were taken. Both the SEM and optical microscopes were used to analyze these specimens.

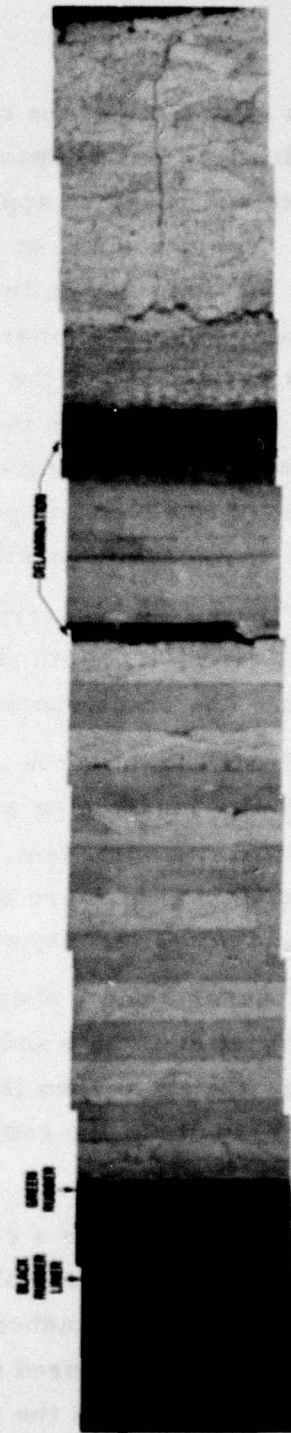
Fig. 5. Cross Section of Prototype at Station 1

Figure 5 shows a cross section of the case at Station 1. The region marked green rubber shows the material used to patch the liner (black rubber) prior to winding the case. This patching was used to fill the low spots and recover the contours of the discrepant plaster mandrel and rubber liner. Figure 5 also shows many radial cracks in the hoop wraps, which were observed prior to pressure testing. (These cracks were also noted

in the x rays taken of the case prior to hydrostatic testing.) They are approximately evenly spaced every 0.04 in. in all the outer hoop wraps observed and result in approximately one percent strain relief in the hoop wraps. The cracking, or "crazing," probably resulted from the thermal strains incurred during the cure cycle and indicates how highly strained the case was. Since the inner portions are held together by the outer, cracking is most pronounced at the boundaries or free surfaces. Note that cracking is also evidenced at the inner boundary adjacent to the rubber liner. Therefore, local crazing may not be prevented simply by greater interspersion of the hoop and polar layers. Finally, Fig. 5 shows the nonuniformity and nonhomogeneity in wrapping, with considerable void space.

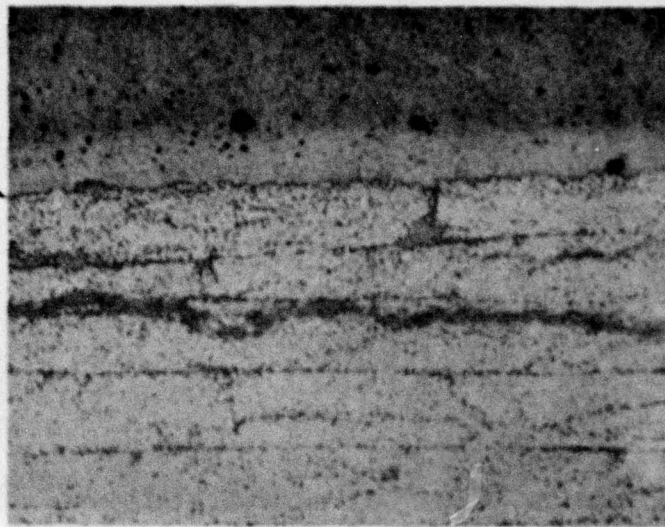
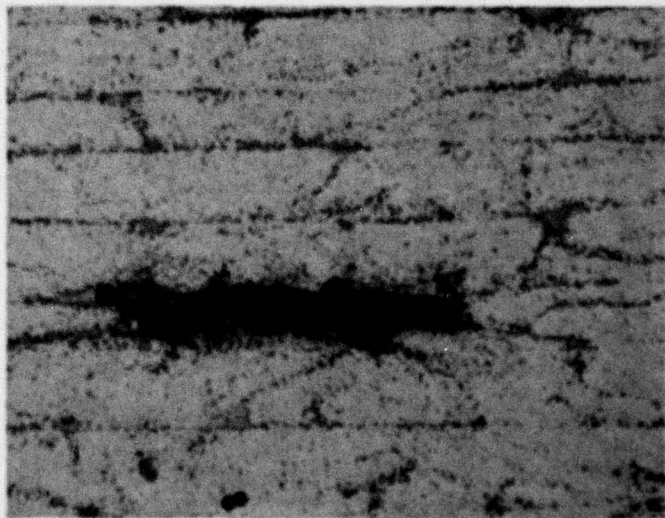
Fig. 6. Cross Section of Prototype at
Station 2

Figure 6 shows a typical cross section of the dome of the motor case region (Station 2). Both photographs exhibit porosity and nonuniformity in winding. The crack running across Fig. 6a occurred during burst testing.

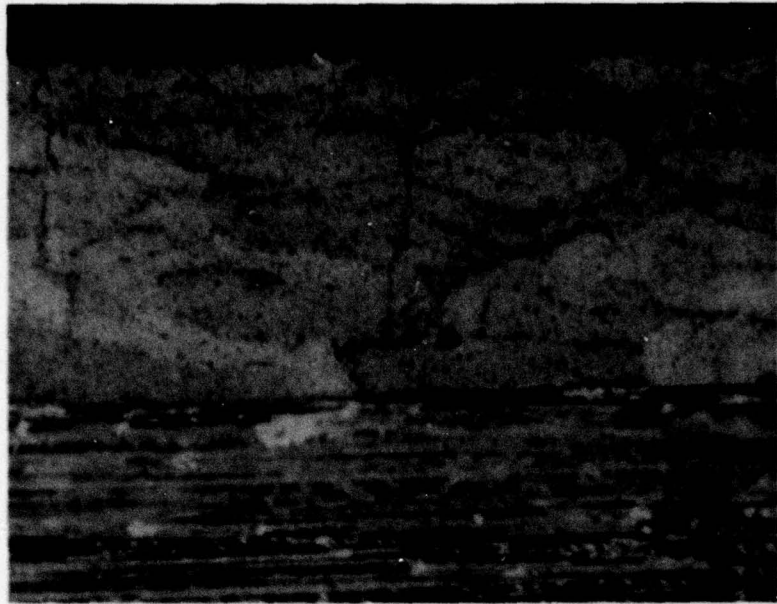
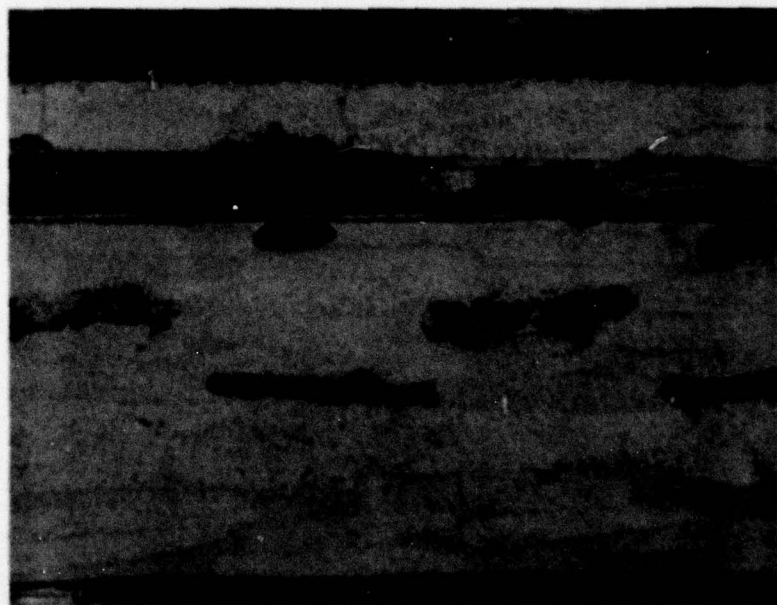
Fig. 7. Cross Section of Prototype at
Station 3

Figure 7 shows the appearance of the motor case in the skirt overhang (Station 3). This region was chosen because it appeared to be unaffected by the hydrostatic burst test. The radial cracks spaced 0.04 in. apart that were noted in Fig. 5 are also evidenced here (Fig. 7a). Considerable void space and nonuniformity are evidenced in the mid-thickness region (Fig. 7b).

Although additional measurements indicate that the aged resin system attains its proper strength if it is later properly cured, it is feared that the gelled resin in the inner regions of the case may fracture due to its brittle, weak state as the stresses from the winding of the outer portion of the case are imparted to it. In any event, premature gelling leads to a nonuniform distribution of strain in the finished case and is probably partly responsible for the radial cracking evidenced in Fig. 7.

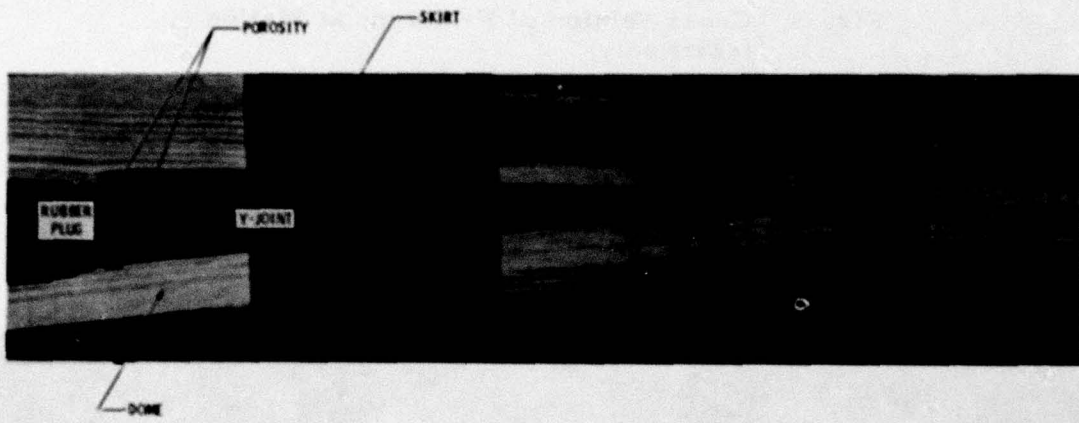
Fig. 10. Cross Section of Prototype Y Joint
(30 deg Aft)

Figure 10 shows a cross section of the Y joint taken at 30 deg aft. A high degree of nonuniformity is evidenced, especially in the layer adjacent to the rubber and the adhesive film laminate. Hoop wrapped filler is seen over the rubber plug used to correct large contour mismatch. Additionally, as noted previously in the other regions of the case, extensive voids were observed in both composite and adhesive.

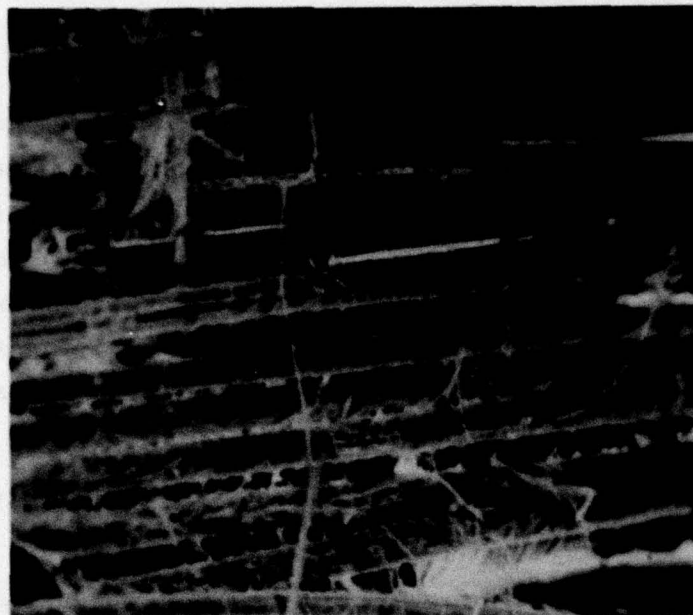
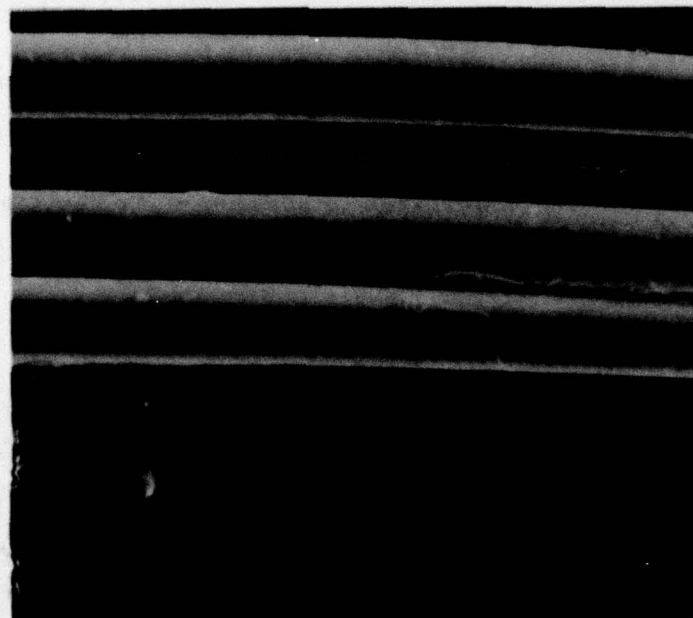
Fig. 11. Evidence of Fiber Wetting

In addition to the optical microscopy of the polished specimens reported above, specimens were removed from the case dome at Stations 2, 3, and 4 and examined under the SEM. The only evidence of fiber wetting was observed in the skirt region in (Fig. 11a). This good adhesion was quite local and was not evidenced in any other region of that particular specimen nor in any other portion of the case. In general, all regions of the motor case observed with the SEM were identical to that shown in Fig. 11b.

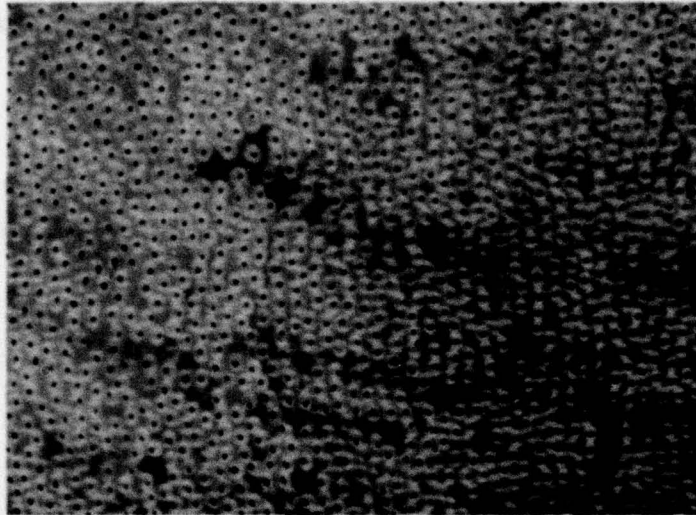
Fig. 12. Fiber Count on Polished Cross Sections

A careful examination of Fig. 12b indicates that approximately 40 to 50 fibers could be placed in the void regions. This is equivalent to between

2 and 3 percent void space, which when substituted into Eq. (2) yields a good correlation between the two techniques. Due to the inhomogeneity of the composite, the actual fiber count technique yields the best results, and the areas used here should be considered minimal. Future studies should include counts from many areas of the case.
