NEW YORK STATE DEPT OF ENVIRONMENTAL CONSERVATION ALBANY F/G 13/13
NATIONAL DAM SAFETY PROGRAM. INGHAMS DAM (INVENTORY NUMBER NY 1--ETC(U)
AUG 79 G KOCH

1. REPORT NUMBER	2. GOVT ACCESSION NO.	3. RECIPIENT'S CATALOG NUMBER
4. TITLE (and Subtitle) Phase I Inspection Report Inghams Dam Mohawk River Basin, Herkimer and Fulton Counties, Inventory No. 183 NY		5. TYPE OF REPORT & PERIOD COVERED Phase I Inspection Report National Dam Safety Program

7. AUTHOR(s) George Koch, P.E.		6. PERFORMING ORG. REPORT NUMBER
9. PERFORMING ORGANIZATION NAME AND ADDRESS New York State Department of Environmental Conservation/ 50 Wolf Road Albany, New York 12233		8. CONTRACT OR GRANT NUMBER(s) DACW-51-79-C-0001

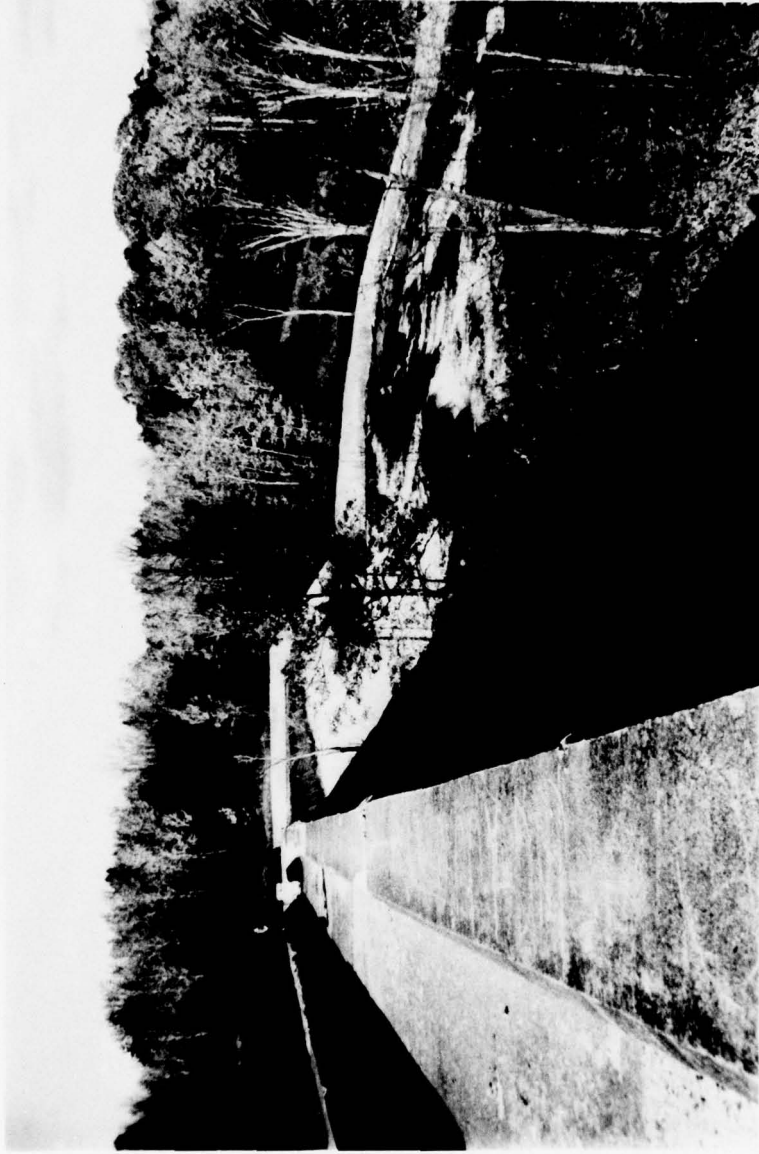
Photograph #2

Overview of Spillway & Tailrace Channel
from top of dam

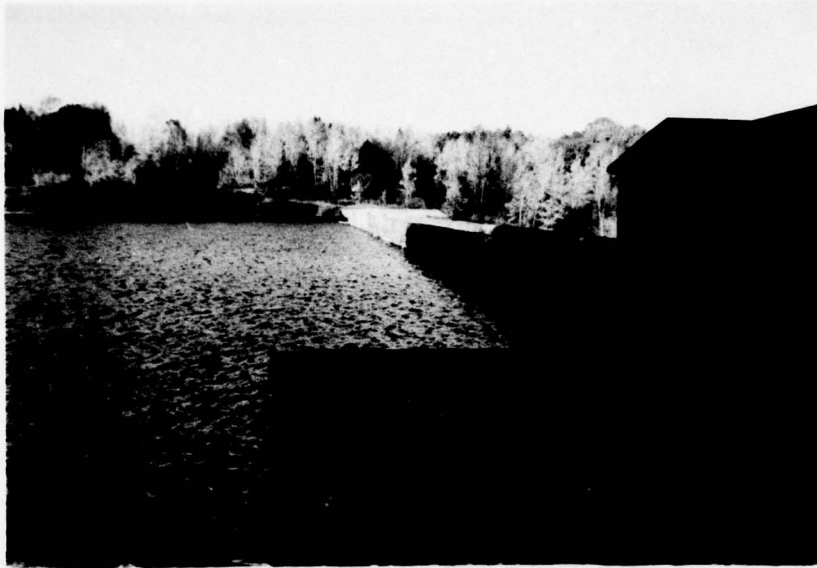
Photograph #12

The non-overflow section has not been rehabilitated since its original construction. There are no signs of horizontal or vertical misalignment and no indication of distress or cracking. No seepage was evident at any location. Some surface spalling of the concrete was evident on the downstream face with the maximum depth estimated to be 3 inches and the average depth of approximately 1 inch (see photographs #4,5 & 6). Surface spalling (see photographs #8,9 & 10) was also apparent on the parapet walls. No internal drainage system was provided. However, 6 borings were progressed in June 1970 to determine uplift pressures and these holes have remained open. No flow was observed from these holes. Boring logs for this work have been included in Appendix F "Stability Analysis". The intake structure for the penstock, located near the south end of the dam is in good condition. Some minor ice caused damage was apparent in the concrete walls of intake structure. (See photographs #8 & 12).

Upstream Face of Non-Overflow Section
and Intake Structure

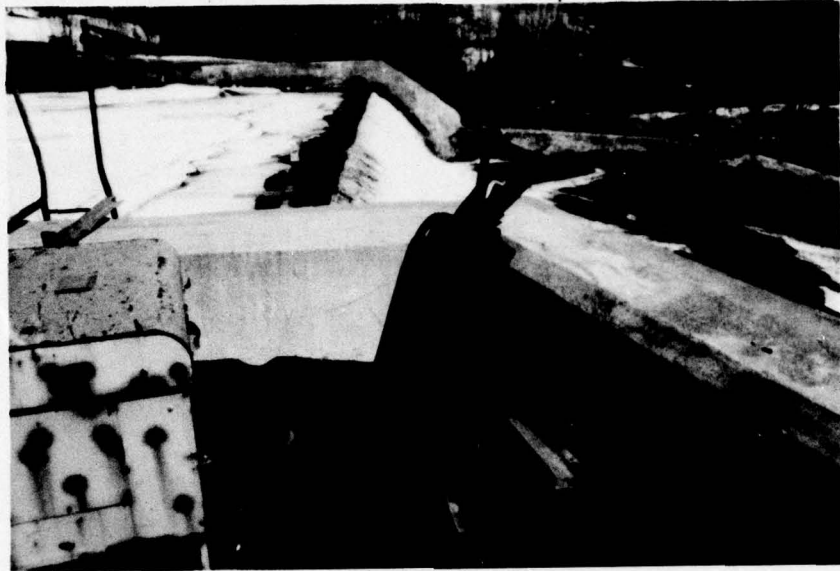
Photograph #20

Ogee Spillway without flashboards looking north
Note bent bars salvaged after failure of flashboards

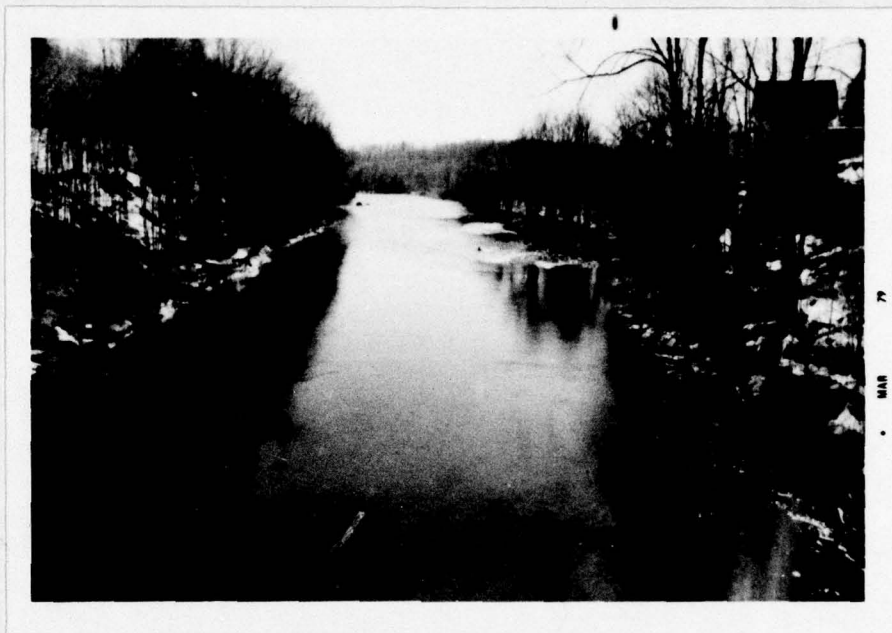
Photograph #22

The downstream channel is primarily bedrock formed and appears in good condition. (See photographs #19 & 22). A bridge located below the power house controls the flow of the channel. Some debris was observed in the downstream channel.

Downstream Channel
as viewed from downstream bridge
below power house
