1. REPORT NUMBER		2. GOVT ACCESSION NO.	3. RECIPIENT'S CATALOG NUMBER
4. TITLE (and Subtitle) Phase I Inspection Report Higinbotham Brook Watershed Project Oswego River Basin, Madison County, New York Inventory No. 703		5. TYPE OF REPORT & PERIOD COVERED Phase I Inspection Report National Dam Safety Program

11. CONTROLLING OFFICE NAME AND ADDRESS New York State Department of Environmental Conservation/ 50 Wolf Road Albany, New York 12233		12. REPORT DATE 25 September 1979

PHASE I INSPECTION REPORT
NATIONAL DAM SAFETY PROGRAM
HIGINBOTHAM BROOK WATERSHED PROJECT
I.D. NO. NY 703
DEC #103C-4286
OSWEGO RIVER BASIN
MADISON COUNTY, NEW YORK

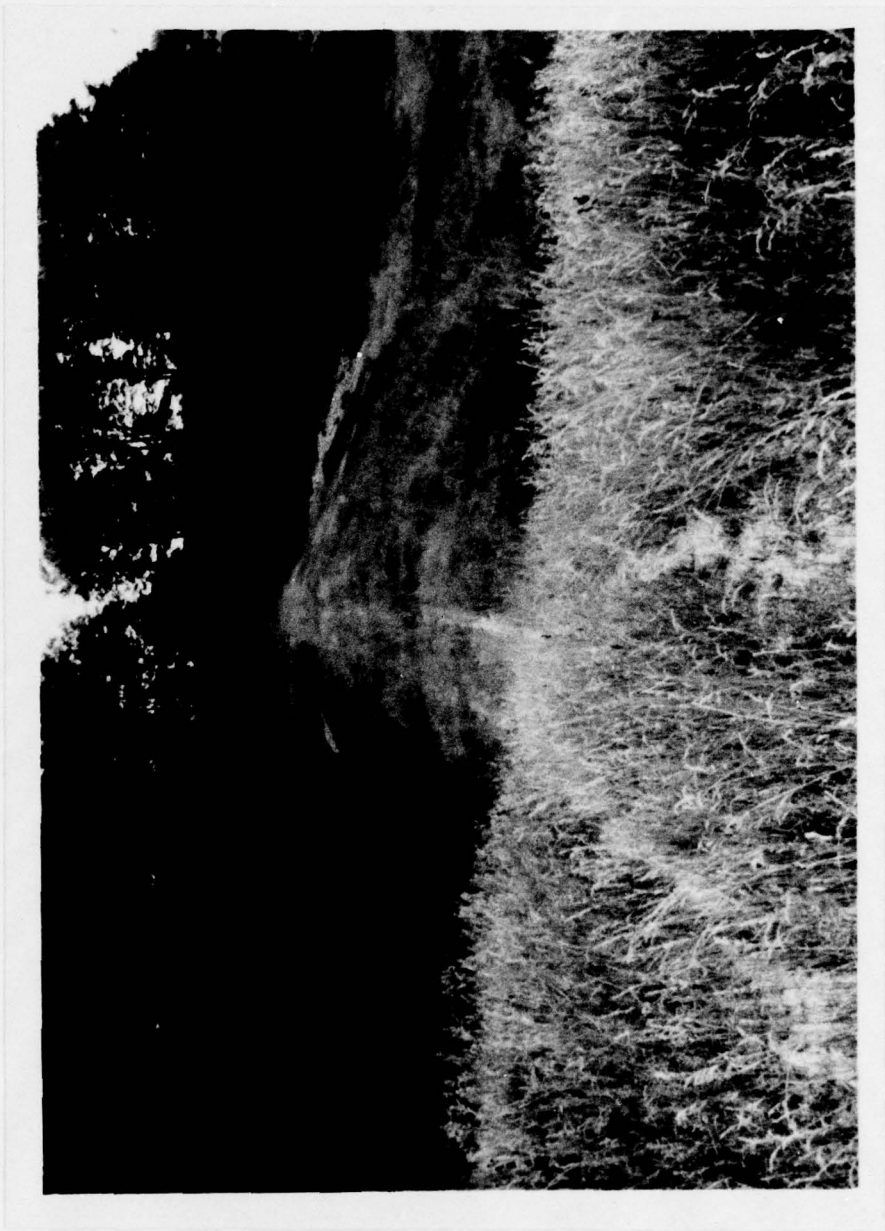
Overview of Dam 3
Photo #2

This dam is a closure embankment located approximately 900 feet southwest of Dam 1 (See photo #2). There are no signs of distress in the earth embankment and no evidence of seepage, misalignment, sloughing, subsidence, depressions, surface cracking, or undesirable growth were noted. Riprap was placed on the original grade at the right (southeast) abutment on both the upstream and downstream sides of the dam to provide erosion protection of the abutment slopes.

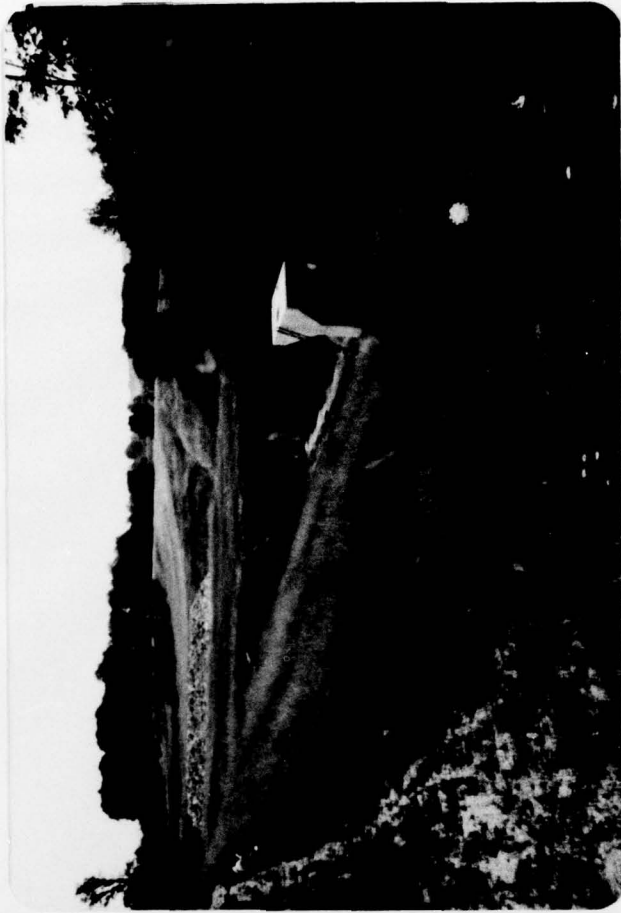
Dam 1
Photo #3 A & B

The principal spillway consists of a vertical drop inlet structure, a reinforced concrete pipe through the embankment, a plunge pool at the toe of the embankment, and an outlet channel. These components appear to be in satisfactory condition. (See photos #3, 7, 8 & 9)

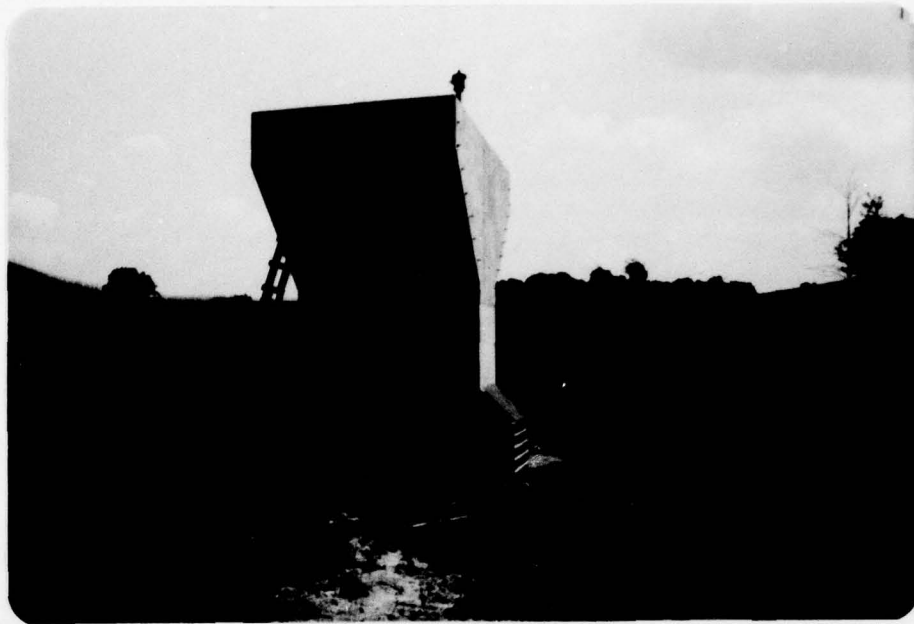
Dam 1 - Principal Spillway Riser
Photo #7

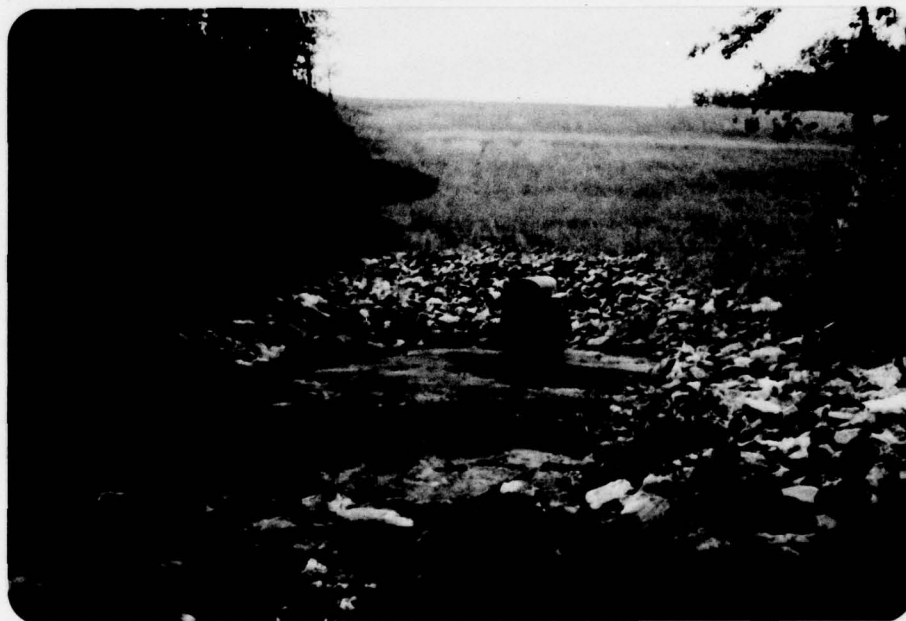
Two 8-inch diameter internal drains encased in a 2 zoned drain fill material provide control of the phreatic surface and foundation seepage. The left drain was discharging at a rate of approximately 3 to 5 gallons per minute. (See photos #8 & 9)

Dam 1 - Outlet of Principal Spillway Conduit
Photo #8

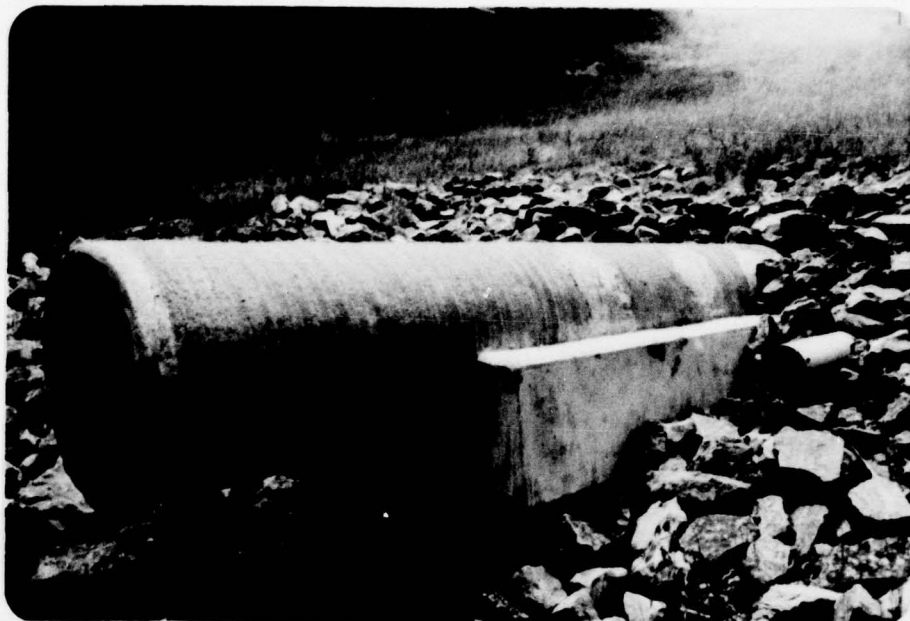
Dam 1 - Principal Spillway Conduit
Note Drainpipe
Photo #9

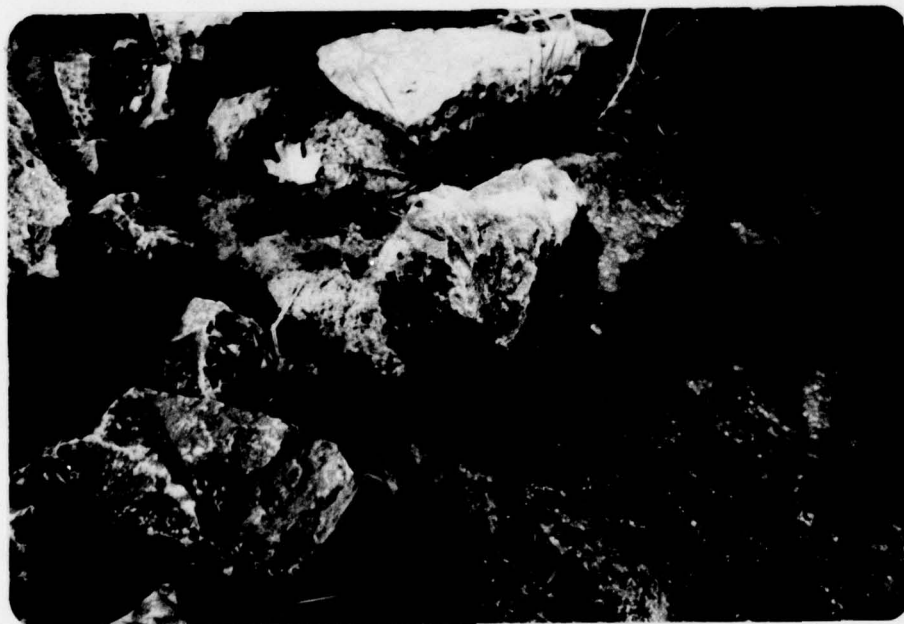
Dam 1 - Seepage Point in Plunge Pool
Right Side of Conduit
Photo #10

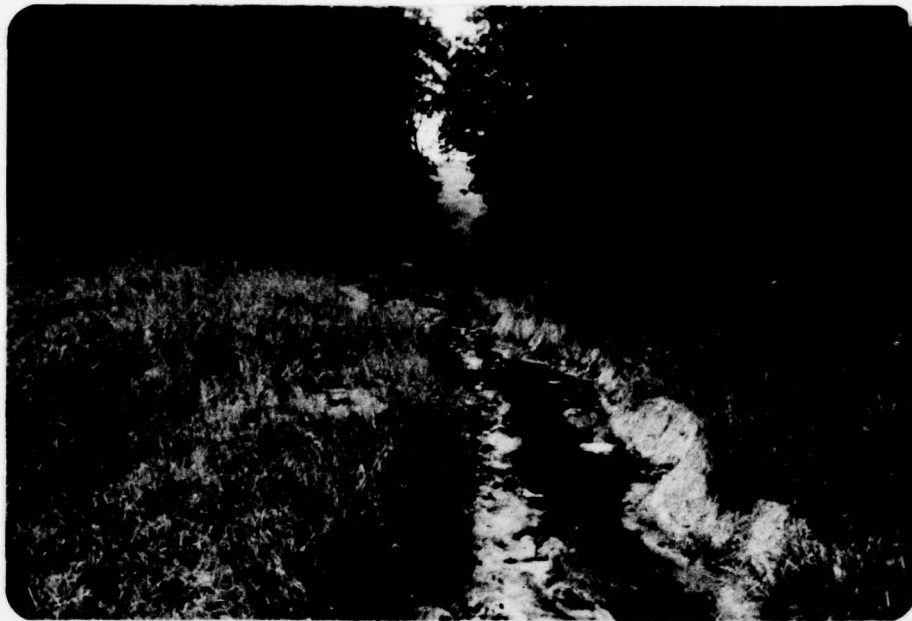
2. Headward erosion in the downstream channel requires repair and erosion protection material;
3. The very steep slopes in the reservoir area and the minor erosion of the adjacent cut slopes should be monitored periodically with repairs initiated as required;

Downstream Channel, Dam 1 in Background
Note Channel Erosion
Photo #11

- b. Repair the eroded area of the downstream channel with erosion protection material.
- c. Periodically monitor the slopes in the reservoir area and repair as required.

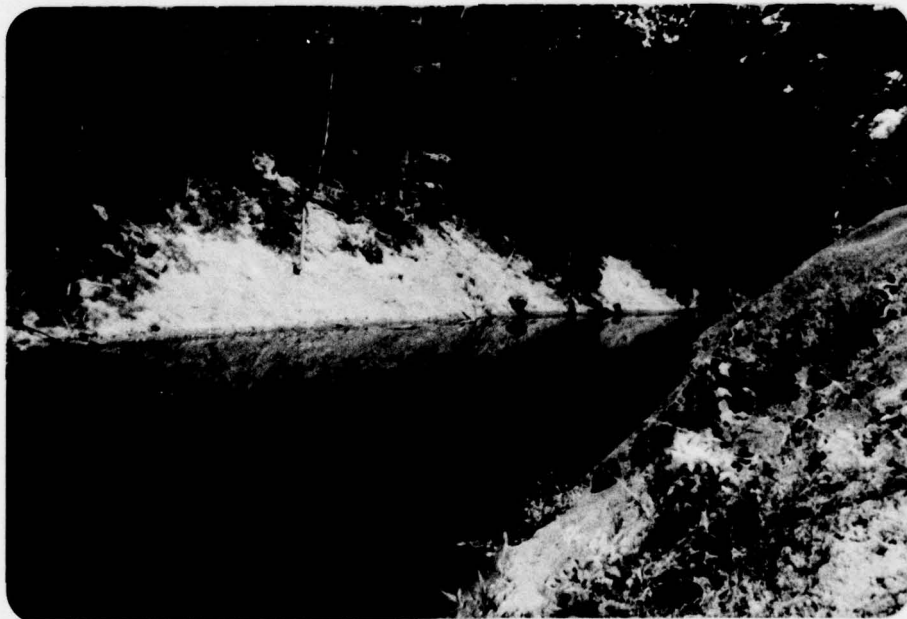
Steep Slopes in Reservoir Area
Note Shale Outcrop at Right
Photo #14
