OSWEGO RIVER BASIN

DE RUYTER DAM

ONONDAGA COUNTY  
NEW YORK

PHASE I INSPECTION REPORT  
NATIONAL DAM SAFETY PROGRAM

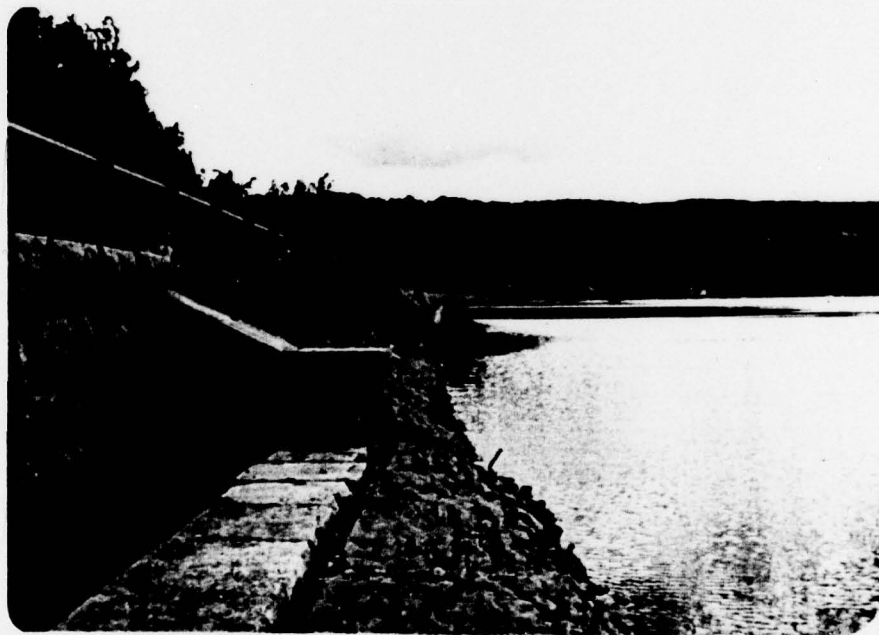
Overview of DeRuyter earth embankment dam located in South-east Onondaga County, New York.

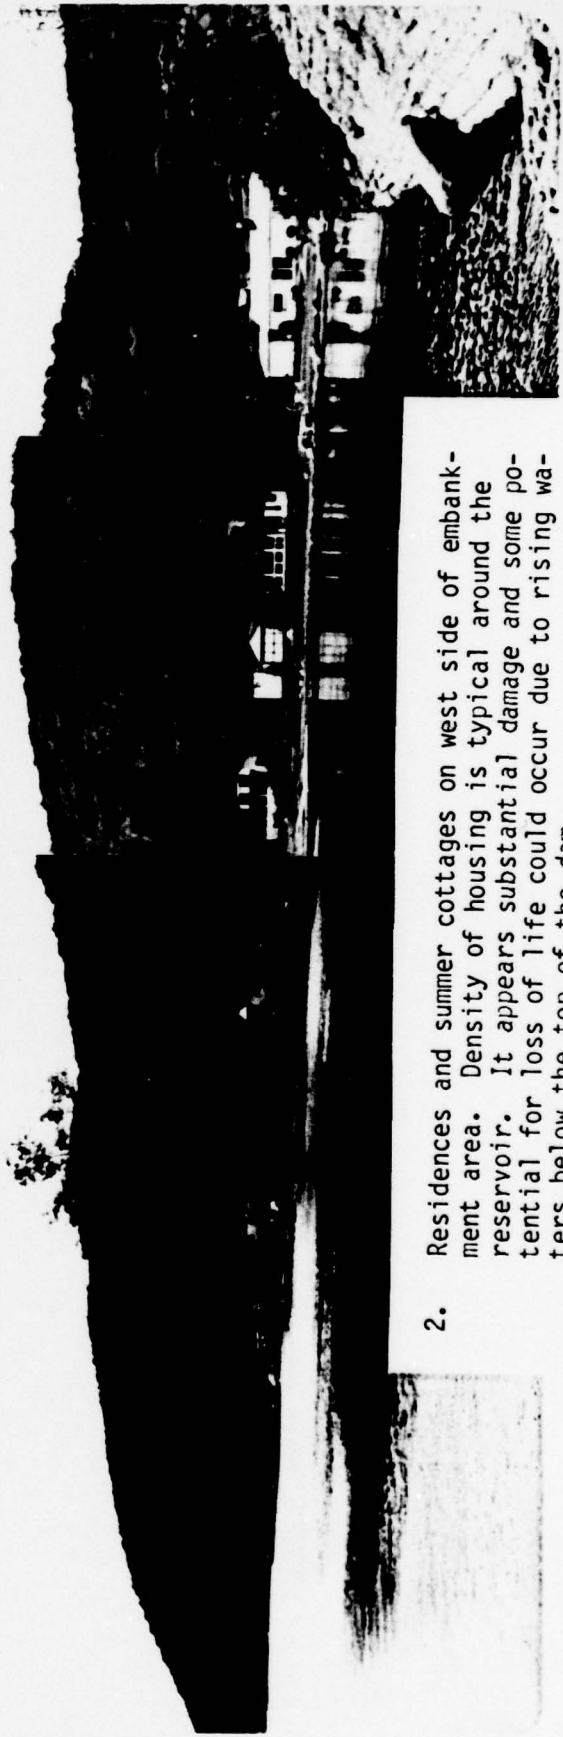
2. Residences and summer cottages on west side of embankment area. Density of housing is typical around the reservoir. It appears substantial damage and some potential for loss of life could occur due to rising waters below the top of the dam.

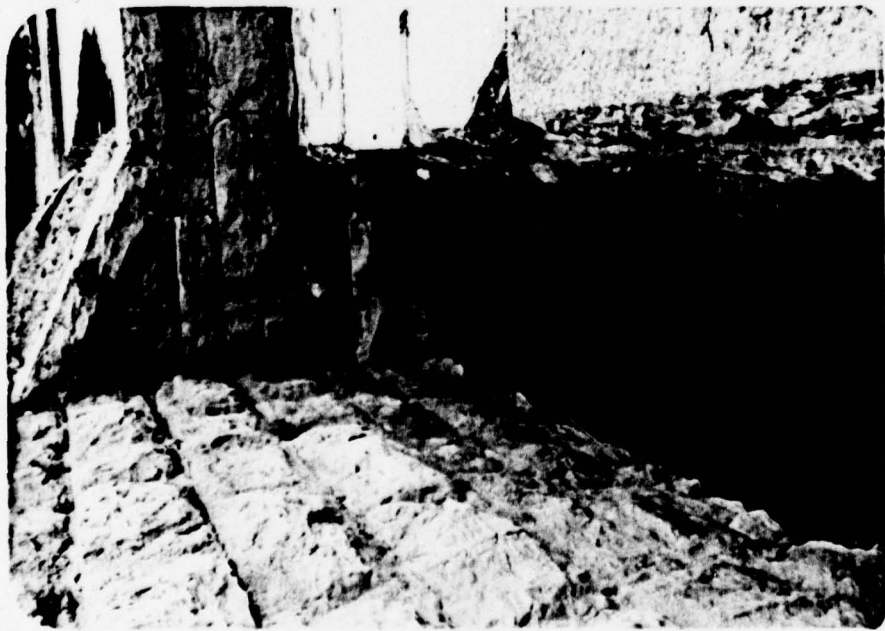
3. Masonry spillway weir. Some separation of stone masonry.

The main spillway located near the west abutment of the dam is in generally good condition. There is some deterioration in the masonry joints, but this is of minor concern. The arch culvert, which receives the flow from the spillway, is in good condition as is the masonry channel downstream from the culvert. The extreme northerly end of the masonry channel is severely deteriorated and undermined. This deterioration will progress up the channel if repairs are not made.

VISUAL EXAMINATION OF	OBSERVATIONS	REMARKS OR RECOMMENDATIONS
CONCRETE WEIR	Masonry weir, some deterioration of mortar joints.	Repoint.
APPROACH CHANNEL	None.	
DISCHARGE CHANNEL	Good condition except for end - 350+ from spillway, severely undermined.	Repair.
BRIDGE AND PIERS	Concrete arch culvert. Good condition.

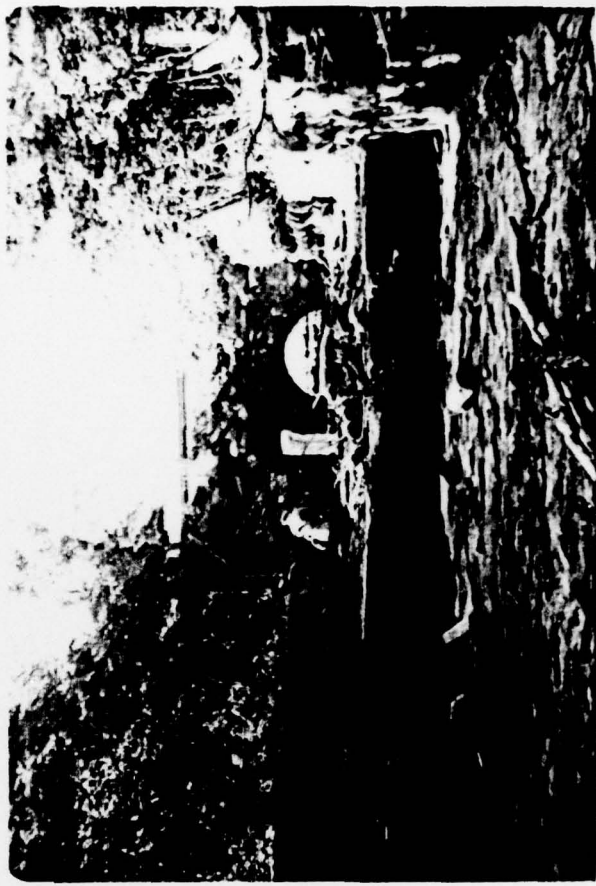
4. Upstream and downstream view of spillway culvert below road across top of dam.

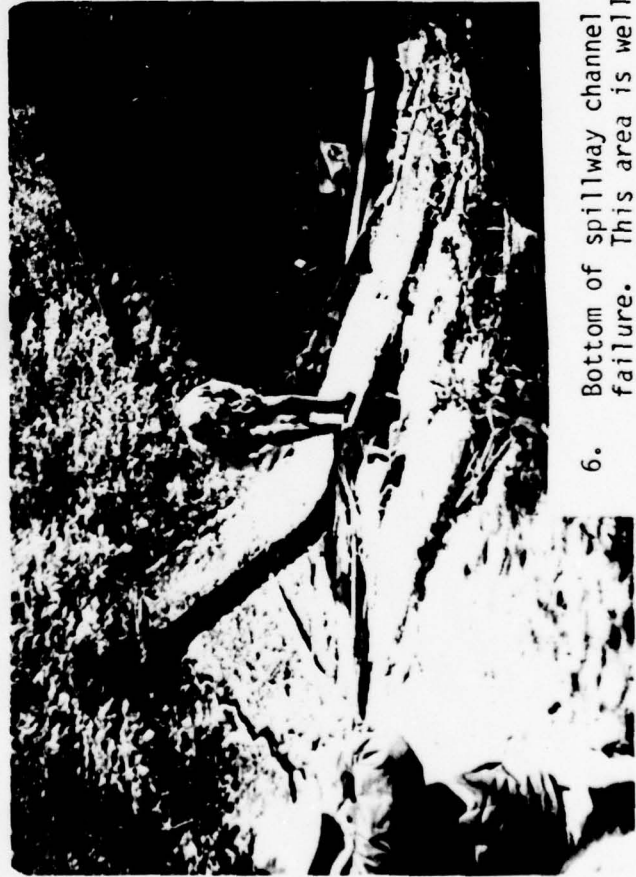
6. Bottom of spillway channel displaced due to foundation failure. This area is well below dam. See plans enclosed in report.

7. The extreme northerly end of the masonry spillway channel is severely deteriorated and undermined. This deterioration will progress up the channel if repairs are not made.

Necessary masonry repair should be provided for the spillway and outlet channel to prevent progressive damage. Damaged and deteriorated areas of the outlet channel should be rehabilitated. A maintenance program should include periodic removal of heavy debris from the channel.

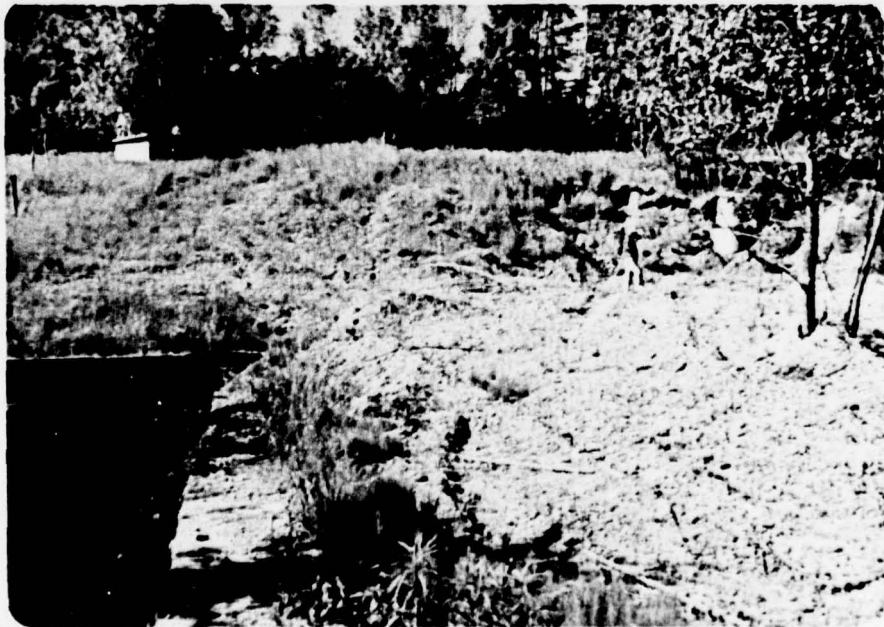
7. Area in deep section of embankment where drainage system was repaired and needs to be regraded.

4. An excavation and repair on the subdrain system near the center of the embankment performed in 1978 to repair blockage in the drain line has not been backfilled.

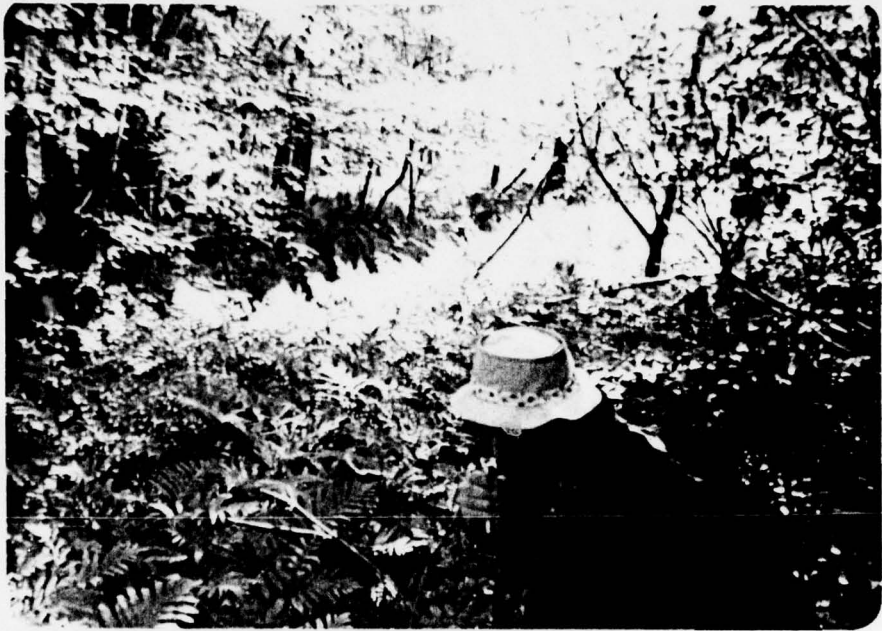
8. Wet area along drainage ditch at toe of embankment on west portion of dam.

3. A seepage condition is present throughout the general vicinity of the dams central downstream embankment area near the toe. Saturated and soft soils and marsh vegetation exist in this area even though the dam has an extensive underdrain system.

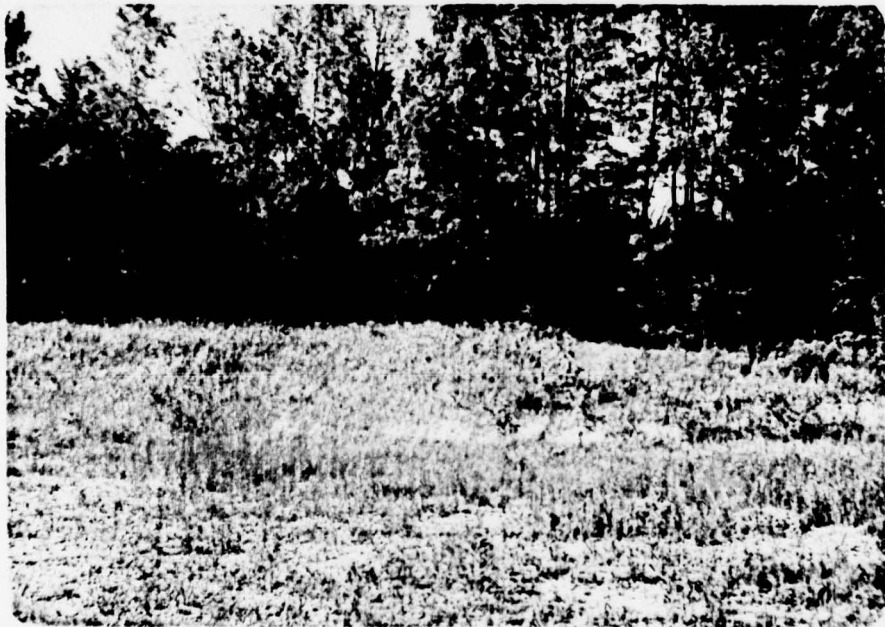
9. View of trees growing near top of embankment. At deepest section, embankment is very wide.

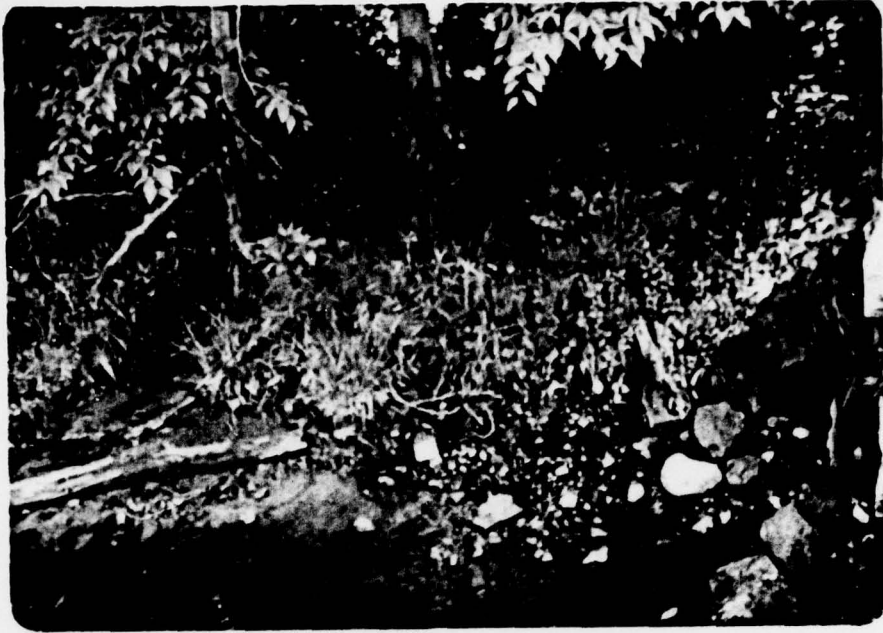
10. Drain outlet for east side of dam where it discharges into main channel.

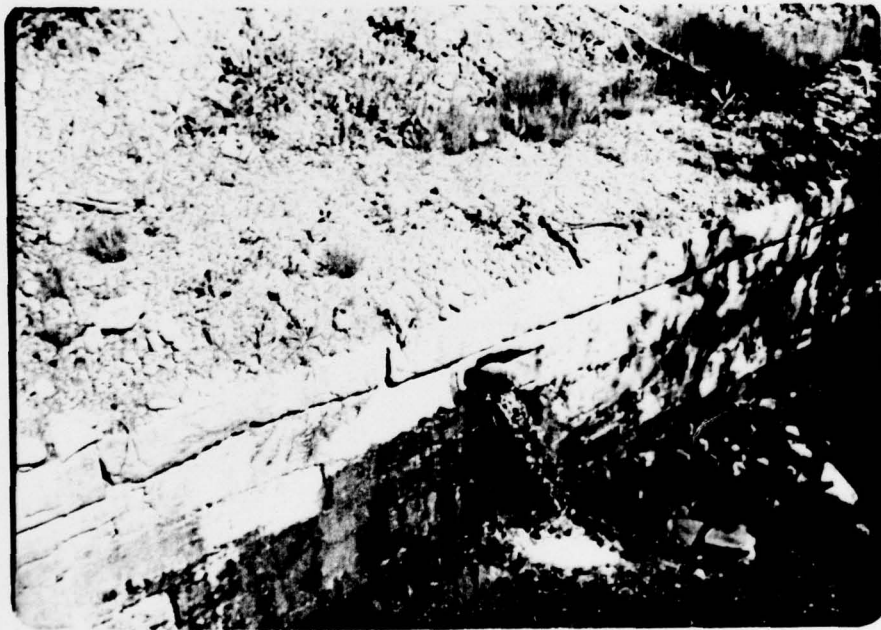
11. Substantial flow from west side of dam drainage system.

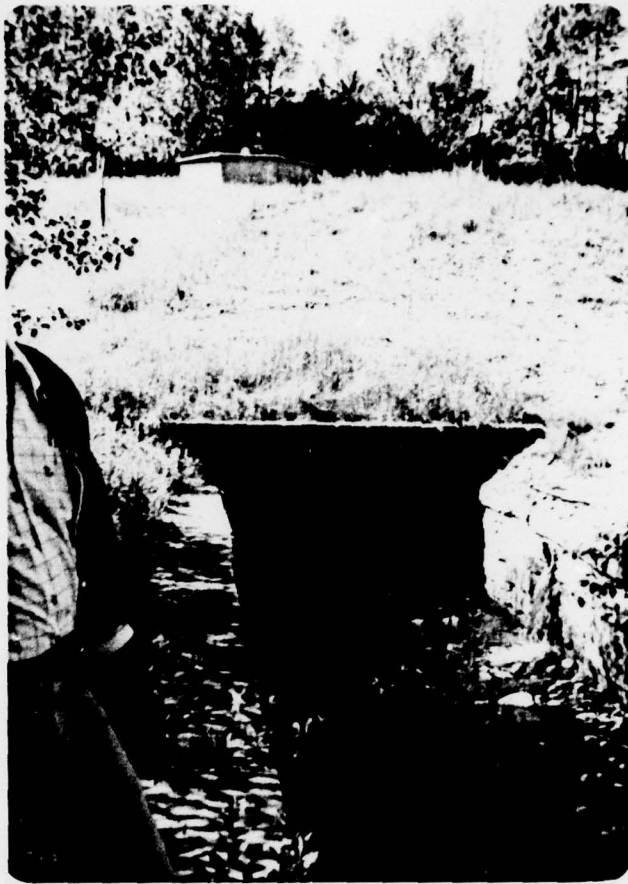
12. Regulated outflow below dam controlled from gates contained in silo seen above.
