Name of Dam: Whites Dam

Location: Albemarle County, State of Virginia

Inventory Number: VA 00327

**PHASE I INSPECTION REPORT
NATIONAL DAM SAFETY PROGRAM**

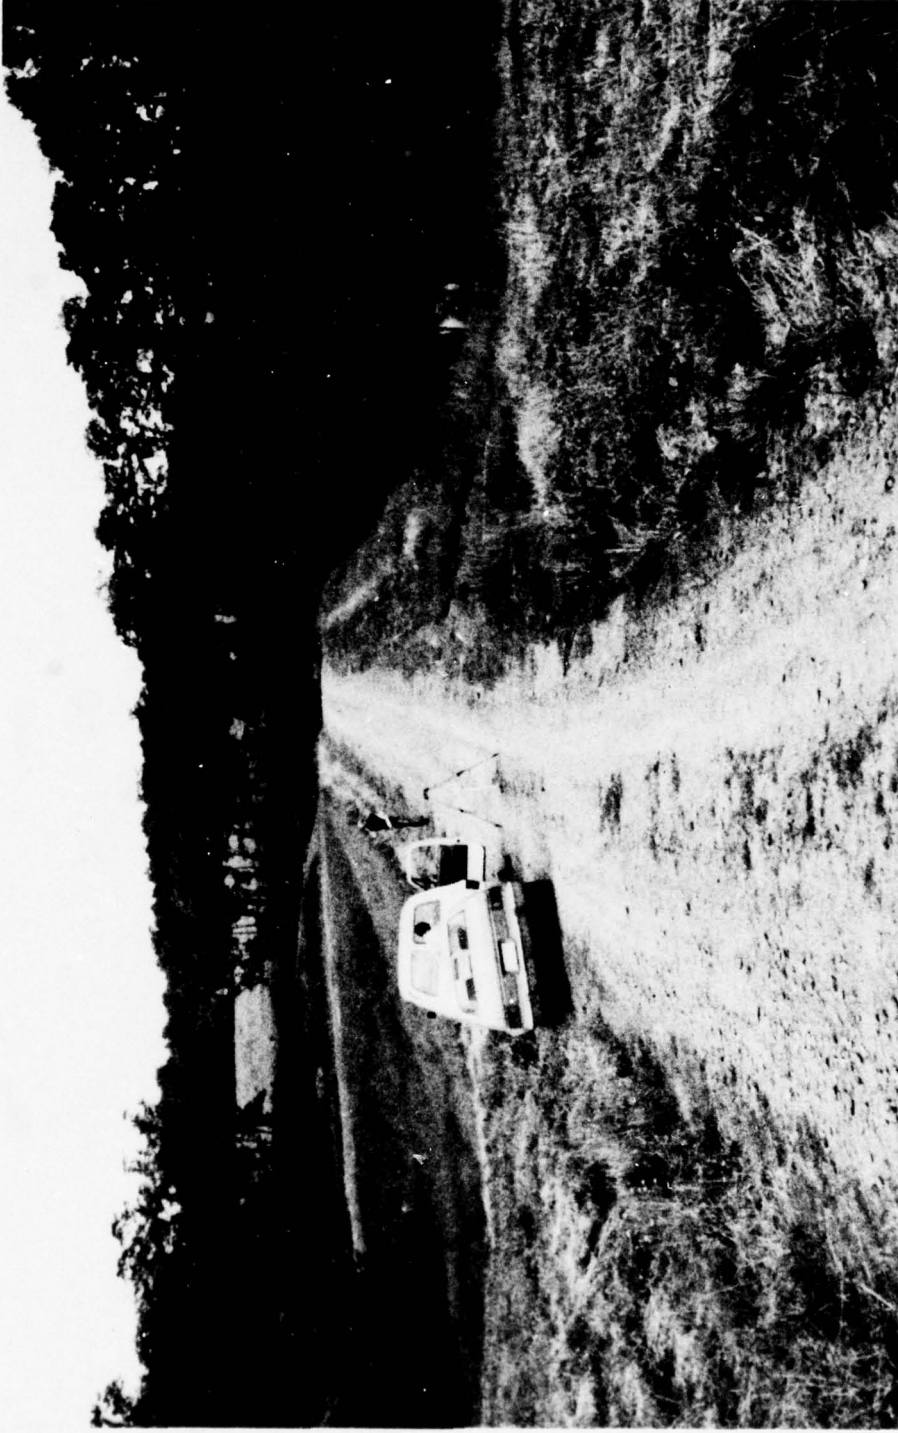
OVERALL VIEW OF DAM

The crest of the embankment is traversed for its full width by an earth roadway (see Overall View of Dam). Although not provided with an erosion resistant surface, no significant amounts of gulleying were noted.

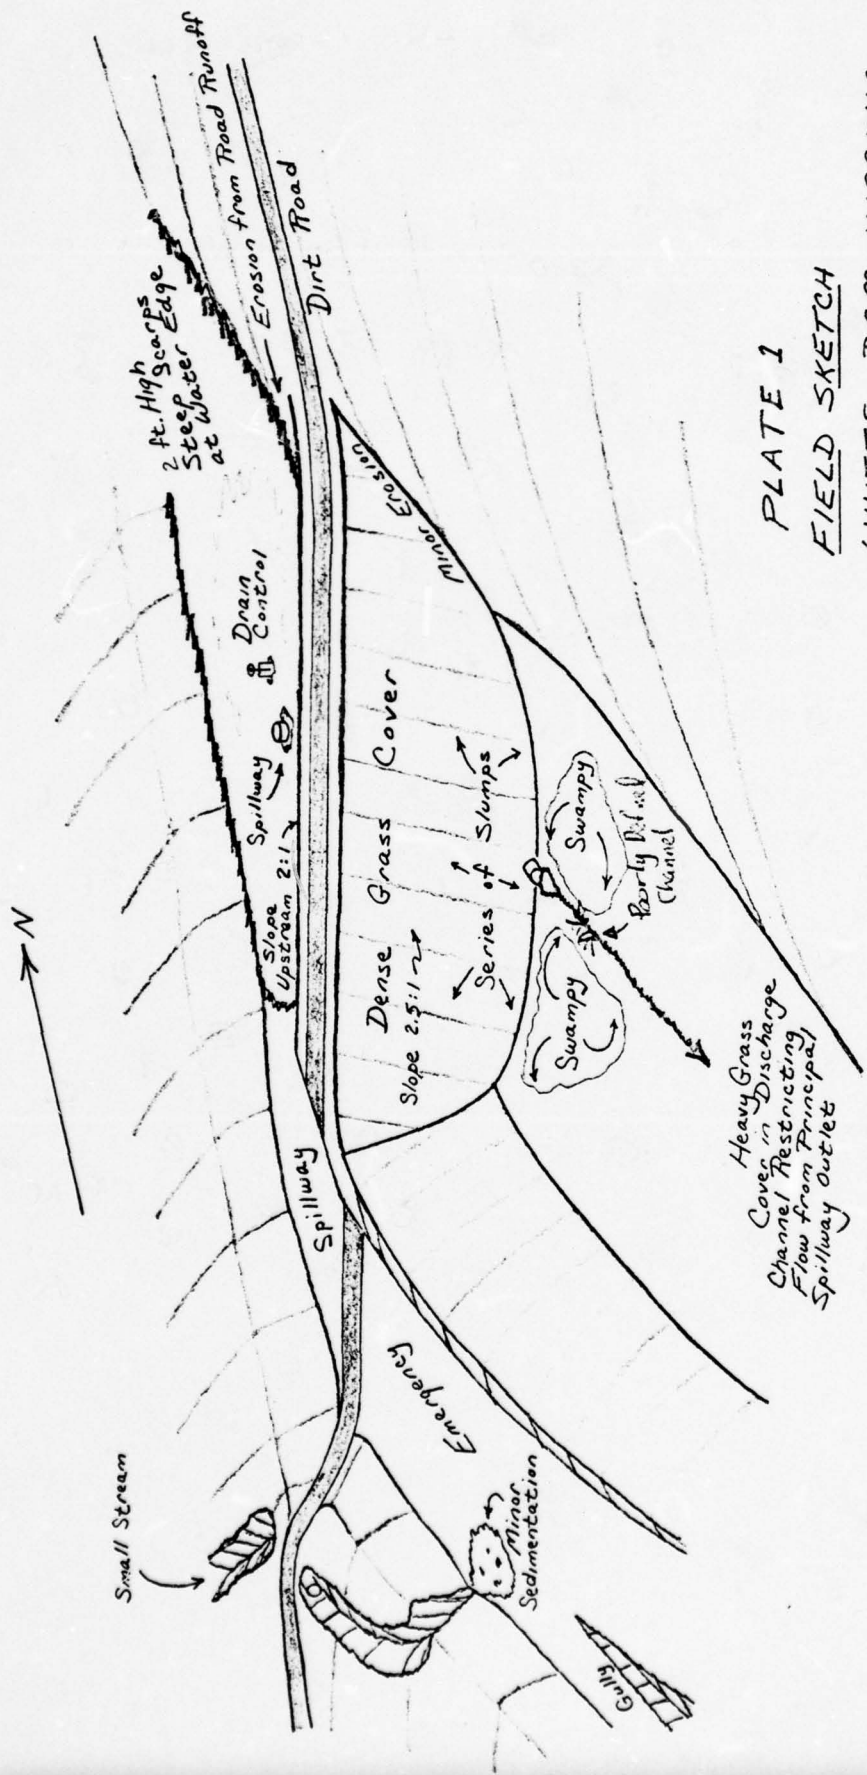
PLATE 1

Plate 1 is a Field Sketch of the dam which illustrates the conditions observed during the visual inspection. The complete visual inspection check list is included in Appendix III. Following are summaries of the deficiencies noted during the inspection.

- 3.1.2 Dam: Step-like slumping of the lower half of the downstream slope of the embankment (slope 2.5:1) has occurred at this facility (see Plate 1). Displacements of up to 2 feet along the more distinct slump scarps were noted. Each slump is less than 3 feet in width. The lower half of the slope is sparsely vegetated and the slumped areas are eroded (see Photo 5). The disturbed embankment material is firm and no seeps were detected in the slumped areas. The downstream toe area of the dam on either side of the outlet channel is very swampy, but no seepage was detected. Surface drainage is poor, probably due to the poor condition of the downstream channel, and the vegetation is thick (see Photo 3) in this area.

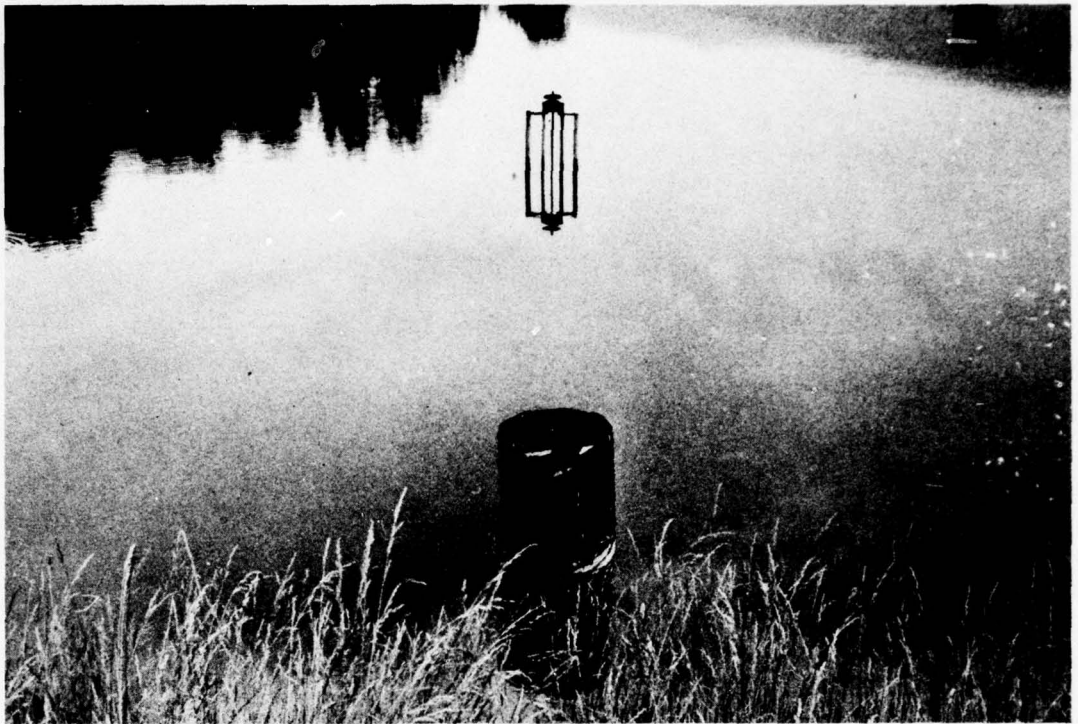
4.3 Maintenance of Operating Facilities: Maintenance of the reservoir drain is the responsibility of the owner. From available information, the structure for the drain hand crank was reinforced in 1978 because of ice damage. The reservoir was drained to accomplish the repair.

PHOTO 1. Principal Spillway Inlet and Drain Hand Crank

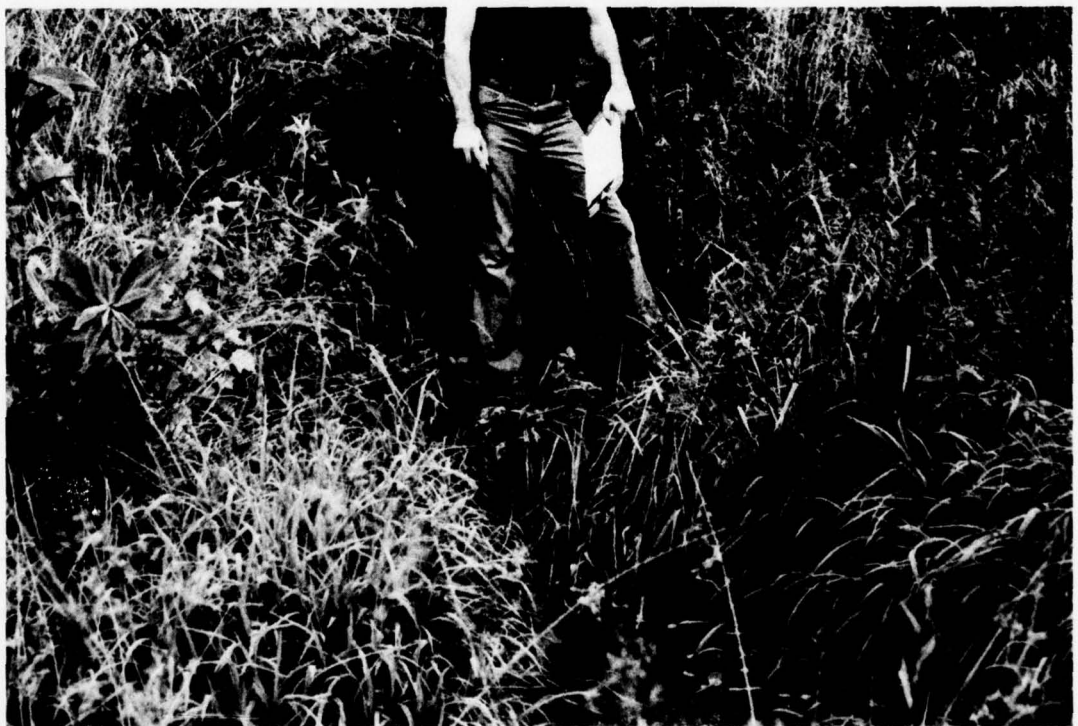
- 3.1.3 Appurtenant Structures: The principal spillway outlet is partially inundated due to restriction of flow in the discharge channel near the outlet. The discharge channel is heavily overgrown by high grass. A stilling basin is not provided and riprap is not present around the outlet to protect the toe of the dam (see Photo 2 and 3).

PHOTO 2. Principal Spillway Outlet and Restricted Discharge Channel

Although a stilling basin is not provided, riprap should be placed around the outlet pipe to prevent erosion of the downstream toe.

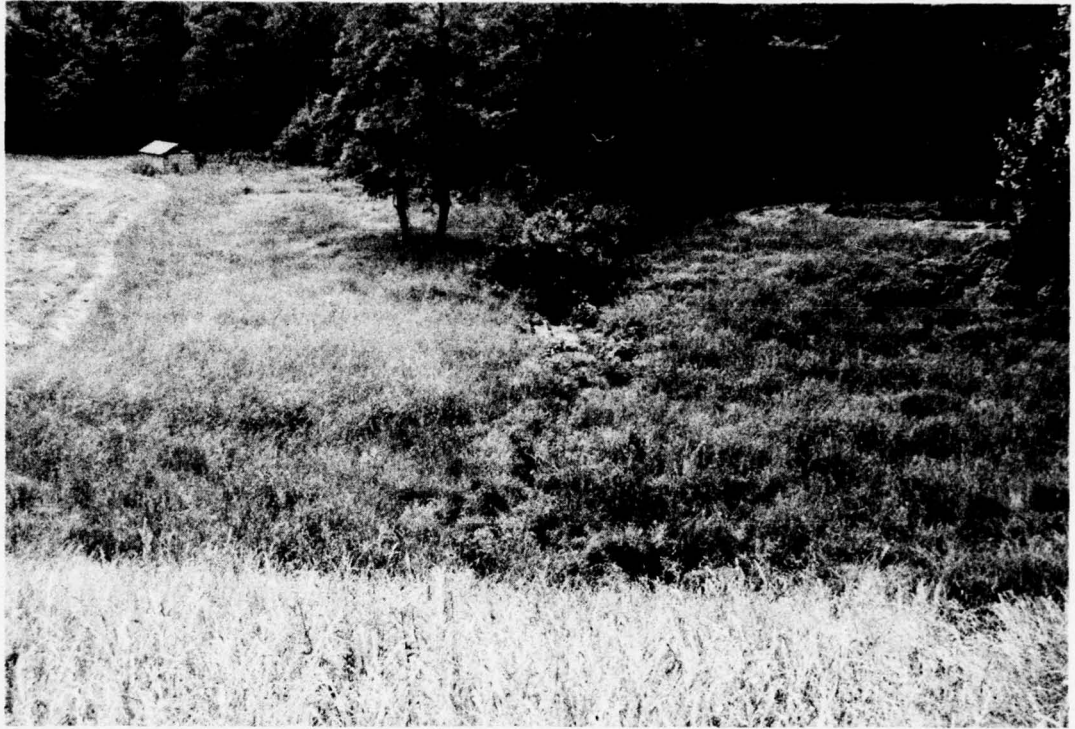
- 3.1.5 Downstream Channel: The downstream channel is overgrown by dense grass and drainage is poor, as explained in Sections 3.1.2 and 3.1.3.

PHOTO 3. View of Downstream Channel from Dam Crest

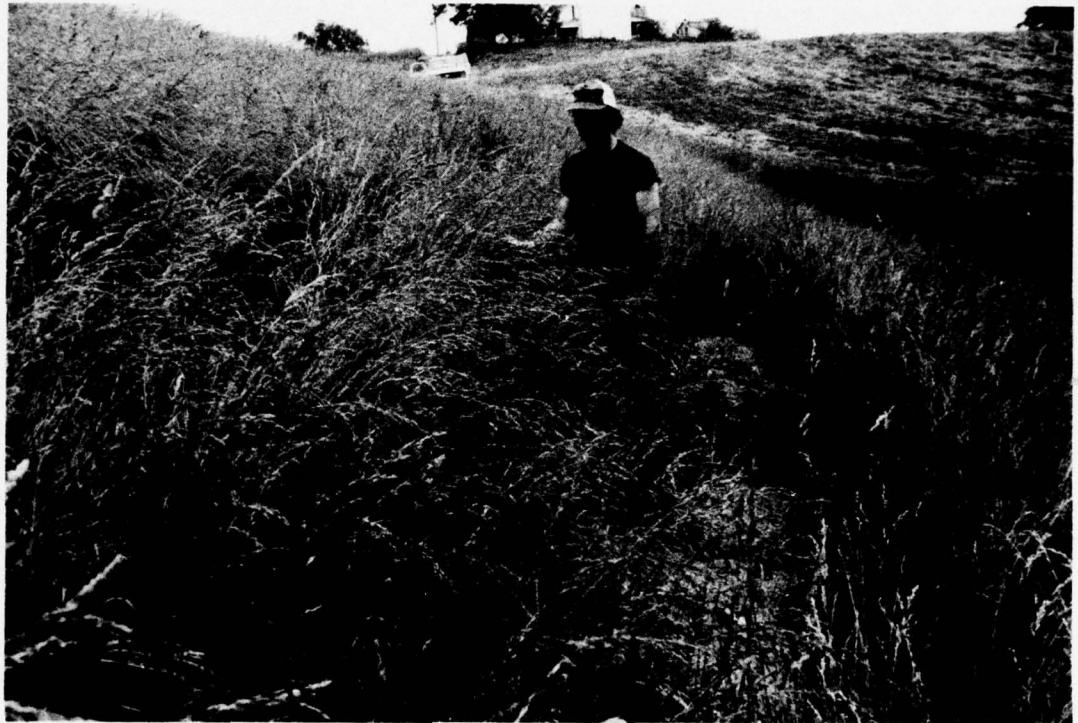
- 3.2 Evaluation: Substantial slumping has occurred on the downstream slope of the embankment. Because bulging at the toe of the dam was not observed, it is believed that the depth of disturbance in the embankment is relatively shallow. The toe area of the dam is very swampy, but the lack of detectable flow implies seepage is not occurring through the embankment. This condition

6.2.1 Visual Observations: Slumping has occurred on portions of the lower half of the downstream slope of the embankment (see Photo 5). The displacement is approximately 2 feet. The slumped areas are eroded and sparsely vegetated, but the silty and clayey soils are firm and no seepage was observed. The toe area of the dam is swampy, but a concentrated discharge was not detected.

PHOTO 5. Eroded Slump Scarps on the Downstream Embankment

The lower half of the downstream embankment has step-like slumps which should be corrected to prevent further deterioration. The exposed portion of the upstream embankment is eroding from wave action and will worsen if not corrected. With the exception of these deficiencies, the embankment is in satisfactory condition with no seepage observed during the field inspection.

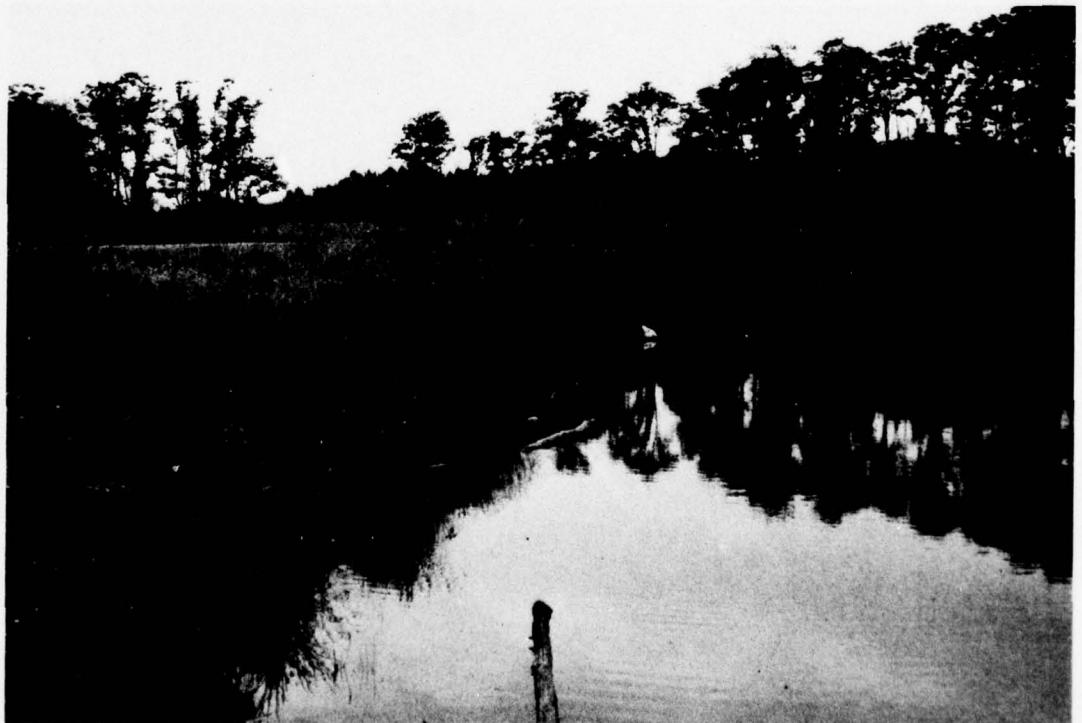
The upstream slope of the embankment (slope 2:1) at the waterline has eroded badly and sloughed into the water in many places. This

has resulted in oversteepening and minor instability. Vegetation is sparse on most of the upstream embankment slope due to continual erosion (see Photo 6).

The upstream embankment slope is badly eroded and subject to continual sloughing due to oversteepening.

PHOTO 6. Erosion and Sloughing of the Upstream Embankment

- 7.2 Recommended Remedial Measures: Because this is a high hazard dam with relatively steep embankment slopes, it is recommended that an investigation and stability analyses be performed by a qualified professional engineering firm. It is recommended that the step-like slumps on the lower half of the downstream embankment slope be repaired as soon as possible to prevent further deterioration. The slump area should be graded, filled where necessary, compacted, and seeded. The discharge channel from the outlet pipe should be improved to allow drainage away from the outlet pipe and the swampy areas along the toe of the dam. Riprap protection should be placed around the outlet pipe. The erosion along the waterline of the upstream embankment slope should be repaired and riprap should be placed on the slope to protect it from further erosion.
