Name of Dam: Johns Creek No. 4  
Location: Craig County, State of Virginia  
Inventory Number: VA 04504

# PHASE I INSPECTION REPORT

## NATIONAL DAM SAFETY PROGRAM

PREPARED BY  
MICHAEL BAKER, JR., INC.  
BEAVER, PENNSYLVANIA 15009

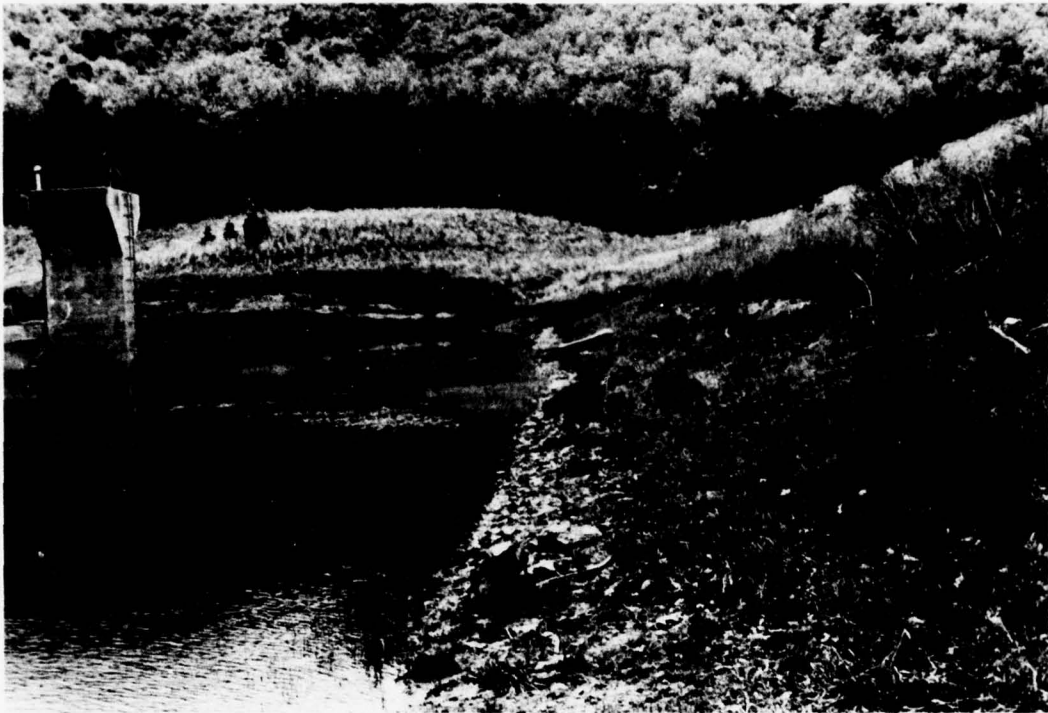
**PHOTO 1. Upstream Embankment and Riser**

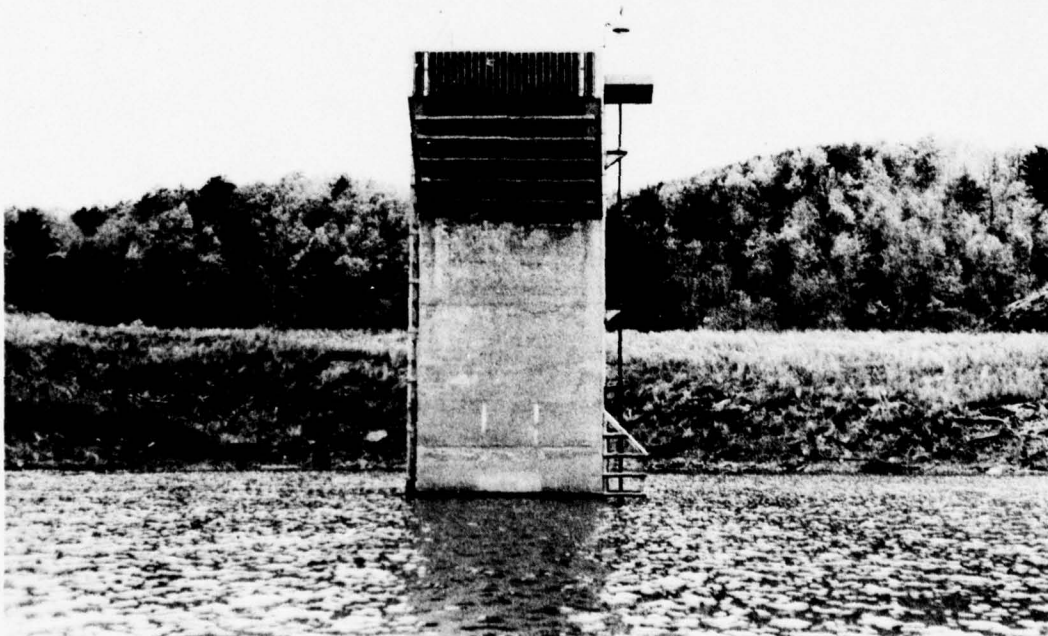
**PHOTO 2. Riser with Trash Rack, Lift Pedestal and Stem for Reservoir Drain**

<b>VISUAL EXAMINATION OF</b>	<b>OBSERVATIONS</b>	<b>REMARKS OR RECOMMENDATIONS</b>
<b>CRACKING AND SPALLING OF CONCRETE SURFACES IN OUTLET CONDUIT</b>	None observed	
<b>INTAKE STRUCTURE</b>	No cracking or spalling was observed; the exterior surfaces of the riser are in good condition.	
<b>OUTLET STRUCTURE</b>	The outlet structure consists of a baffle wall and an end sill dissipater. The outlet structure is in good condition. No cracking or spalling was observed.	Removal of briars, vines and small trees from the area of the outlet structure is recommended.
<b>OUTLET CHANNEL</b>	The outlet channel at the immediate end of the outlet works is partially obstructed by vine and tree growth.	
<b>EMERGENCY GATE</b>	The reservoir may be drained by use of the slide gate on the upstream side of the riser. Lift pedestal and stem guides appear to be in good working order.

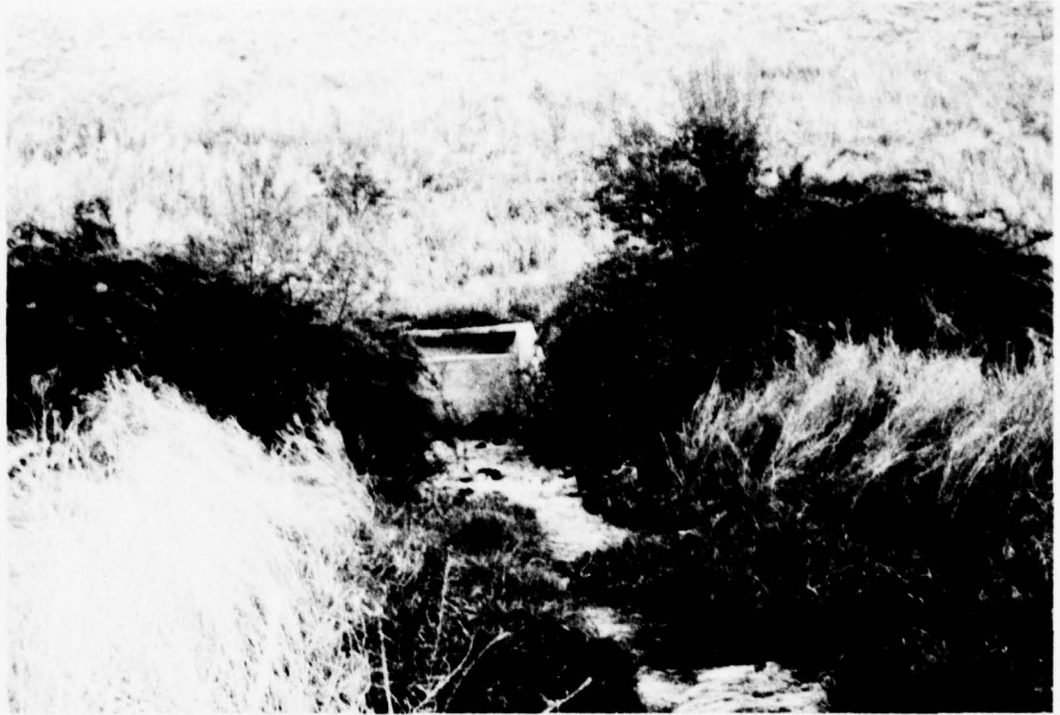
**PHOTO 3. Impact Basin and Outlet Channel**

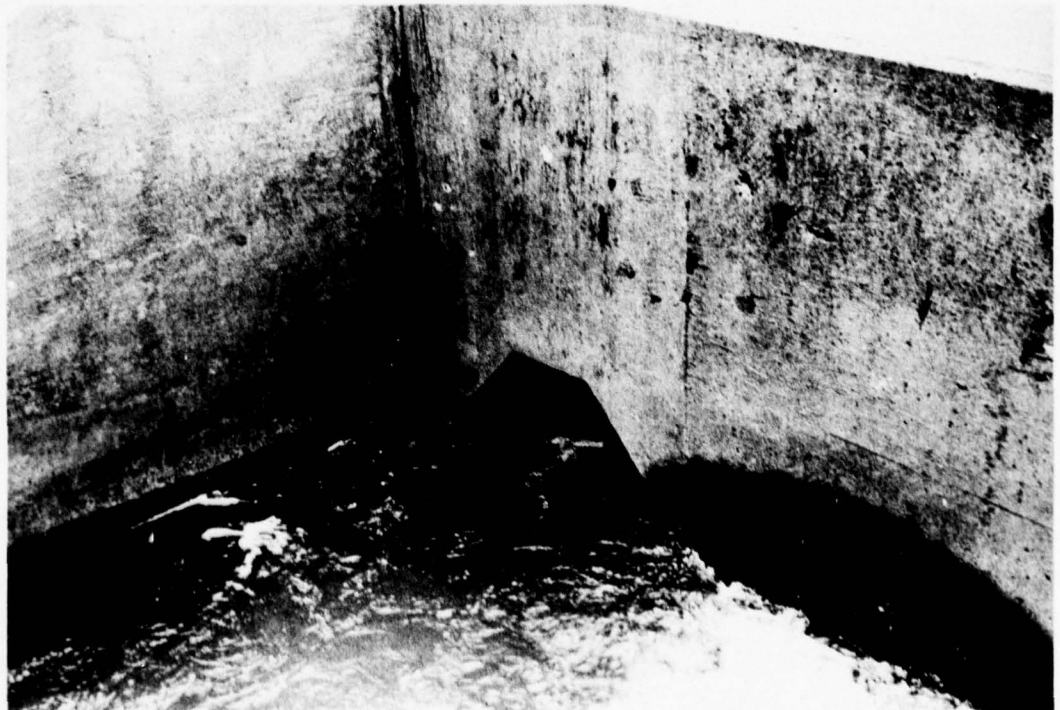
**PHOTO 4. Concrete Surface and Opening in Baffle Wall of Impact Basin**

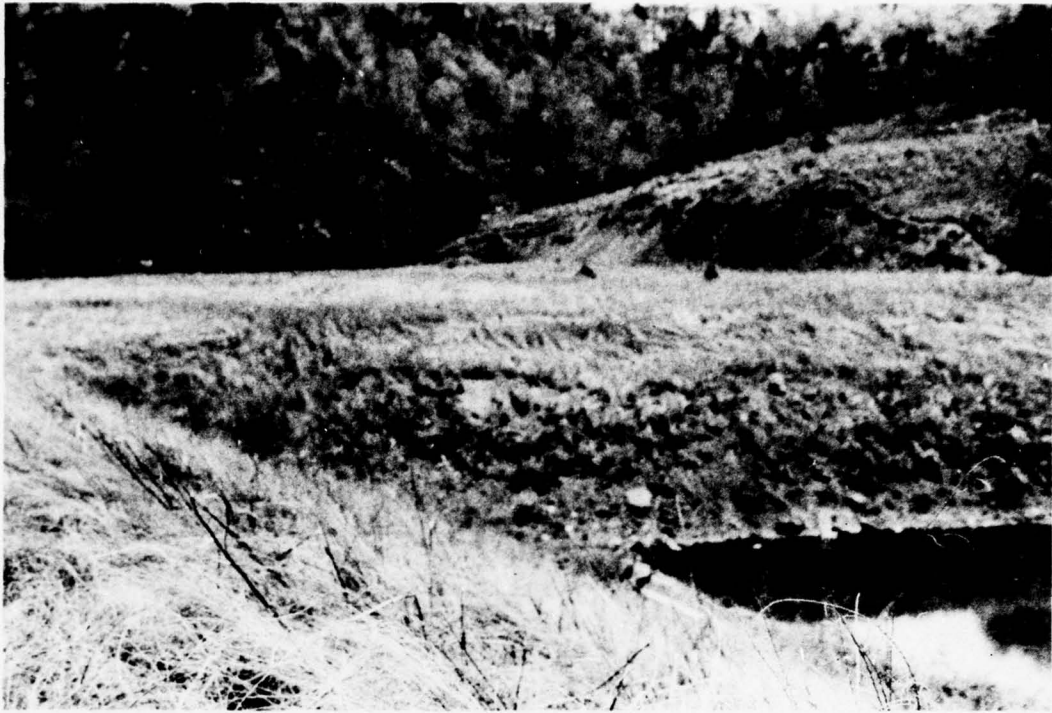
**PHOTO 5. Upstream View of Emergency Spillway and Rock Disposal Area**

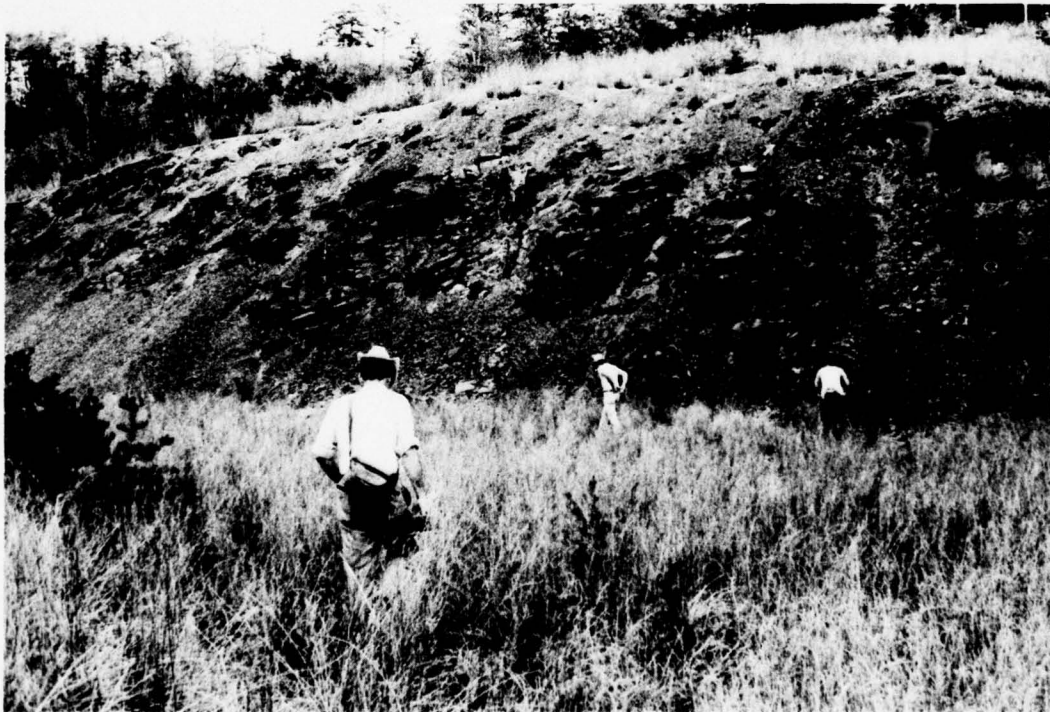
**PHOTO 6. Right Cut Slope of Emergency Spillway**

VISUAL EXAMINATION OF	OBSERVATIONS	REMARKS OR RECOMMENDATIONS
CONTROL SECTION	The control section is 250 ft. wide and 30 ft. long with a crest elevation of 1892.9 ft. M.S.L. and is heavily vegetated. The right cut slope of the emergency spillway is sloughed due to the weathering of exposed shale on the cut face.	
APPROACH CHANNEL	The approach channel is well vegetated with a 2% adverse slope. The rock disposal area contains some sloughing and minor erosion on the reservoir slope.	
DISCHARGE CHANNEL	The discharge channel is heavily vegetated; it has a slope of approximately 3% and discharges outside of the right abutment.	
BRIDGE AND PIERS	Not Applicable

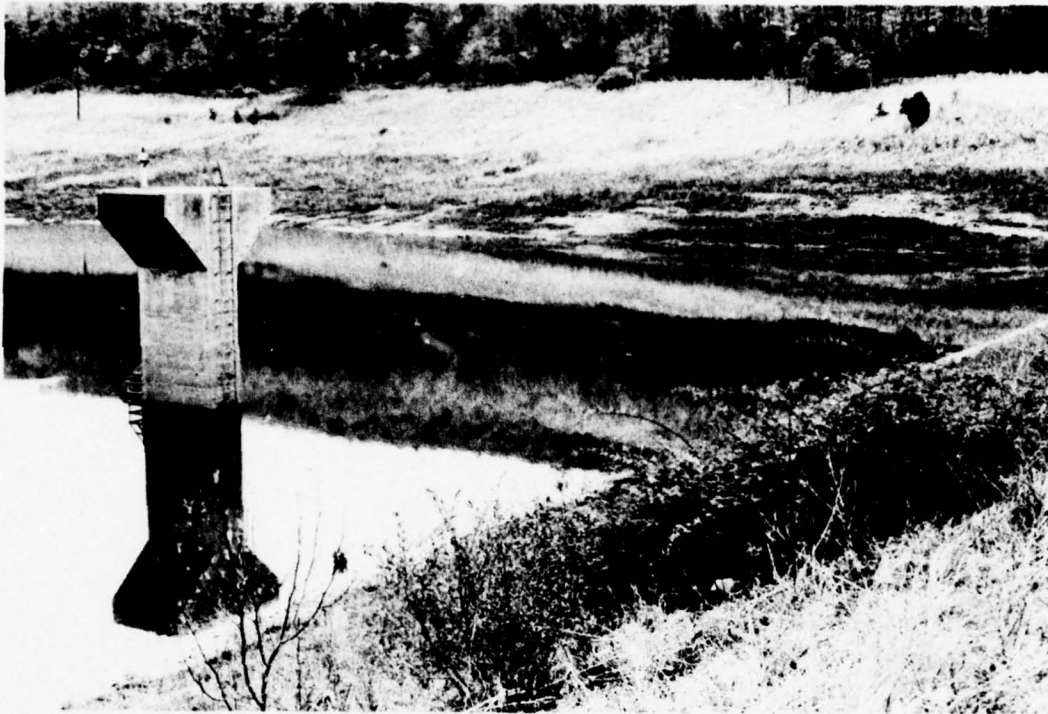
- 3.1.3 Appurtenant Structures: No apparent structural deficiencies were found during the inspection.
- 3.1.4 Reservoir Area: No apparent unstable areas were noted in the reservoir area. The area upstream from the disposal area is moderately sloped and heavily wooded. The slope on the left is relatively flat and appears to be stable although there are some wet areas (see Photo 7).

**PHOTO 7. View of Left Reservoir Area from Upstream Embankment**

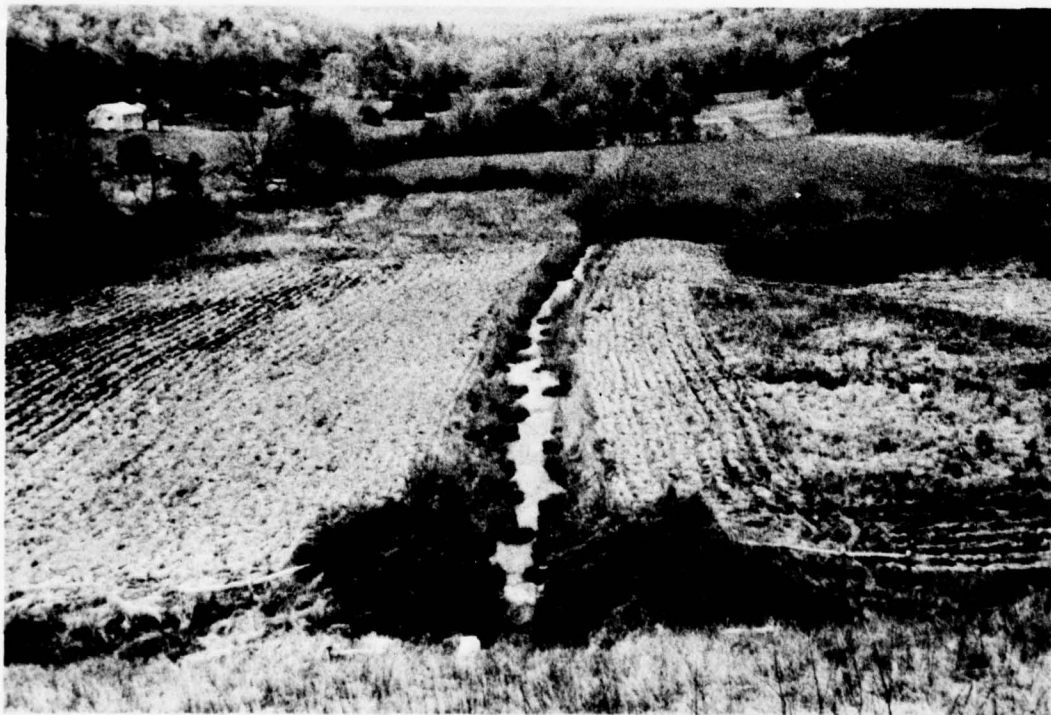
- 3.1.5 Downstream Channel: The area around the outlet structure and the upper portion of the downstream channel contains a dense growth of small trees, generally less than 2 inches in diameter, and brush which should be removed (see Photo 3). Otherwise, the downstream channel is unobstructed and the outlet works are in good condition.

**PHOTO 8. View of Downstream Channel Area**
