Name of Dam: Mays Dam
Location: Amherst County, State of Virginia
Inventory Number: VA 00909

PHASE I INSPECTION REPORT
NATIONAL DAM SAFETY PROGRAM

SEPTEMBER 1979

Name of Dam: Mays Dam
State: Virginia
County: Amherst
USGS 7.5 Minute Quadrangle: Forks of Buffalo, VA
Stream: Sneads Run
Date of Inspection: 23 May 1979

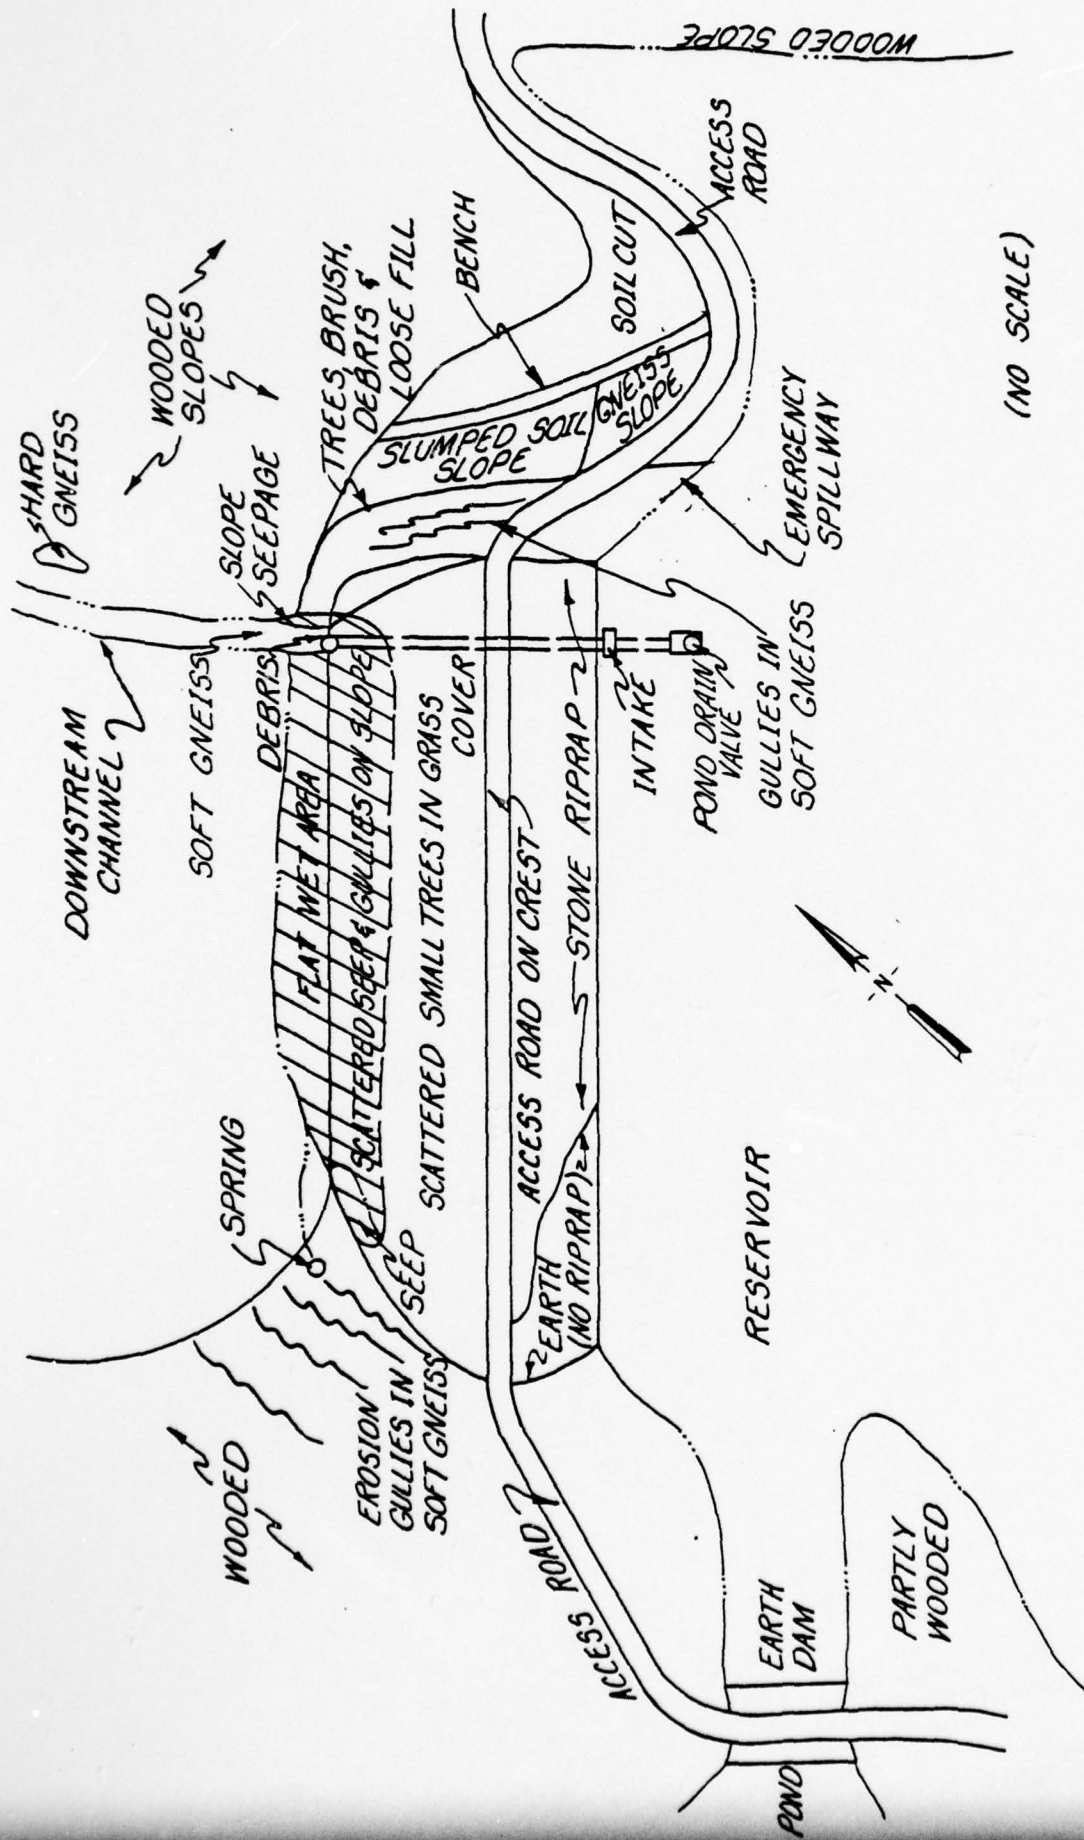
FIELD SKETCH
 MAYS DAM
 Michael Baker, Jr., Inc.
 July 1979
 PLATE I

- 3.1.2 Dam: The embankment was generally found to be in satisfactory condition, with no surface cracks, slumps, or other indications of instability either on the embankment or at the toe. Numerous small erosion gullies have formed in the lower portion of the downstream slope where scattered, nonmeasurable seepage is prevalent (see Plate 1 and Photos 3 and 4). An upper limit of clear seepage on the downstream embankment was very noticeable at approximate elevation 752 feet M.S.L., 8 feet below normal pool. There is good grass cover with some small trees on the downstream slope (see Overall View of Dam). Dumped riprap covers most of the upstream slope except for a section on the left side (see Photo 1 and Plate 1). A road crosses the crest of the dam and the spillway.

- There is a spring with a flow of 1 g.p.m. from the hillside near the left abutment of the dam. The spring does not appear to affect the embankment (see Plate 1). There are some bare and eroded areas on the hillside at the left abutment (see Photo 2).

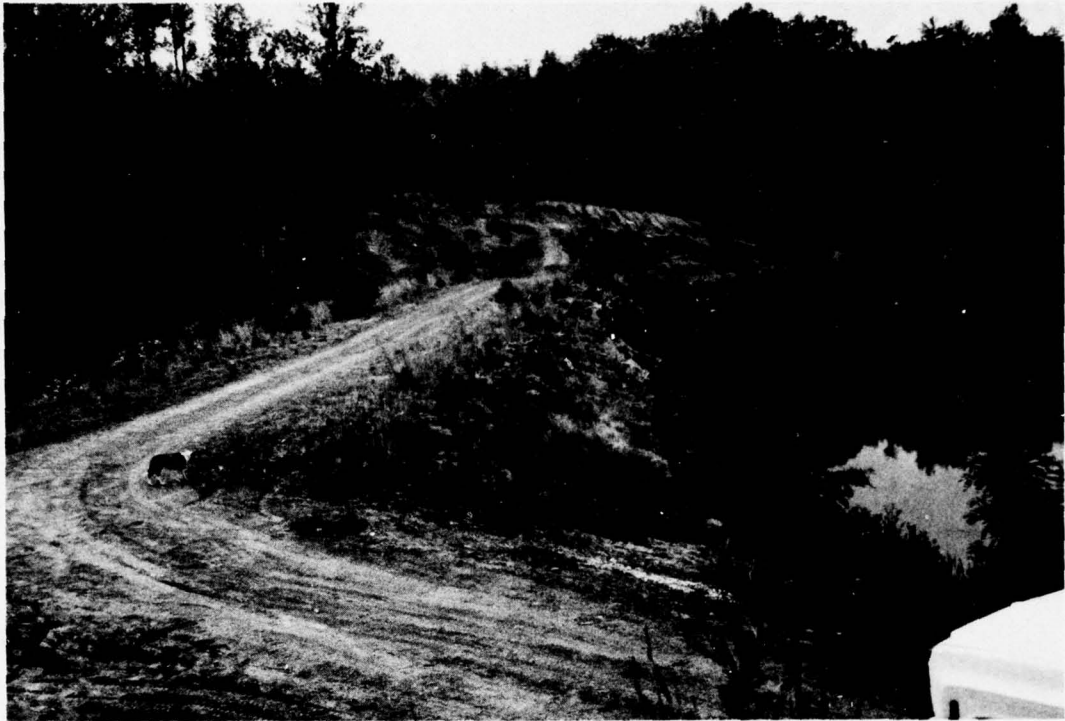
PHOTO 1. Upstream Face of Dam Showing Dumped Rock and Cut Slope of Emergency Spillway at Right Abutment

It is recommended that the following remedial measures be accomplished as part of the annual maintenance of the dam: provide uniform riprap slope protection on the upstream embankment, fill and seed erosion gullies of the embankments and emergency spillway, remove trees from the embankments, remove debris from discharge channel of emergency spillway and stilling basin, and install a staff gage to monitor reservoir levels above normal pool.

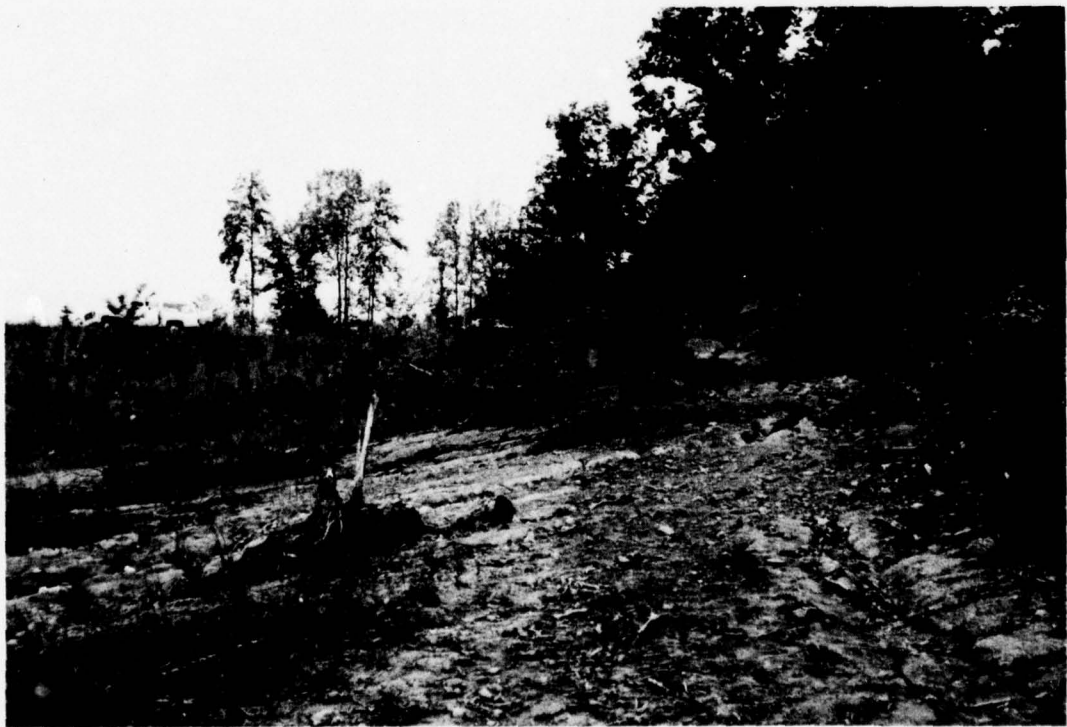
PHOTO 2. Eroded Area on Left Abutment

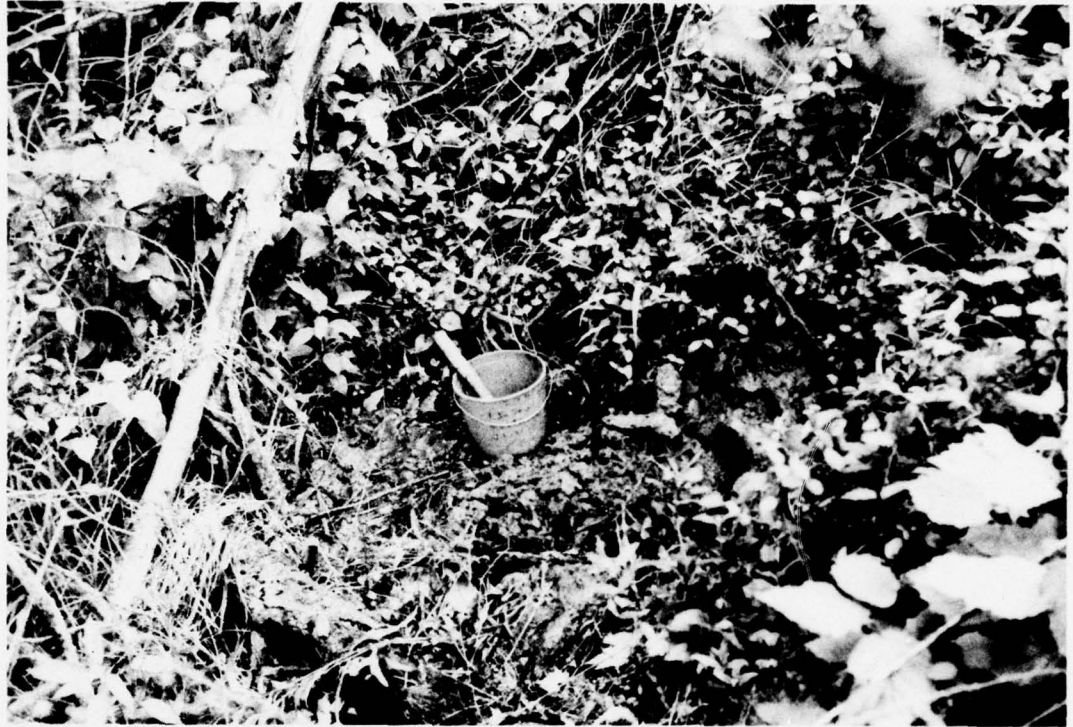
PHOTO 3. Close-up View of Seepage Area Located Near Right Side of Outlet Pipe

occur if adequate compaction was not attained during construction of the shell. Therefore, it is recommended that the seepage areas on the downstream slope be visually inspected during all periods of high reservoir levels to determine (1) any increases in turbidity and/or (2) increases in the rate of seepage. In the interim, a qualified professional engineer should be engaged to investigate the stability of the embankment. These analyses should be made based on full loading conditions with a high phreatic line or on conditions determined from a subsurface investigation.

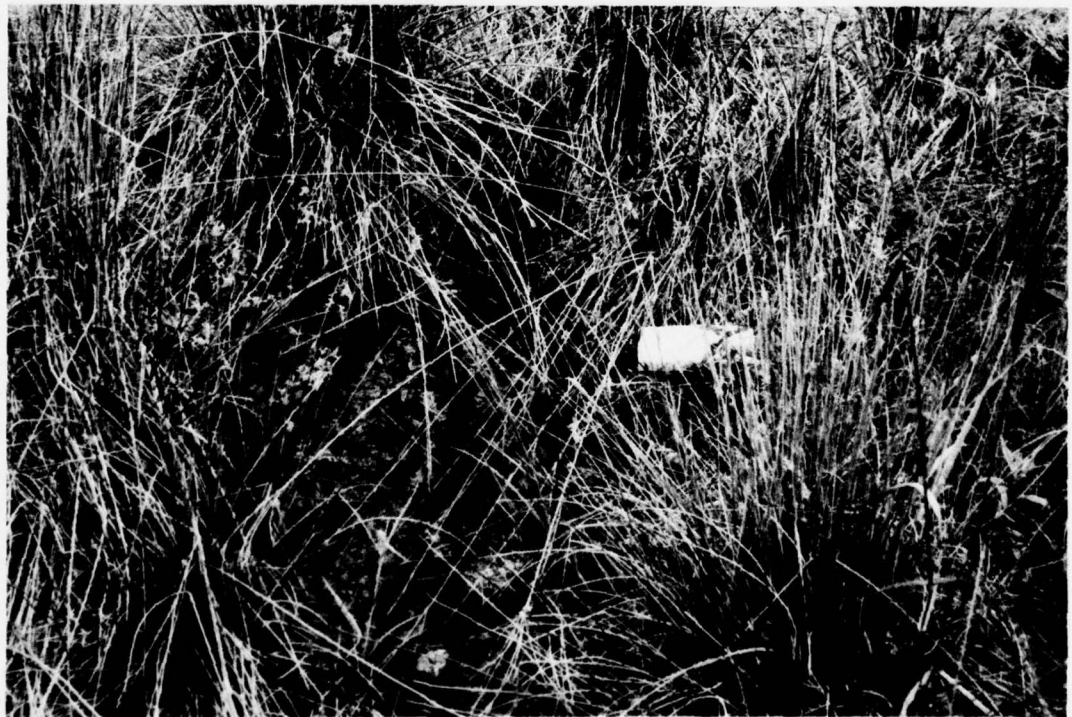
**PHOTO 4. Close-up View of Seepage Area Located to the Left of the Outlet Pipe
at Downstream Toe of Dam**

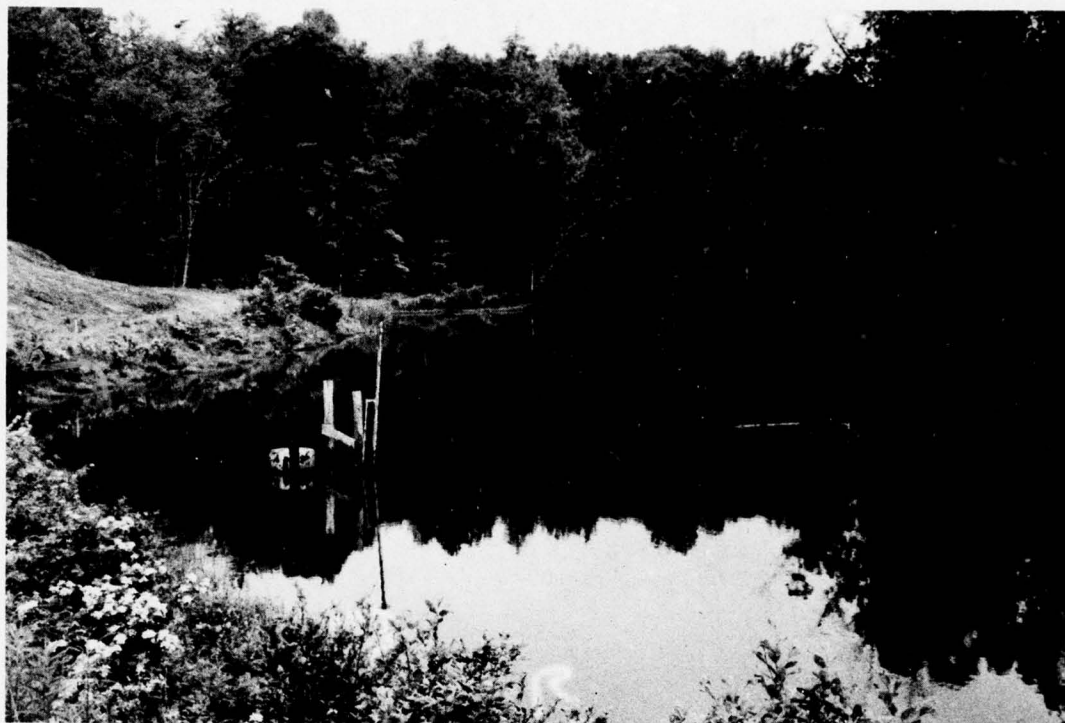
- 3.1.3 Appurtenant Structures: The principal spillway consists of an 8 inch vertical section of pipe (see Photo 5) which is connected to a 20 inch diameter horizontal steel pipe extending through the embankment and outletting near the right abutment (see Photo 6). The intake pipe appeared to be structurally sound with

PHOTO 5. Intake Structure (Left) and Reservoir Drain Valve (Right) of Principal Spillway

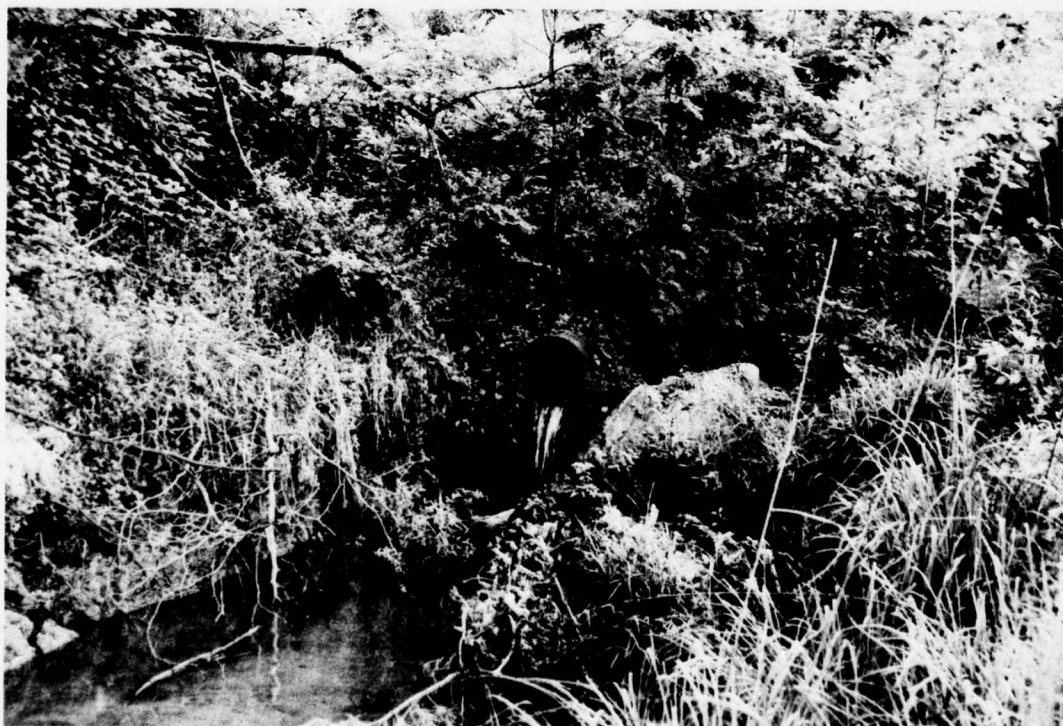
3.1.5 Downstream Channels: The stilling basin for the outlet pipe is not lined with riprap. There is weathered bedrock in the stream bottom and a loose tree stump with debris in the basin (see Photo 6). The downstream channel is in satisfactory condition (see Photo 7).

PHOTO 6. Outlet Pipe and Debris in Stilling Basin

- 6) Remove tree stumps and debris from stilling basin.
- 7) Regrade emergency spillway to remove erosion gullies and provide a defined channel away from the dam. The regraded channel should be fertilized and seeded.
- 8) Remove loose fill, debris, and excessive vegetation from the discharge channel of emergency spillway.
- 9) Seed the right cut slope of the emergency spillway.
- 10) Install a staff gage to monitor reservoir levels above normal pool.
- 11) Initiate a yearly maintenance and inspection program.

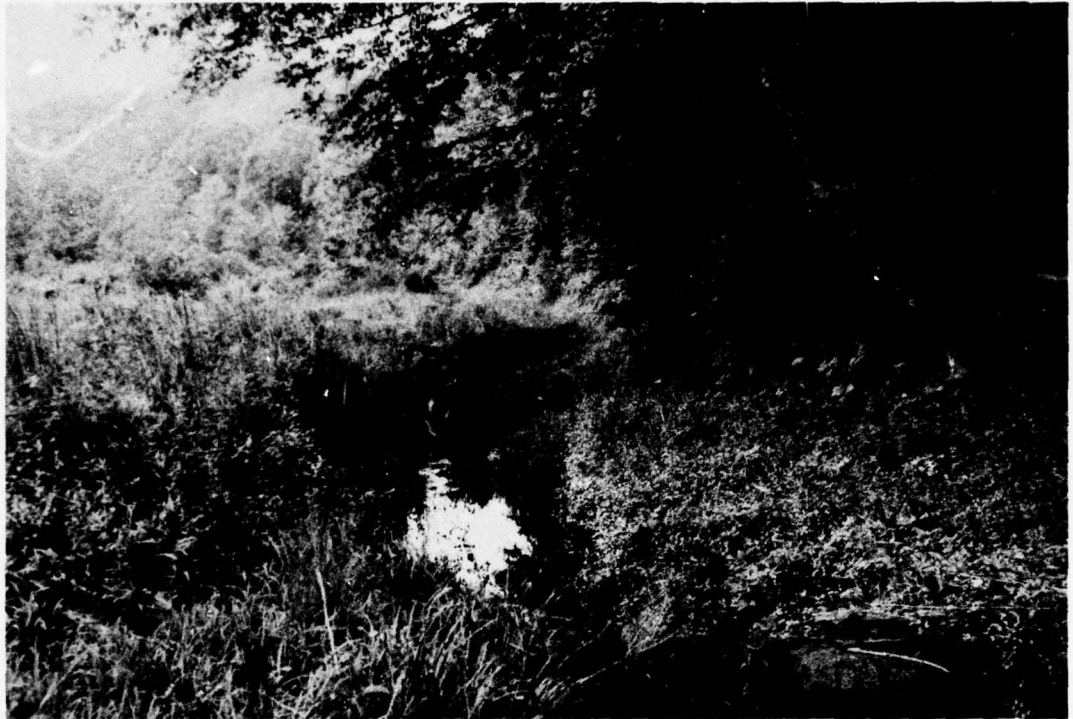
PHOTO 7. Downstream Channel

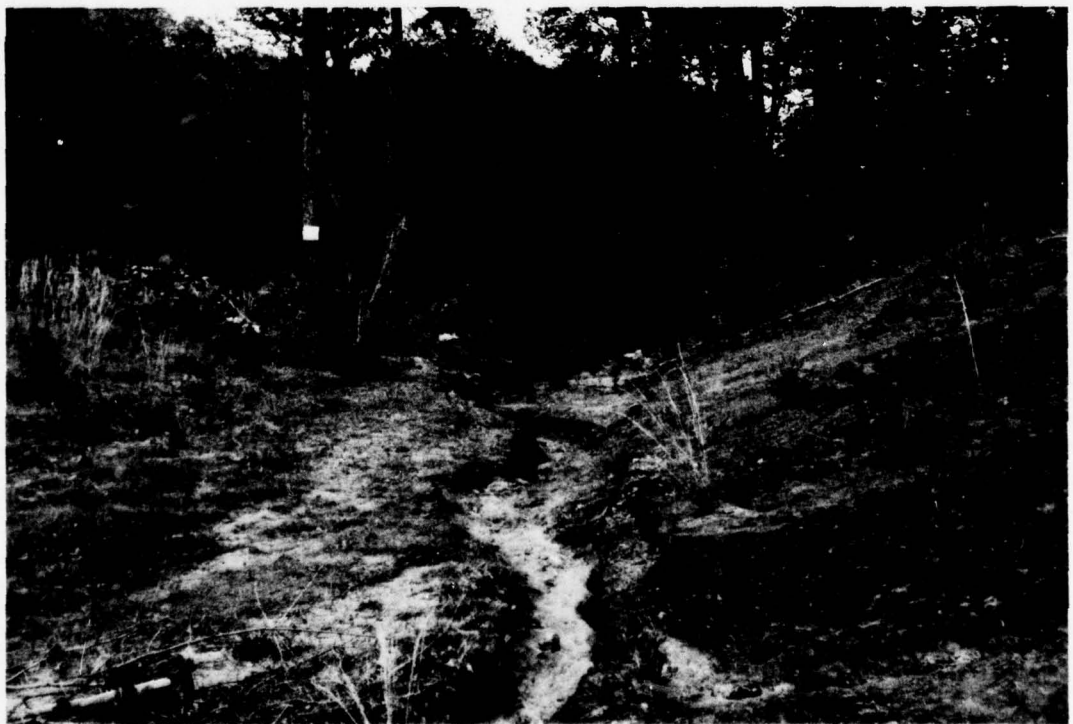
steel angles supporting both it and the reservoir drain valve and stem. The principal spillway was functioning properly. The emergency spillway has a poorly defined channel to direct flow away from the dam. The discharge slope for the emergency spillway into the stilling basin is covered with vegetation. Loose earthfill has been left in the discharge slope causing obstructions to form. Eroded gullies have developed in the soil and soft bedrock of the emergency spillway (see Photo 8) and a major portion of the lower cut slope on the right side is wet and slightly slumped.

PHOTO 8. Erosion in Discharge Channel of Emergency Spillway

In the emergency spillway, the wet area in the right cut slope should be graded and seeded to prevent erosion. The debris, excessive live vegetation, and loose soil fill at the discharge end of the spillway on the slope above the stilling basin should be removed to prevent blockage.
