Name of Dam: Buffalo River No. 3  
Location: Amherst County, State of Virginia  
Inventory Number: VA 00911

# PHASE I INSPECTION REPORT

## NATIONAL DAM SAFETY PROGRAM

SEPTEMBER 1979

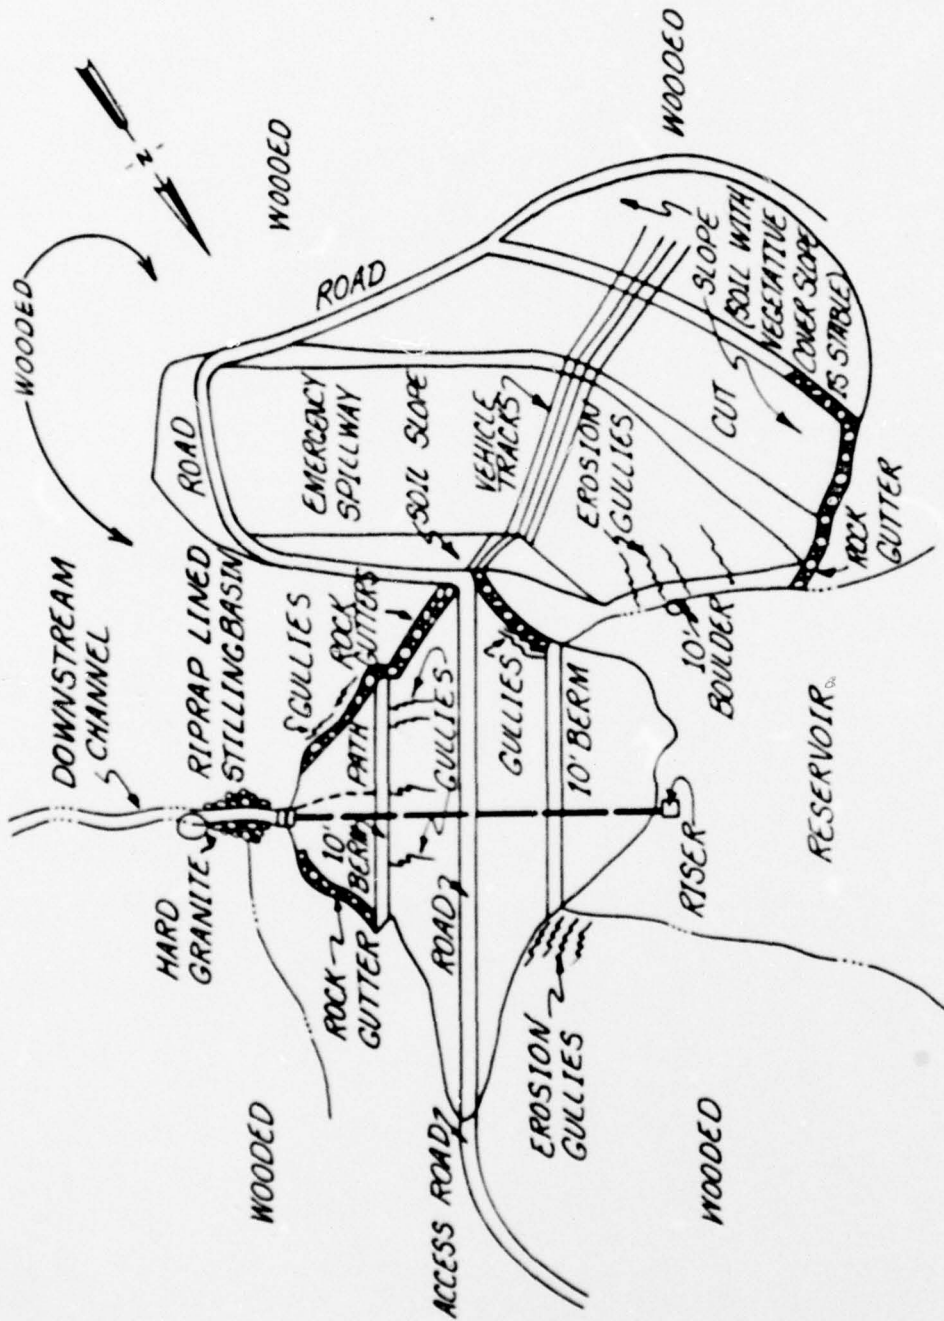
**FIELD SKETCH**  
 BUFFALO RIVER  
 DAM No. 3  
 Michael Baker, Jr., Inc  
 July 1979  
 PLATE I

- 3.1.3 Appurtenant Structures: The principal spillway was in good condition (see Photo 6). Small erosion gullies were observed in the approach channel of the emergency spillway. Several vehicle tracks are located across the emergency spillway and up the right cut slope (see Plate 1 and Photo 7).

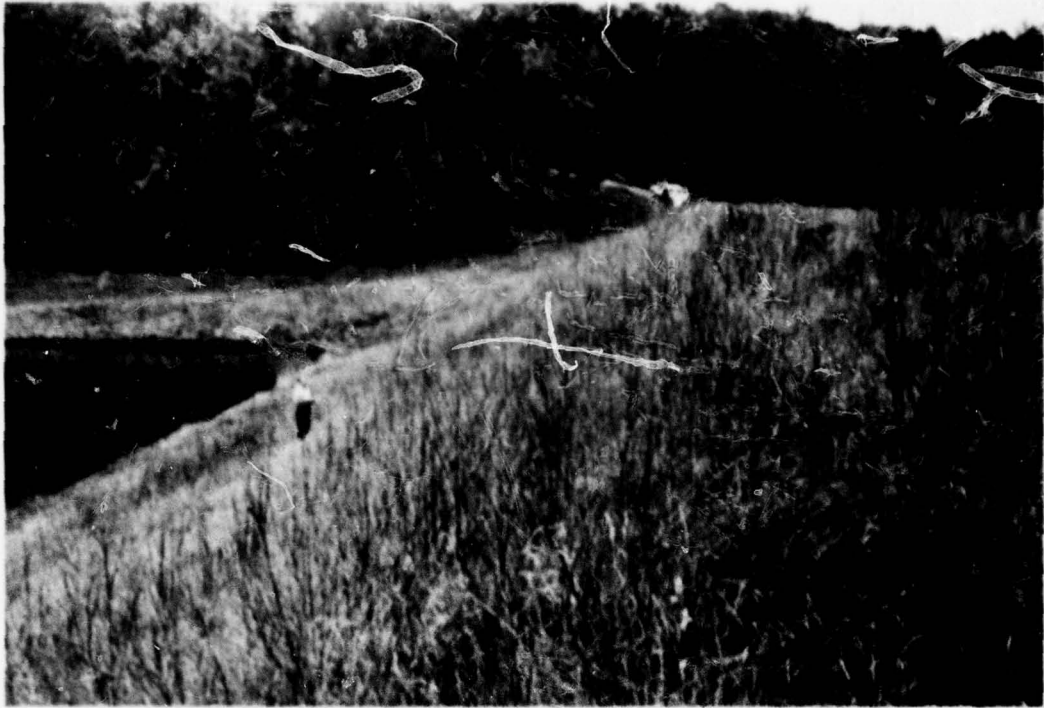
**PHOTO 1. Upstream Face of Dam Showing Tall Weeds in Grass**

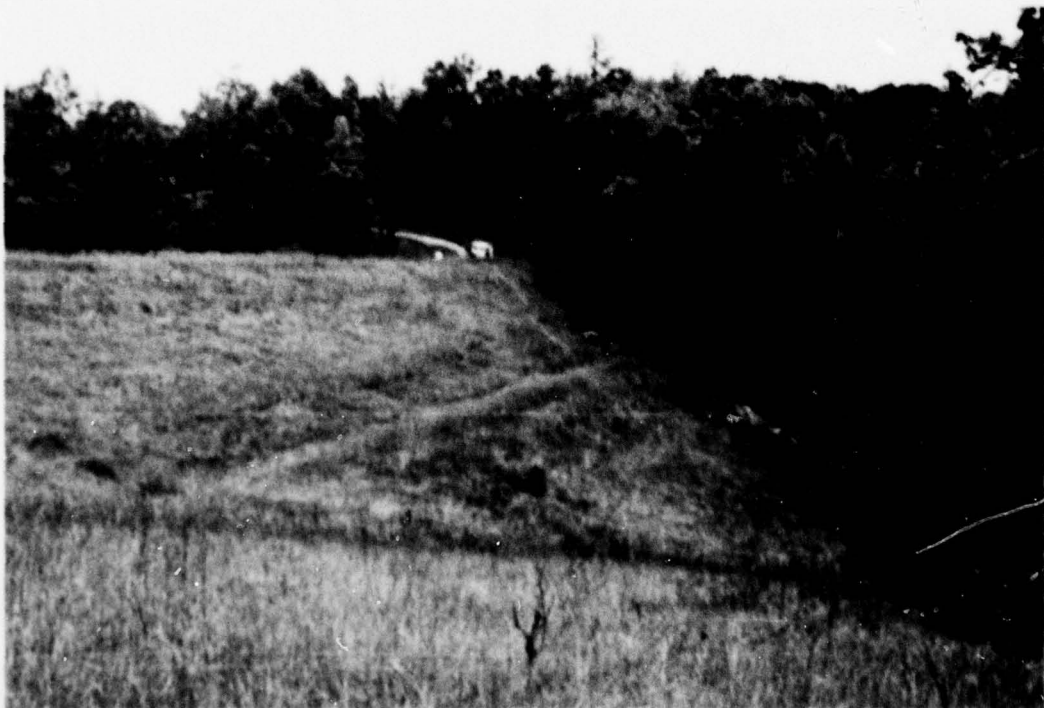
**PHOTO 2. Downstream Face of Dam Showing Tall Weeds and Bench**

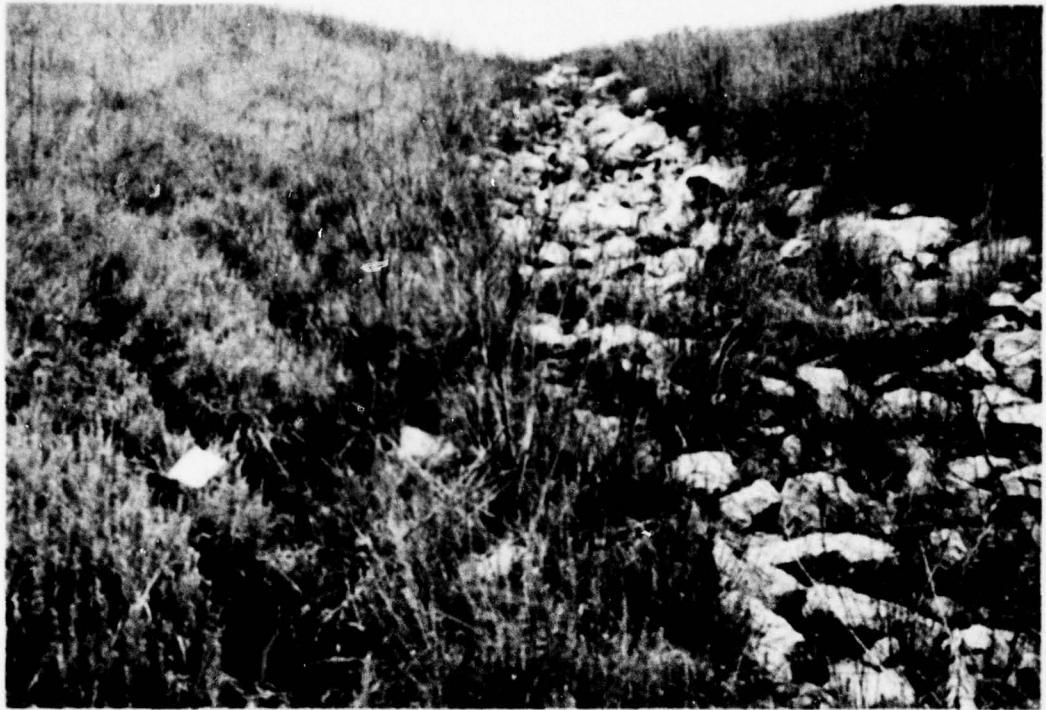
**PHOTO 3. Junction of Dam and Right Abutment (Upstream Slope)  
Showing Erosion Gullies Adjacent to Rock Slope Drain**

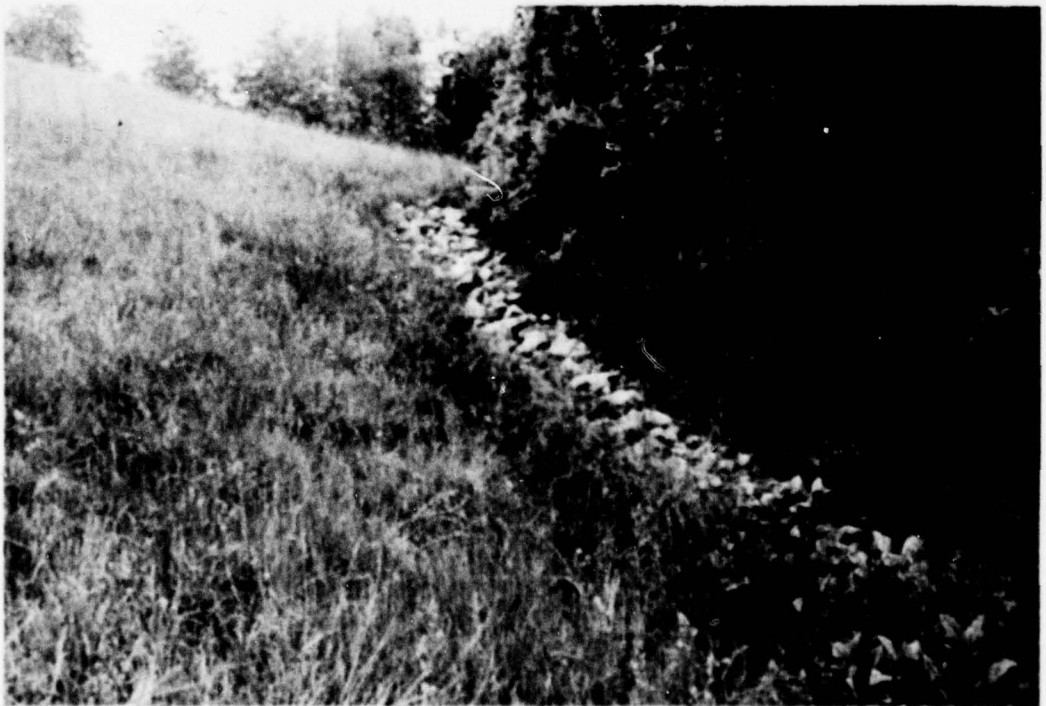
**PHOTO 4. Junction of Dam and Left Abutment with Rock Drain on Downstream Slope**

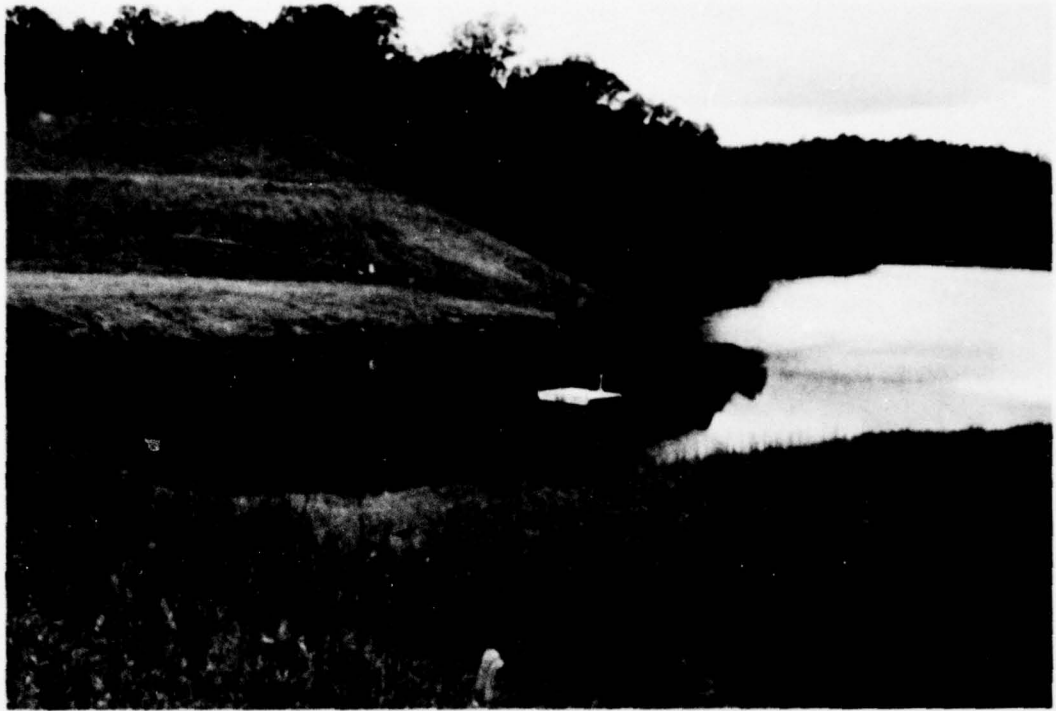
**PHOTO 5. View of Riser, Reservoir and Approach Slope of Emergency Spillway  
(Note Erosion Gullies in Approach Slope)**

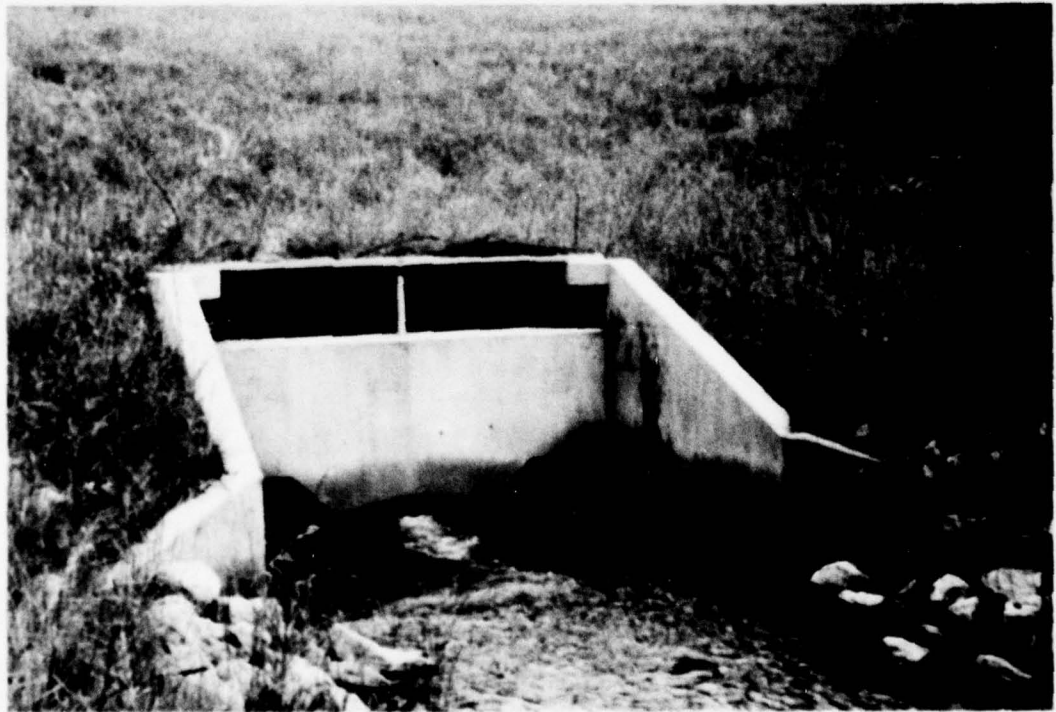
**PHOTO 6. Impact Basin with Baffle Wall and End Sill**

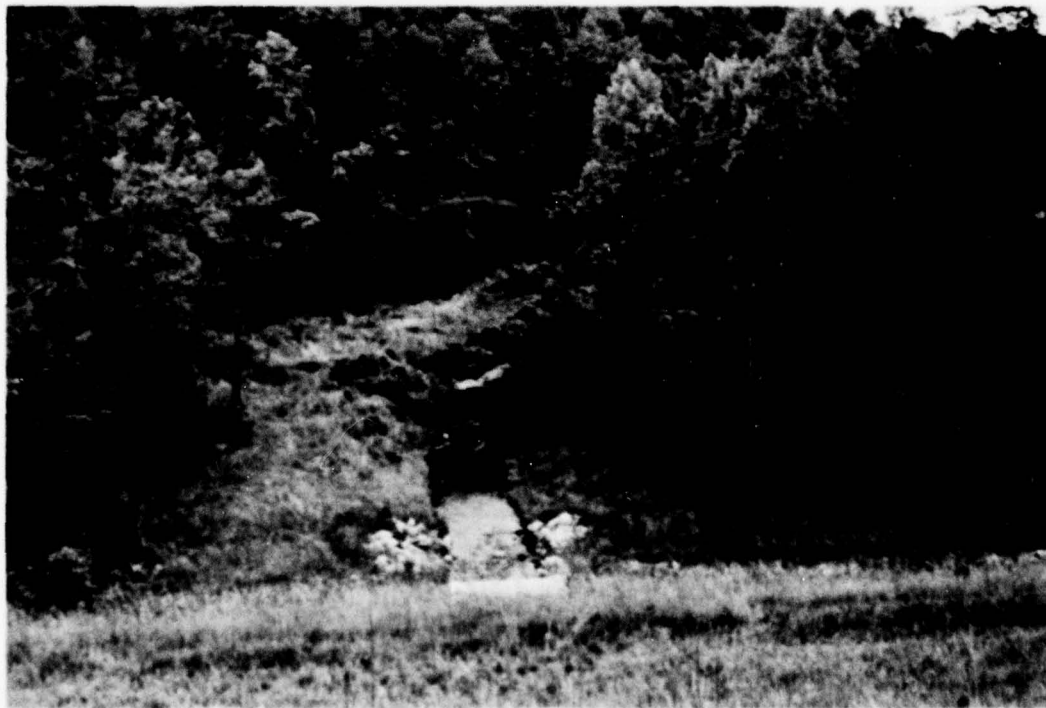
**PHOTO 8. Stilling Basin and Downstream Channel**
