Name of Dam: Buffalo River No. 2
Location: Amherst County, State of Virginia
Inventory Number: VA 00912

**PHASE I INSPECTION REPORT
NATIONAL DAM SAFETY PROGRAM**

**PREPARED FOR
NORFOLK DISTRICT CORPS OF ENGINEERS
803 FRONT STREET
NORFOLK, VIRGINIA 23510**

**PREPARED BY
MICHAEL BAKER, JR., INC.
BEAVER, PENNSYLVANIA 15009**

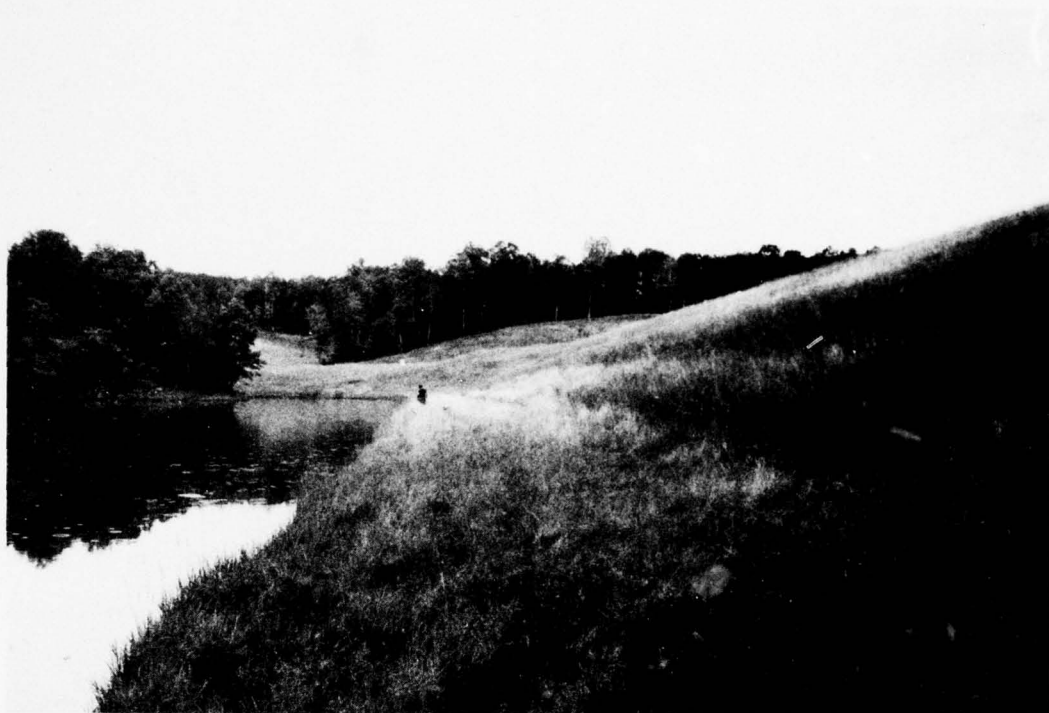
PHOTO 1. Upstream Face of Dam Looking Toward Approach to Emergency Spillway

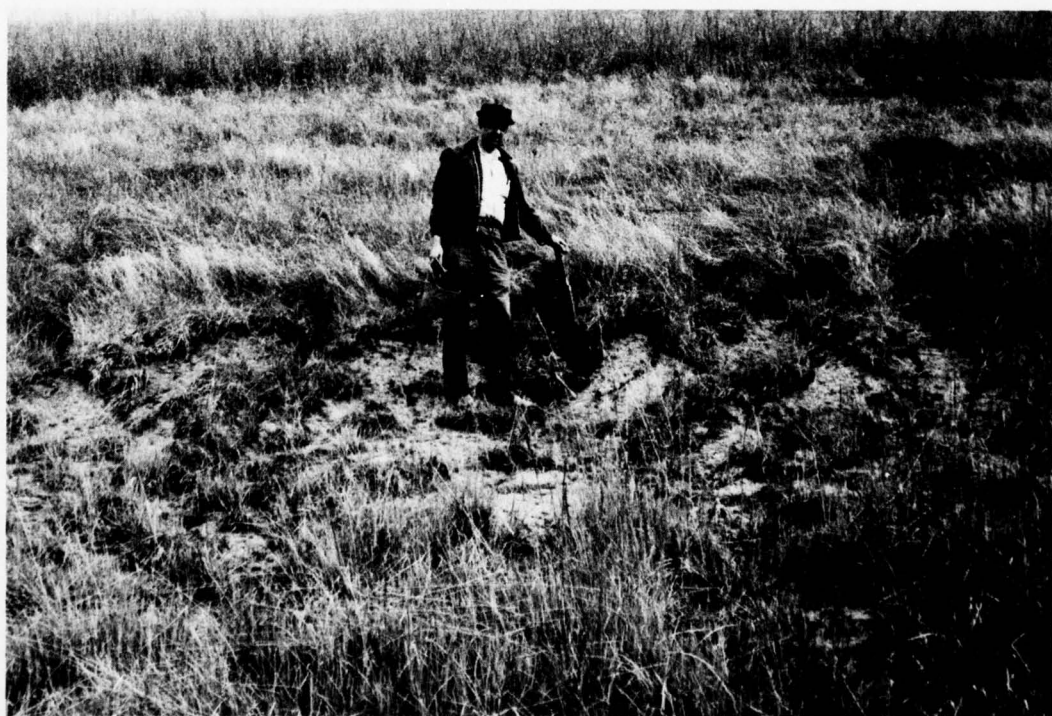
- 6.2.1 Visual Observations: No evidence of movement, such as tension cracks or bulging of the embankment, was noted. There was some erosion and slight sloughing located 50 feet from the left abutment in the soft wet clayey silt (100 foot by 20 foot area) just above the toe of the upstream slope. Several tree branches are imbedded in the soil. There are minor erosion gullies on the downstream slope. Otherwise, the embankment is in good condition with no visible seepage on the downstream slope.

PHOTO 2. Sloughing and Erosion Area Near Upstream Left Abutment

- 1) Remove wet sloughing soil with imbedded branches near the left upstream abutment and replace with compacted earth.
- 2) Grade and seed eroded bare areas near the bench on the downstream slope. Also, grade and seed erosion gullies in the vicinity of the rock gutters at the left downstream abutment and right upstream abutment.
- 3) Seed and fertilize areas with dead grass.
- 4) Remove driftwood on shoreline of dam and fallen branches from rock gutters.
- 5) Place additional stone riprap on the banks of the stilling basin where discharge has washed it away.
- 6) Remove small tree from stone riprap adjacent to left wing wall of impact basin.
- 7) Fill and seed erosion gullies in discharge channel of emergency spillway.
- 8) Install a staff gage to monitor reservoir levels above normal pool.

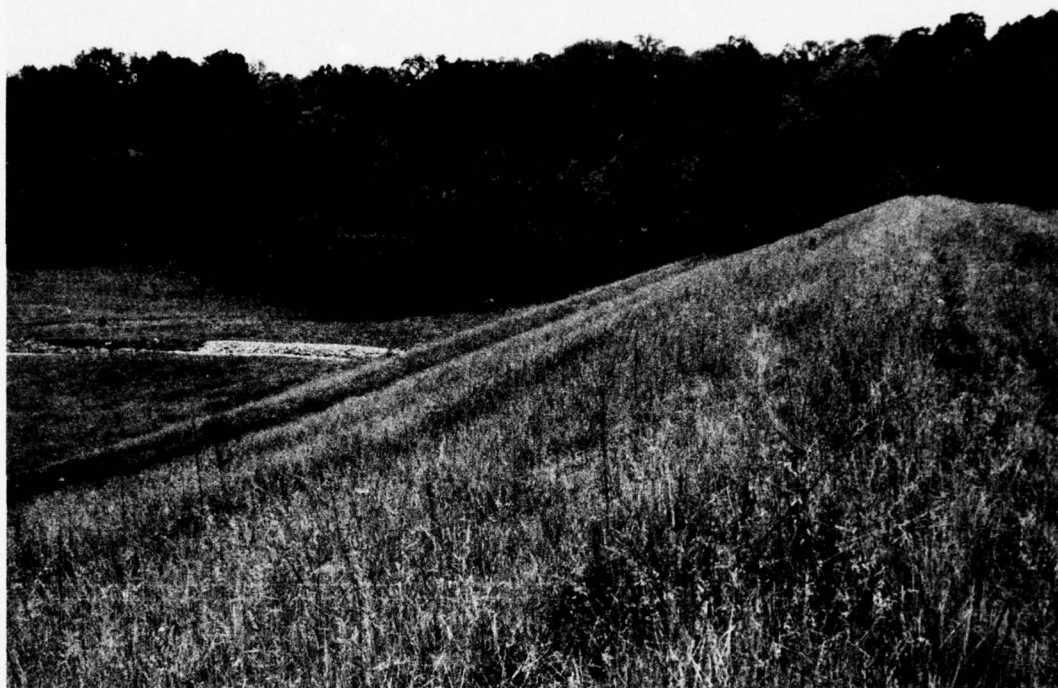
PHOTO 3. Downstream Face of Dam

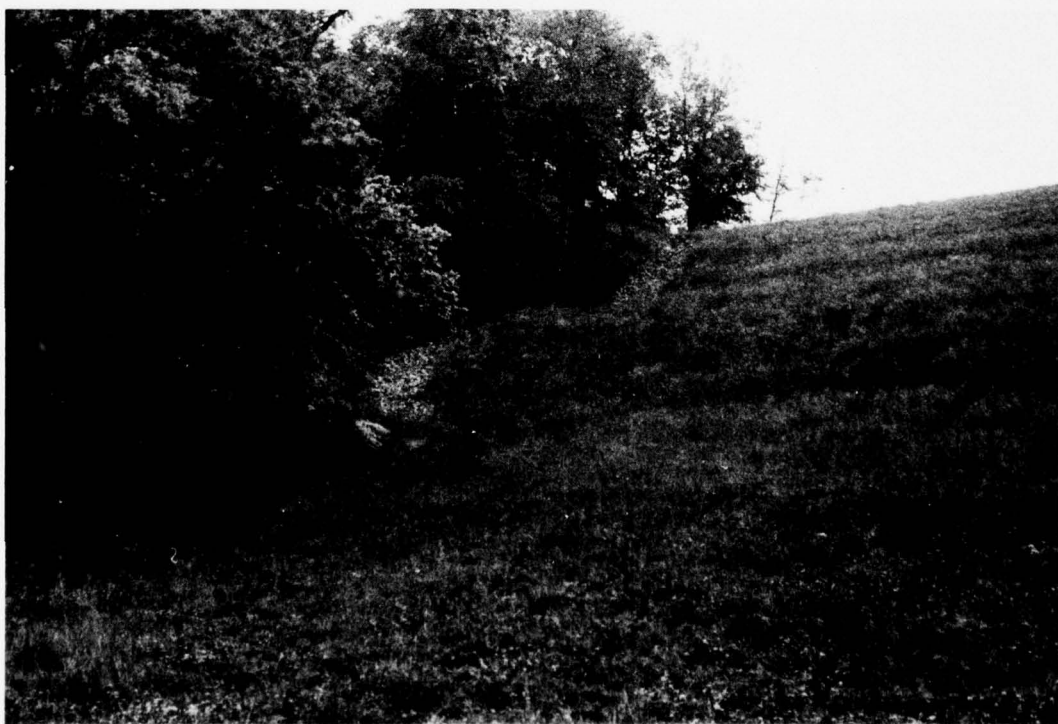
PHOTO 4. Junction of Downstream Embankment and Right Abutment

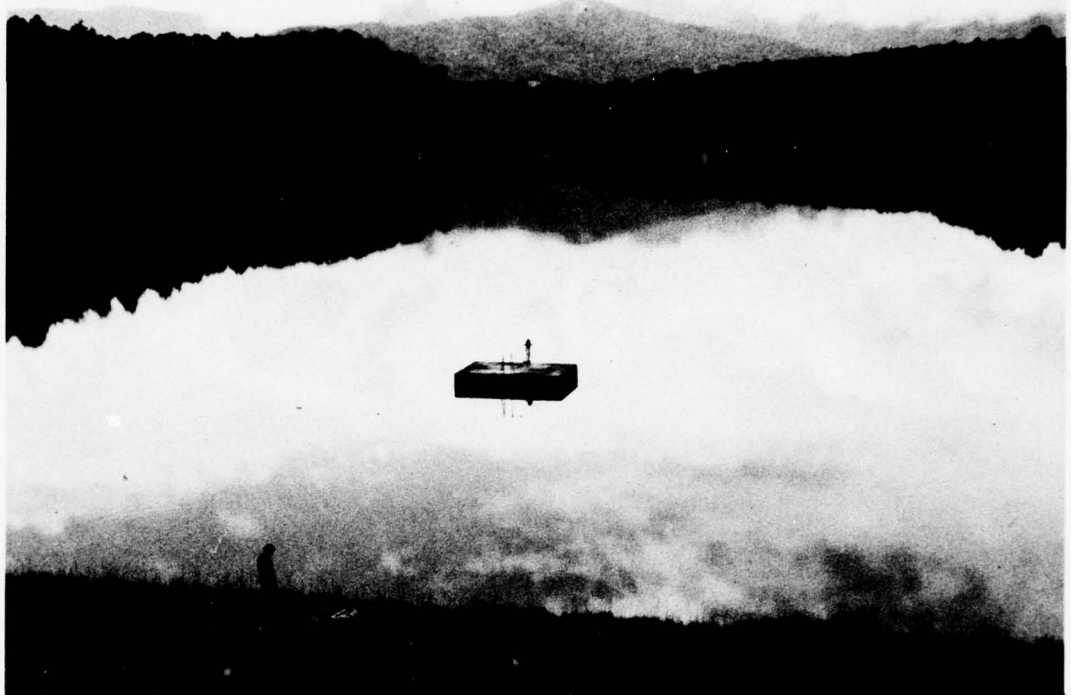
PHOTO 5. View of Riser and Reservoir from Crest of Dam

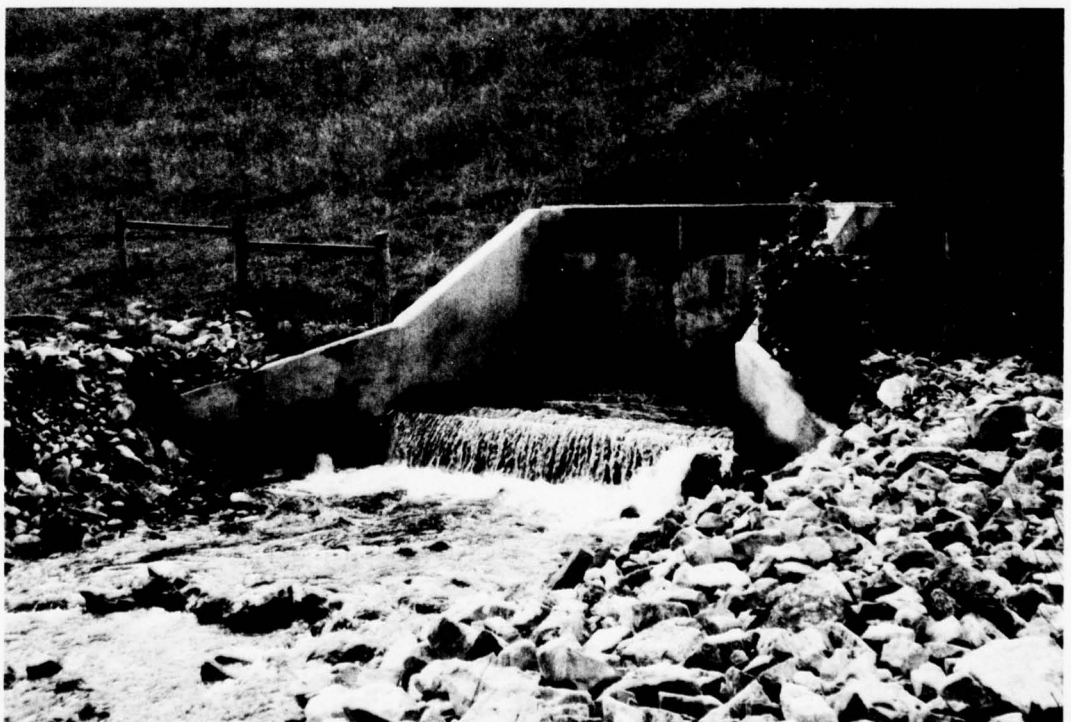
- 3.1.3 Appurtenant Structures: The principal spillway was functioning satisfactorily (see Photo 6) and no structural deficiencies were found on the appurtenant structures.

PHOTO 6. Outlet of Principal Spillway, Impact Basin and Riprap-Lined Channel

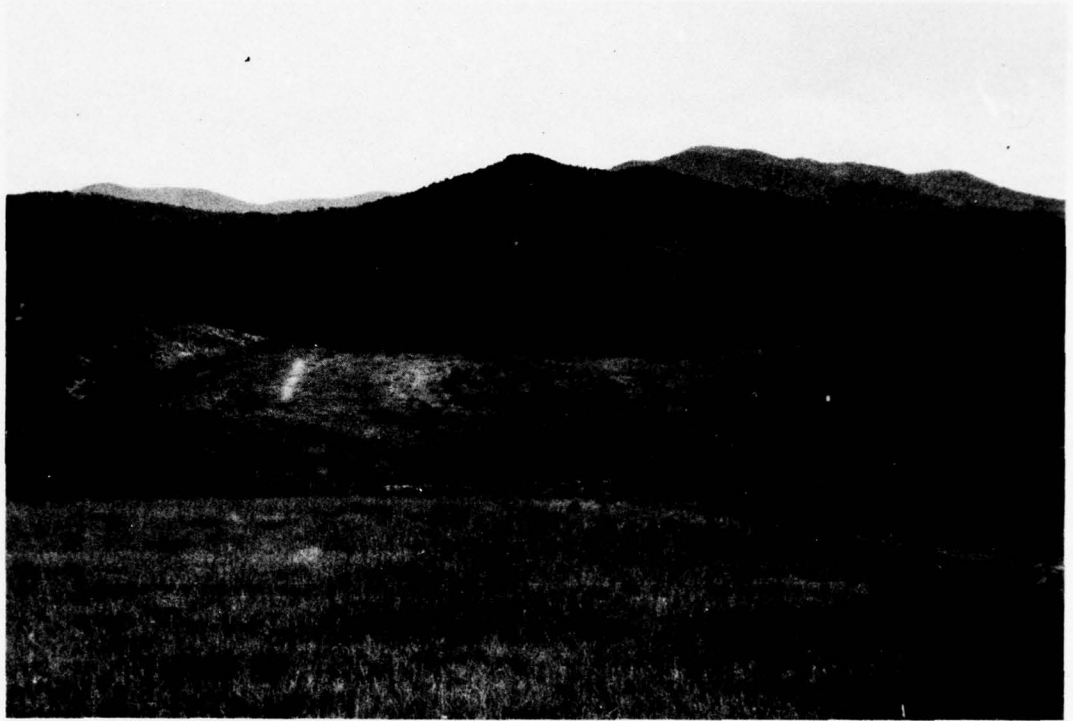
PHOTO 7. View of Emergency Spillway and Left Abutment Looking Downstream

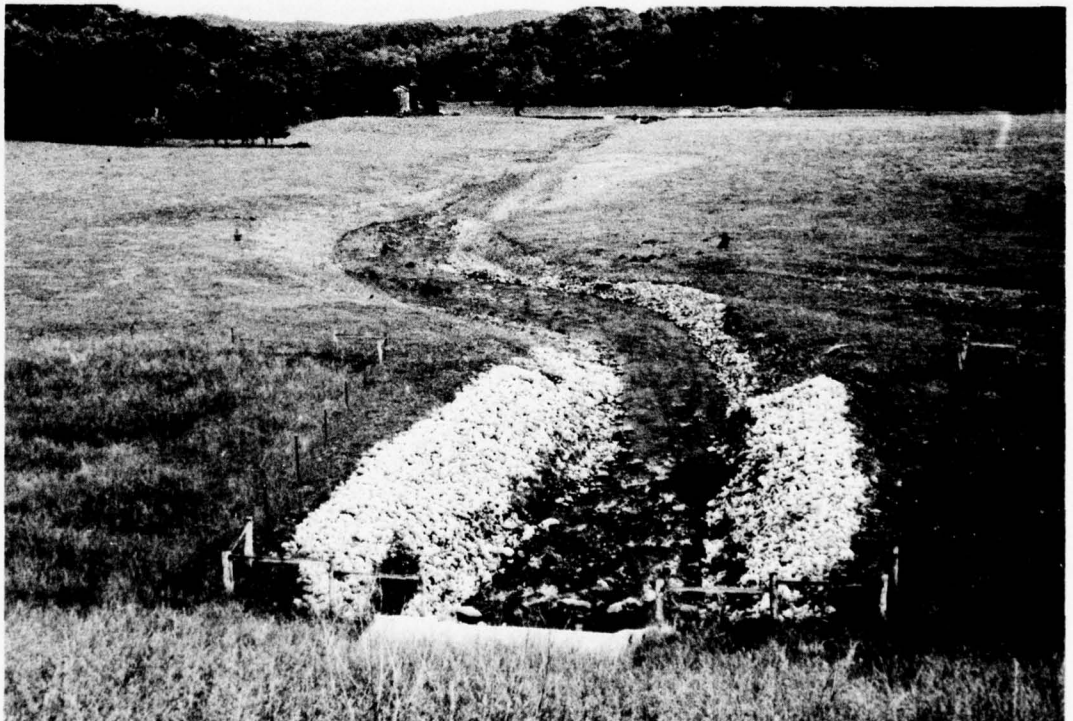
PHOTO 8. Downstream Area with VA Route 610 and Farmhouse in Background
