REPORT DOCUMENTATION PAGE		READ INSTRUCTIONS BEFORE COMPLETING FORM
1. REPORT NUMBER	2. GOVT ACCESSION NO.	3. RECIPIENT'S CATALOG NUMBER
4. TITLE (and Subtitle) Phase I Inspection Report Cliff Lake Dam Delaware River Basin, Sullivan County, New York Inventory No. 584		5. TYPE OF REPORT & PERIOD COVERED Phase I Inspection Report National Dam Safety Program

CLIFF LAKE DAM

JUNE , 1979

PHASE 1 INSPECTION REPORT
NATIONAL DAM SAFETY PROGRAM
CLIFF LAKE DAM, I.D. NO. NY 584
DEC #148D-1133
DELAWARE RIVER BASIN
SULLIVAN COUNTY, NEW YORK

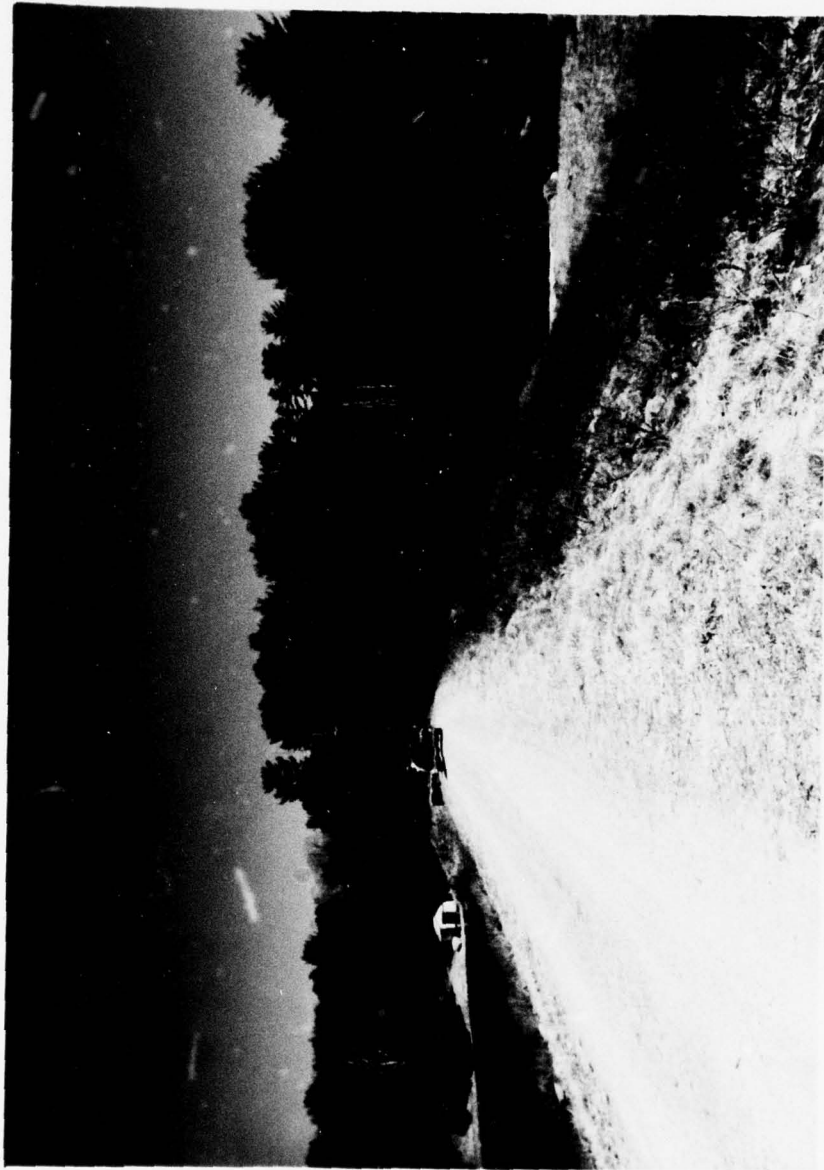
Overview of Cliff Lake Dam
Photo #1

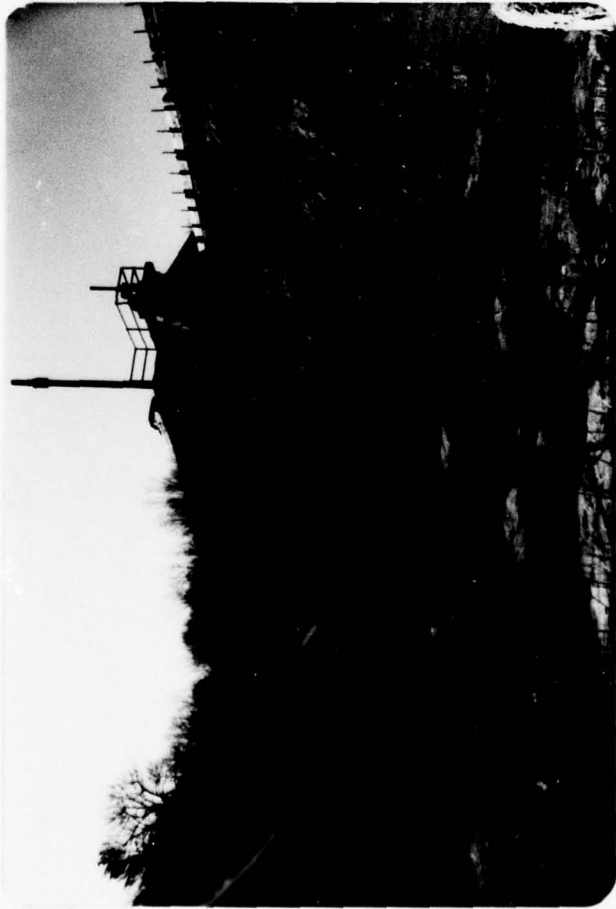
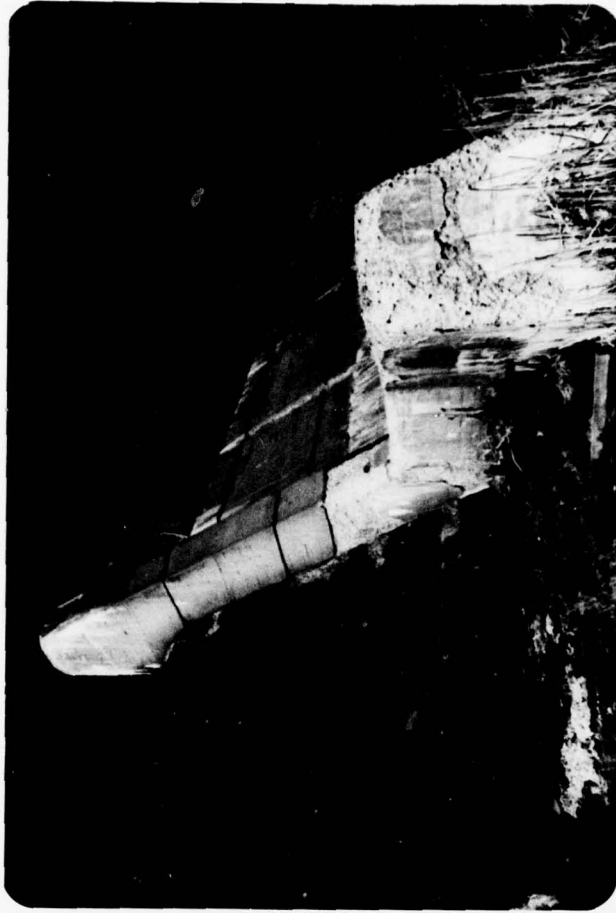
Surface spalling of concrete was evident particularly at the construction joints. The wingwalls are cracked and deteriorated. Hairline cracks were noted in the spillway concrete. A 1-inch opening was observed at the contact of the spillway toe and the apron. No indication of recent movement and no seepage was observed. (See Photo #3) A 2-inch diameter pipe was protruding from the spillway; purpose unknown. Two rectangular drains were noted at the base of the spillway. (See Photo #4) These drains provide relief of seepage and uplift forces beneath the spillway and non-overflow sections (See sketch Appendix C, Section 6, and Appendix G, Drawings #1300-56 and 1300-57 for drain details). Seepage from these drains was clear and estimated to be 5 gpm from the west drain and 8 to 10 gpm from the east drain. Approximately 1 gpm was evident seeping from the east wingwall drain. These drains are partially blocked with debris and vegetation. The area behind this wingwall is soft and wet with vegetation present having an affinity for water (See Photo #3B).

Spillway
Note Deteriorated Concrete
Photo #3 A&B

1. Significant deterioration of concrete particularly at the construction joints require repair.

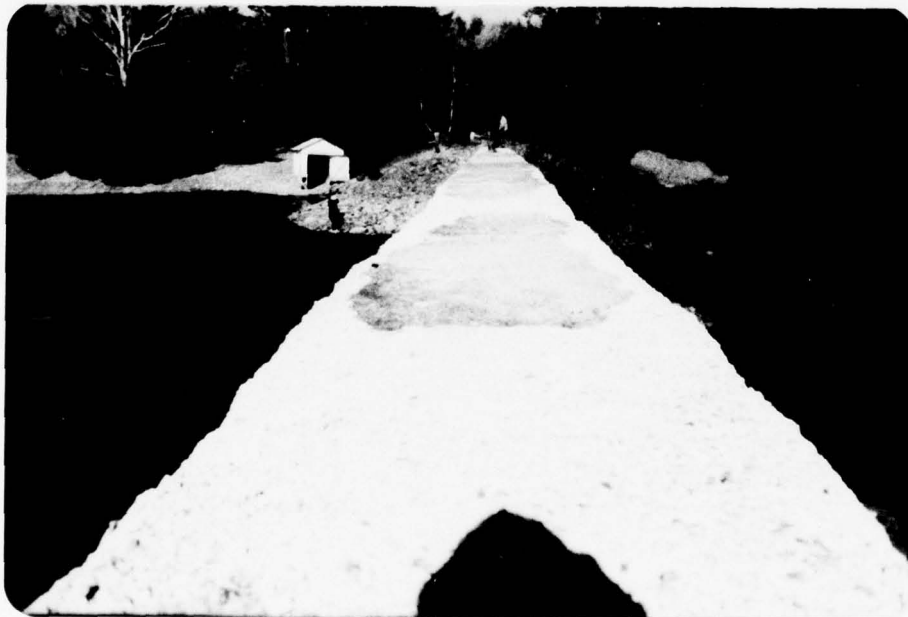
Surface spalling, calcification, and deterioration was evident in the non-overflow section of the dam particularly at the construction joints, along the top of this section and at the east wingwall of the spillway (See Photos #5,6,&7). Surface spalling on the eastern most panel of the downstream face was 2 to 3 inches (Photo #7); on the upstream face spalling was approximately 6 inches at the western most construction joint. Numerous hairline cracks were evident, and 2 of the vertical shear keys at the construction joints had hairline cracks through the shear key, indicating reduced strength of the key. A large depression at the base of the non-overflow section was observed (See Photo #7). The size of the depression was 28 feet long, 5 feet wide, and 3 feet deep. The origin of the depression is unknown. No evidence of seepage or erosive

The horizontal and vertical alignment of the east embankment section appears to be good. No evidence of surface cracks or movement of the slopes, crest, toe, or area beyond the toe was noted (See Photo #5). Small trees were evident on the upstream and downstream slopes, at the east abutment, and on the crest of the embankment. The upstream and downstream slopes are riprapped. No evidence of seepage was encountered on the slopes, at the toe or abutments, or beyond the toe of the east embankment section.

Crest of Non-overflow Section and East Embankment
Photo #5

1. Significant deterioration of concrete of the non-overflow section should be repaired.
2. Investigate the condition of the shear keys to determine if the necessary strength is available to resist the shear forces.
3. Investigate the area at the toe of this section to determine the condition of the foundation drain outlets and the large depression. Drains should be kept free of debris and an outlet of sufficient capacity installed and maintained to assess the conditions of seepage and uplift beneath the dam.
4. Seepage observed exiting from behind the east spillway abutment should be investigated. This may be related to the adjacent foundation drain system.

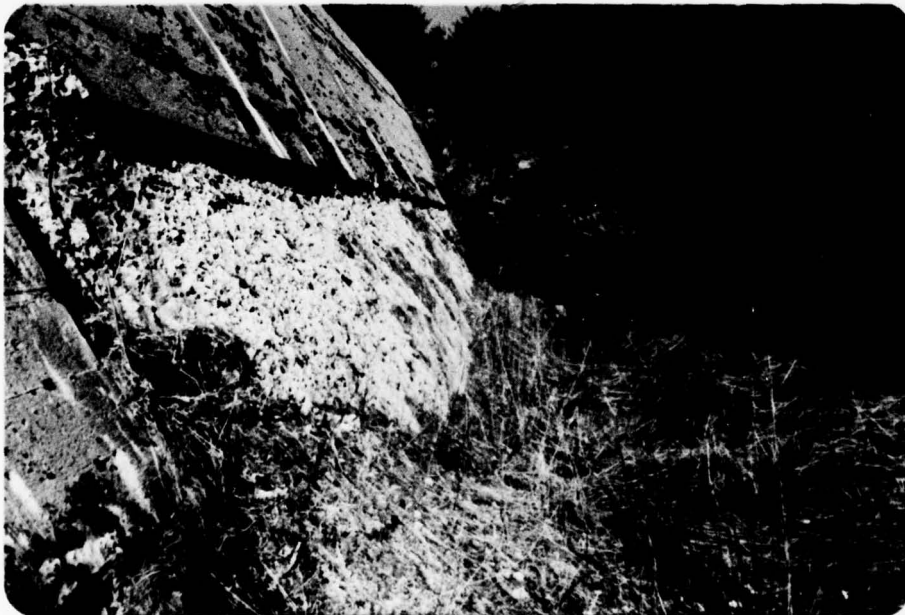
force was apparent, which would be needed to create this depression. This area may have been the remnants of construction excavation, or post construction excavation to clear the foundation drain outlets.

The plans indicate that 3 foundation drain outlets were installed at the toe of this section. Apparently, backfill at the toe obscured these outlets. Seepage encountered in the backfill of the east spillway abutment may result from these outlets.

Deteriorated Panel Non-overflow Section
Note Depression at Toe
Photo #7

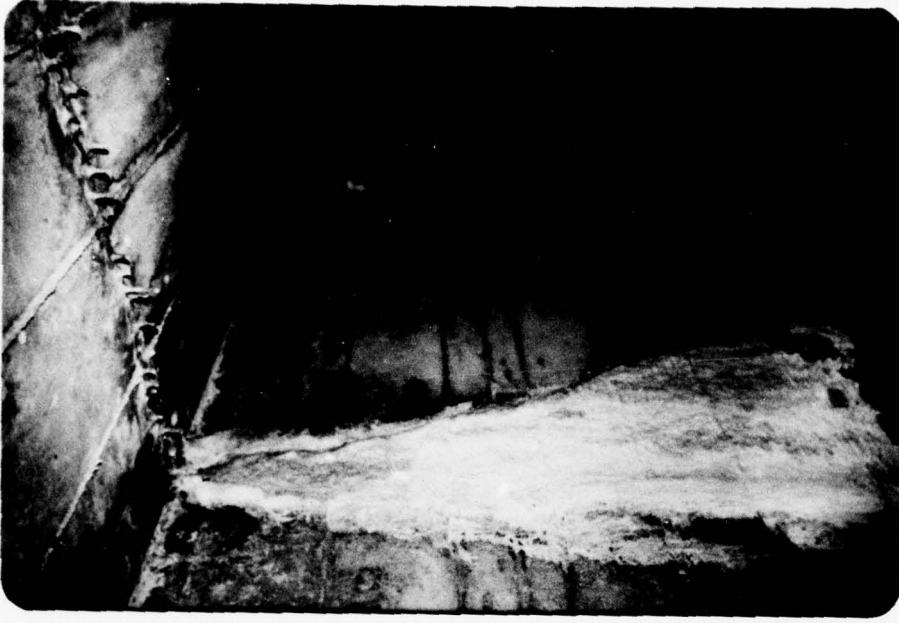
The concrete at the drain is deteriorated at the outlet with reinforcing bars exposed. Slight seepage and calcification was evident in the walls of the drain initiating from the joint between the top and walls of the box drain. (See Photos #8 & 9) the concrete slab at the west end of the spillway channel which covers the reservoir drain is deteriorated and some reinforcing is exposed. Surface spalling was noted particularly at the construction joints.

Reservoir Drain Interior
Note Calcification at
Construction Joint
Photo #9

1. Repair the deteriorated concrete of the reservoir drain. Repair the construction joints within the drain.

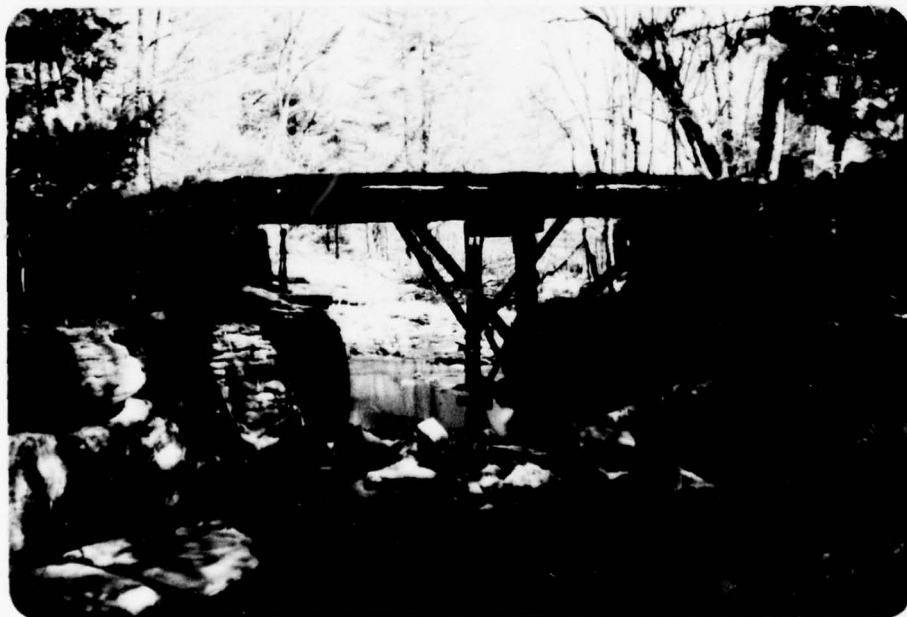
Considerable tree growth and debris was observed in the outlet channel and spillway channel. An access bridge also constricts the spillway flow below the dam. (See Photo #15) The outlet channel is extremely narrow and overtopping of the channel walls may result during high flow conditions.

The downstream channel is partially bedrock formed. Numerous small trees, debris, and rock outcrops were observed. The side slopes appear to be stable with no unusual erosion problems observed. A narrow access bridge crosses the downstream channel approximately 50 feet below the old masonry dam. A sketch of this bridge is included in Appendix C. The bridge is used solely for maintenance and operation purposes by Orange and Rockland Utilities. (See Photos #14,15 & 16)

Downstream Bridge and Channel
Below Abandoned Masonry Dam
Photo #15

Remove all trees and debris found within the downstream channel immediately above the access bridge to maintain a clear channel between the dam and the bridge.

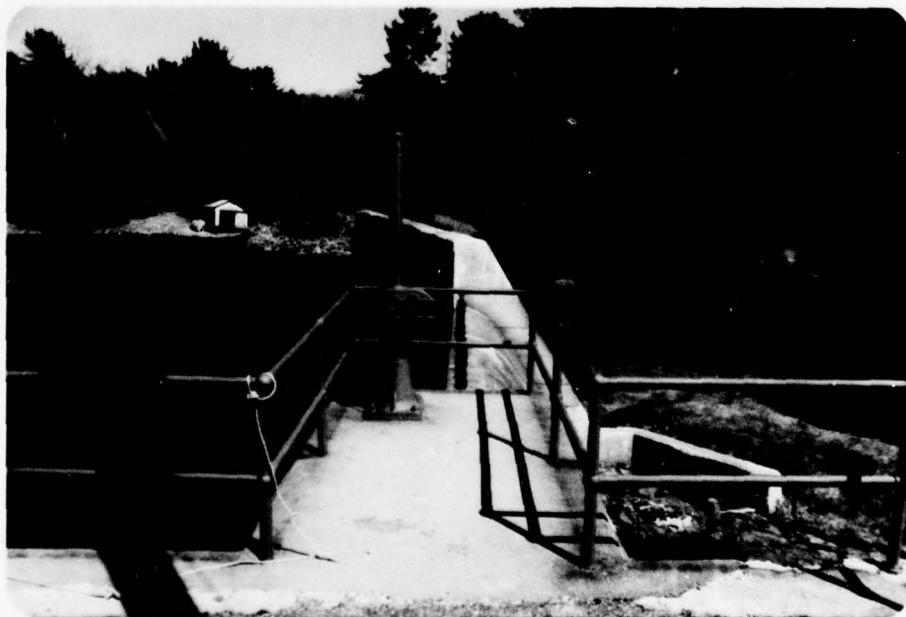
Reservoir Drain Controls,
Crest of Spillway and Non-Overflow Section
Photo #17

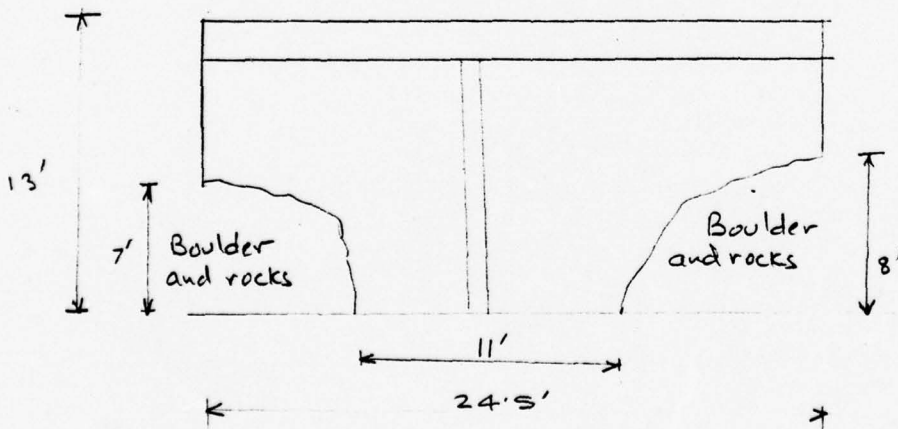
Access bridge on downstream channel
Looking downstream.
