AD-A077 492

DEFENSE ATOMIC SUPPORT AGENCY WASHING N DC
BIKINI SCIENTIFIC RESURVEY. VOLUME II
DEC 47

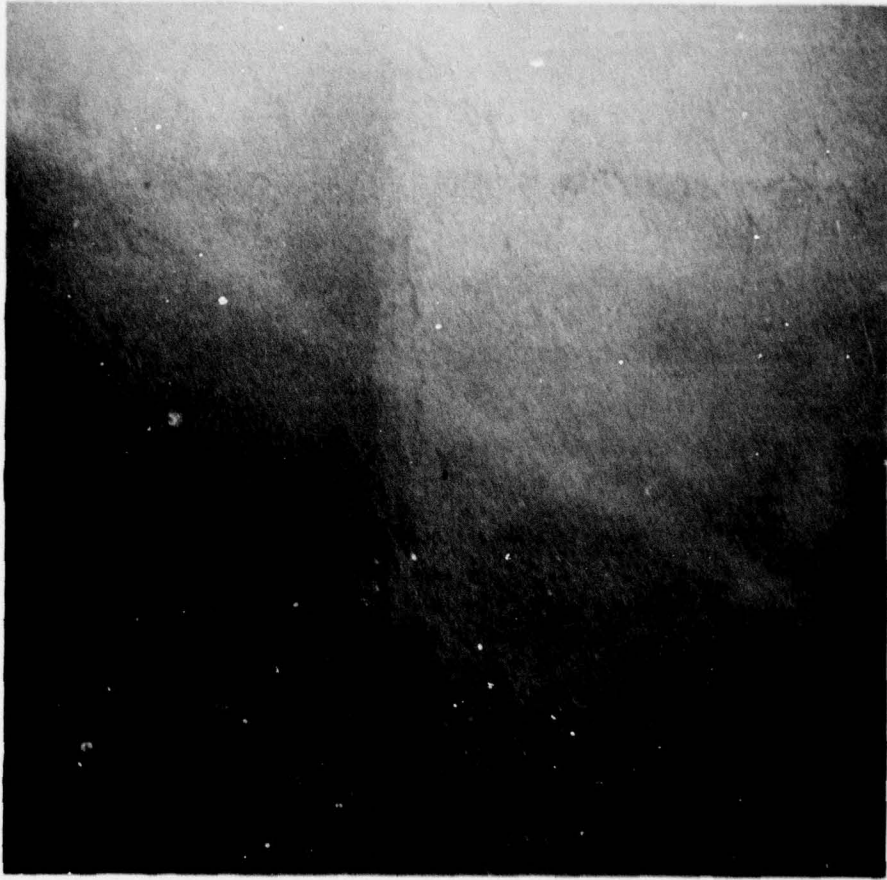
Figure 2. SARATOGA. Broken blister looking forward, about frame No. 120. ABCR Photo No. 6022-4.

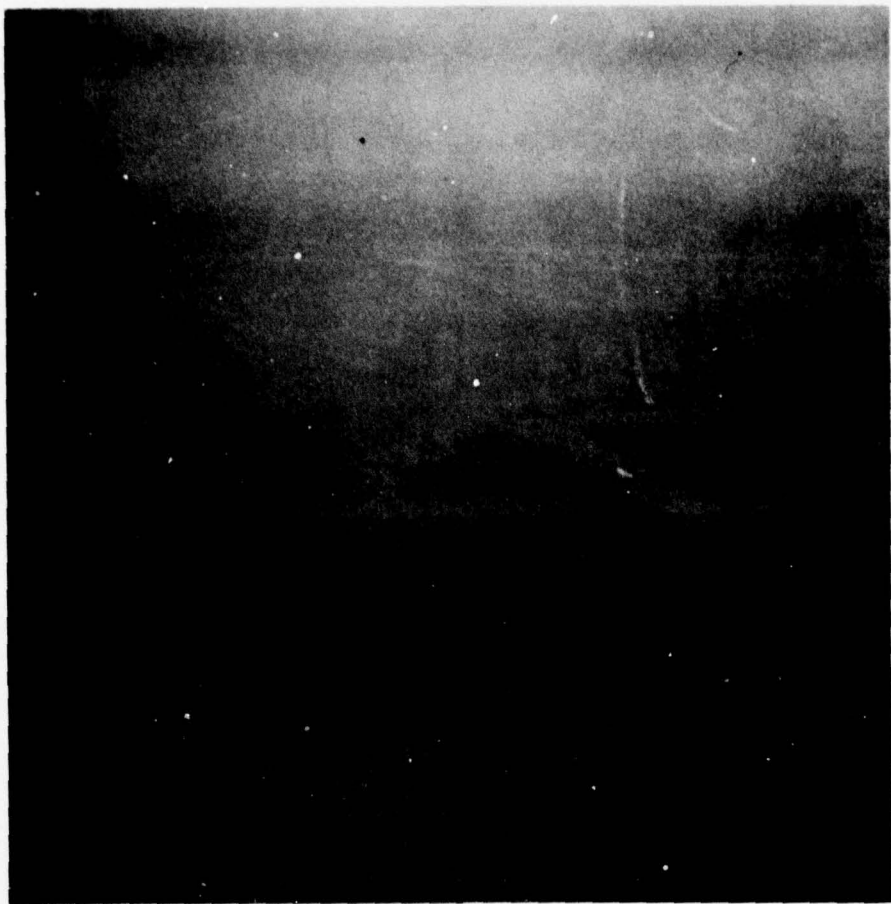
Figure 3. SARATOGA. Damaged flight deck, port side, about frame No. 157. ABCR Photo No. 6025-14.

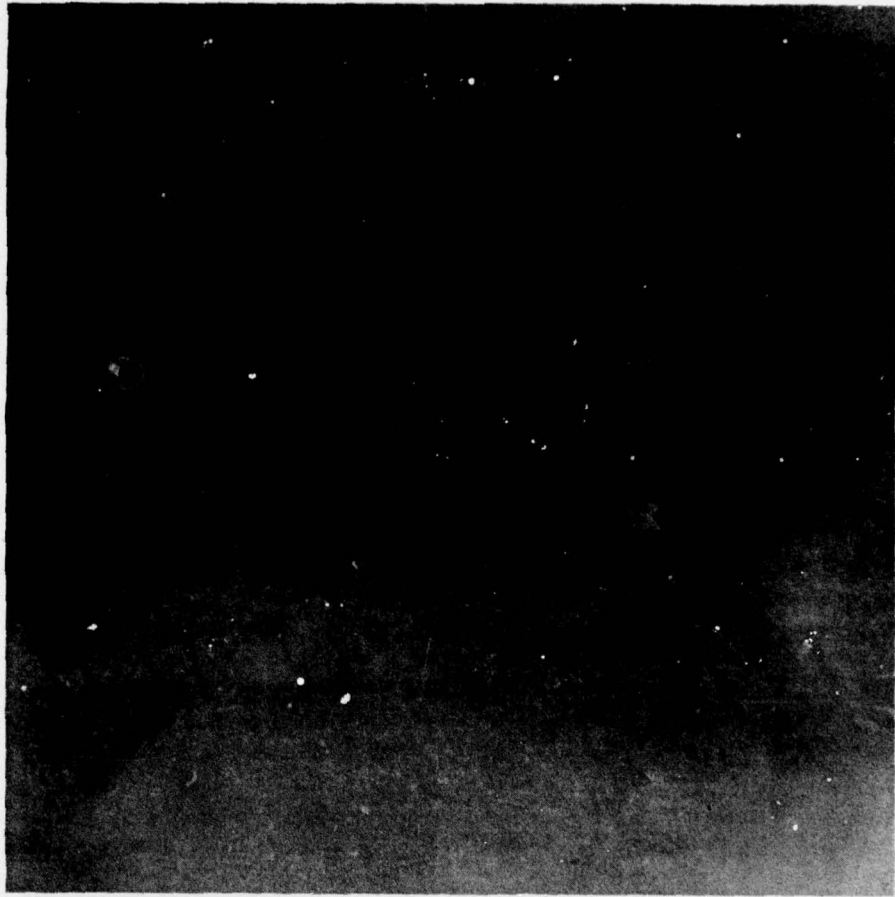
Figure 4. SARATOGA. Port side, starboard to port, deck break at frame No. 195. Note drop along deck edge indicating ruptured sheer strake. ABCR Photo No. 6026-10.

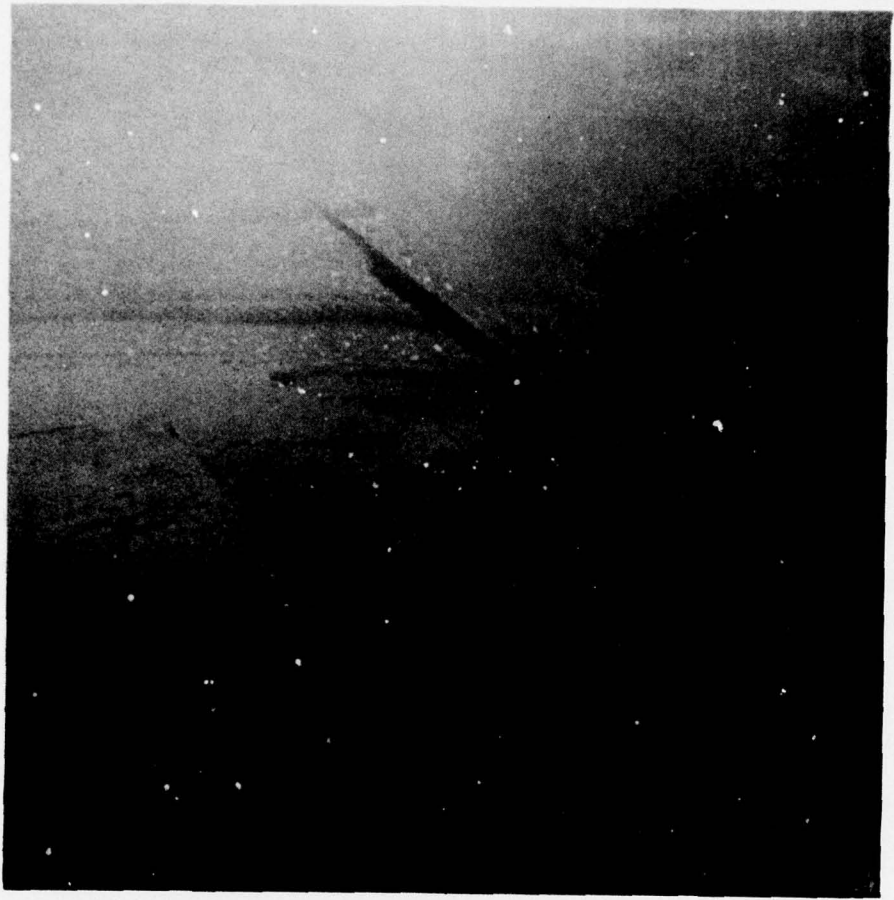
Figure 5. SARATOGA. Broken flight deck, port side looking forward, about frame No. 126. ABCR Photo No. 6030-2.

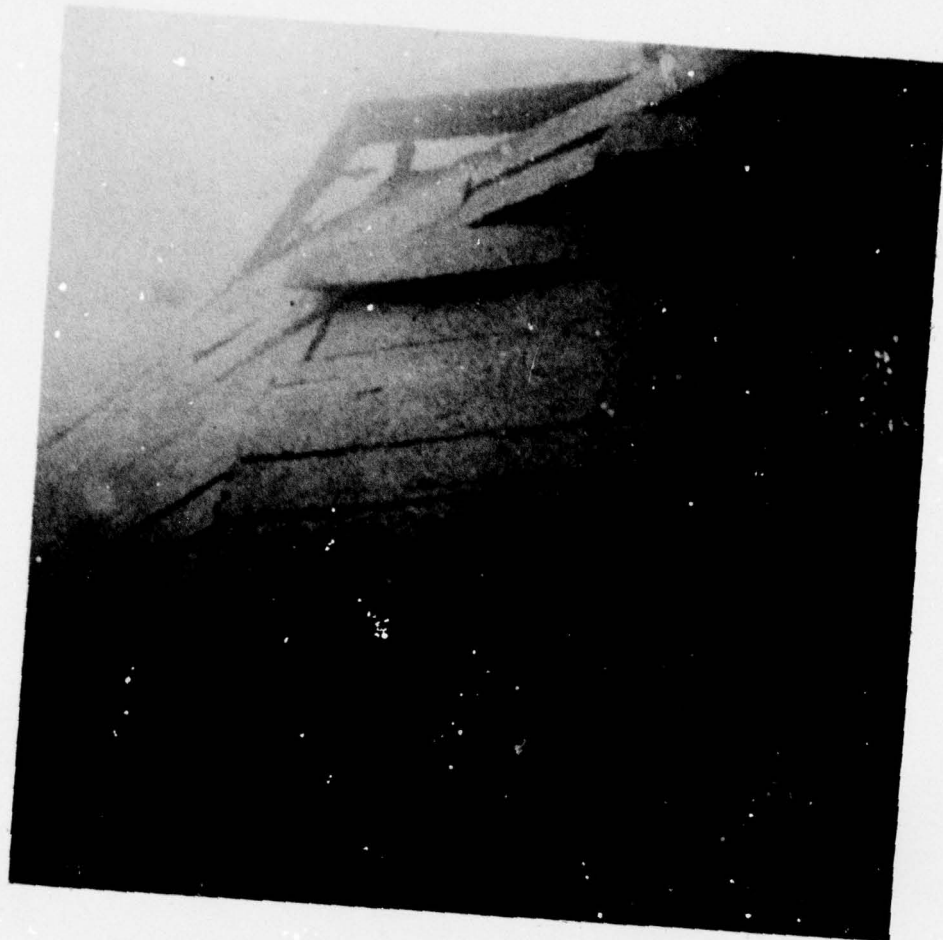
Figure 7. SARATOGA. Damaged flight deck, port side, about
frame No. 157. ABCR Photo No. 6030-14.

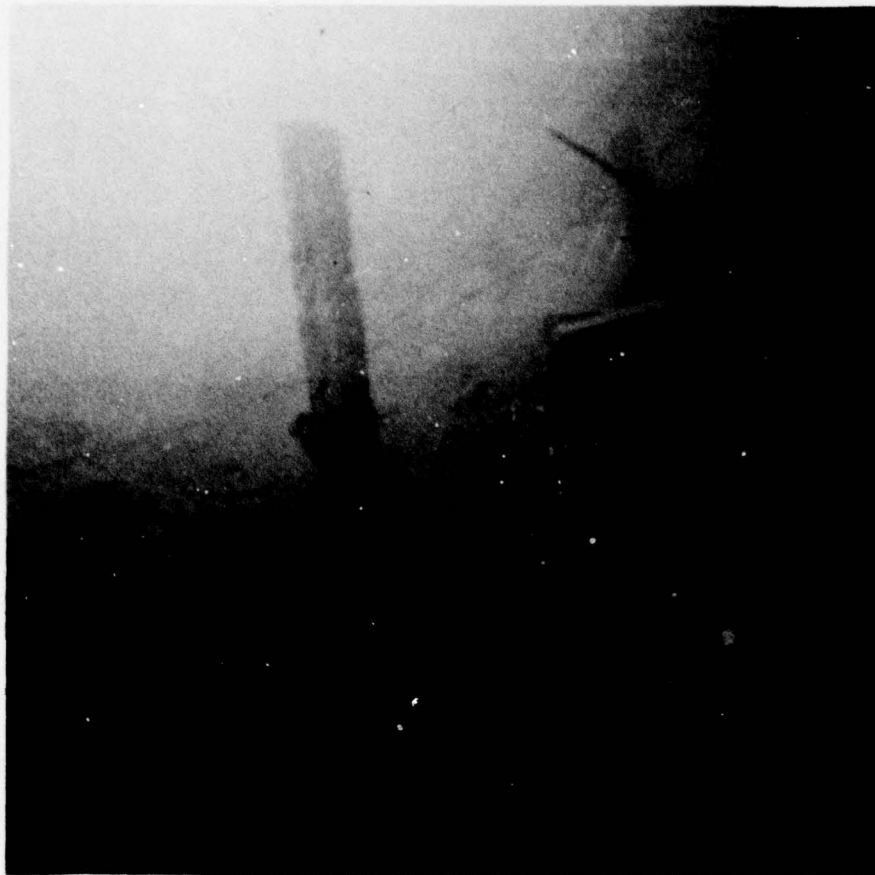
Figure 8. SARATOGA. Damaged deck about frame No. 162 near centerline. ABCR Photo No. 6030-15.

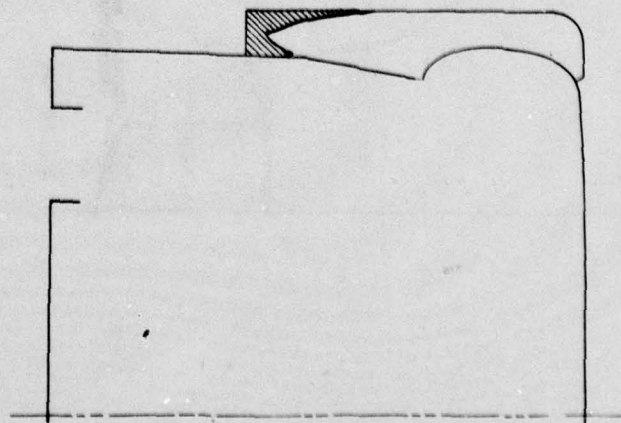
TYPICAL BLISTER
DAMAGE ABOUT FRAME 100

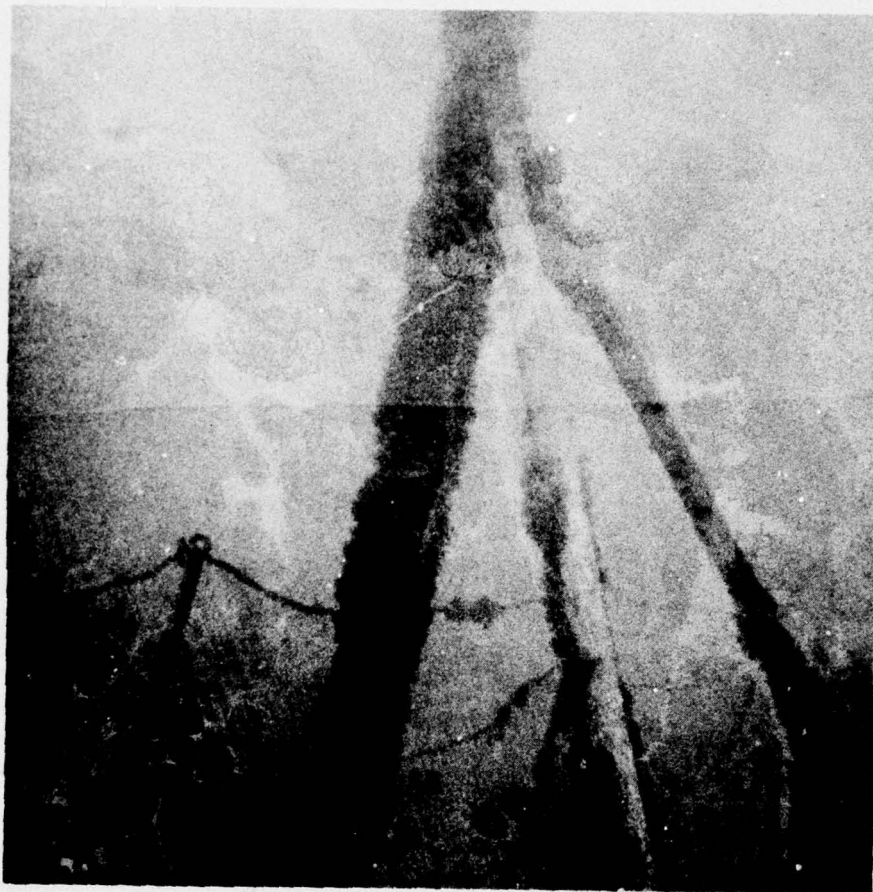
Jackstaff and forward lifeline damage. ABCR Photo No. 6002-8.

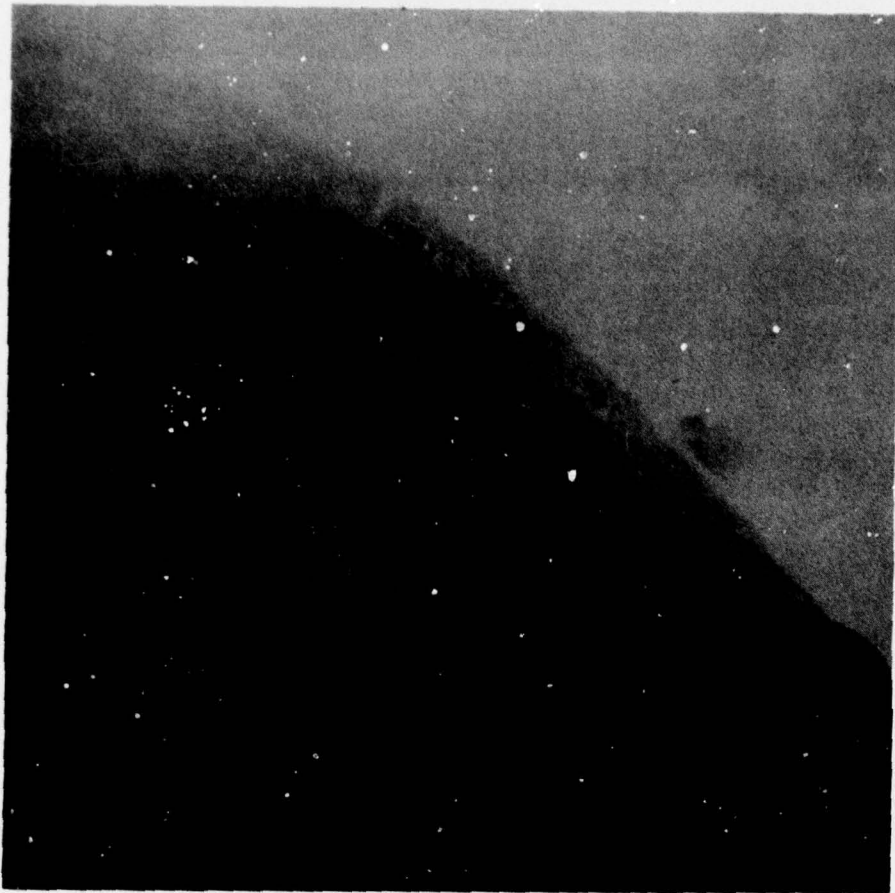
View of damage to stack near top of stack. ABCR Photo No. 6004-2.

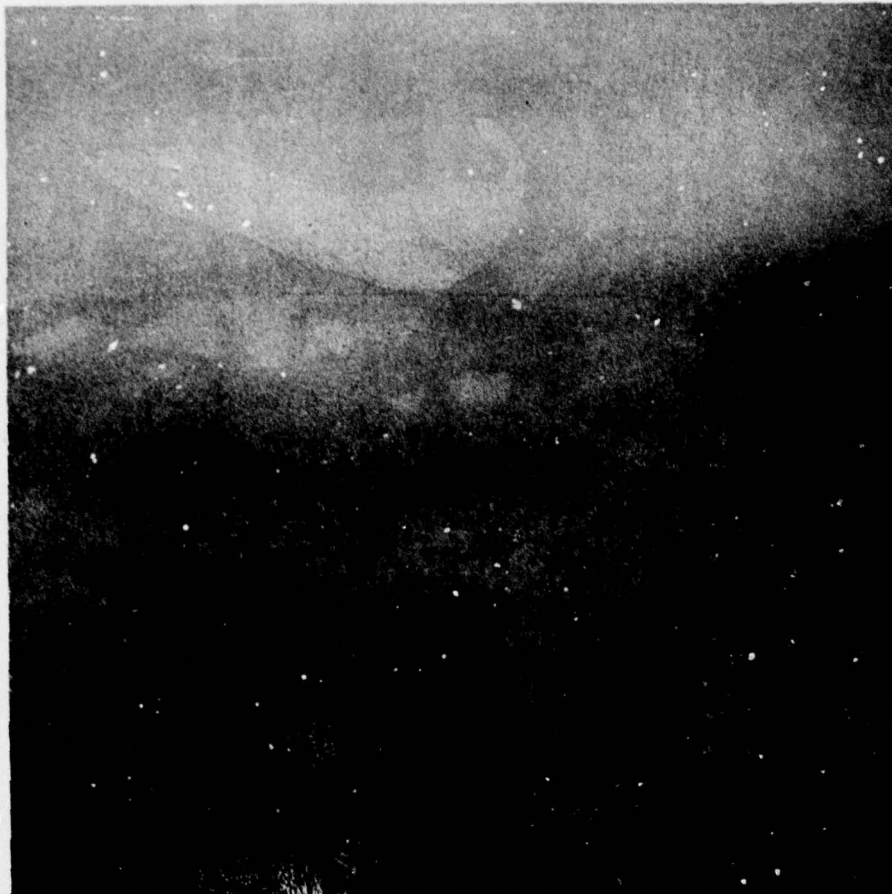
Damage to forward edge of stack. ABCR Photo No. 6004-4.

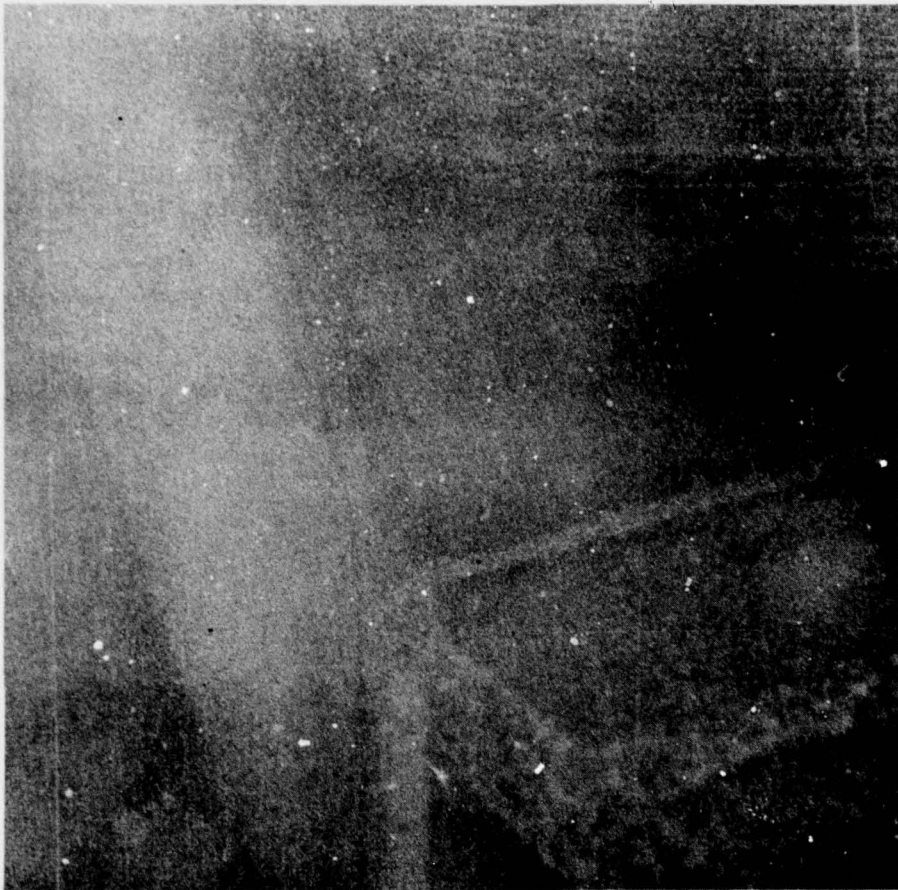
Unidentified damage near stack, presumably near forward edge of uptakes. ABCR Photo No. 6004-9.

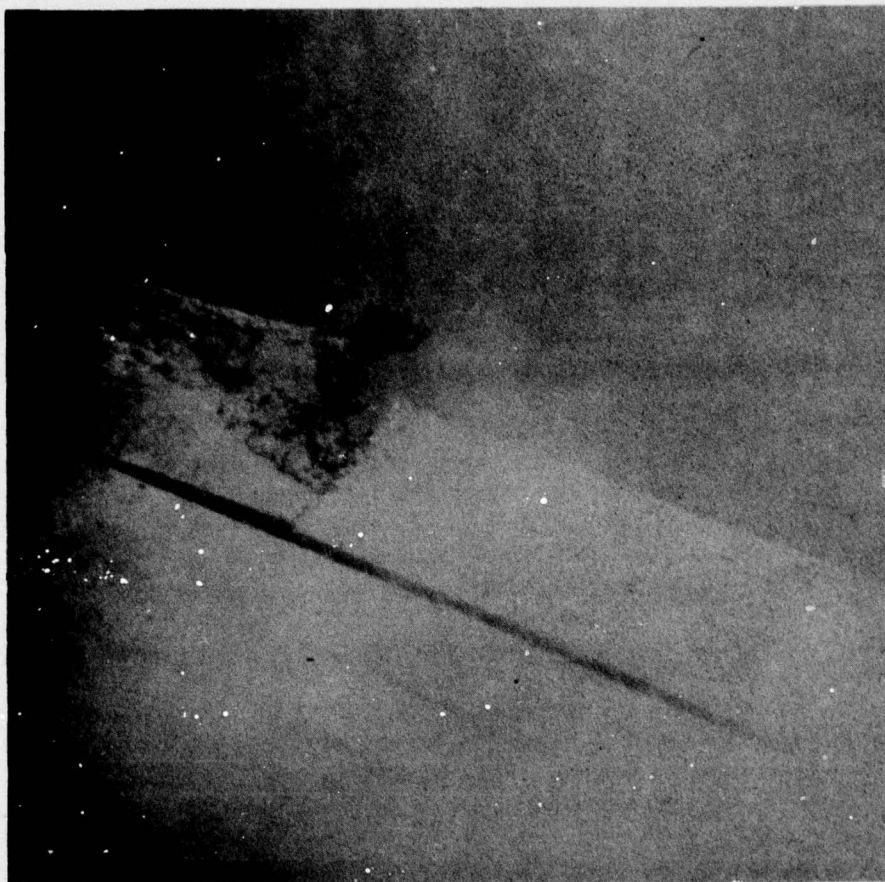
Damaged wood decking in way of broken stanchion, starboard side, between 5" 38 cal. mount #5 and forward deck house, about frame 59. ABCR Photo No. 6005-8.

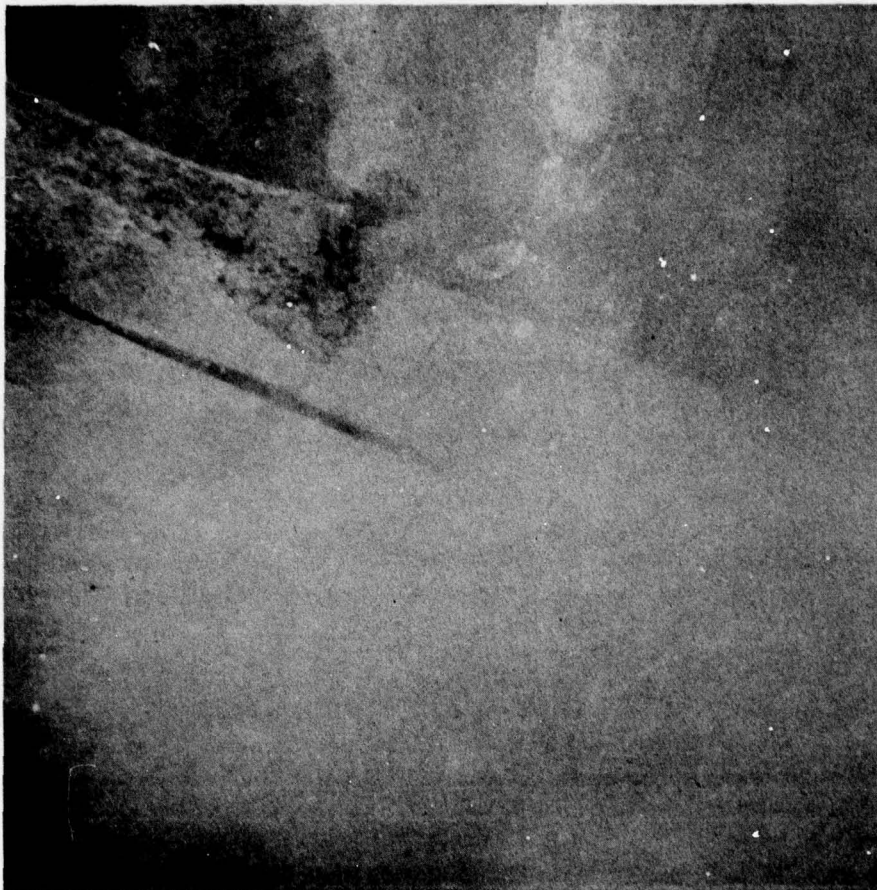
Damaged wood decking in way of broken stanchion, starboard side, between 5" 38 cal. mount #5 and forward deck house, about frame 59. ABCR Photo No. 6005-9.

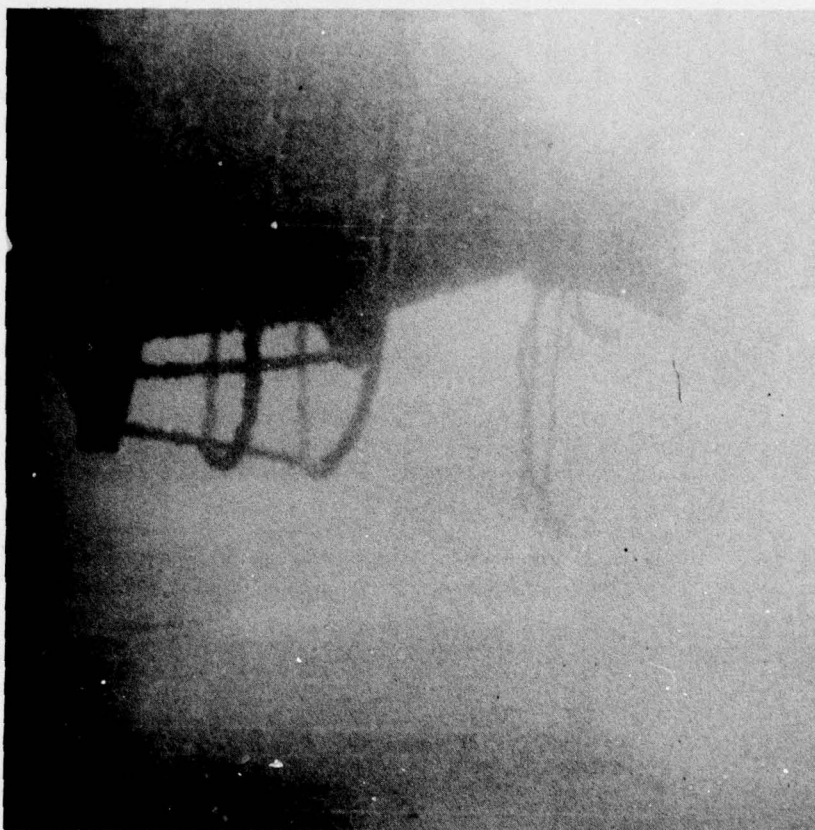
Radar Antenna found on stack top lying across flight deck,
looking aft. ABCR Photo No. 6005-17.

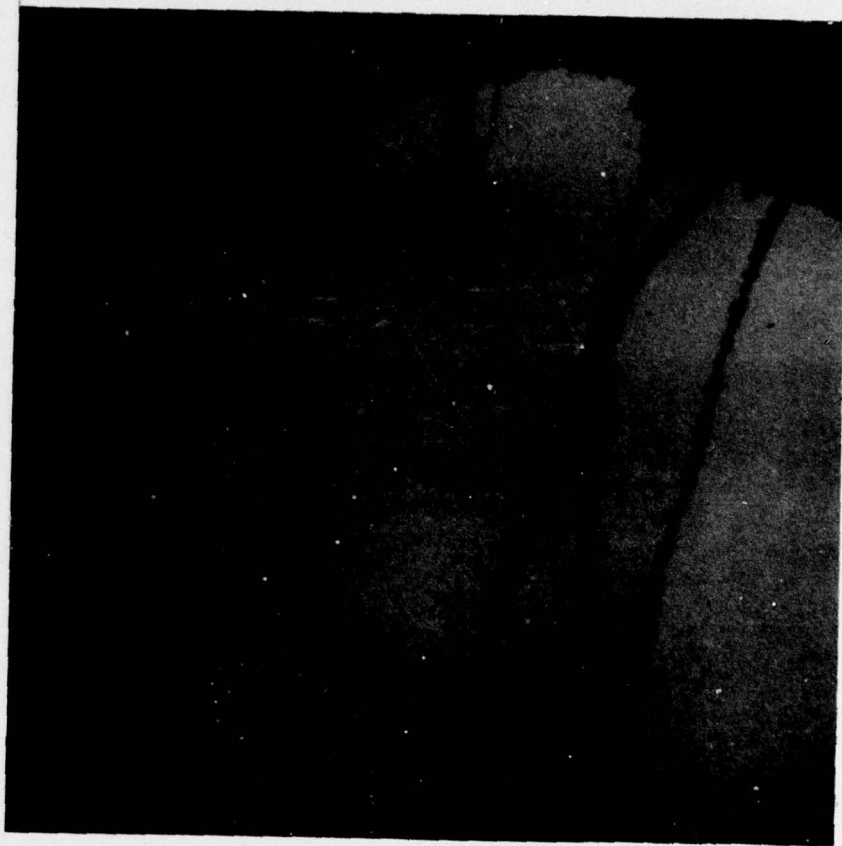
Damaged stack below radar platform. ABCR Photo No. 6005-21.

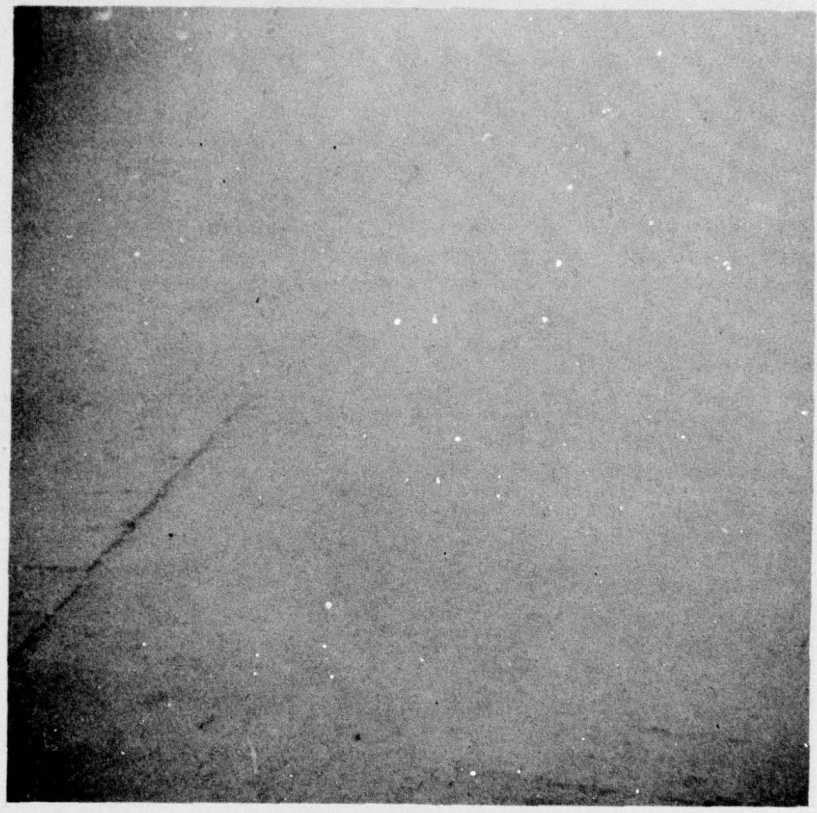
Damaged wood decking in way of top forward end of stack. ABCR
Photo No. 6007-6.

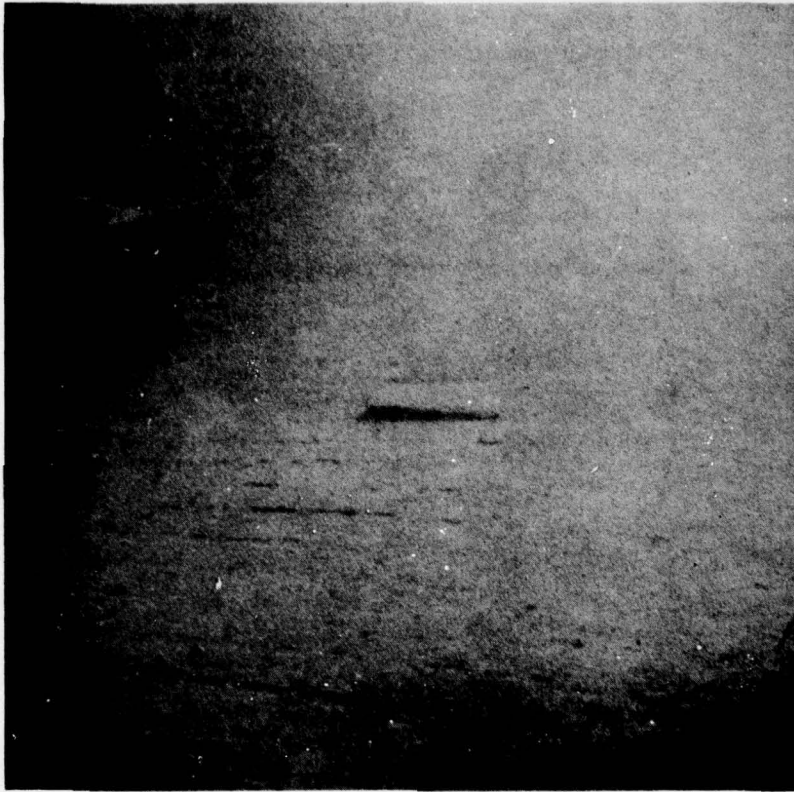
Damaged wood decking in way of top forward end of stack. ABCR
Photo No. 6007-8.

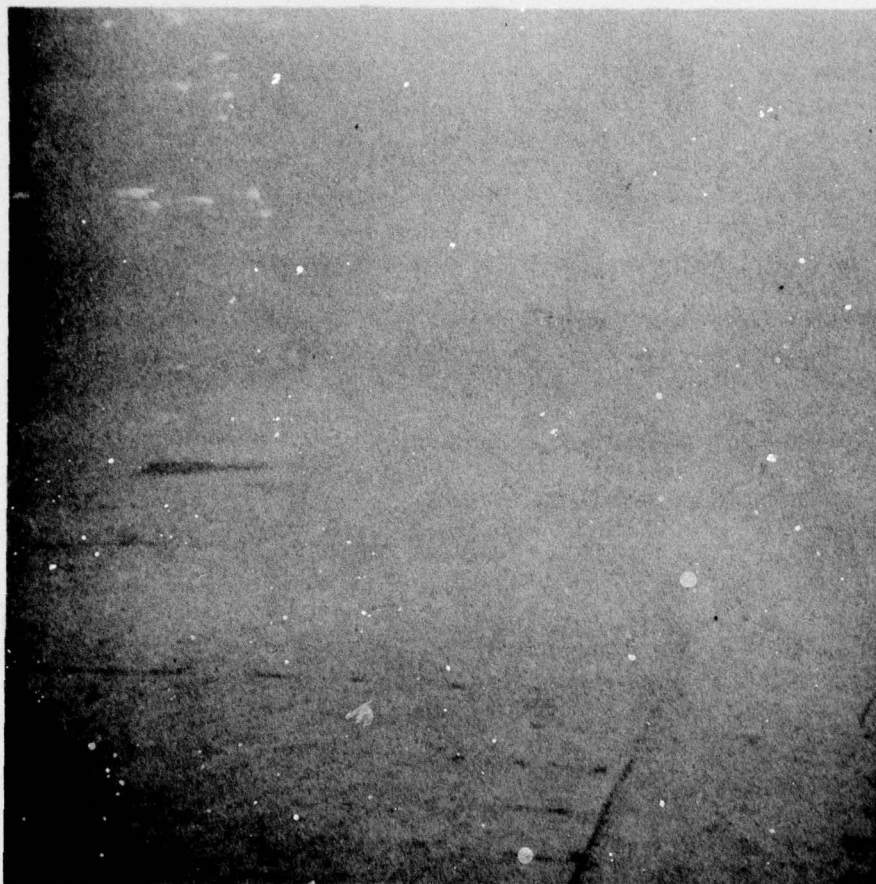
Damaged wood decking in way of top forward end of stack. ABCR
Photo No. 6007-7.

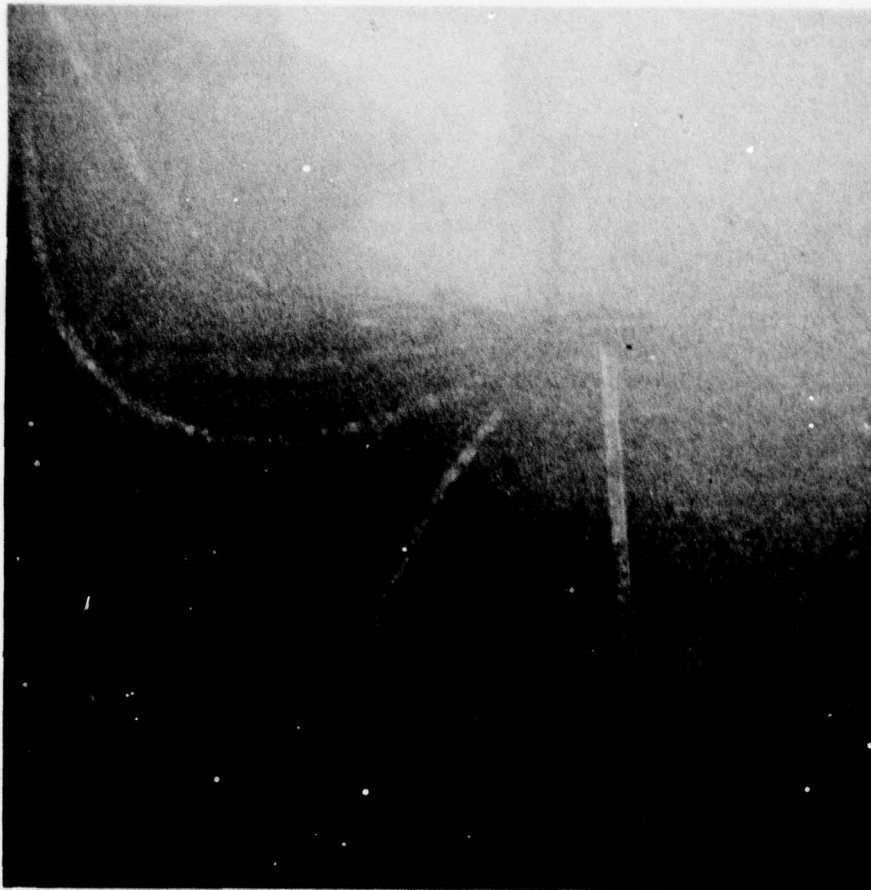
Looking through stack showing ruptured plating from top of stack to bottom, across flight deck. ABCR Photo No. 6007-9.

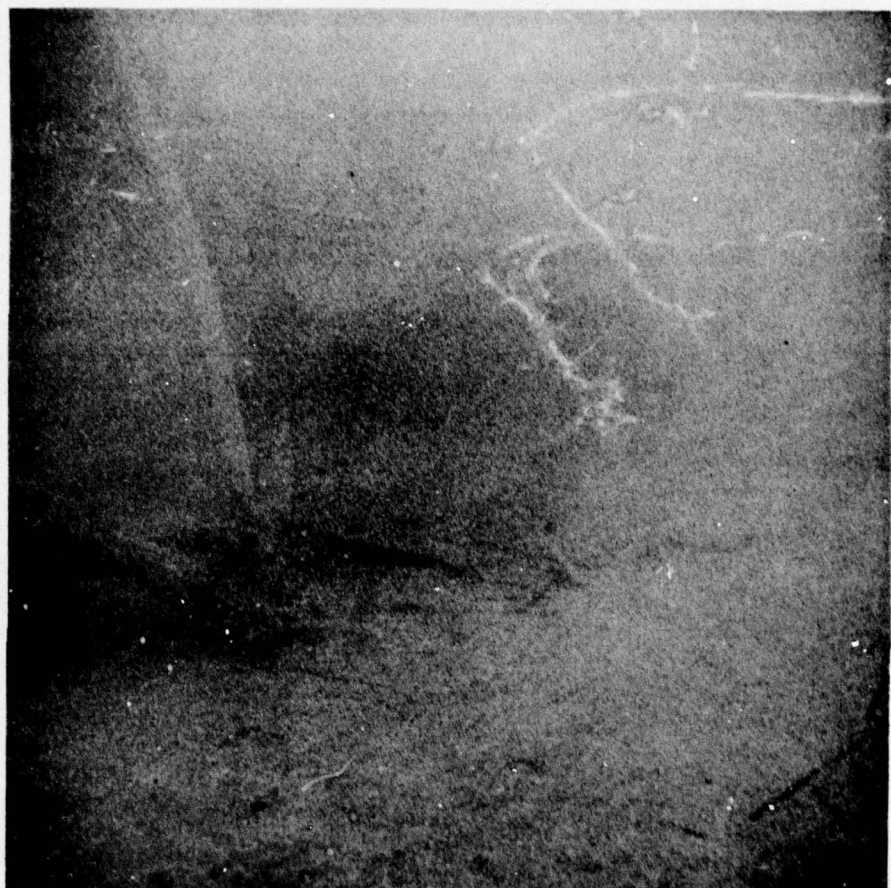
Damaged wood decking in way of top forward end of stack. ABCR
Photo No. 6007-10.

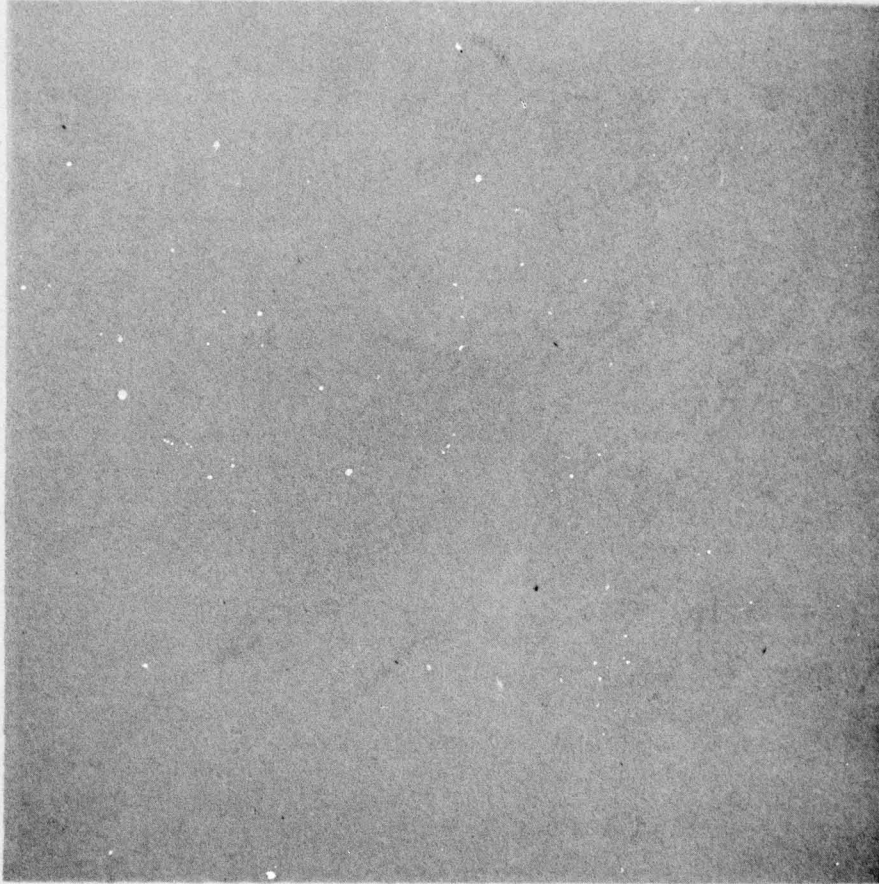
Damaged wood decking in way of top forward end of stack. ABCR
Photo No. 6007-11.

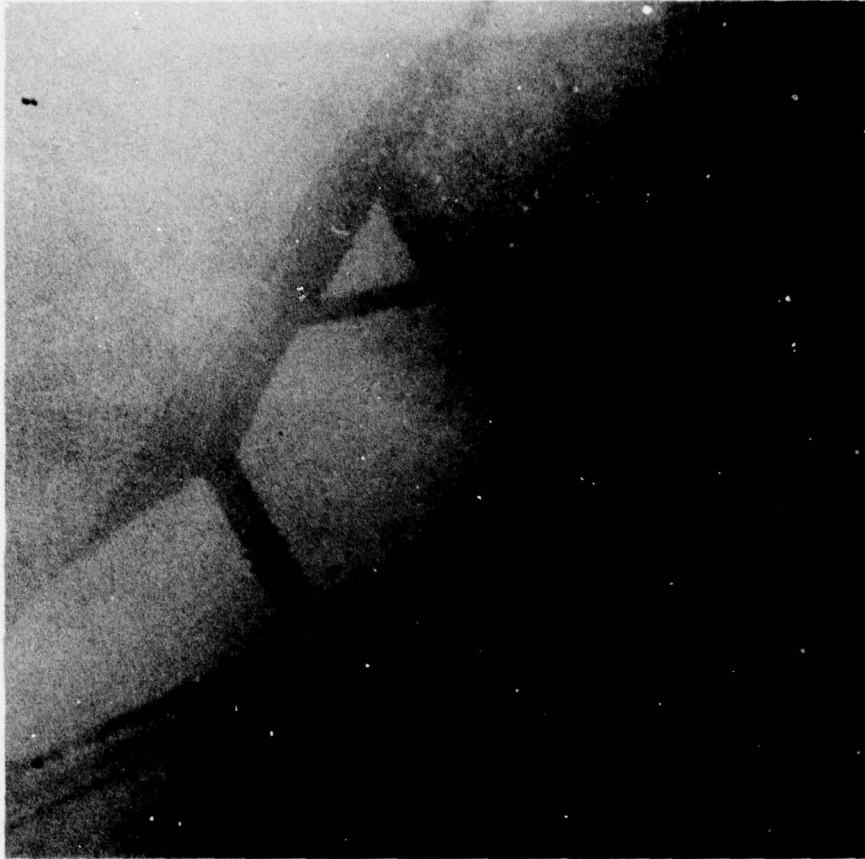
Port side, main deck, about frame 192 near crack. ABCR Photo
No. 6014-3.

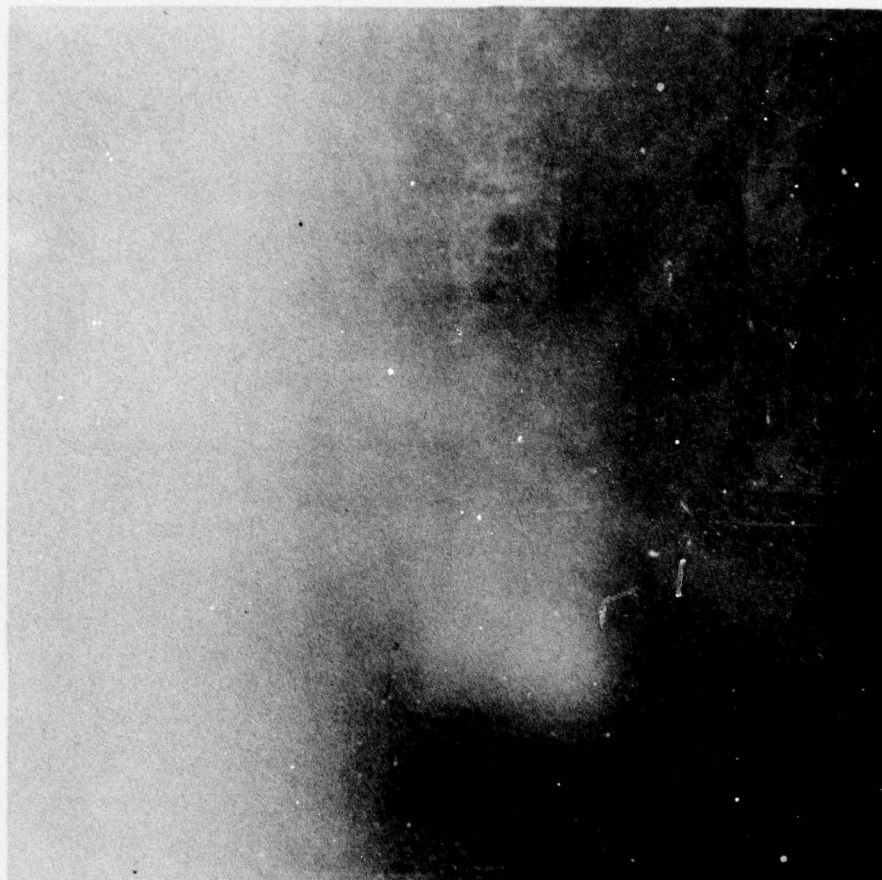
Crack at about frame 192, port side, main deck. ABCR Photo
No. 6014-4.

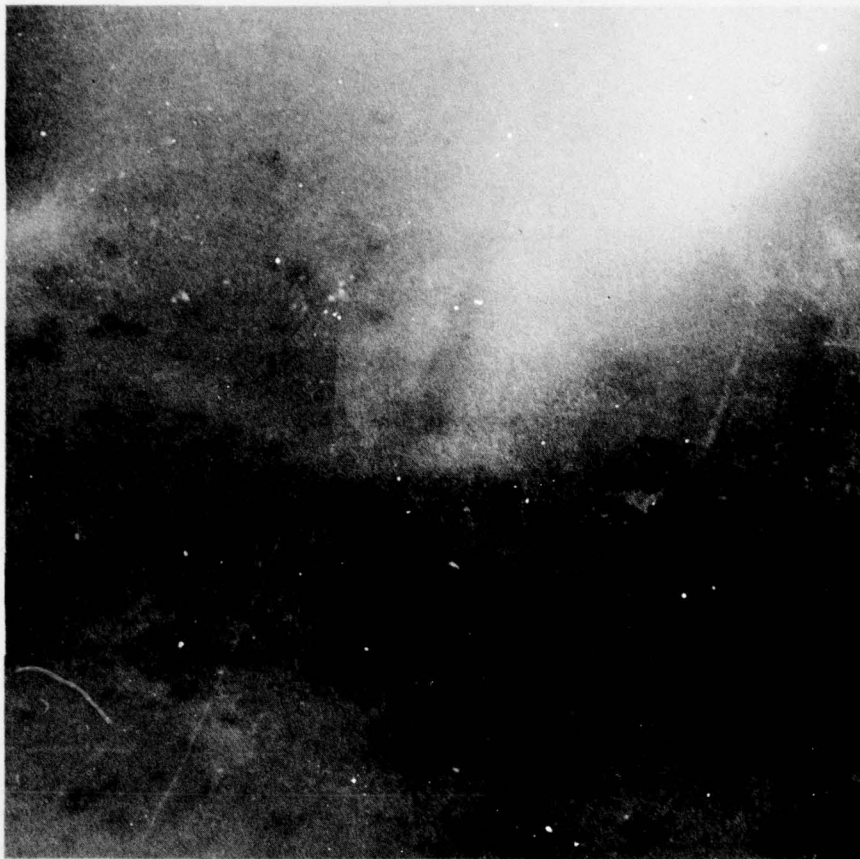
Forward port edge of ruptured plating covering #2 elevator shaft, looking aft. ABCR Photo No. 6016-2.

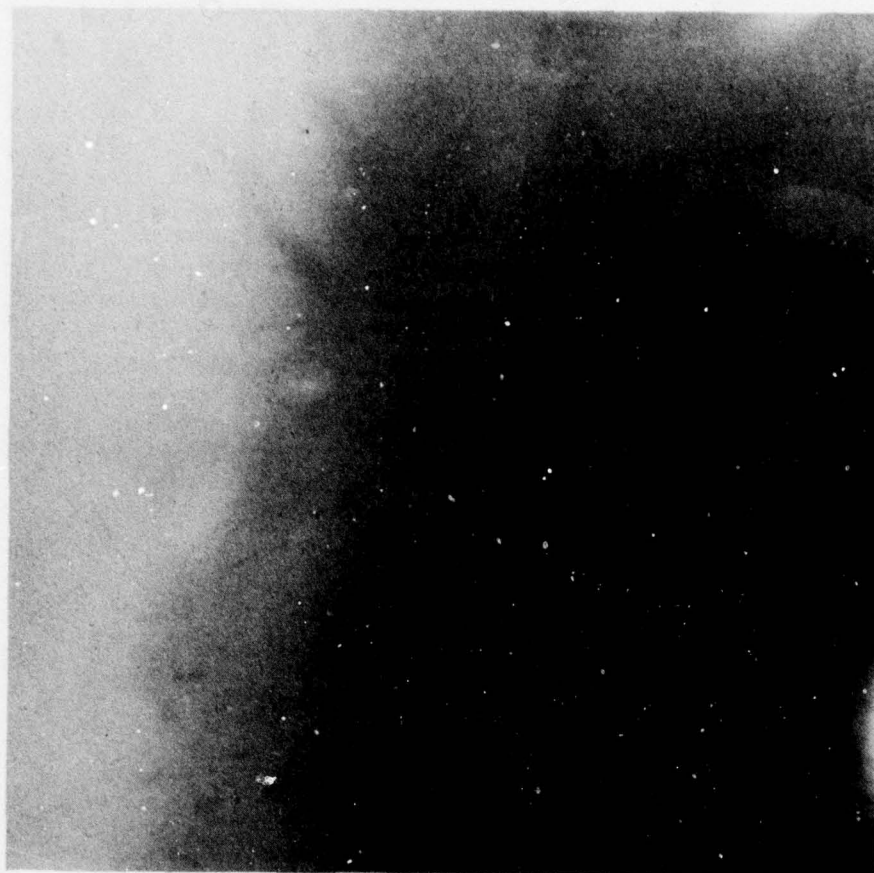
Ruptured plating covering #2 elevator shaft, looking aft on starboard side. ABCR Photo No. 6016-4. END.

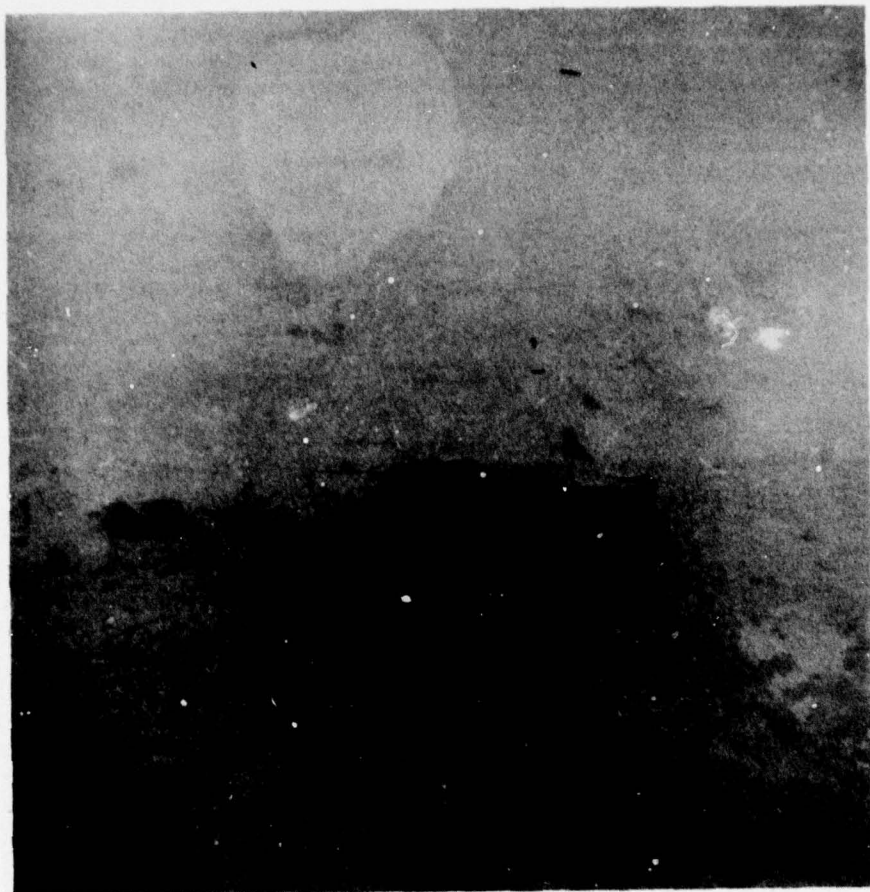
Broken decking sloping inboard about frame 140. ABCR Photo No. 6017-5.

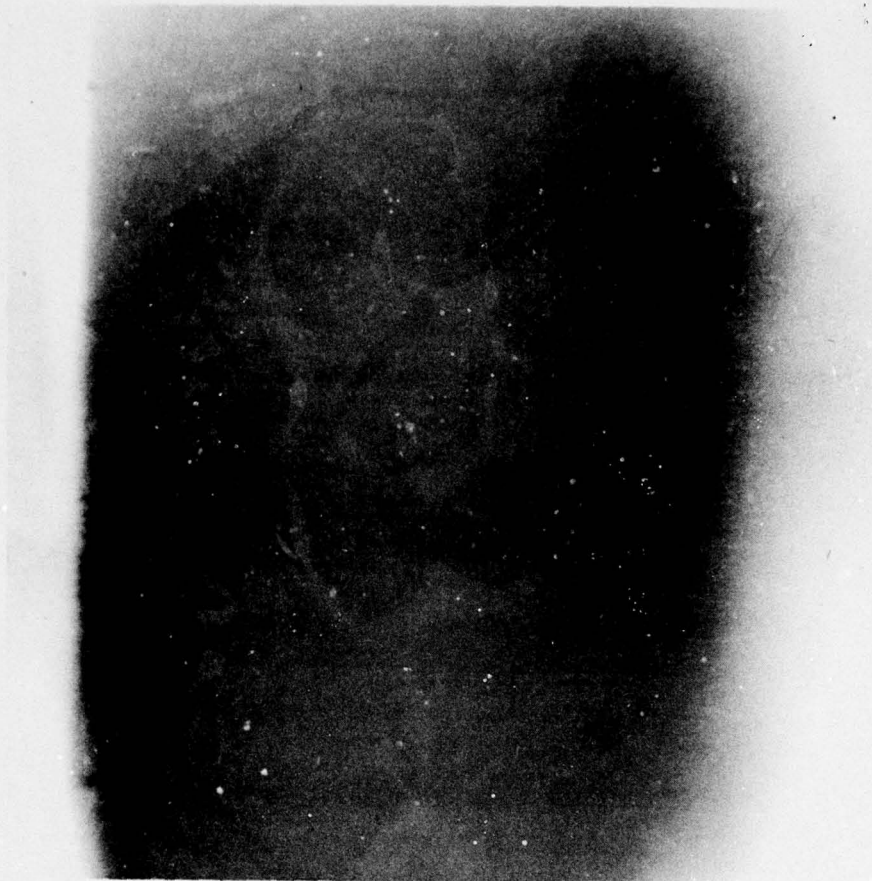
Tire imprint left by vehicle torn loose by shock. Vehicle could not be found, yet all four wheel imprints were. ABCR Photo No. 6018-1. END.

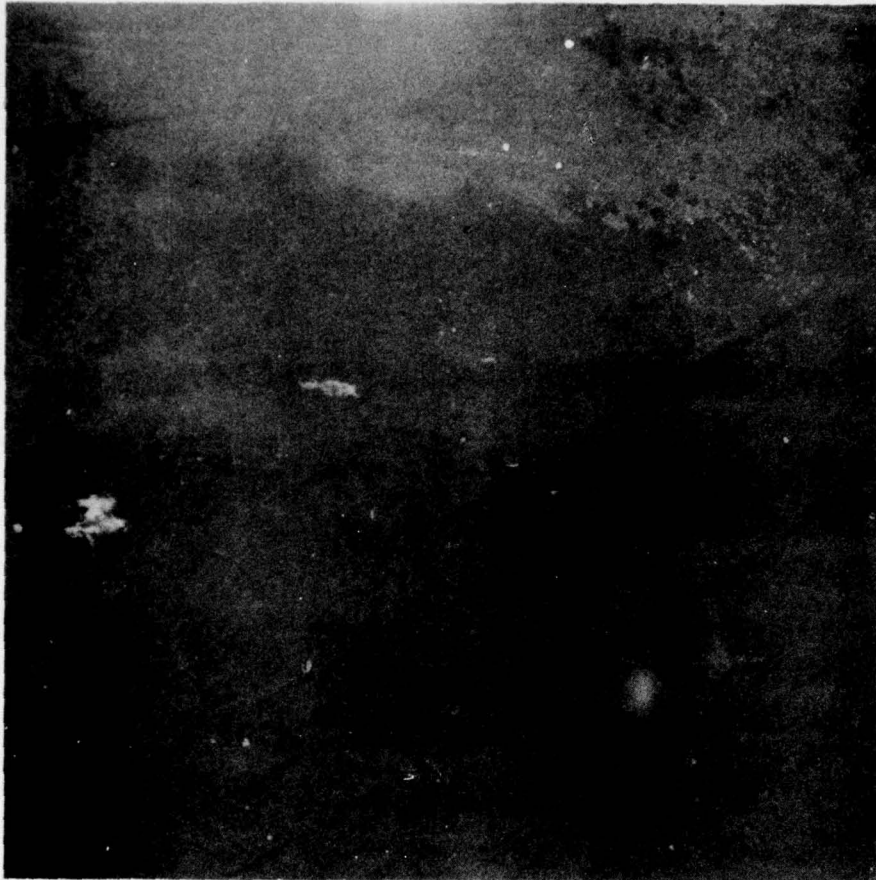
Damaged flight deck just aft of last 40mm. mount looking from
aft forward. ABCR Photo No. 6023-2.

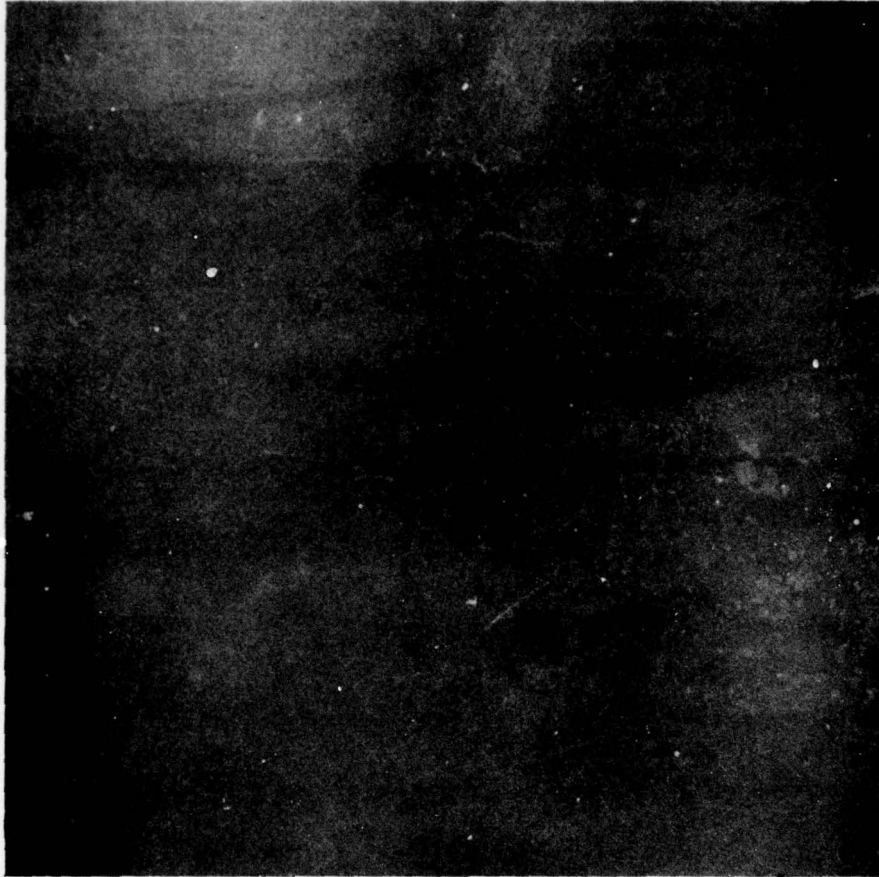
Damaged flight deck just aft of last 40mm. mount looking from
aft forward. Note bump over transverse girder 190. ABCR
Photo No. 6023-3.

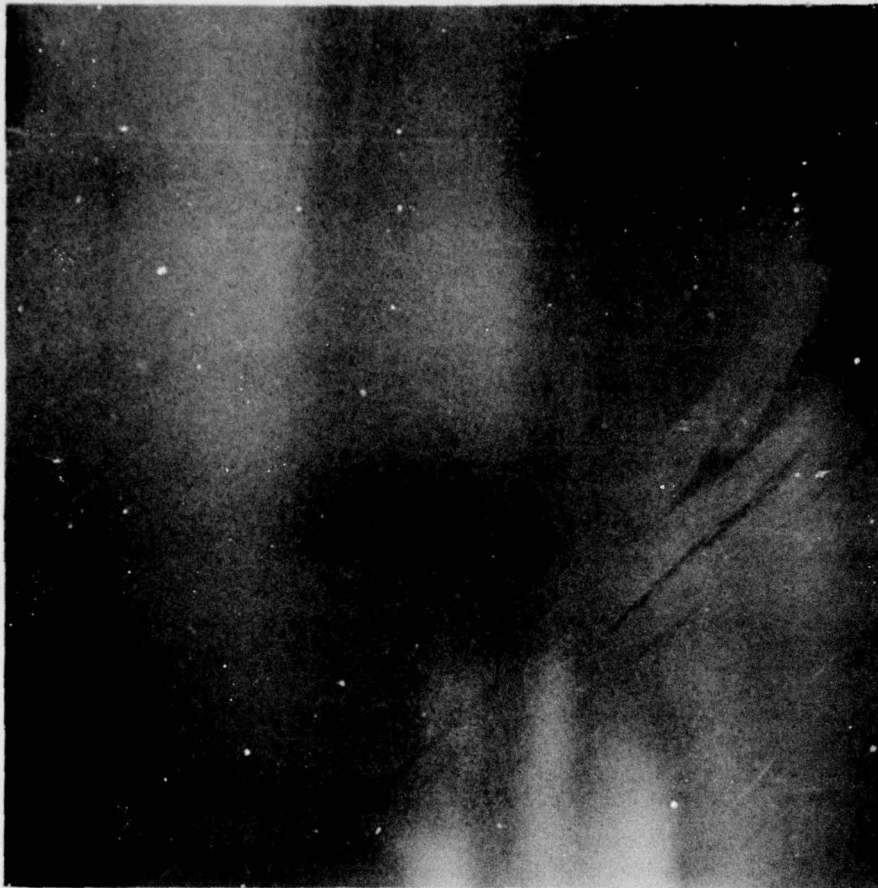
Unsatisfactory view of after deck damage. ABCR Photo No.
6023-4. END.
