AD-A077 492

DEFENSE ATOMIC SUPPORT AGENCY WASHING N DC
BIKINI SCIENTIFIC RESURVEY. VOLUME II
DEC 47

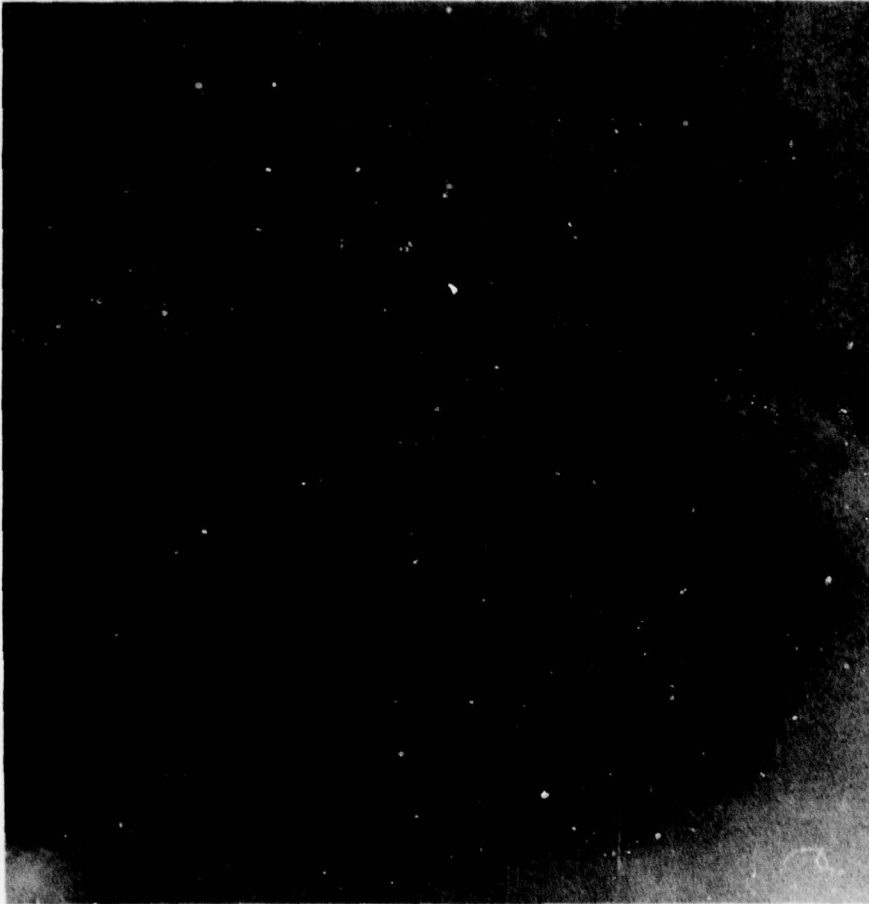
View of starboard side of uptakes where stack is broken off
about frame 106. ABCR Photo No. 6024-7.

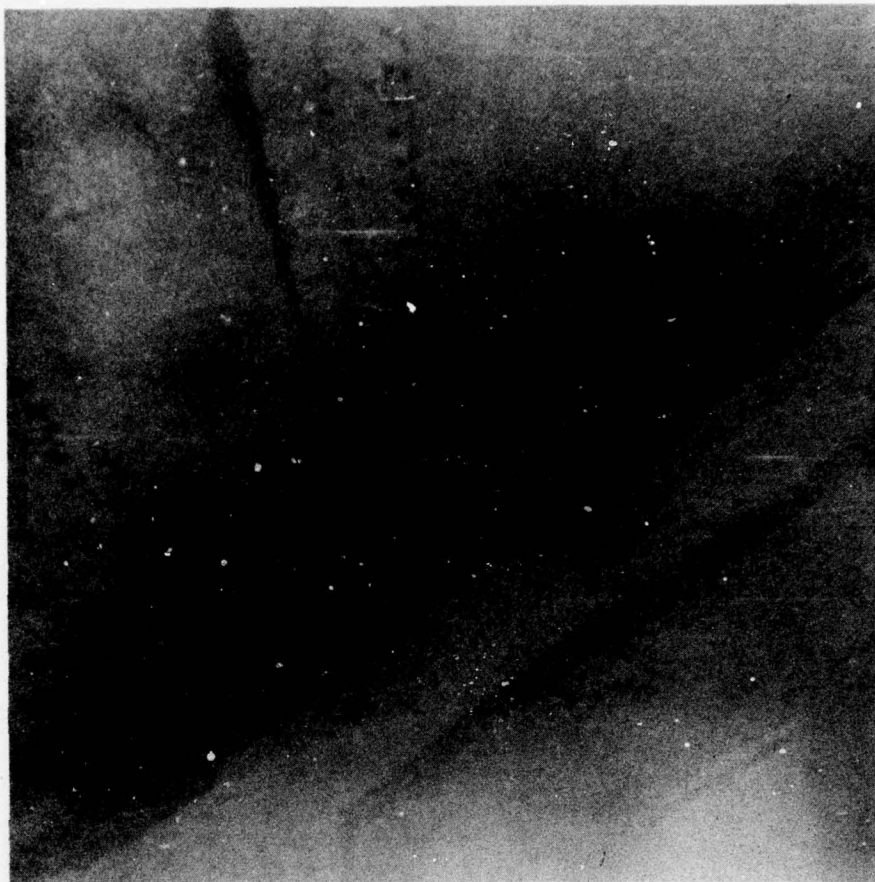
Crack in superstructure in or near uptakes. ABCR Photo No.
6024-11.

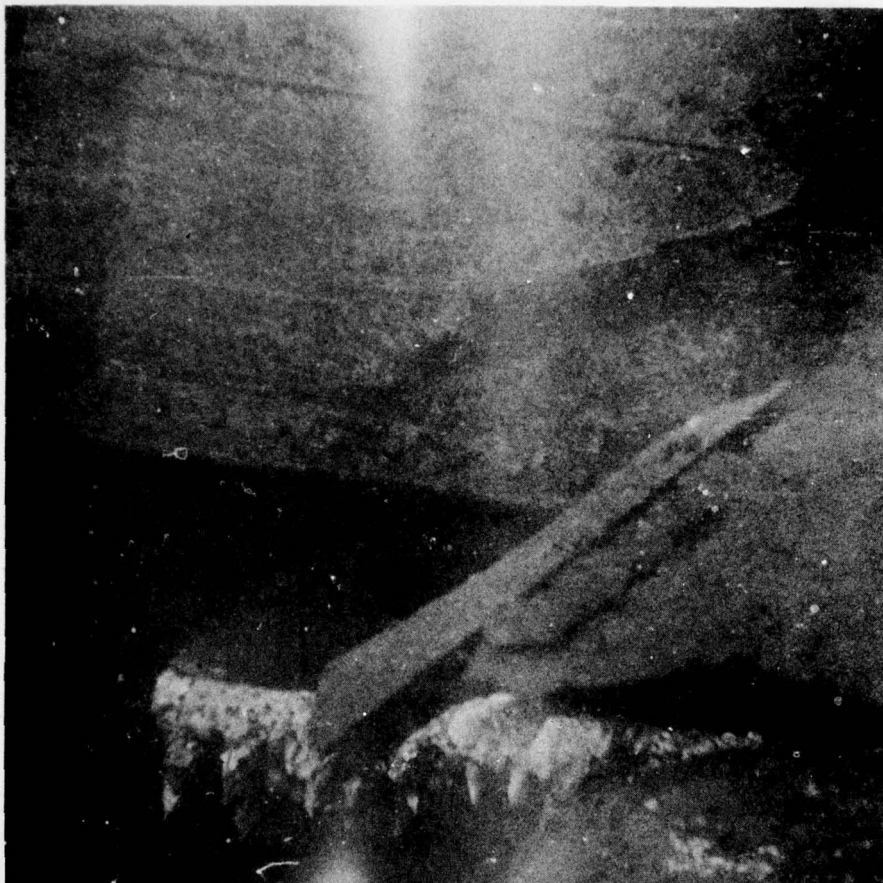
Stack where it is broken from base showing uptake #3 or 4.
ABCR 6026-1.

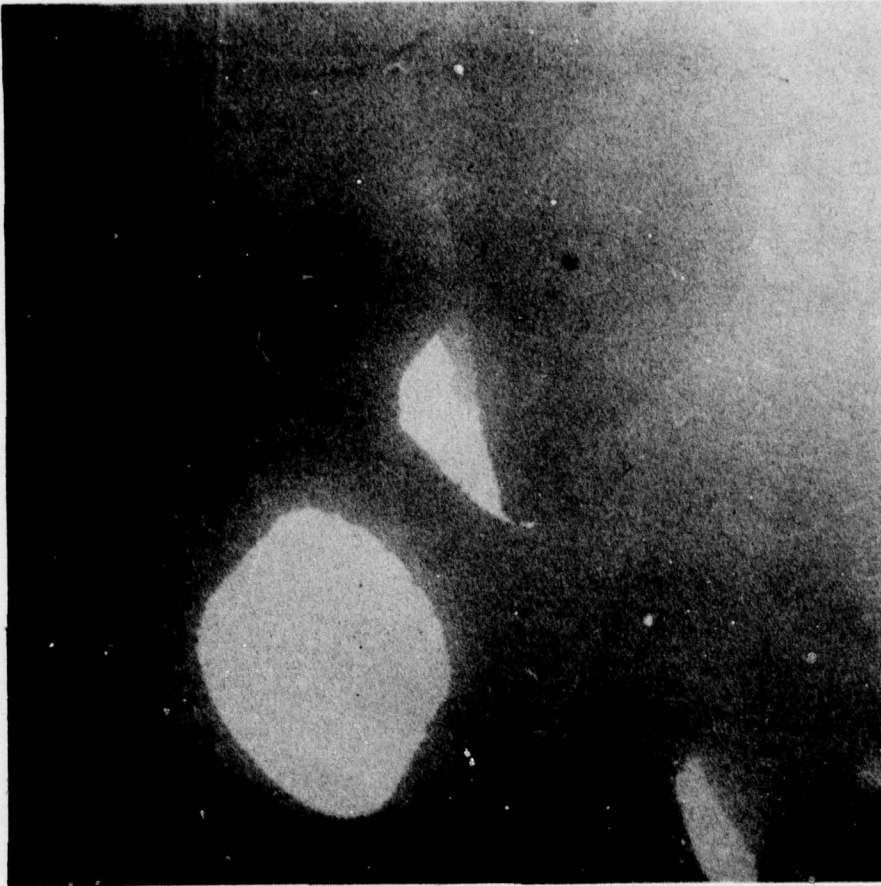
Section near base of broken stack, about frame 110, starboard side of flight deck. ABCR Photo No. 6026-3.

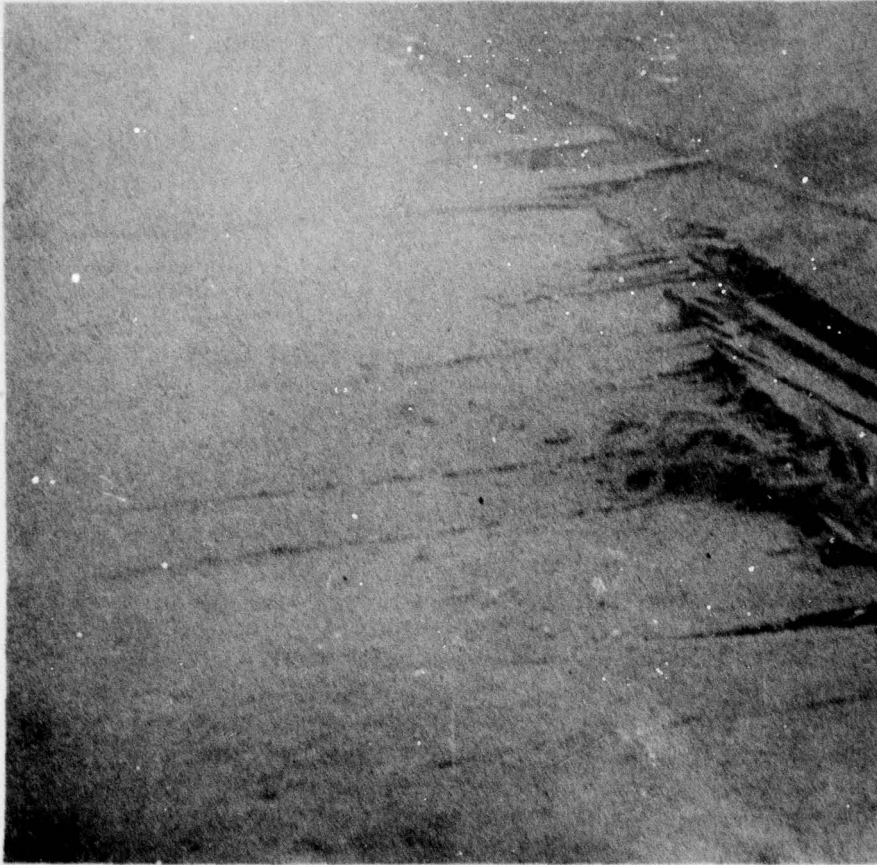
#1 of a series of photographs of damaged flight deck on port side looking forward, about frame 182. ABCR Photo No. 6027-3.

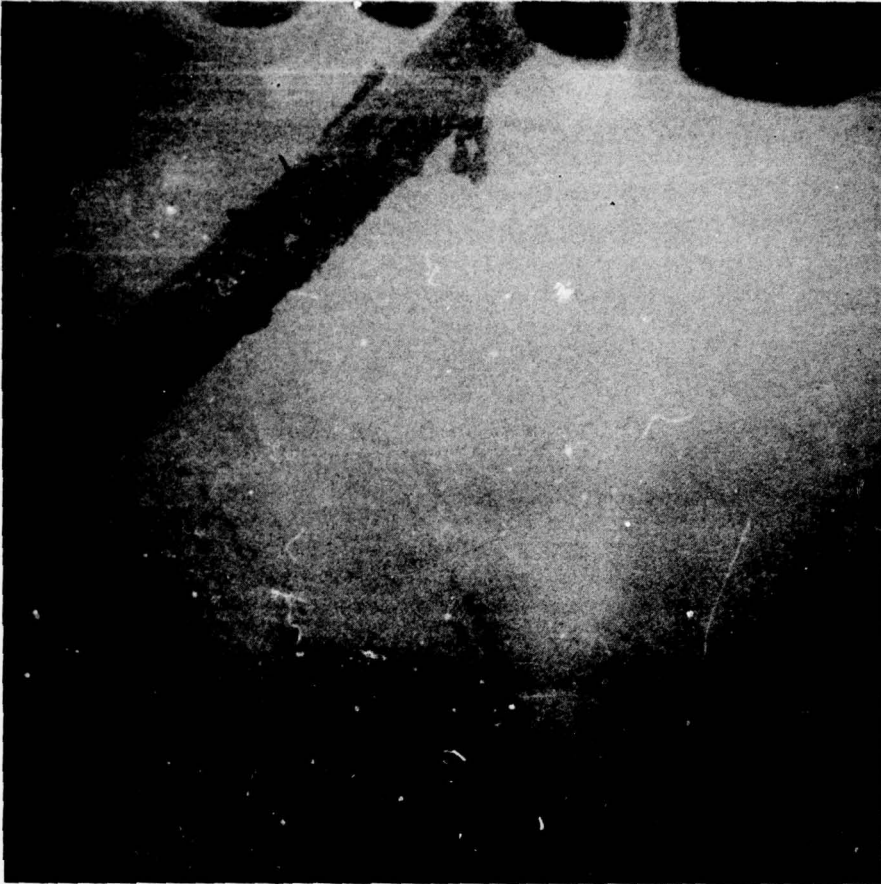
Wreckage found under starboard side of SARATOGA, aft of frame
77. ABCR 6009-2. END.

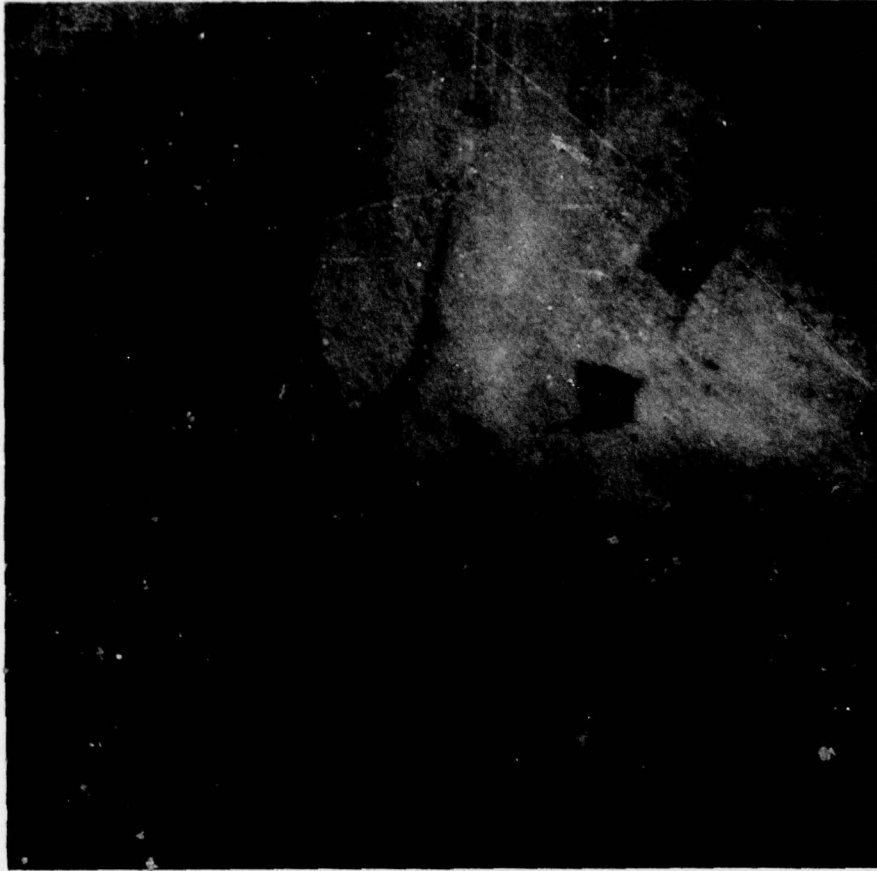
#1 stern tube showing crack. ABCR Photo No. 6028-1.

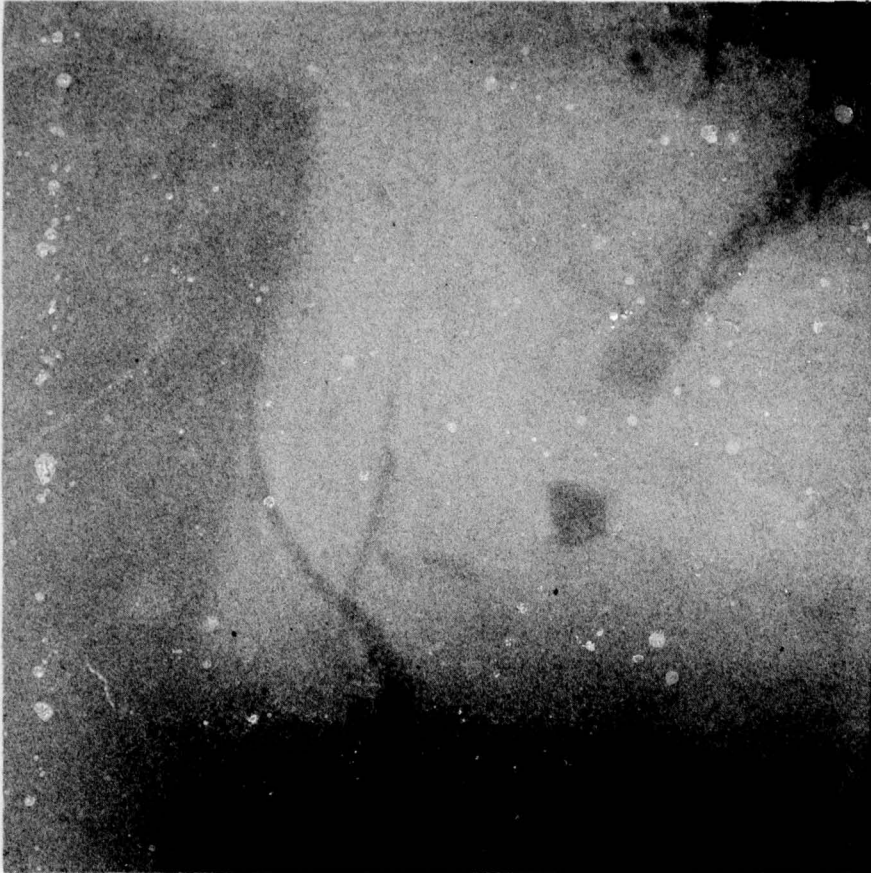
#1 stern tube showing crack. ABCR Photo No. 6028-2.

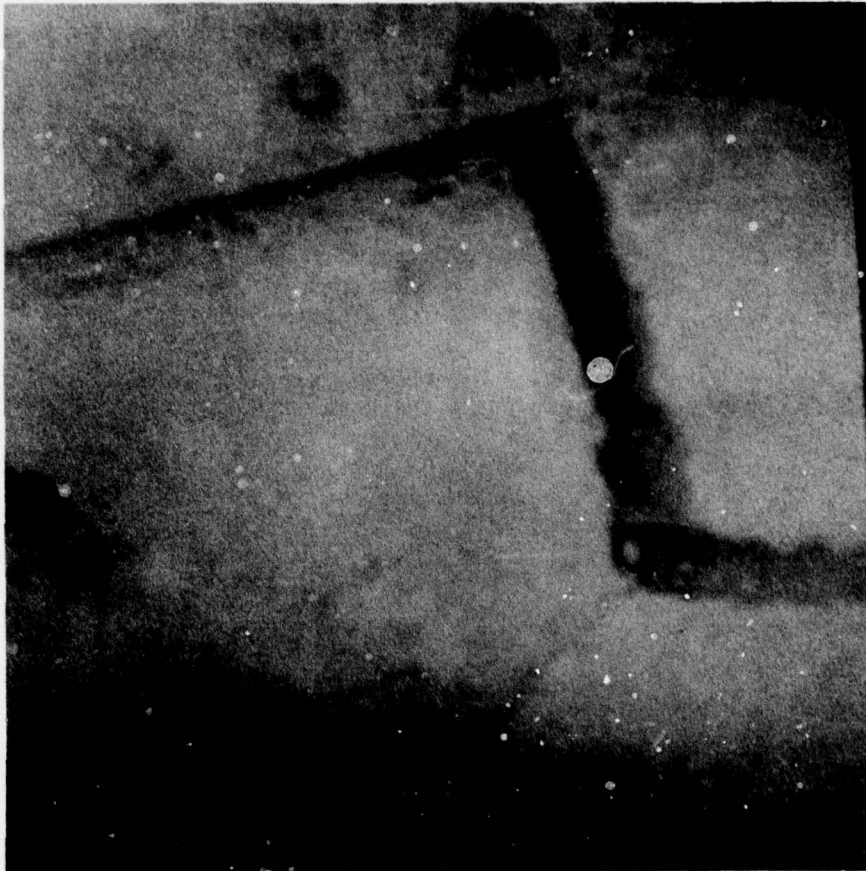
#1 stern tube showing end of crack. ABCR Photo No. 6028-3.
END.

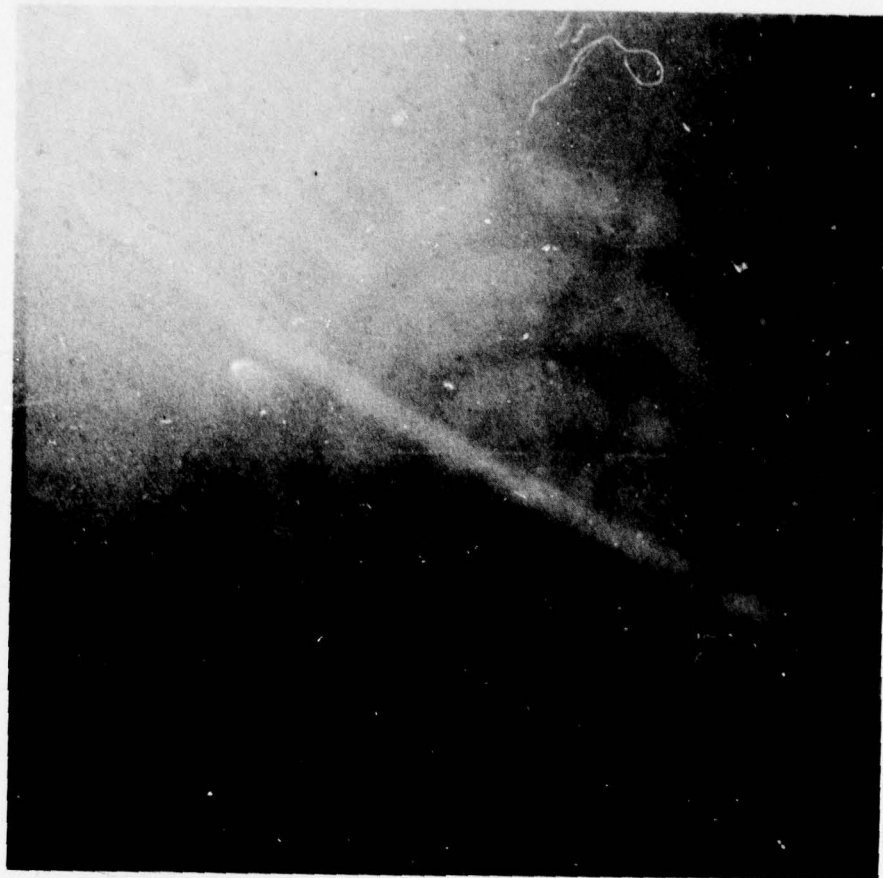
View of bent and ruptured blister looking aft, about frame
128. ABCR Photo No. 6022-7. END.

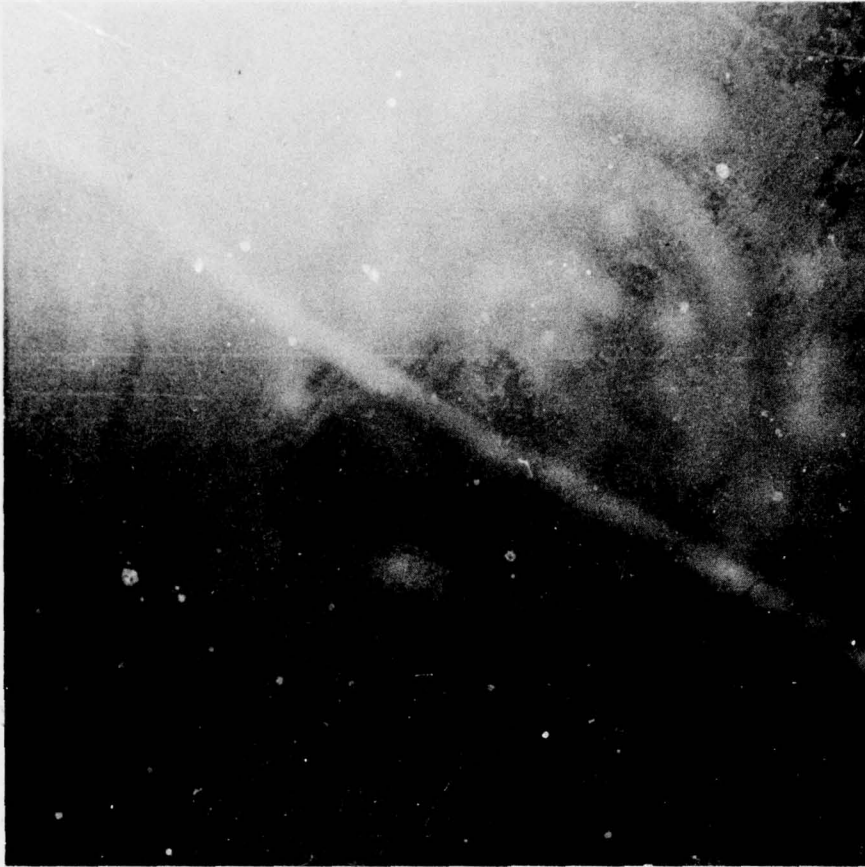
Blister broken loose from hull, looking forward about frame
122. ABCR 6022-2.

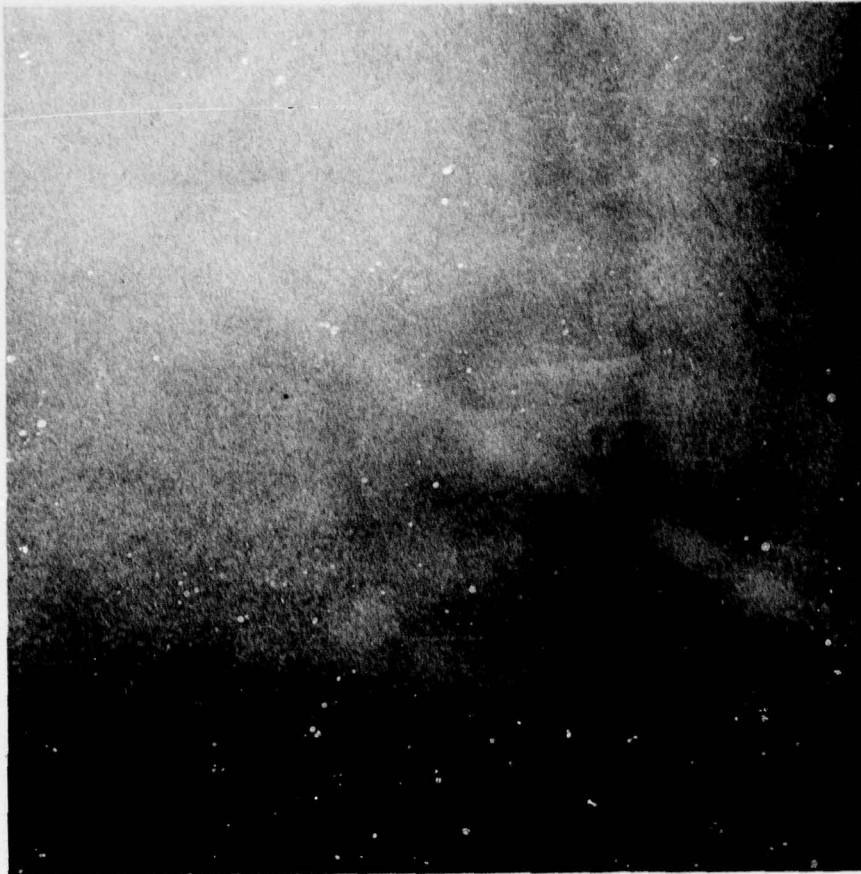
Broken blister looking forward about frame 114. ABCR Photo No. 6022-5.

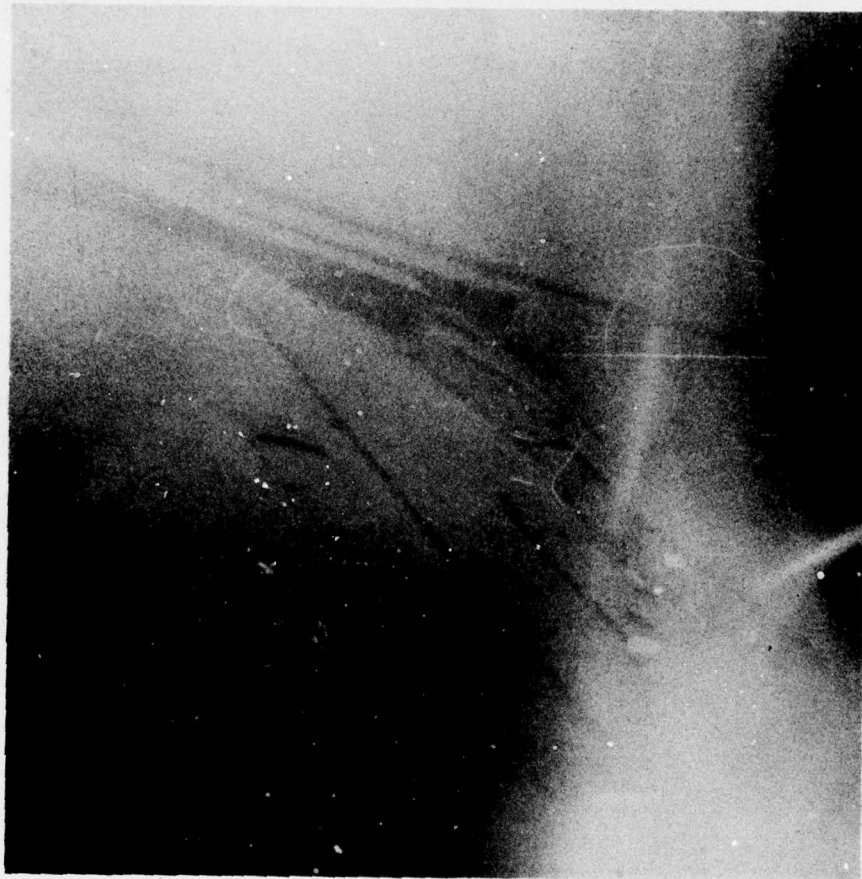
View of broken flight deck, port side looking forward, about
frame 136. ABCR Photo No. 6030-7.

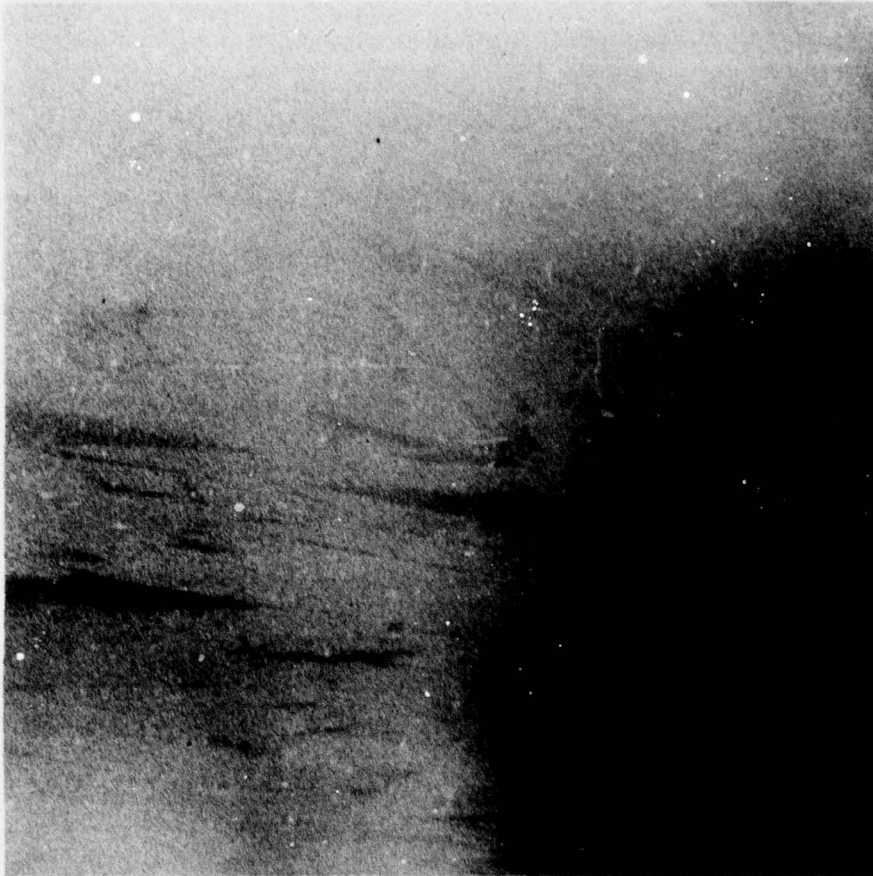
View of broken flight deck, port side looking forward, about
frame 140. ABCR Photo No. 6030-8.

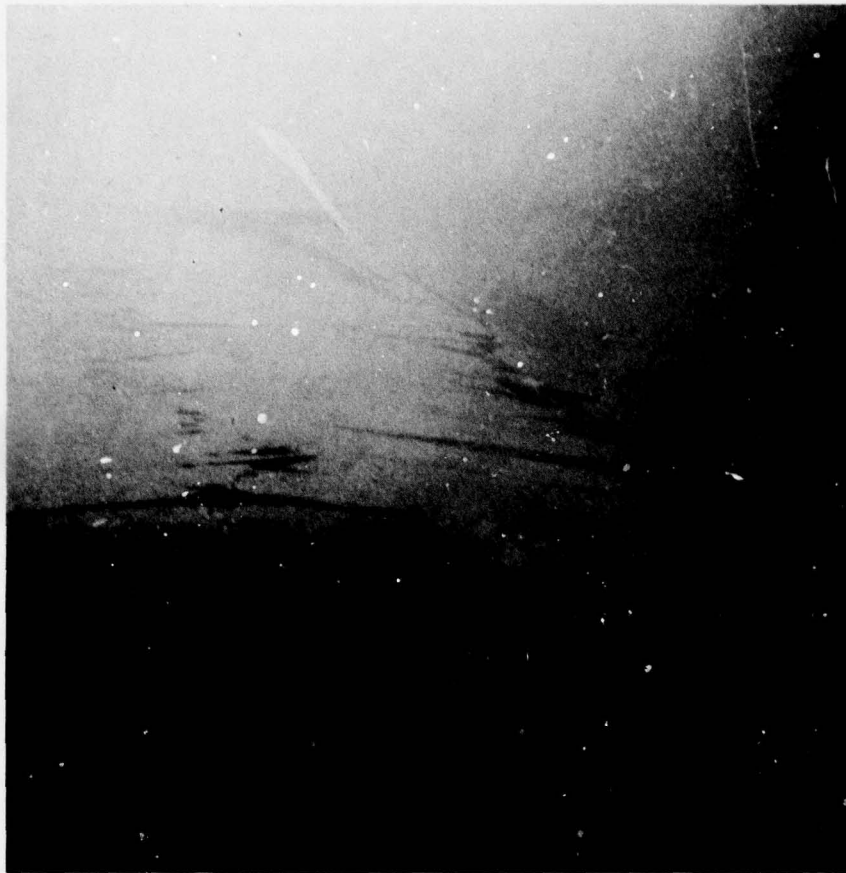
View of broken flight deck, port side looking forward, about frame 144. ABCR Photo No. 6030-9.

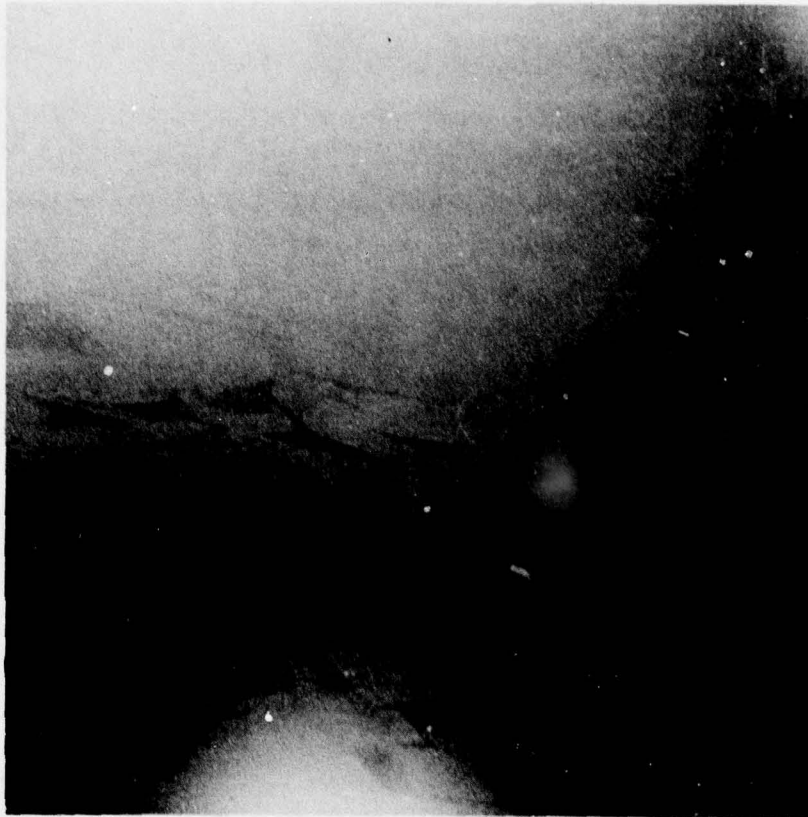
View of broken flight deck, port side looking forward, about
frame 150. ABCR Photo No. 6030-10.

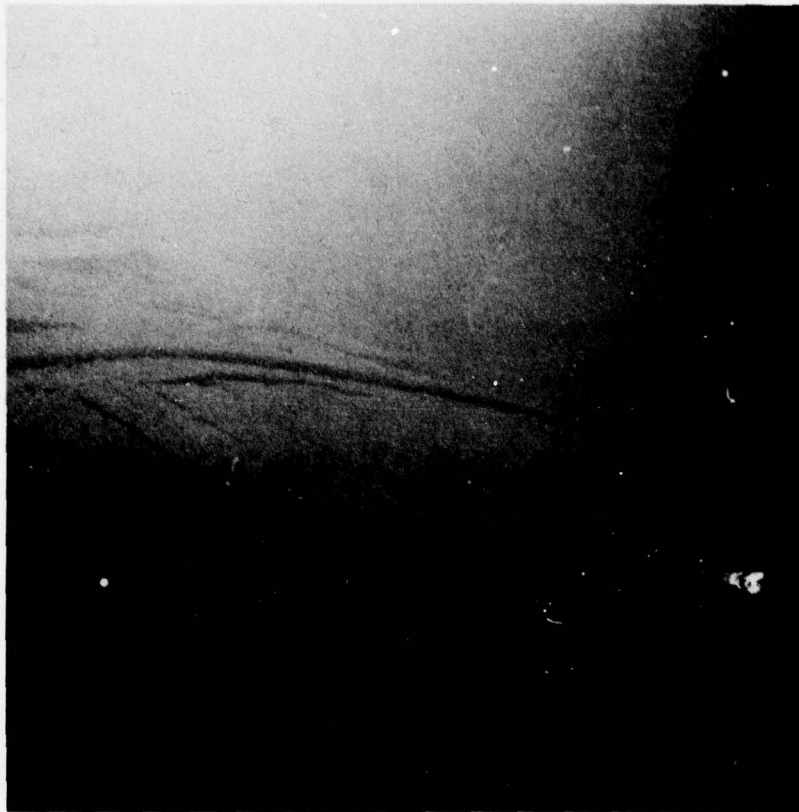
View of broken flight deck, port side looking diagonally forward, about frame 150. ABCR Photo No. 6030-11.

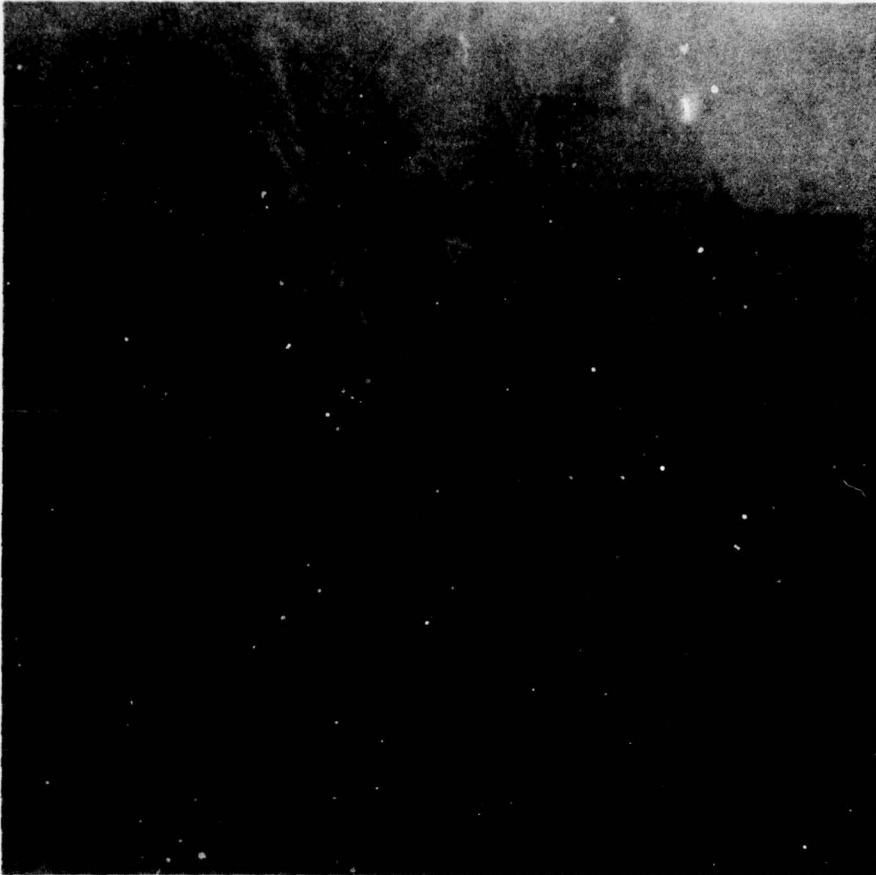
#4 of a series of photographs of crack in side of ship, about frame 192 starboard side below flight deck in way of break in flight deck. ABCR Photo No. 6029-5.

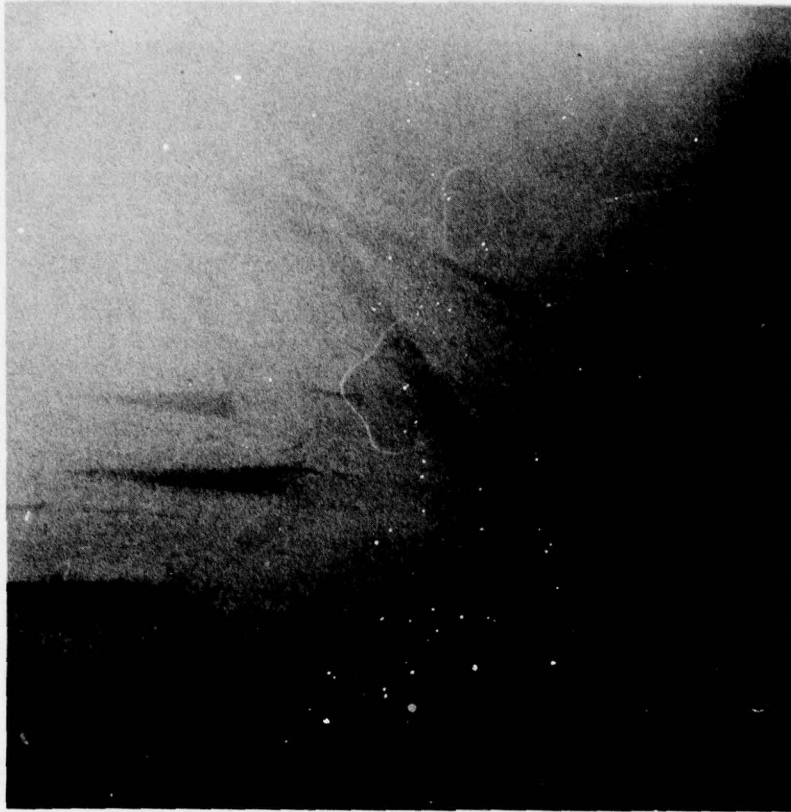
View of broken flight deck, port side looking forward, about
frame 128. ABCR Photo No. 6030-3.

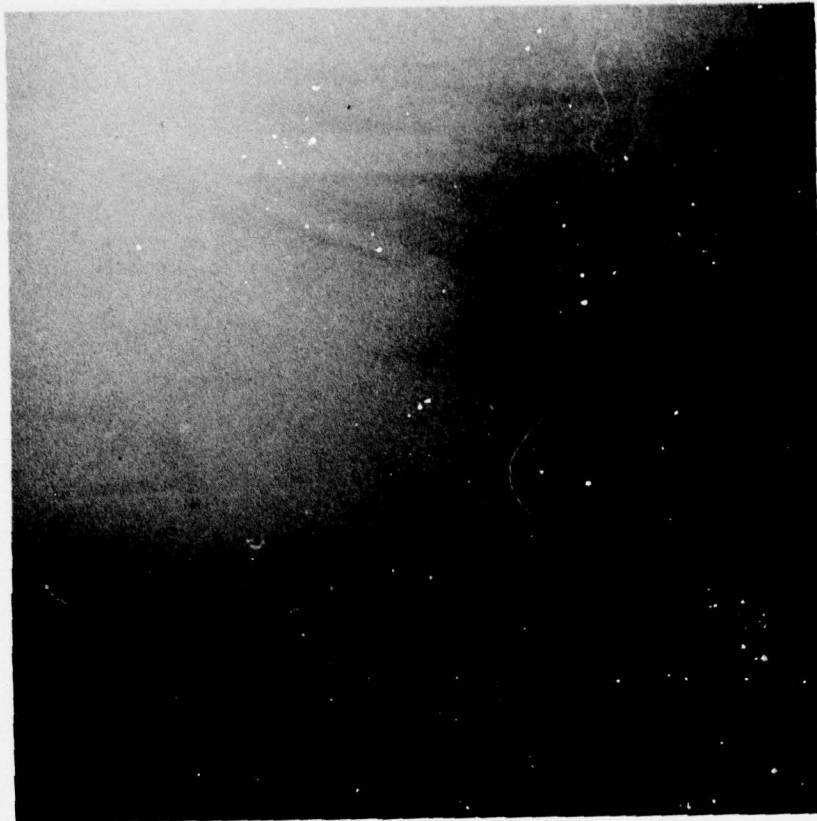
View of broken flight deck, port side looking forward, about
frame 130. ABCR Photo No. 6030-4.

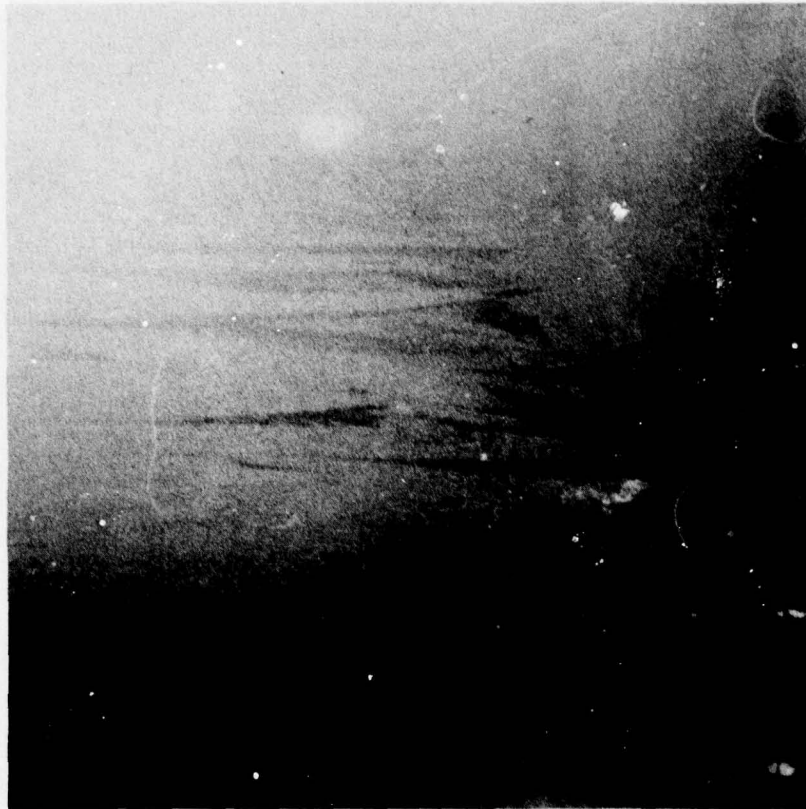
View of broken flight deck, port side looking forward, about
frame 132. ABCR Photo No. 6030-5.

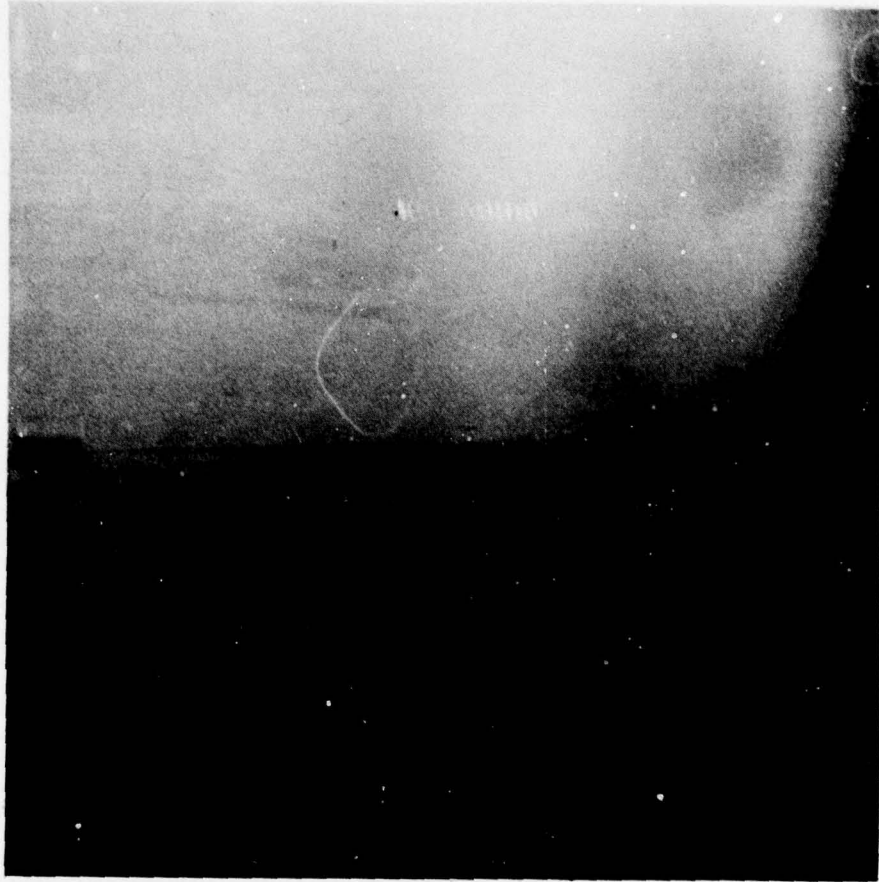
View of broken flight deck, port side looking forward, about
frame 136. ABCR Photo No. 6030-6.

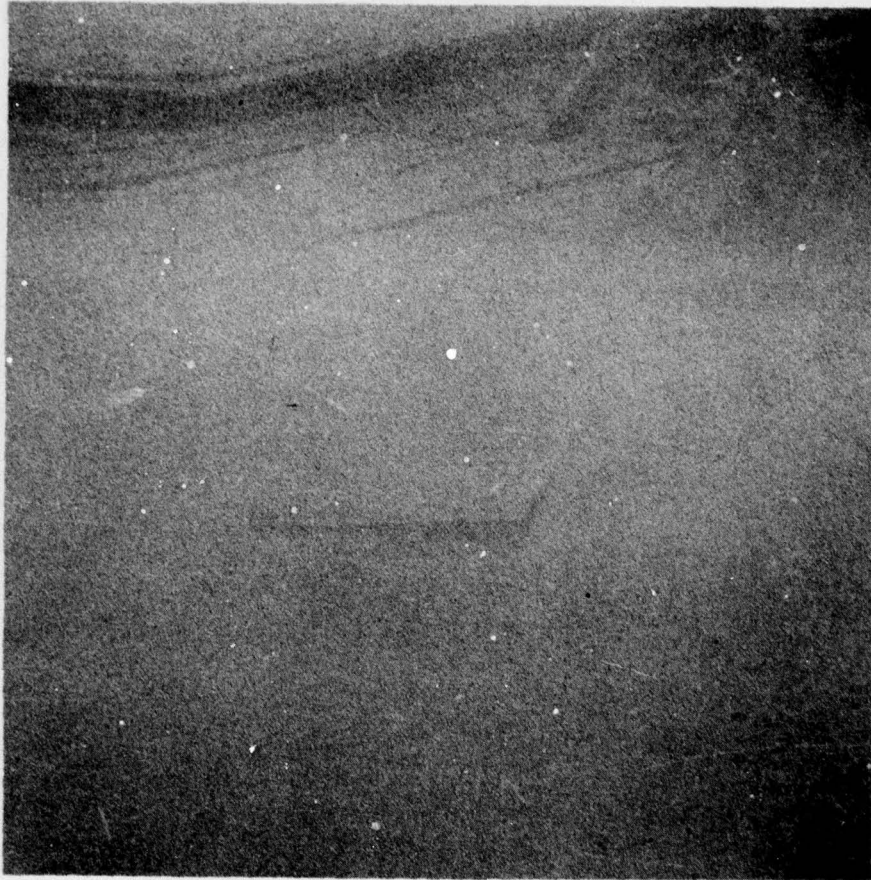
#2 of a series of photographs of damaged flight deck near centerline about frame 180. ABCR Photo No. 6027-5.

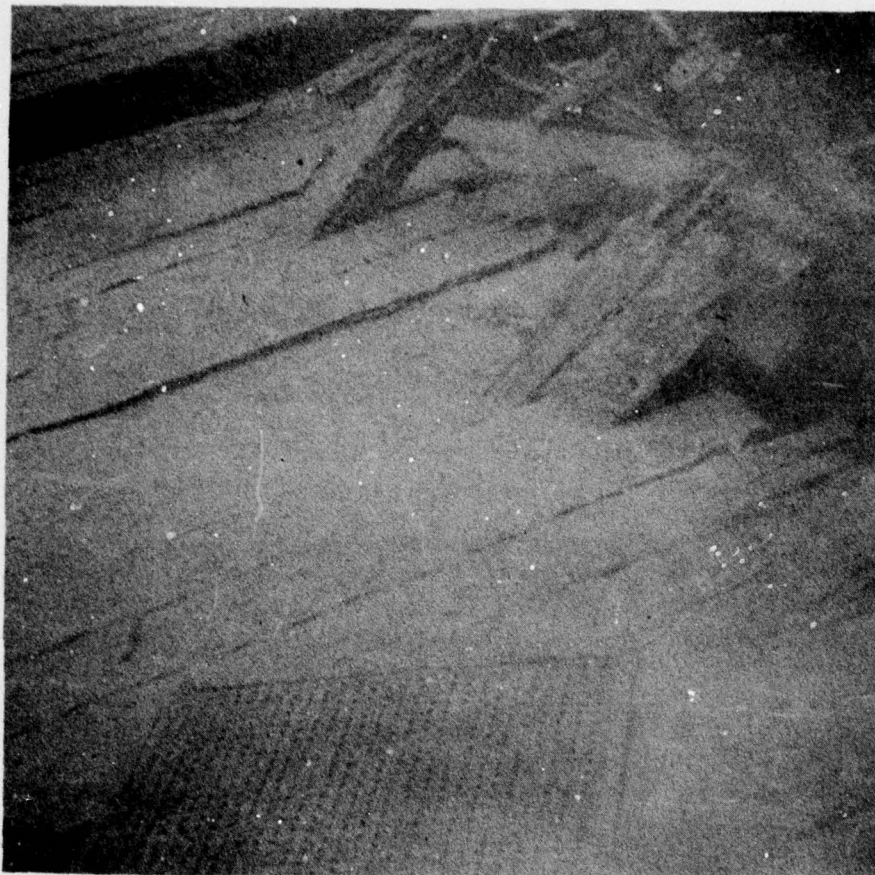
#3 of a series of photographs of damaged flight deck near centerline about frame 178. ABCR Photo No. 6027-6.

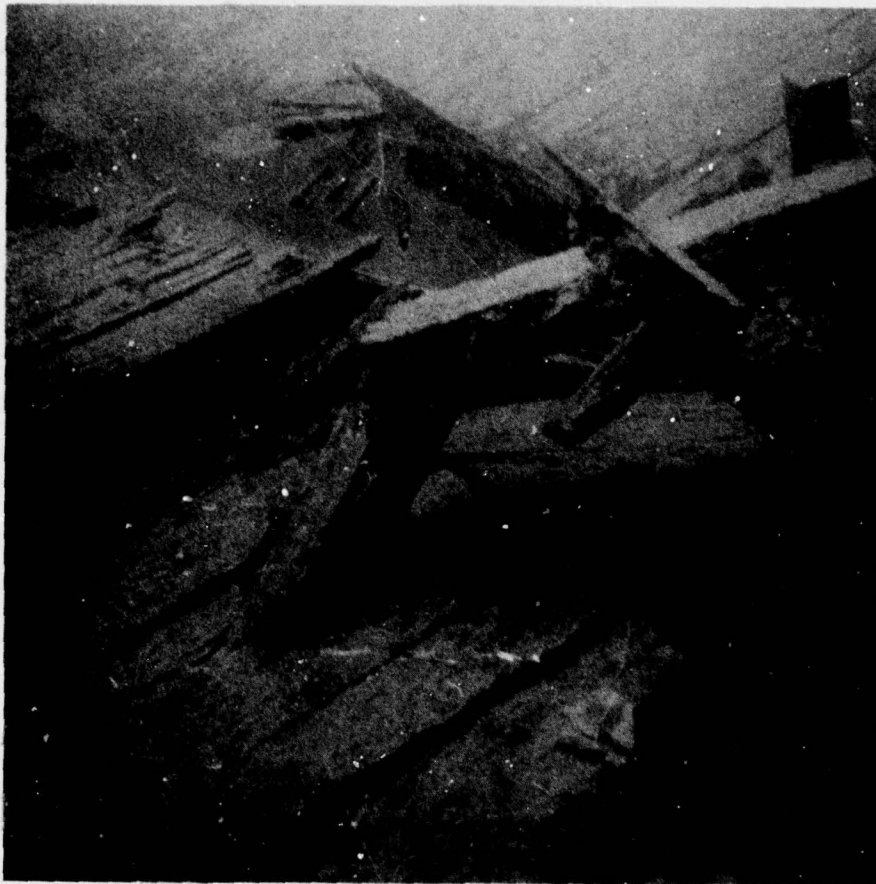
#4 of a series of photographs of damaged flight deck near centerline about frame 177. ABCR Photo No. 6027-7.

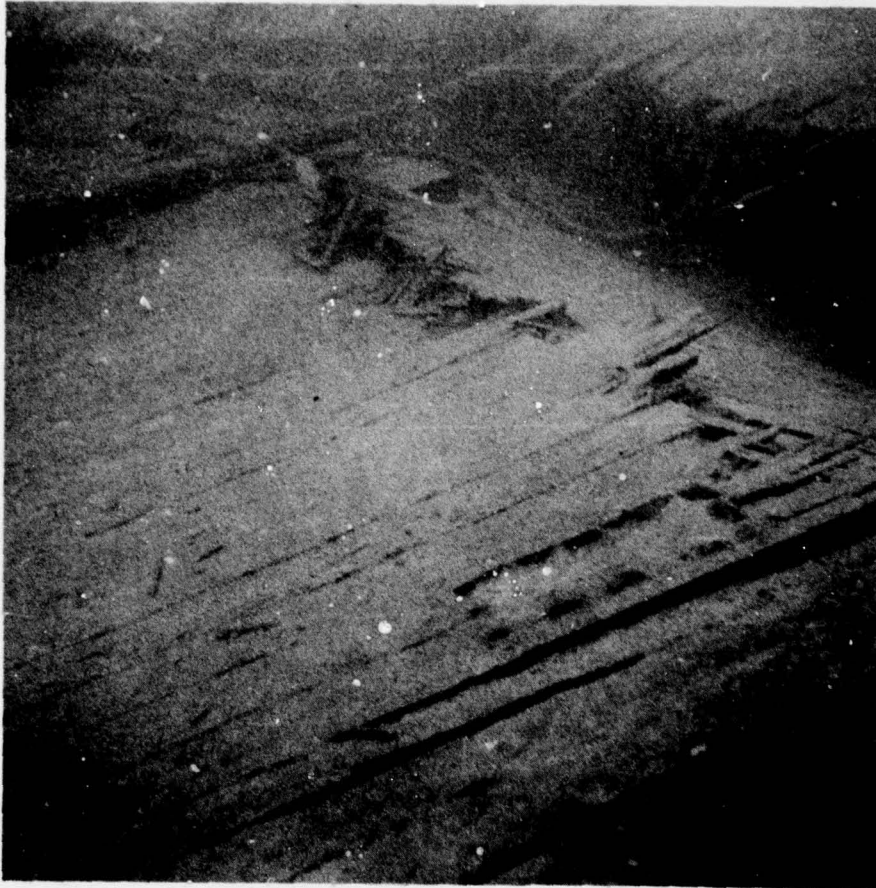
#5 of a series of photographs of damaged flight deck near centerline about frame 176. ABCR Photo No. 6027-3.

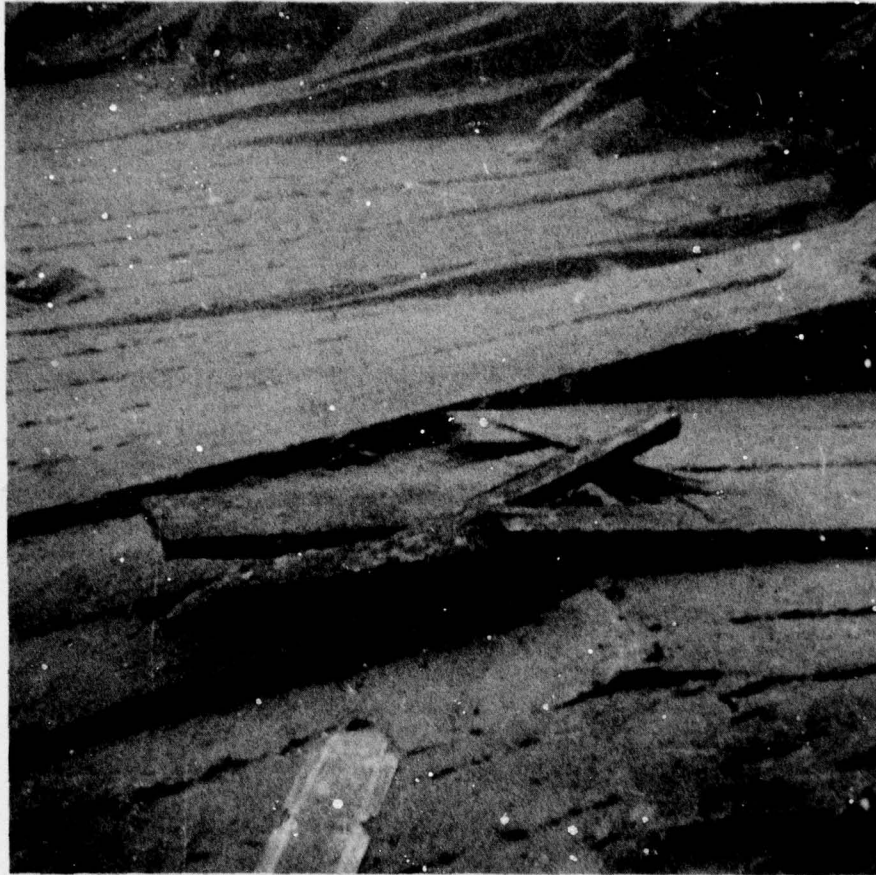
#8 of a series of photographs of damaged flight deck near centerline about frame 168. ABCR Photo No. 6027-11.

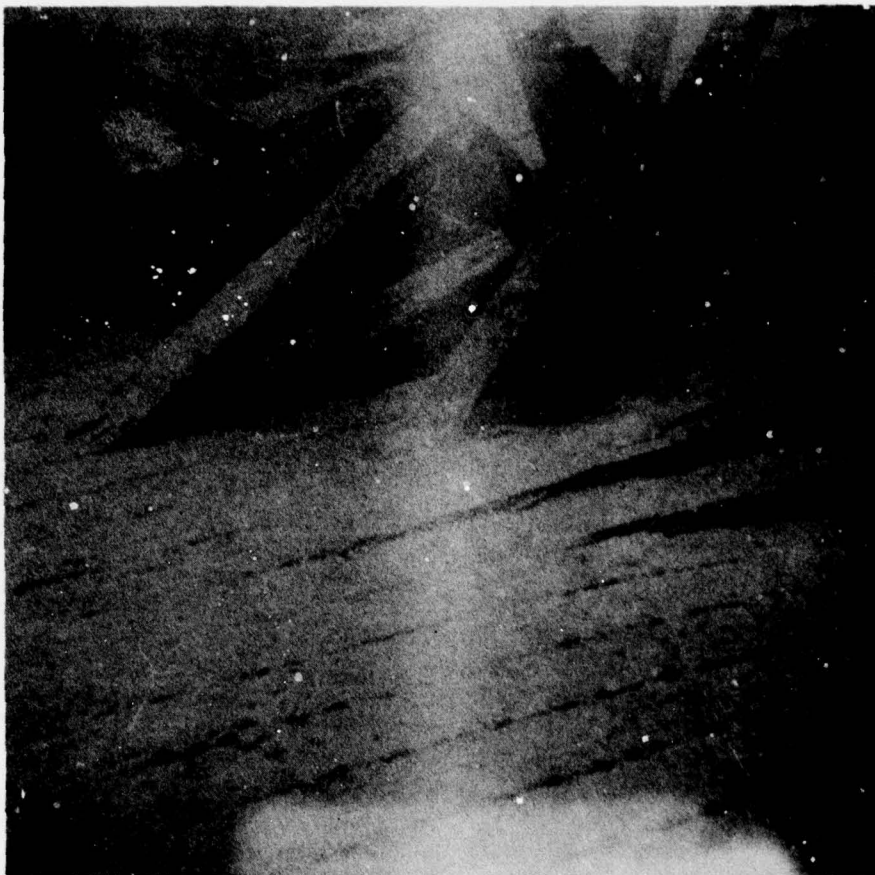
#9 of a series of photographs of damaged flight deck near centerline about frame 165. ABCR Photo No. 6027-12.

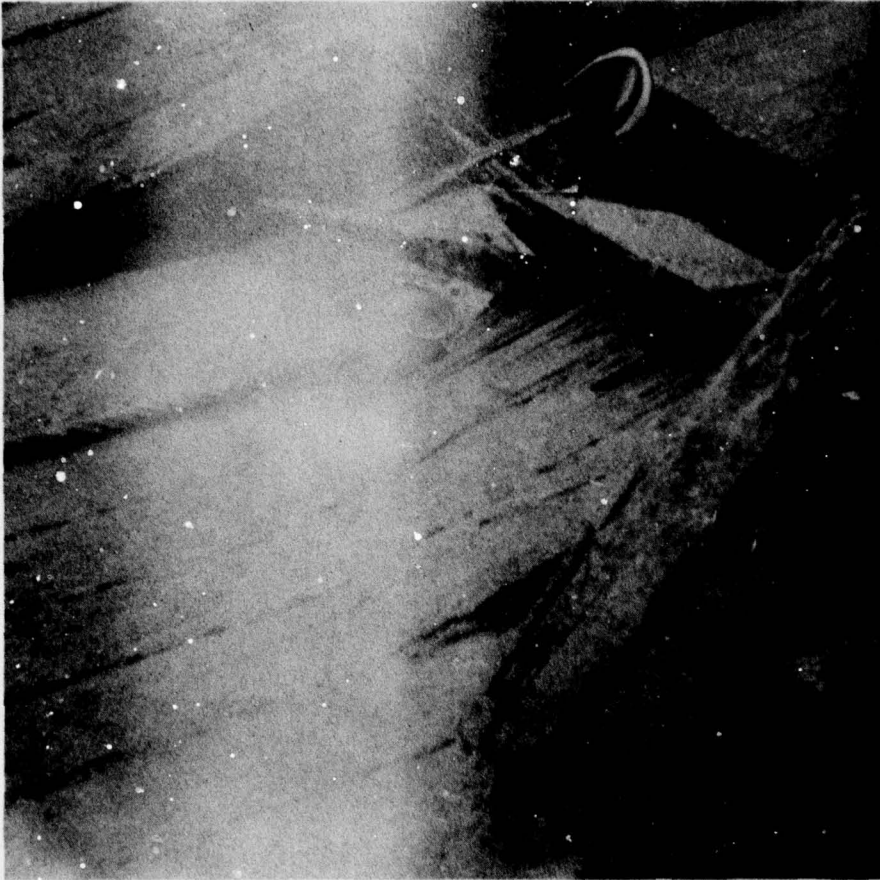
#10 of a series of photographs of damaged flight deck near centerline about frame 162. ABCR Photo No. 6027-13.

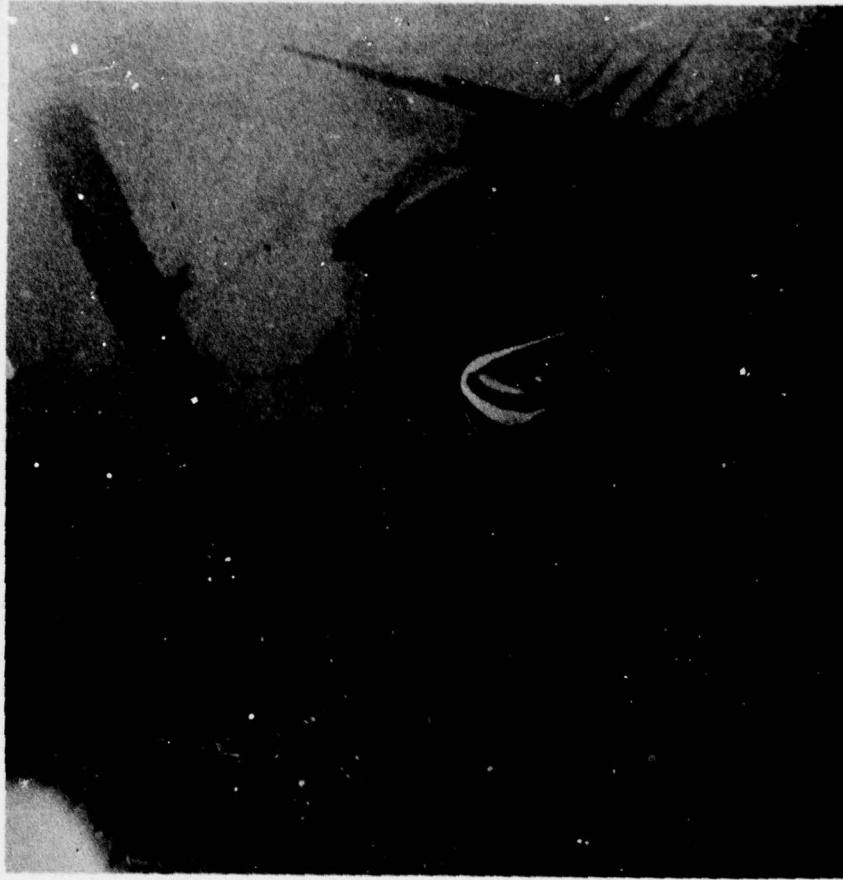
#11 of a series of photographs of damaged flight deck near centerline about frame 160. ABCR Photo No. 6027-14. END.
