AD-A077 492

DEFENSE ATOMIC SUPPORT AGENCY WASHING N DC
BIKINI SCIENTIFIC RESURVEY. VOLUME II
DEC 47

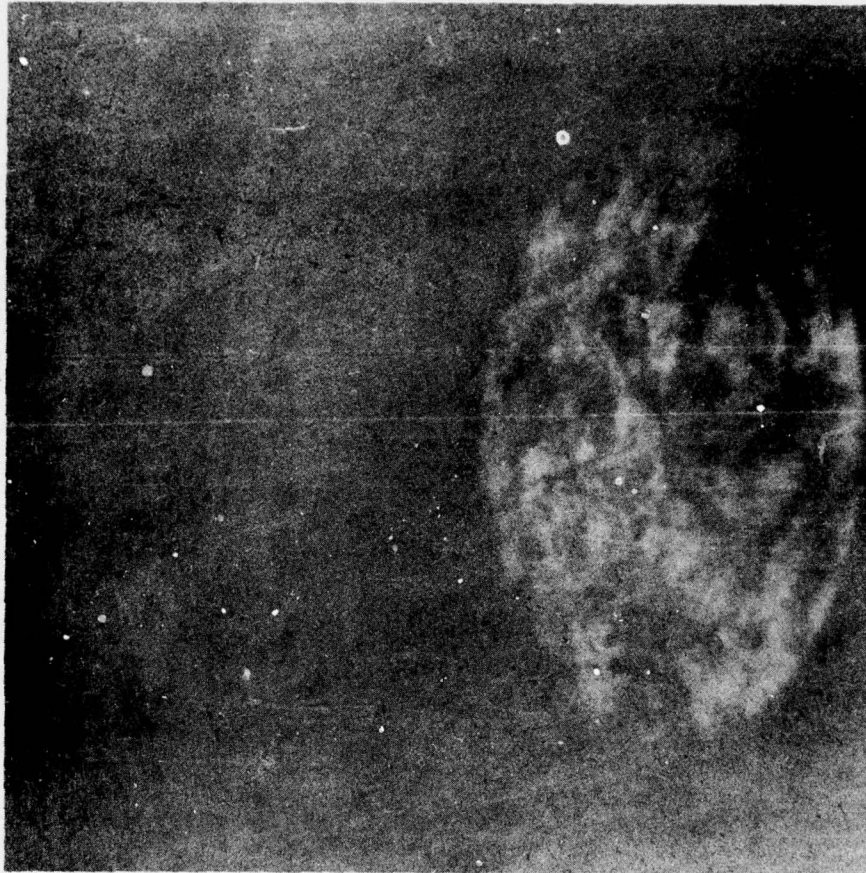
#1 of a series of photographs of crack in side of ship, about frame 192 starboard side below flight deck in way of break in flight deck. ABCR Photo No. 6029-2.

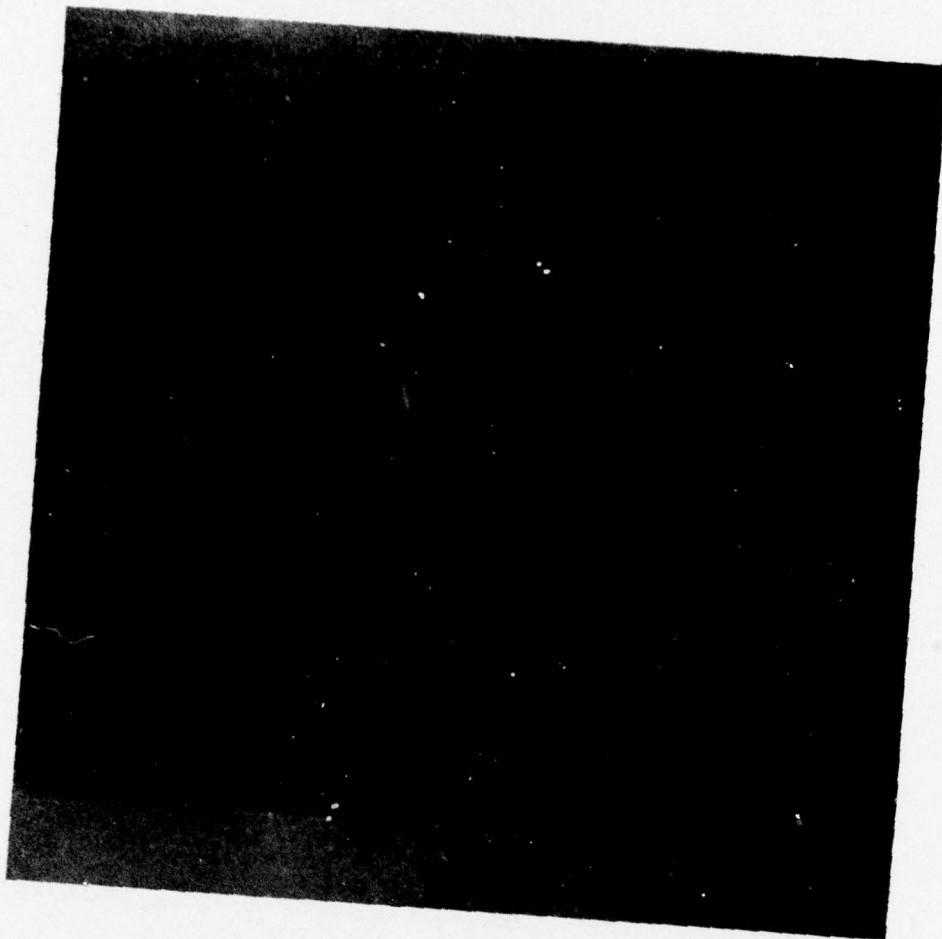
#3 of a series of photographs of crack in side of ship, about
frame starboard below flight deck in way of break in flight
deck. ABCR Photo No. 6029-3.

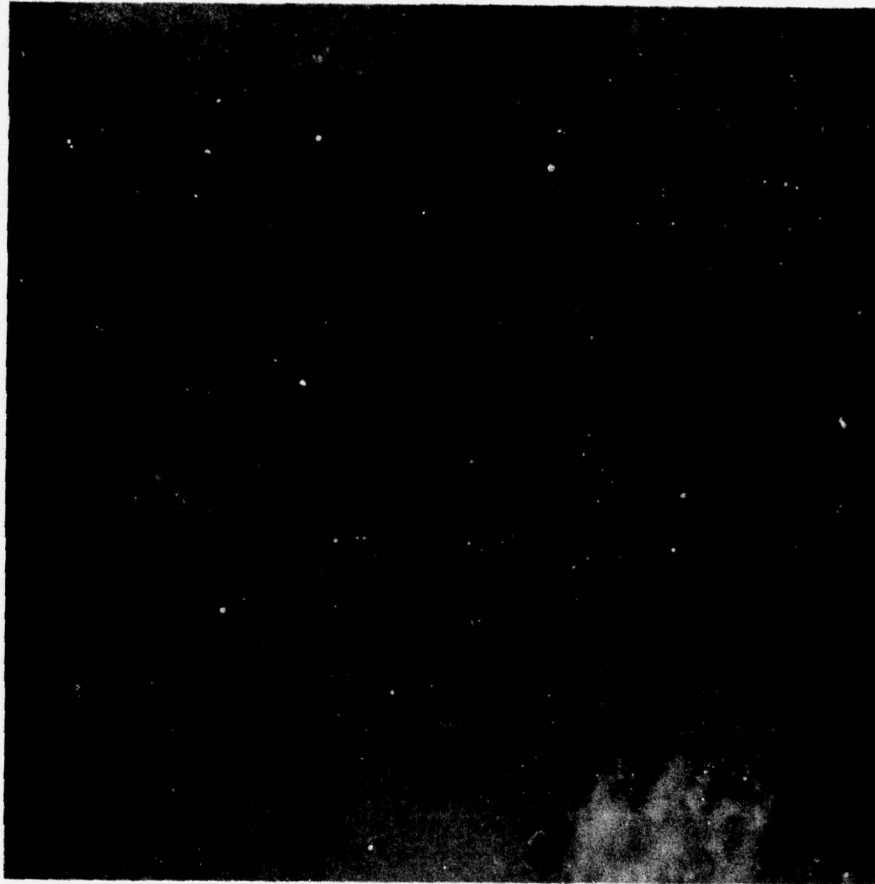
#3 of a series of photographs of crack in side of ship, about frame 192 starboard side below flight deck in way of break in flight deck. ABCR Photo No. 6029-4.
