Name of Dam: South River No. 23
Location: Augusta County, State of Virginia
Inventory Number: VA 01508

PHASE I INSPECTION REPORT
NATIONAL DAM SAFETY PROGRAM

PREPARED BY
MICHAEL BAKER, JR., INC.
BEAVER, PENNSYLVANIA 15009

SEPTEMBER 1979 79 11 30 045

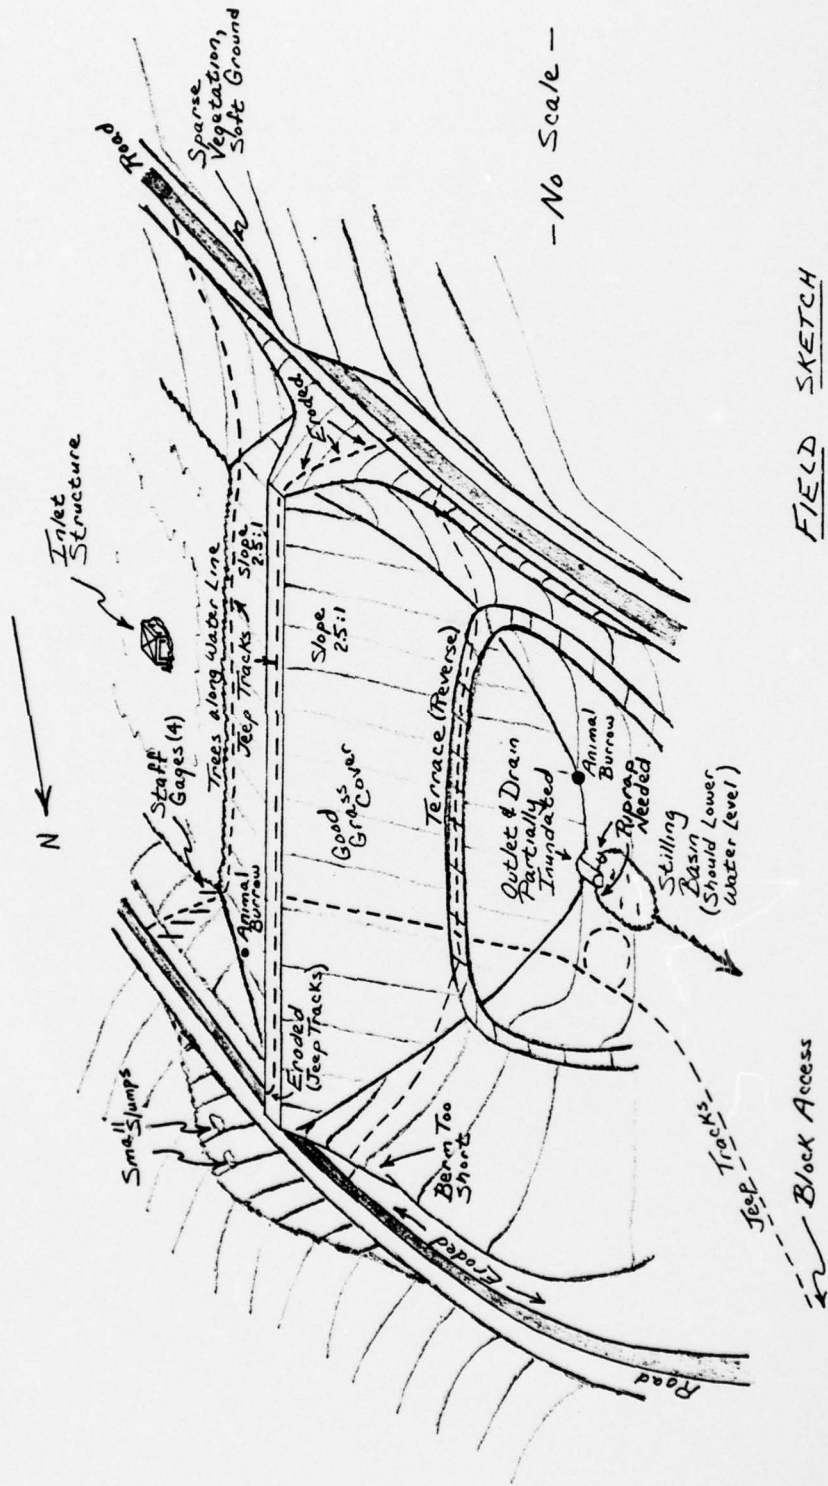
FIELD SKETCH
 SOUTH RIVER #23, VIRGINIA
 PLATE 1

Plate 1 is a Field Sketch of the facility which depicts the conditions observed during the visual inspection. The complete visual inspection check list is included in Appendix III. Following are summaries of the deficiencies noted during the inspection.

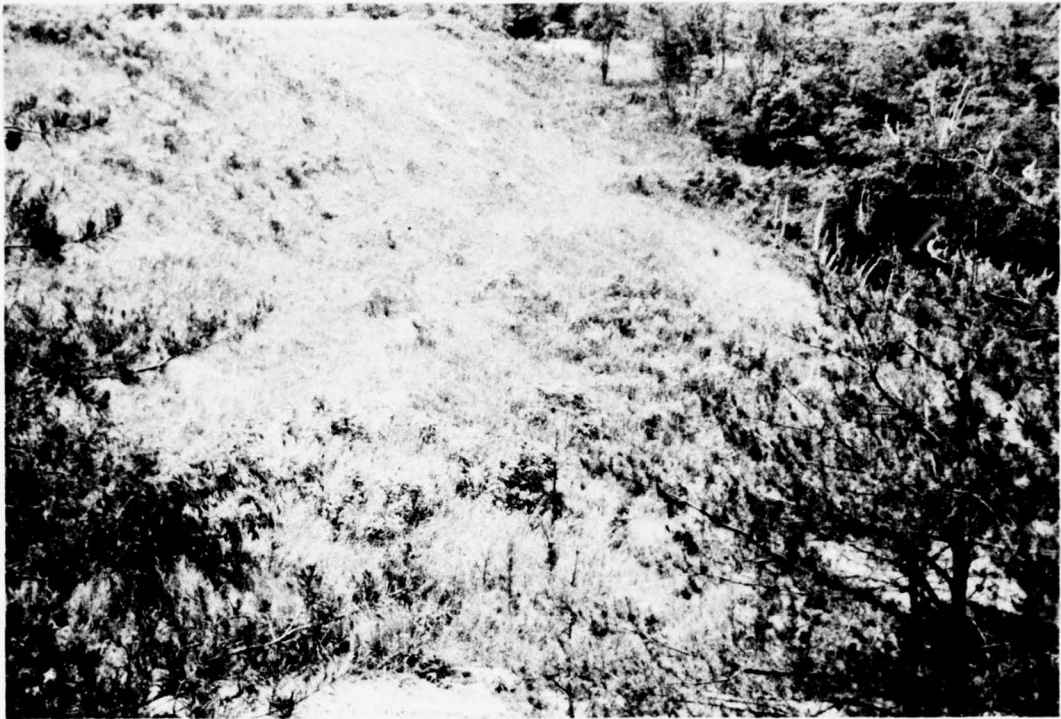
PHOTO 1. View of Downstream Embankment from Right Side of Dam

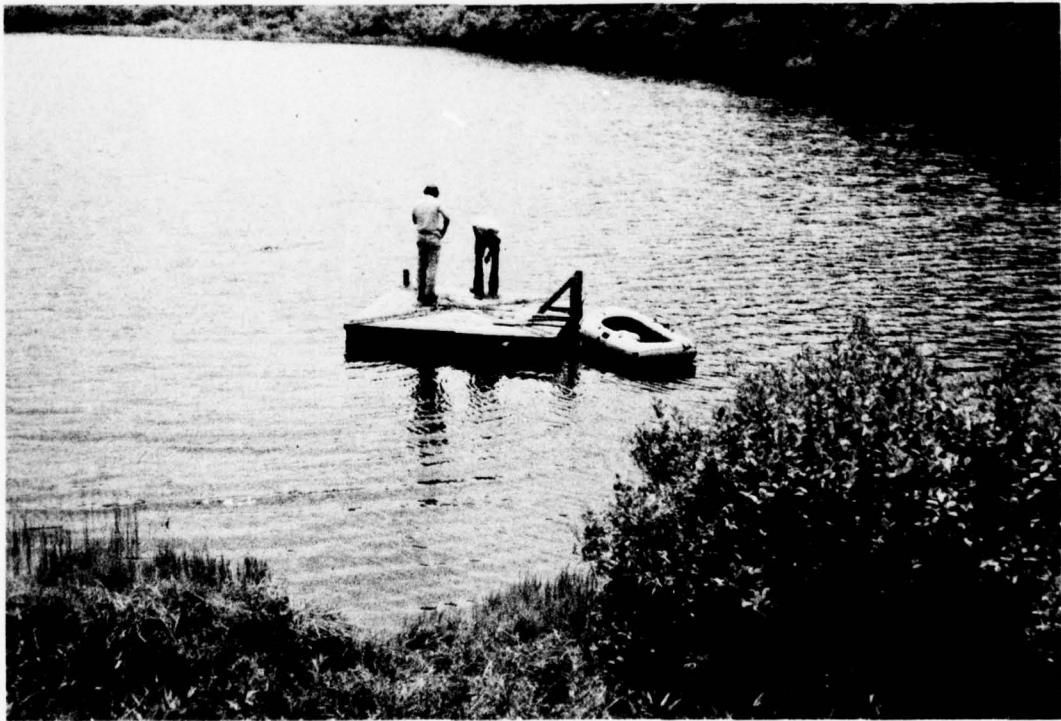
PHOTO 2. Riser Structure Looking Upstream

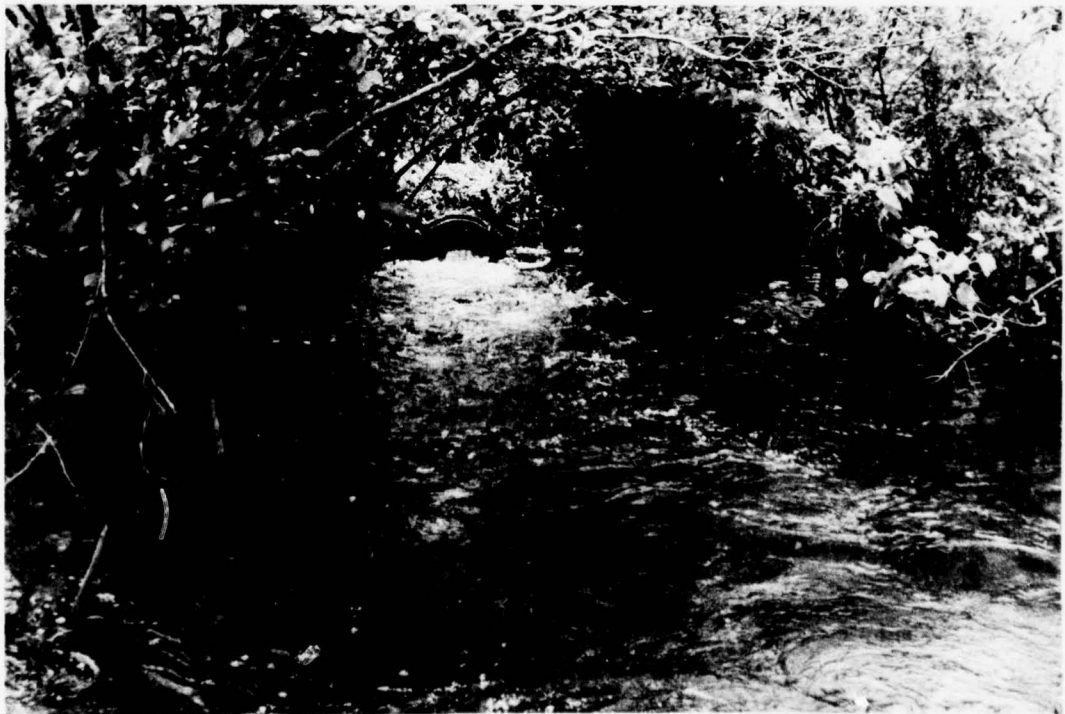
The discharge channel immediately surrounding the principal spillway outlet is badly overgrown (see Photos 4 and 8). The water level in the stilling basin is too high and 50 percent of the principal spillway outlet is inundated. A drain pipe, situated approximately 2 feet left of the main outlet, is also inundated by approximately 0.2 foot. Riprap around the outlet pipes is insufficient.

PHOTO 4. Principal Spillway Outlet, Overgrowth, and Stilling Basin

- 7.2 Recommended Remedial Measures: The following repair items should be completed as part of the general yearly maintenance of the dam.
- 1) Investigate the need of extending the berm separating the right emergency spillway discharge channel from the downstream embankment.
 - 2) Restrict jeep traffic from the embankment to prevent further erosion. Repair and seed eroded areas.
 - 3) Seed the poorly vegetated areas on the upstream embankment slope.
 - 4) Regrade small slumps in the hillside of the right emergency spillway and seed this area and the sparsely vegetated areas in the left emergency spillway.

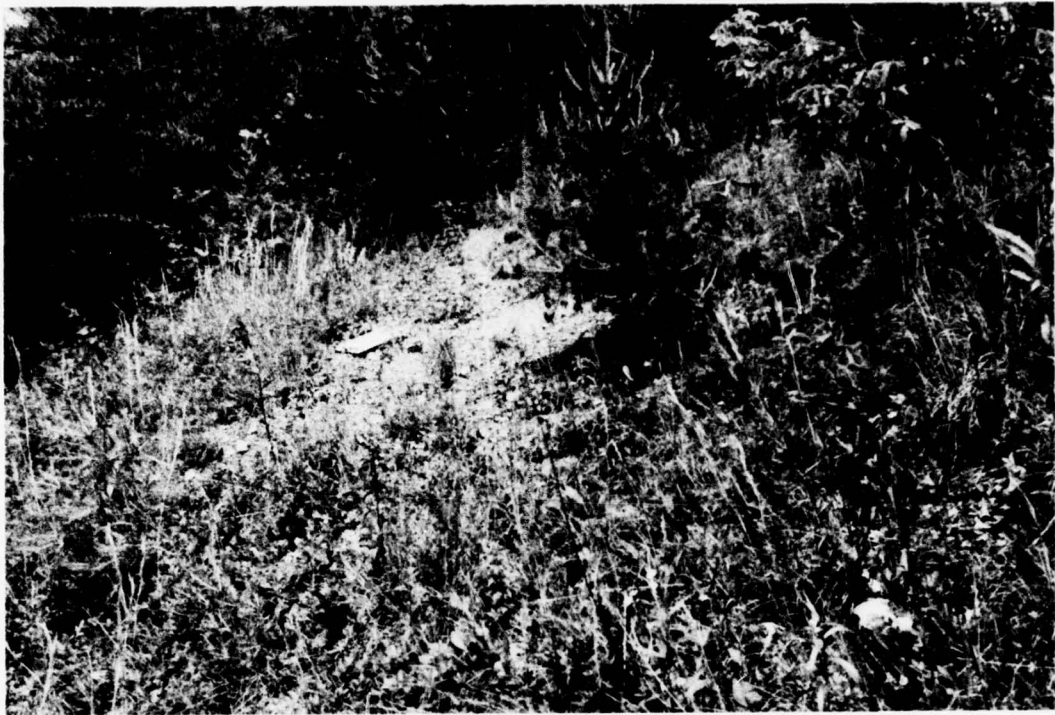
3.1.3 Appurtenant Structures: Minor slumps are present in the right emergency spillway hillside cut (see Photo 7). The discharge channel of the right emergency spillway is badly eroded (see Photo 6) and the berm separating the discharge channel from the abutment appears to be insufficient in length.

PHOTO 7. Small Slumps in Hillside Cut of Right Emergency Spillway
