NRL Memorandum Report 4123

# Mechanical Properties of Wrought Iron from Hull Plate of USS MONITOR

C. D. BEACHEM, D. A. MEYN, AND R. A. BAYLES

November 20, 1979

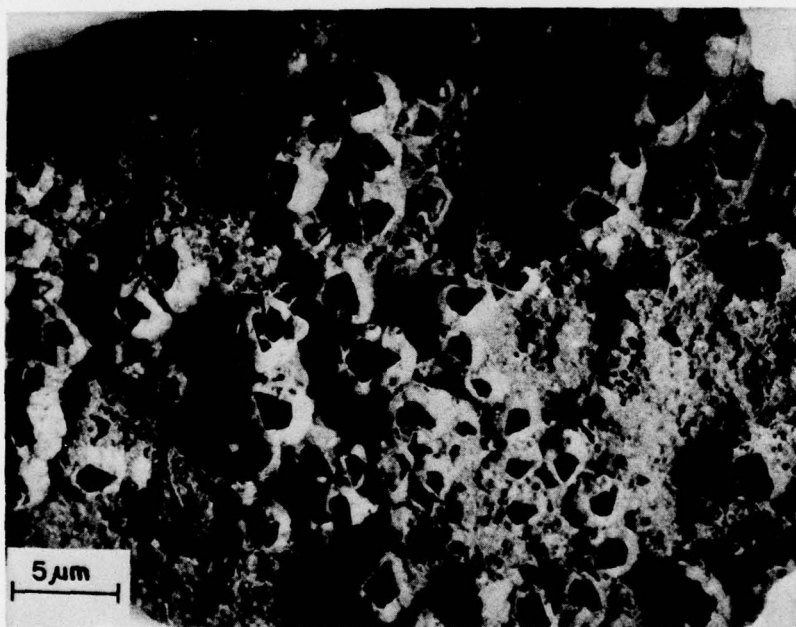
Prior to studying the metal which comprises much of the samples, a piece of the rust and accretion which covered the metal was examined. The primary constituents of the piece were rust, barnacle-like encrustations, a black, waxy material, and silicate particles. The latter are usual constituents of wrought iron. Figure 1 shows the rust piece which is typical of the coating of the plate. Figure 2 shows the layers of rust, wax, and barnacles. Figure 3 shows a two phase silicate particle embedded in the rust.

Fig. 1 — Piece of rust and accretion typical of that observed on surface of samples

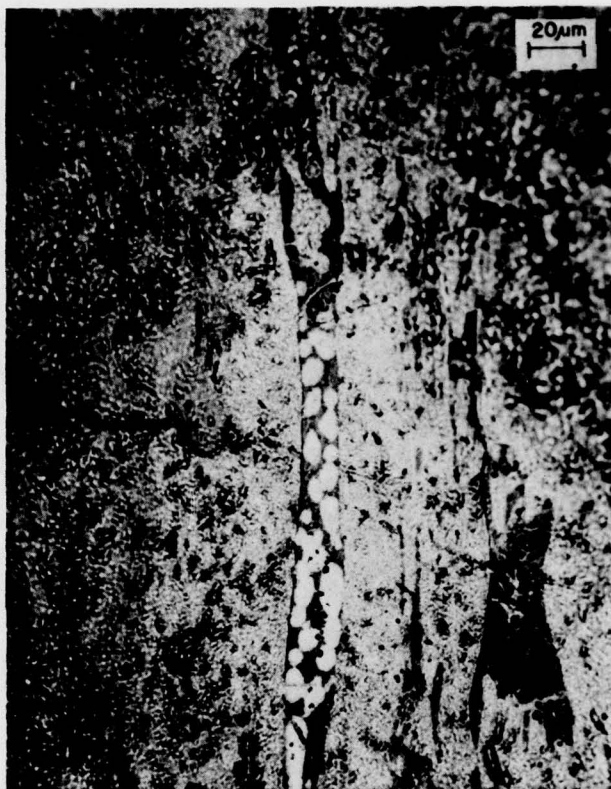
Fig. 3 — Optical micrograph showing two phase silicate particle embedded in rust

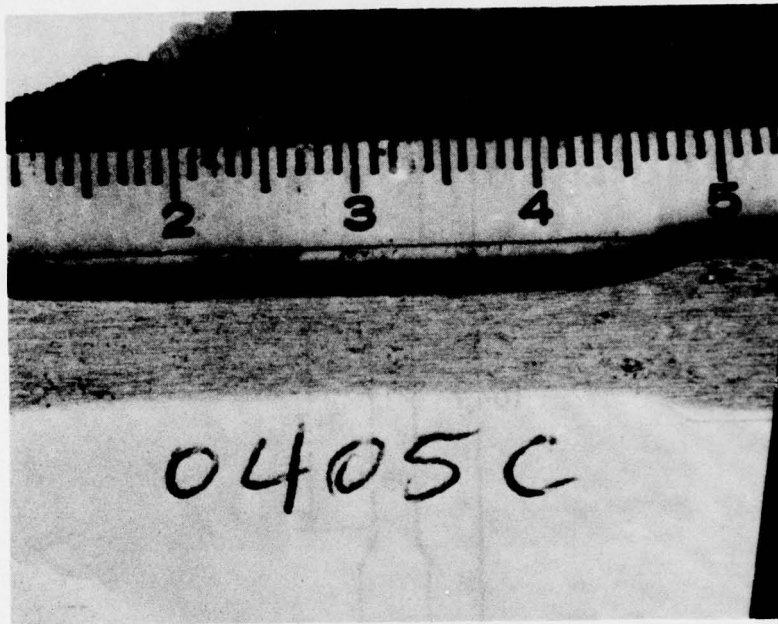
Fig. 5 — Corrosion pits remaining on surface of machined tensile test specimens

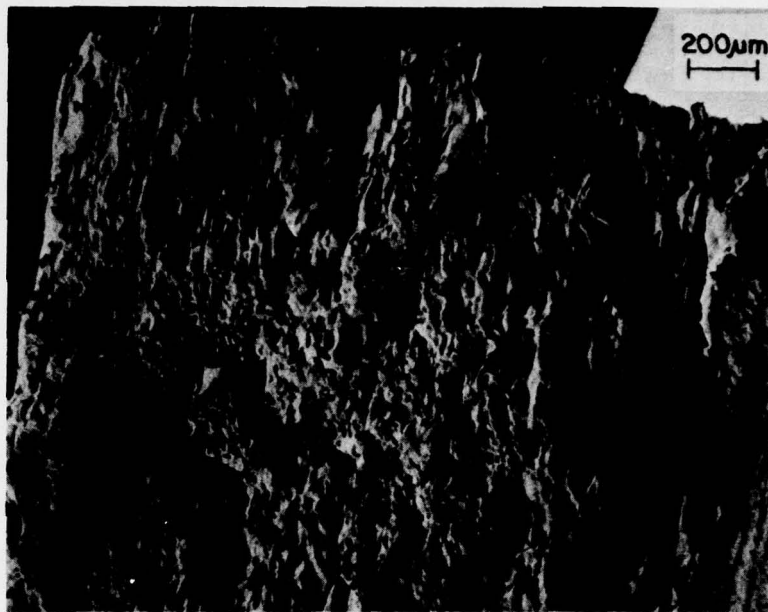
high resolution scanning electron microscope. Figure 6 shows a typical woody fracture surface and Figure 7 shows the flat delamination surface. At higher magnifications the fracture surface is composed of dimpled and flat surfaces indicating a combination of microvoid coalescence around inclusion particles, ductile tearing, and shear. The inclusion particles are silicates in the form of spheres and platelets. These silicates probably form much of the debris observed on the surface. Figures 8 and 9 are micrographs of typical fracture surfaces and Figure 10 shows an area of the delaminated surface. Two large silicate platelets lie on the delaminated fracture surface. At higher magnification, in Figure 11, is seen the two phase nature of these particular platelets. Note that the secondary crack passes straight through an embedded particle indicating good bonding at the interface between the particle and the surrounding silicate. Electron/x-ray spectrometry indicates that the small nodules are iron containing a small amount of titanium while the surrounding silicate is composed of iron, silicon, calcium, phosphorous, manganese, and small amounts of titanium, aluminum, and magnesium. The silicate particles observed on the typical fracture surfaces often show solidification structures in voids and dendritic structures as seen in Figures 12 and 13.

Fig. 6 — Woody fracture surface typical of wrought iron.  
Specimen 0405A.

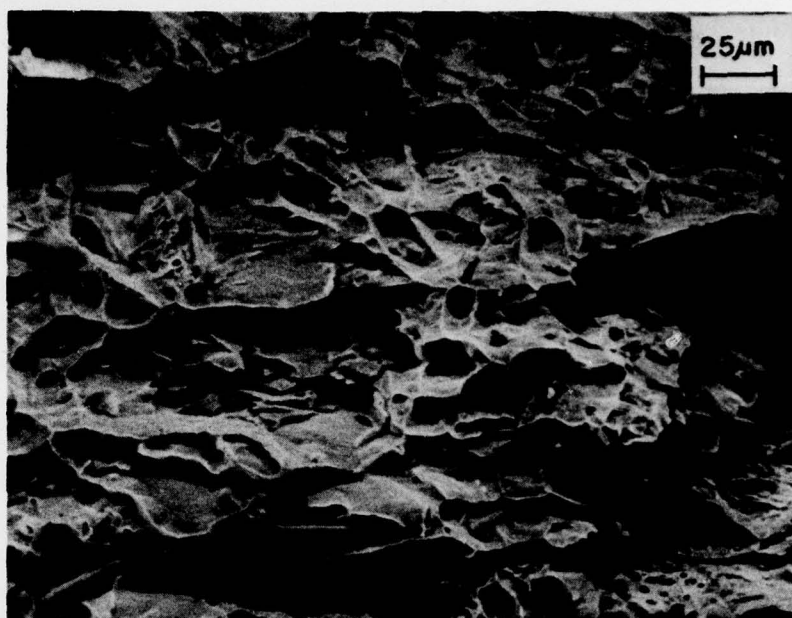
Fig. 8 — Typical fracture surface showing void formation around inclusion particles. Specimen 0405A.

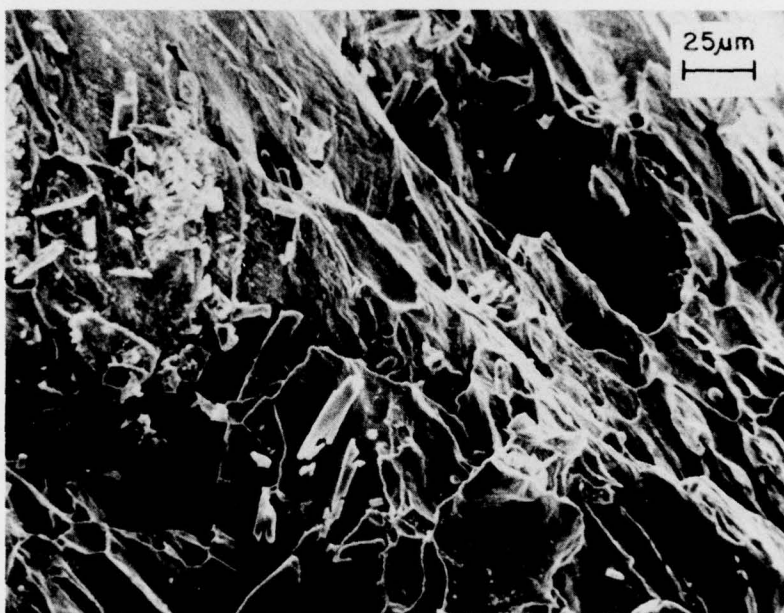
Fig. 9 — Typical fracture surface showing siliceous debris

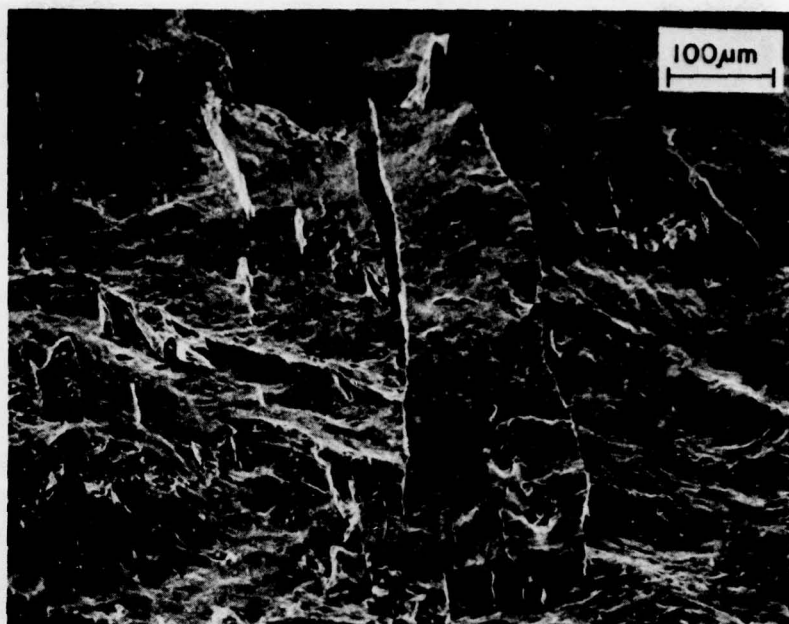
Fig. 10 — Large silicate platelets on delaminated surface.  
Specimen 0404A.

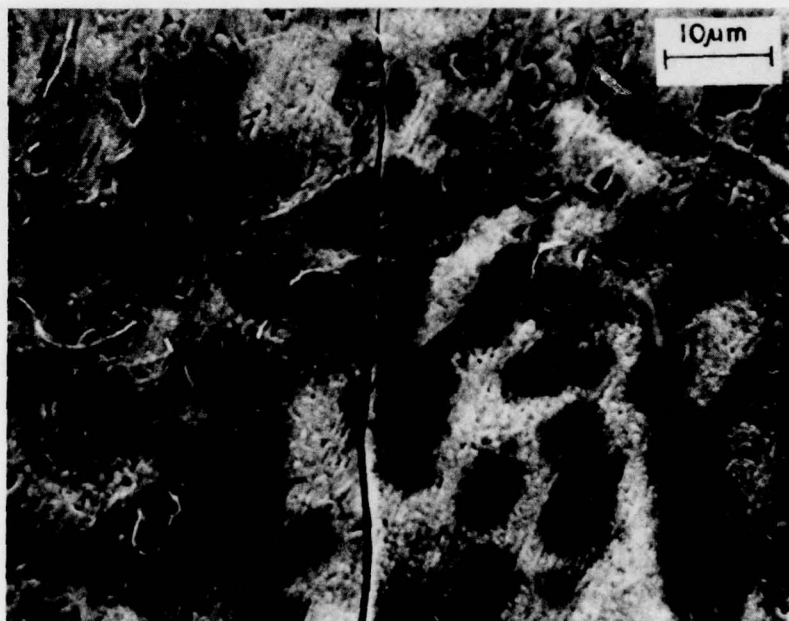
Fig. 11 — Iron particles embedded in silicate platelet on delaminated surface. Higher magnification of Figure 10.

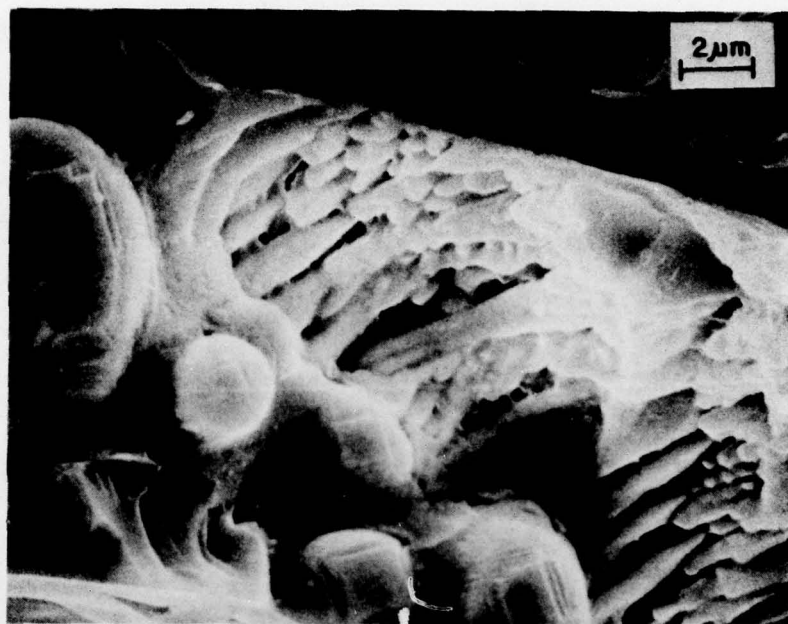
Fig. 12 — Faceted growth structures in siliceous void.  
Specimen 0404B.

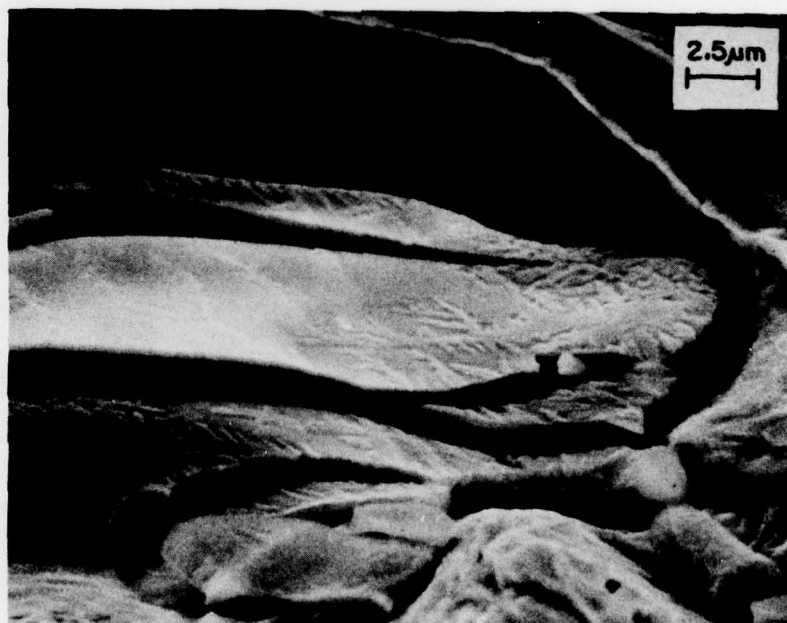
Fig. 13 — Dendritic second phase in silicate platelet.  
Specimen 0405A.

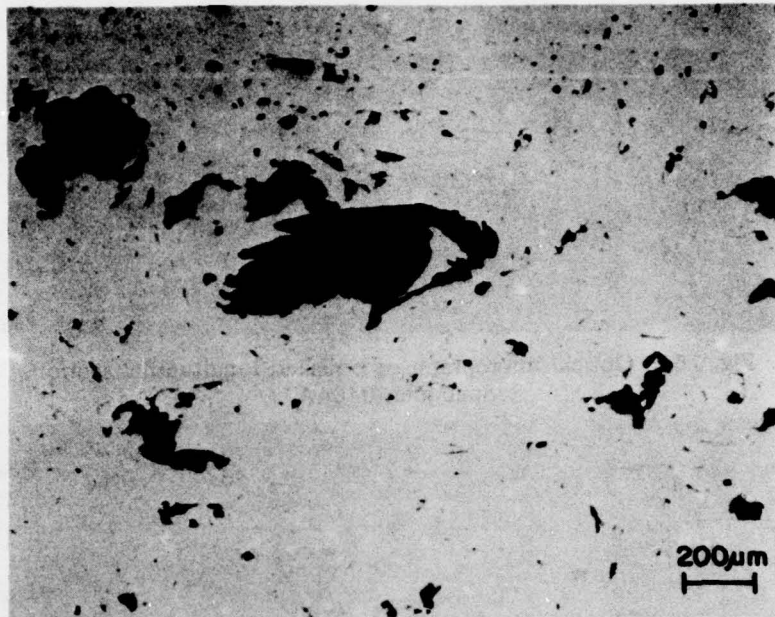
A typical magnified image from the face section obtained by an optical metallograph is shown in Figure 14. The inclusions have two types of composition as indicated by electron/x-ray spectrometry of this polished surface. Some smaller inclusions are composed of iron and silicon with small amounts of phosphorous and titanium. Some larger inclusions have a dendritic or spherical phase surrounded by another phase. This surrounding phase is composed of iron, silicon, calcium, phosphorous, sulfur, titanium, manganese, aluminum, and magnesium; while the inner phase is composed of the same elements but has less calcium, slightly less manganese, more sulfur, and somewhat more titanium.

**Fig. 14 — Optical micrograph of polished face section.  
Specimen 0404A.**

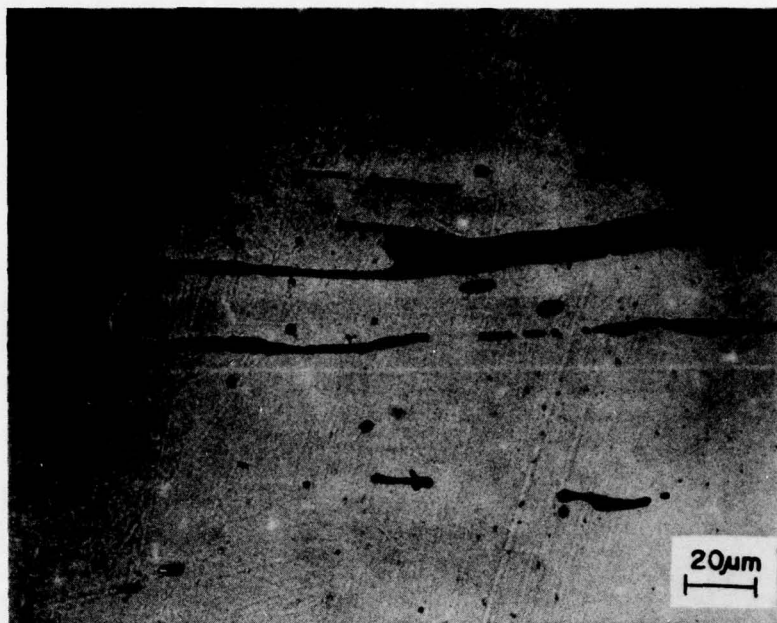
On the face section the inclusions have irregular shapes but they are roughly equiaxed. On the longitudinal and transverse sections, shown in Figures 15 and 16 respectively, the larger inclusions are long and thin and so they are platelets while the smaller inclusions are equiaxed and so they are roughly spherical. On both the transverse and longitudinal sections an occasional large inclusion will be equiaxed indicating a large particle.

Fig. 15 — Optical micrograph of polished longitudinal section.  
Specimen 0404A.

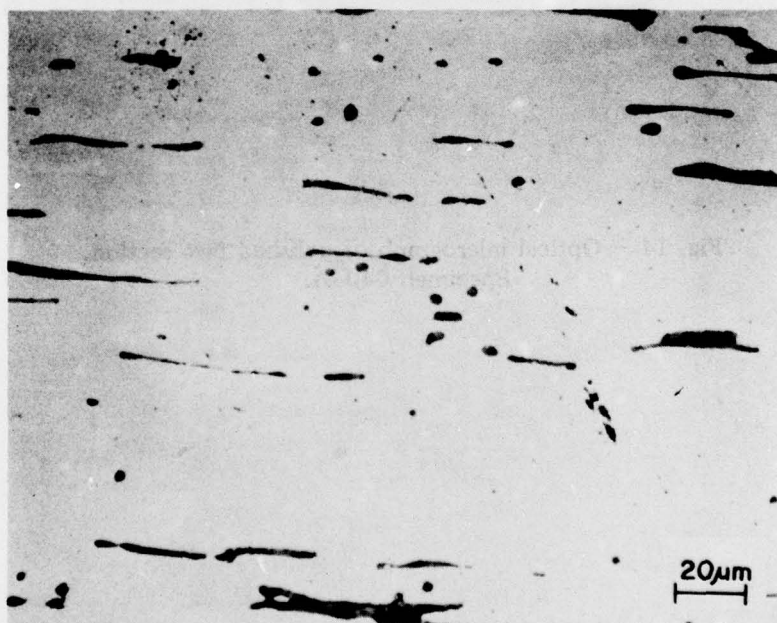
Fig. 16 — Optical micrograph of polished transverse section.  
Specimen 0404A.

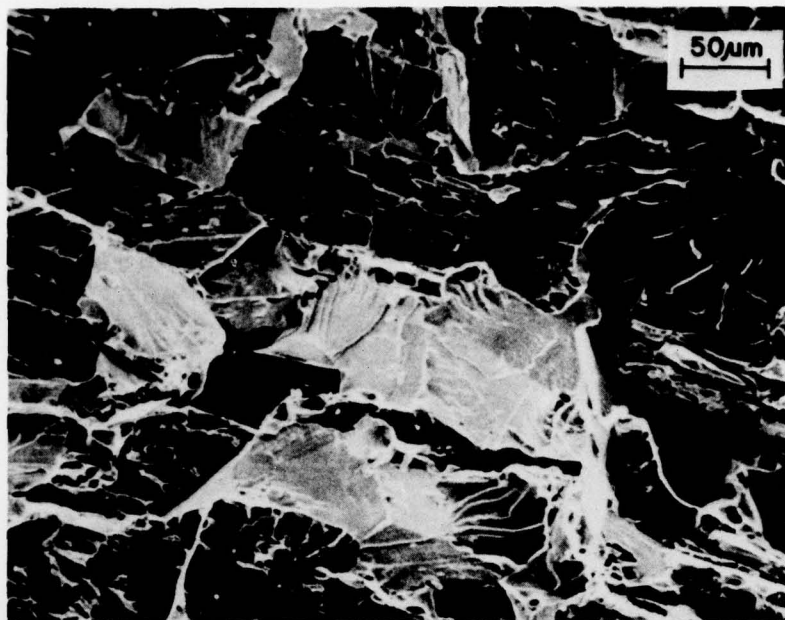
transition, if it occurred between the temperature of the wreck and the temperature at which the mechanical properties were determined, about 297K (75F), would cause the wreck to be much more fragile than the tensile tests indicated. To determine whether the wreck would remain ductile at the temperature of the seawater, two notch impact tests were performed at about 77K (-321F) and 273K (32F). The specimen struck at 77K broke in a brittle manner and the fracture surface had large, shiny facets. Figure 17 is a scanning electron micrograph of this surface showing the facets and river markings characteristic of brittle cleavage. The specimen struck at 273K behaved in a ductile manner, requiring much more energy to cause fracture. The fracture surface appeared woody like those in the tensile tests. Figure 18 is a representative micrograph of this fracture surface.

Fig. 17 — Brittle fracture surface of specimen fractured by impact at 77K (-321F). Specimen 0404C.

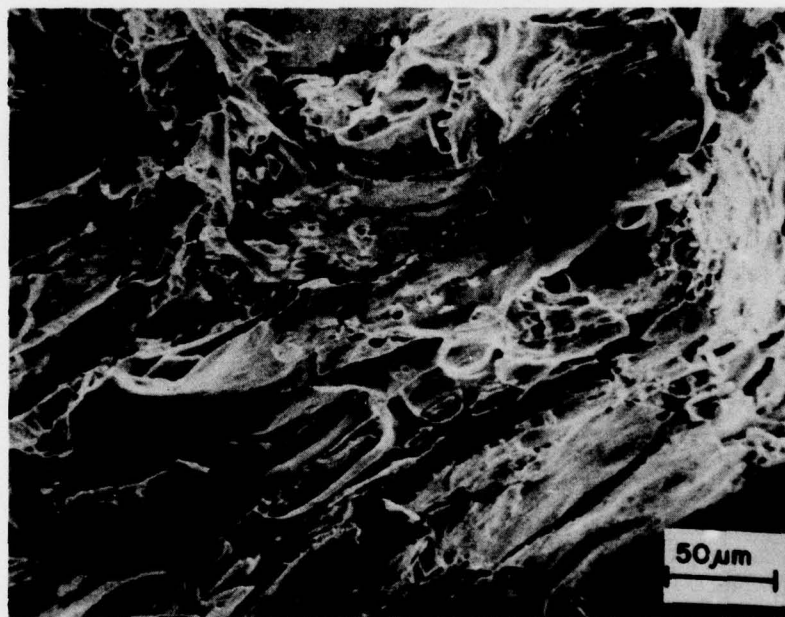
Fig. 18 — Ductile fracture surface of specimen fractured by impact at 273 K (32F). Specimen 0404B.
