# LAKE BARNEGAT DAM NJ 00058

## PHASE 1 INSPECTION REPORT NATIONAL DAM SAFETY PROGRAM

LAKE BARNEGAT DAM (NJ00058)

Name of Dam Lake Barnegat Dam Fed ID# NJ 00058  
NJ ID# 271

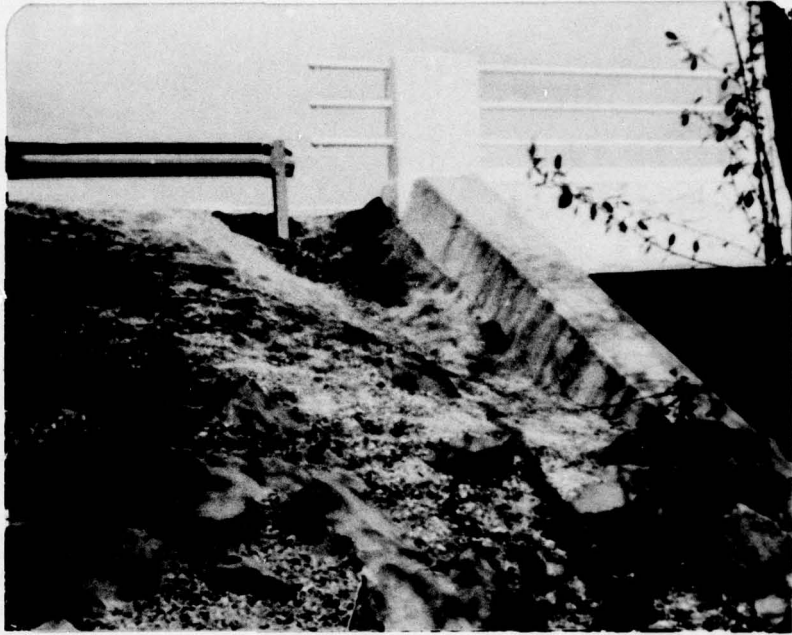
| VISUAL EXAMINATION OF | OBSERVATIONS | REMARKS OR RECOMMENDATIONS |
|---|---|---|
| CRACKING AND SPALLING OF CONCRETE SURFACES IN OUTLET CONDUIT | Numerous heavy cracks, especially in downstream wingwalls. | Bridge built in 1936. |

View of Erosion - Right Wingwall May, 1979

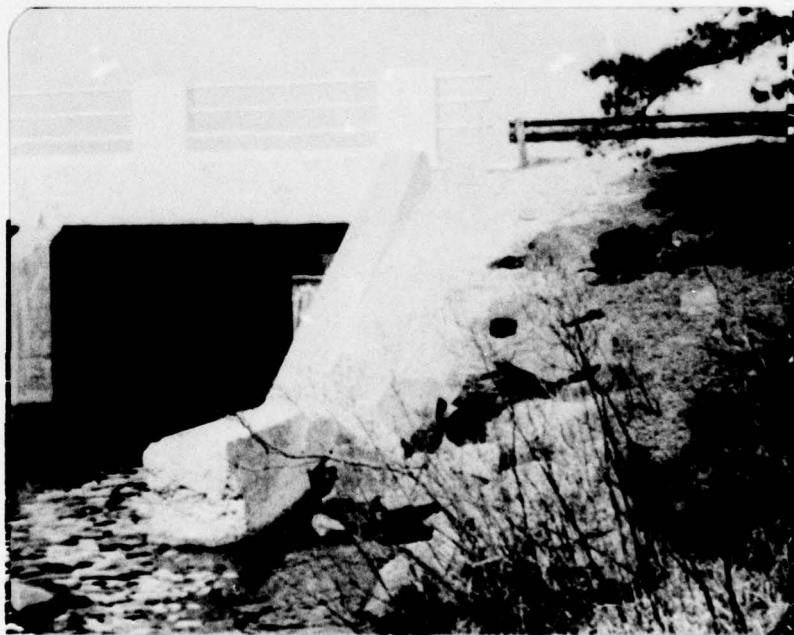
View of Erosion - Left Wingwall May, 1979
