DELAWARE RIVER BASIN
MANTUA CREEK, GLOUCESTER COUNTY
NEW JERSEY

STERLING LAKE DAM
NJ 00434

PHASE 1 INSPECTION REPORT
NATIONAL DAM SAFETY PROGRAM

STERLING LAKE DAM (NJ00434)

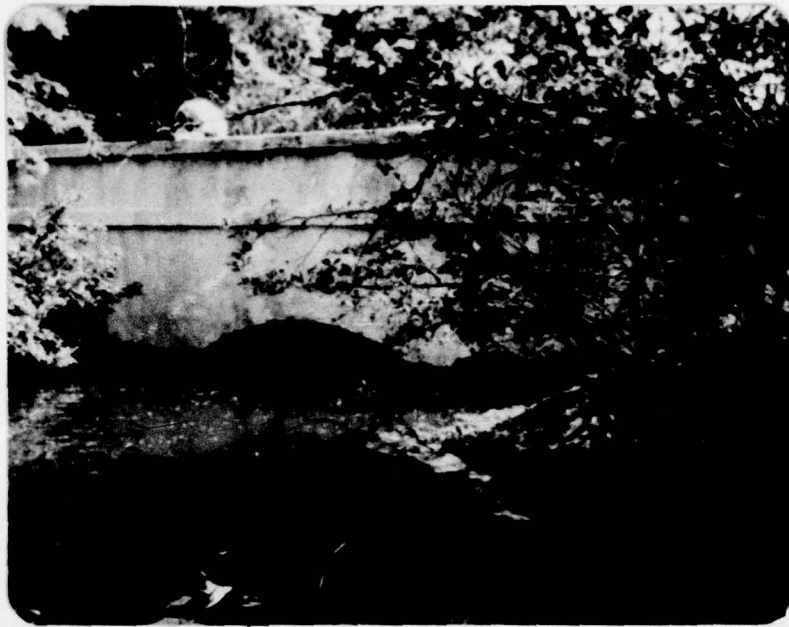
The reinforced concrete arch bridge is in excellent structural condition in view of its age. The wingwalls and parapets display minor cracking and spalled areas but the structurally important zones are in an integral condition. The semi-circular culvert opening has a clear span of 16 feet. The headroom above a reinforced concrete paved invert is about 7 feet. The paved invert which forms the culvert floor is 6" thick and was installed when the spillway was built. The lower portions of the culvert are permanently inundated by the backwater from Wadsworth Lake immediately downstream, leaving a clear headroom of only two feet beneath the intrados crown. This backwater condition from the lower reservoir severely limits the hydraulic capacity of this outlet.

View of Outlet Structure May, 1979

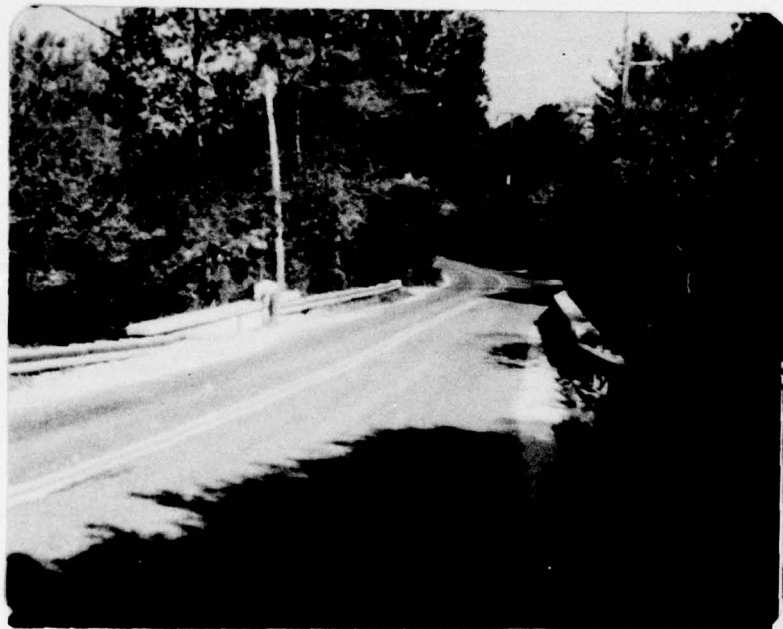
The roadway embankment portions were found to be substantial and in moderately good condition. The lake water level appears to be quite constant during most periods as the banks are well stabilized and show little evidence of sloughing at the waterline. The variable sideslopes are grassed over and have several good-sized trees placed along each side. There is evidence of considerable pavement runoff in certain locations which have cut out erosion channels. The upstream embankment slope is very irregular and it appears the lake has silted up considerably against the upstream face of the dam. There is no evidence of any riprap slope protection.

View of Crest Looking North May, 1979
