DELAWARE RIVER BASIN  
RACCOON CREEK, GLOUCESTER COUNTY  
NEW JERSEY

# WRIGHTS MILL DAM NJ 00432

## PHASE 1 INSPECTION REPORT NATIONAL DAM SAFETY PROGRAM

WRIGHTS MILL DAM (NJ00432)

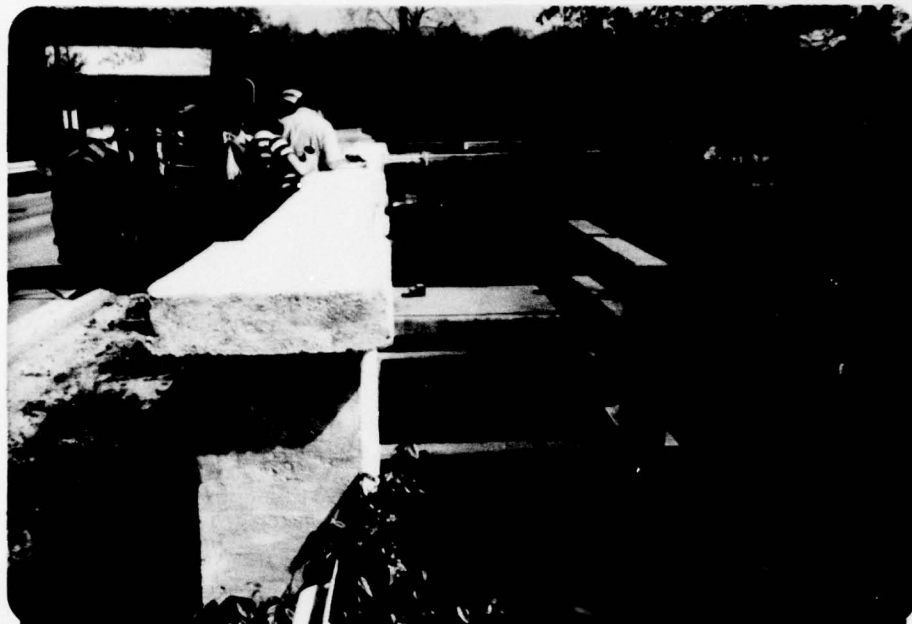
View of Spillway

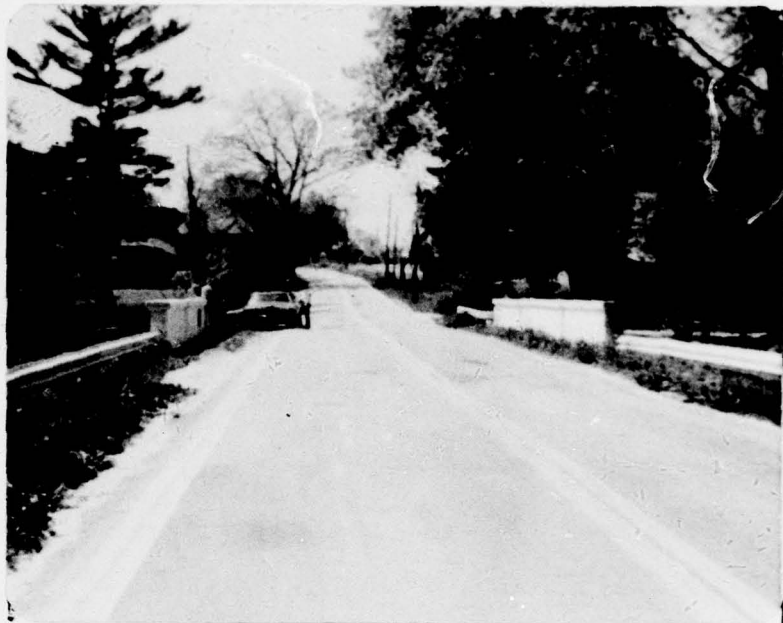
View of Crest Looking Southwest **May, 1979**
