1. REPORT NUMBER		2. GOVT ACCESSION NO.		3. PARTICIPANT'S REPORT NUMBER	
4. TITLE (and Subtitle) Phase I Inspection Report Newtown-Hoffman Creek Watershed Site 3A Chemung River Basin, Chemung County, New York Inventory No. N.Y. 617			5. TYPE OF REPORT & PERIOD COVERED Phase I Inspection Report National Dam Safety Program

NEWTOWN-HOFFMAN CREEK
WATERSHED SITE 3A

CHEMUNG COUNTY NEW YORK
INVENTORY NO 617

PHASE I INSPECTION REPORT

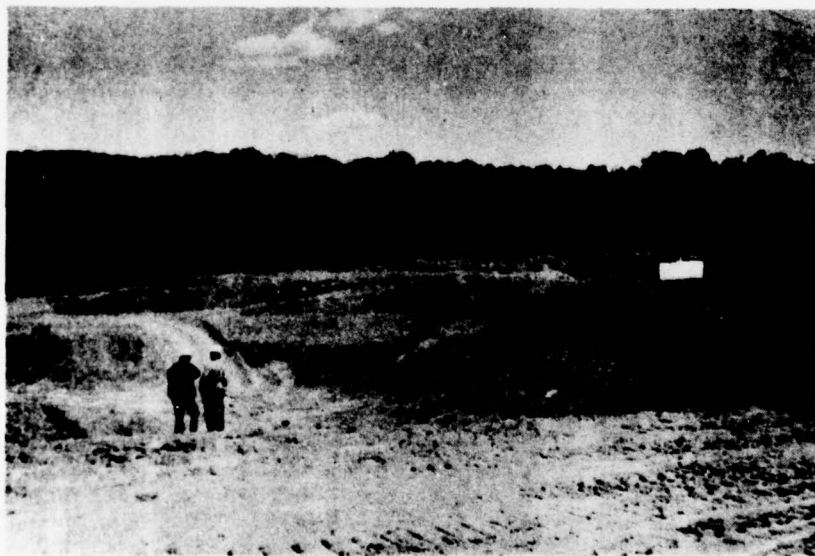
2. View looking down into dry impoundment area in the front of the dam. At time of inspection multi-purpose dam had never been filled.

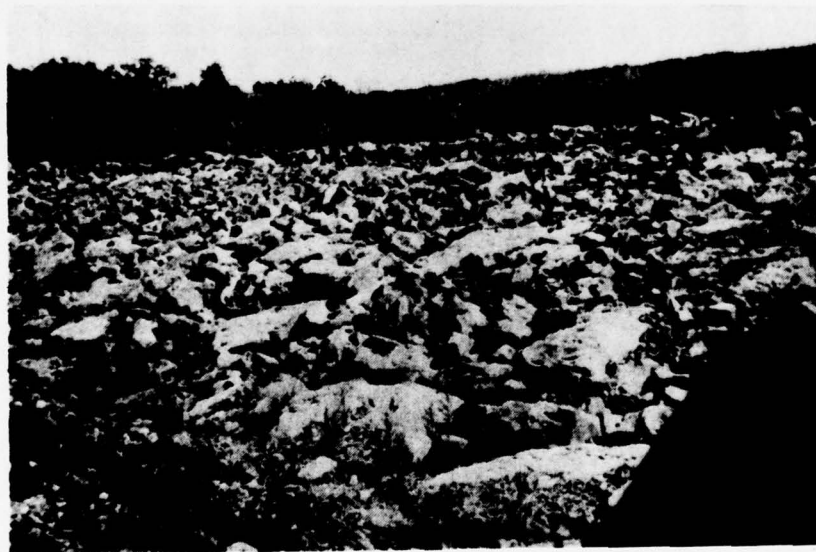
4. Detail of riprap on face of dam.

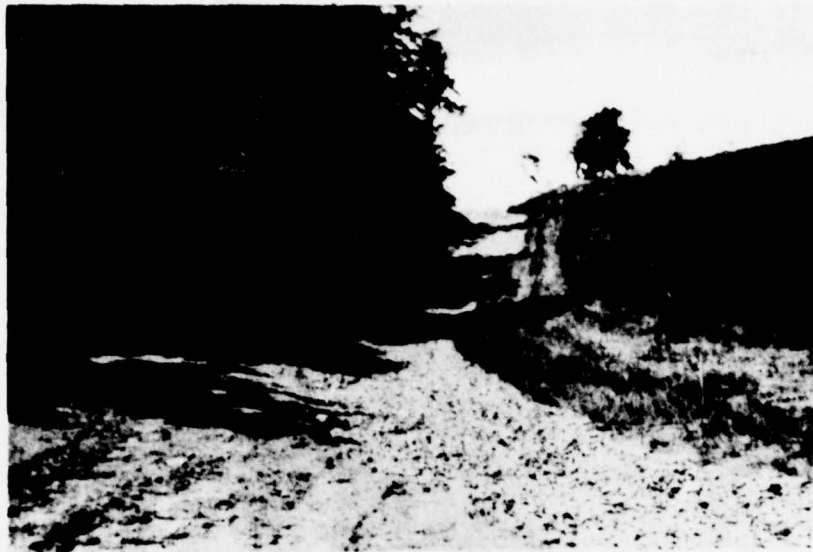
5. Downstream embankment at west abutment. Stone-filled trench at west abutment carries surface drainage and treated effluent from sewage treatment facility.

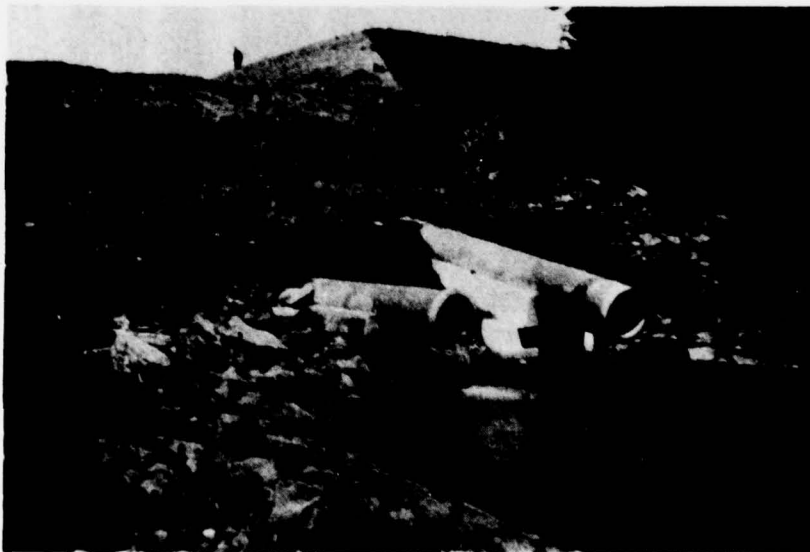
8. Detail of discharge pipes; left pipe draw-down, right pipe principal spillway for multi-purpose pool. Notice small drain pipe on left of pipes.

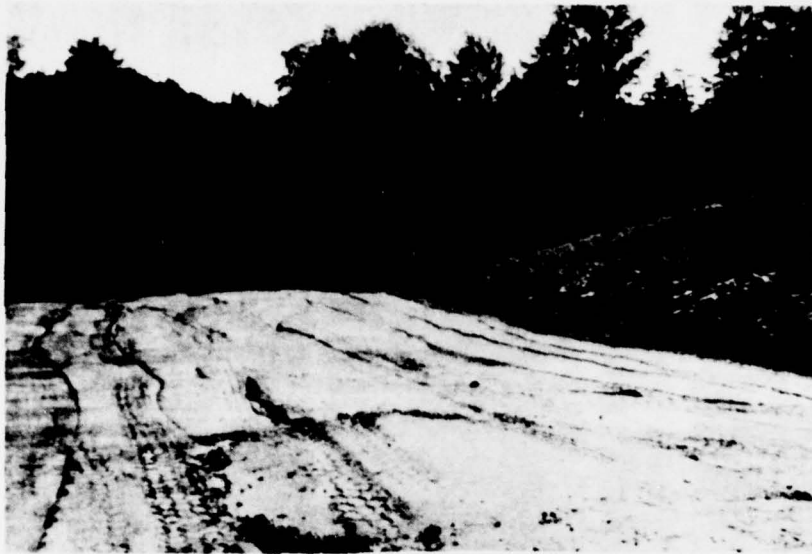
9. South view of compacted earth in cut section over in-place seepage collars and principal spillway pipe.

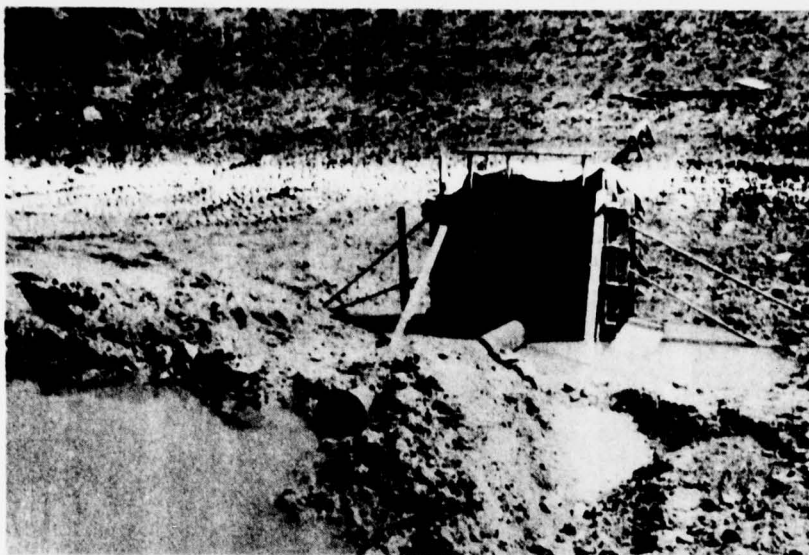
11. Detail of new drawdown gate under construction.

The drawdown intake structure was under construction at the time of inspection, a photograph of the structure is included herein. The new principal spillway intake was recently completed. Restoration of the embankment cut and drawdown intake was still incomplete. The drawdown and principal spillway pipes were inspected and found to be in good condition. The plunge pool, however, was not apparently modified during the repair work and it is questioned whether the discharge pipe may reach across the designated discharge pool area.
