Susquehanna River Basin, Inventory
Number NY-575. Nanticoke Creek Watershed
Project Site 9E. Broome County, New York.
Phase I Inspection Report.

PHASE 1 INSPECTION REPORT
 NATIONAL DAM SAFETY PROGRAM
 NANTICOKE CREEK WATERSHED PROTECTION PROJECT
 DAM SITE No. 9E
 I.D. No. NY 575
 (#85D-3646)
 SUSQUEHANNA RIVER BASIN
 BROOME COUNTY, NEW YORK

Name of Dam: Nanticoke Creek Watershed
Protection Project Dam Site No. 9E
I.D. No. NY 575 (#85D-3646)

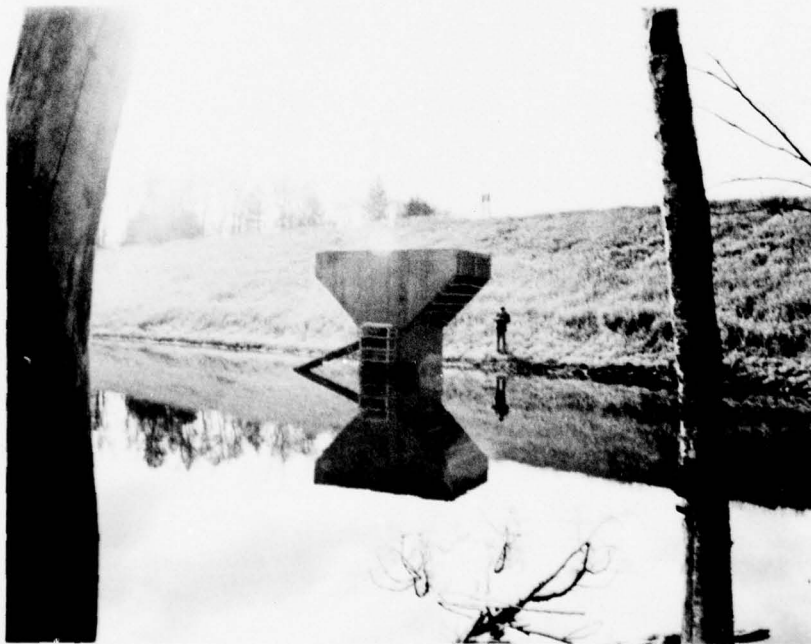
RISER - NOTE LOG LODGED IN TRASH RACK

b. Principle Spillway 26.2' HIGH RECTANGULAR RC DROP INLET;
36" DIA RC PRESSURE PIPE ; CONCRETE IMPACT
BASIN - A 10" DIA. LOG WAS LODGED IN THE RISER'S TRASH RACK.
ALL IN SATISFACTORY CONDITION - VERY SLIGHT SEPARATION
AROUND RC PIPE AT JUNCTION WITH IMPACT BASIN
HEADWALL -

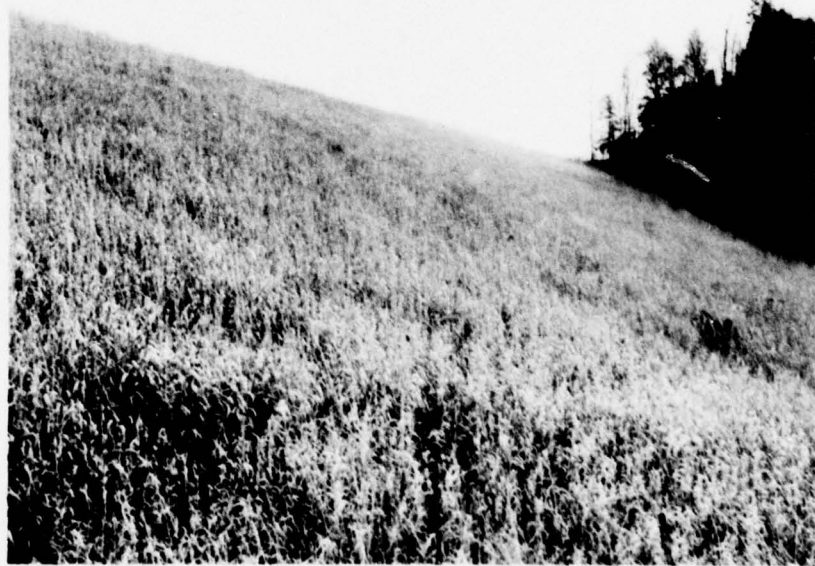
The earth embankment showed no signs of distress. The vertical and horizontal alignment of the crest of both embankments appeared to be satisfactory, with no visible surface cracks appearing on the crest or embankment slopes. There were no areas of serious sloughing or subsidence noted. Some minor sloughing was observed on the upstream slope in the range of fluctuation of the water surface level.

DOWNSTREAM SLOPE OF NORTHERN EMBANKMENT

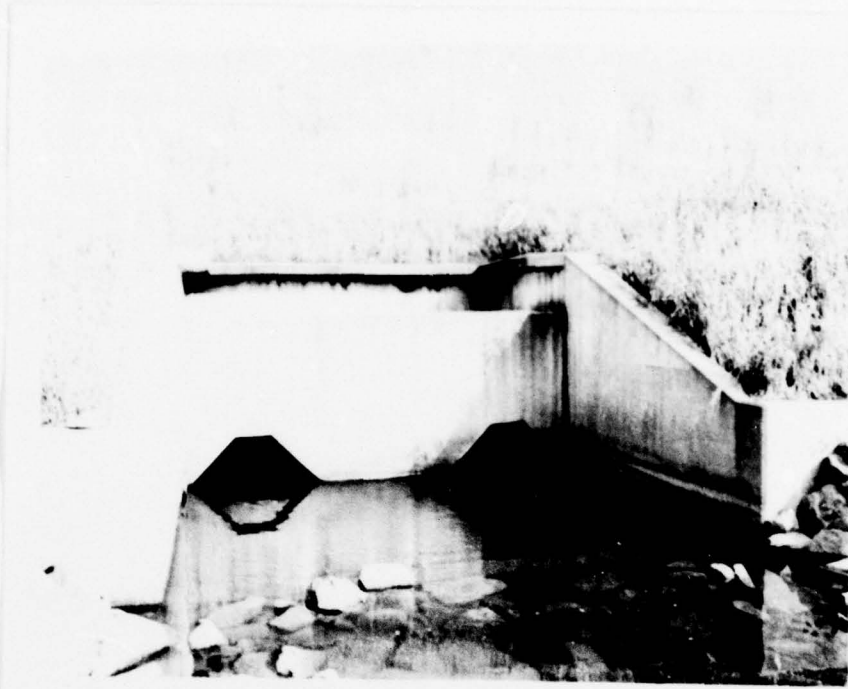
IMPACT BASIN - LOOKING UPSTREAM

h. Joints - Construction, etc. SOME MORTAR WAS MISSING
AT IMPACT BASIN - CONDUIT GASKET.

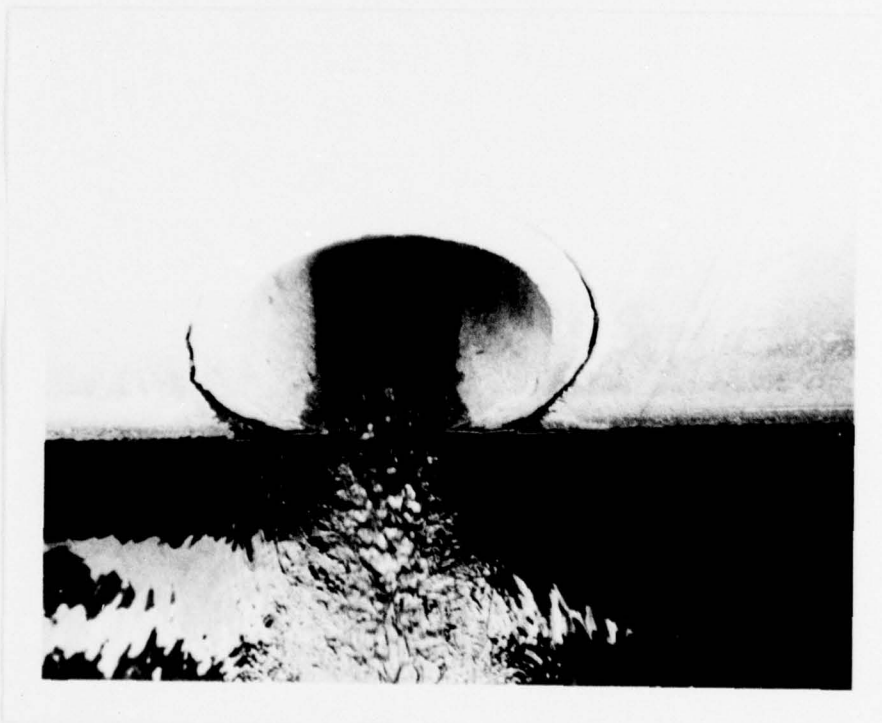
The principal spillway consists of the vertical drop inlet structure, a reinforced concrete pressure pipe through the embankment, an impact basin and an outlet channel. All of these components were in satisfactory condition. There was a small gap around the principal spillway pipe at its joint with the headwall of the impact basin.

OUTLET TO PRINCIPAL SPILLWAY PIPE
