**EPHRATAH DAM**

**FULTON COUNTY, NEW YORK  
INVENTORY NO. N.Y. 178**

**PHASE I INSPECTION REPORT  
NATIONAL DAM SAFETY PROGRAM**

PHASE 1 INSPECTION REPORT  
NATIONAL DAM SAFETY PROGRAM  
EPHRATAH DAM I.D. No. NY 178  
DEC #456  
MOHAWK RIVER BASIN  
FULTON COUNTY, NEW YORK

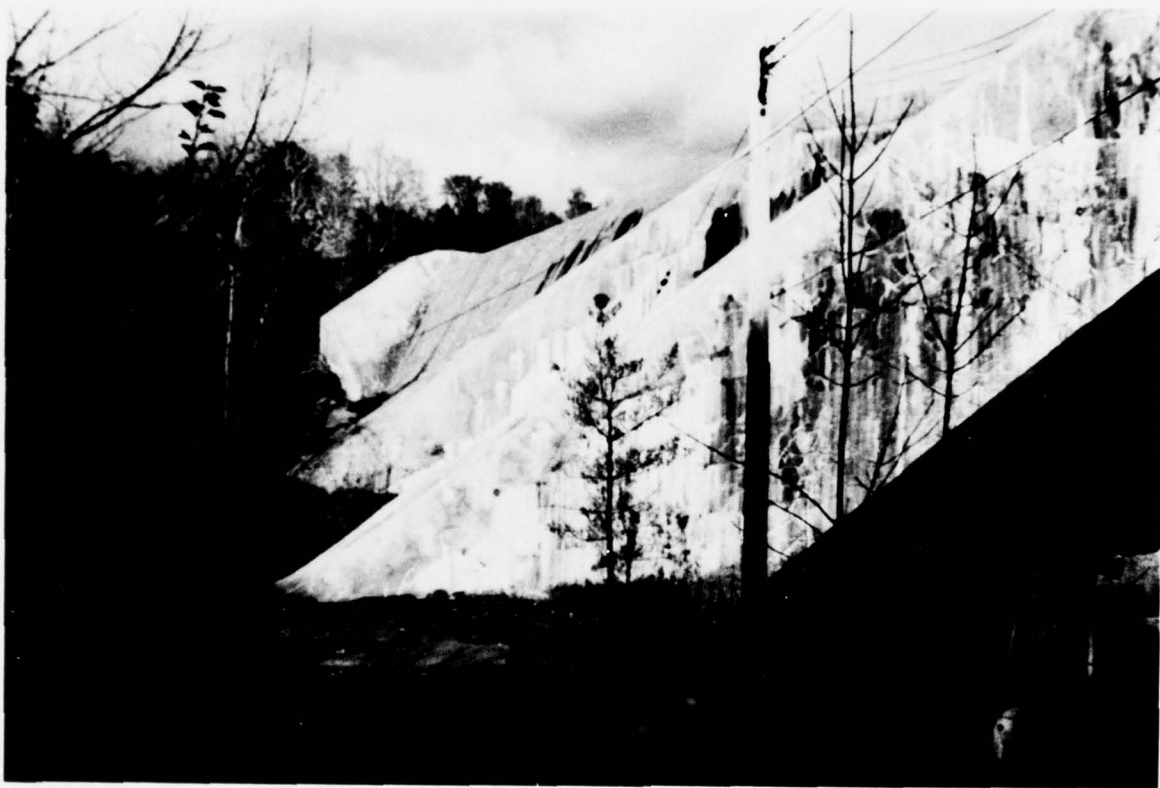
Overview of Ephratah Dam  
Downstream Face Looking North

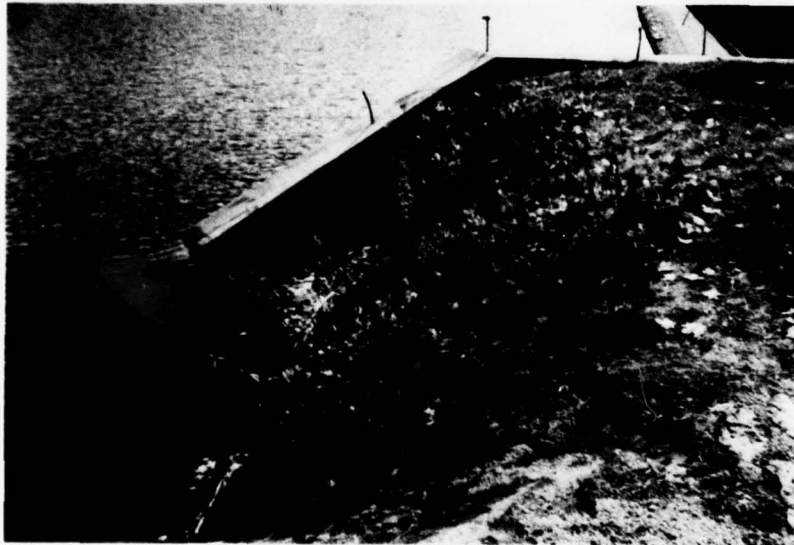
The earth embankment portions show no signs of major distress. However, the following problem areas were observed: Erosion of the upstream face near the north buttress of the spillway is probably due to wave action and the lack of energy dissipating material such as riprap. The void and seepage observed near the toe of the spillway at the north buttress may be related to seepage along the earth-concrete interface or related to seepage from the jointed shale bedrock. The embankment slopes appear to be excessively steep.

Upstream Face of Embankment  
Looking South

2. Repair the erosion on the upstream face of the earth embankment near the north spillway buttress and place erosion protection material. Monitor periodically the void observed at the toe of the north spillway buttress on the downstream face to determine if further movement is occurring.

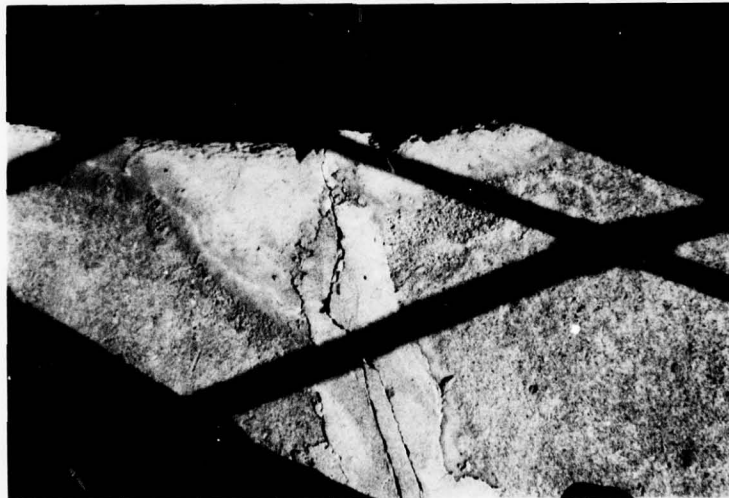
Top of Dam - Arched Section  
Note Crack

- b. Structural Cracking cracking at crest of buttress sections  
completely thru top of dam (see photo), cracks were  
repaired and have cracked again
- c. Movement - Horizontal & Vertical Alignment (Settlement) \_\_\_\_\_  
no problems observed
