SWAN LAKE DAM

INVENTORY NO. N.Y. 333

**PHASE I INSPECTION REPORT
NATIONAL DAM SAFETY PROGRAM**

Name of Dam: Swan Lake Dam (I.D. No. NY 333)
State Located: New York
County Located: Sullivan
Stream: West Branch of the Mongaup River
(tributary of Delaware River)
Dates of Inspection: October 19, 1978
February 27, 1979

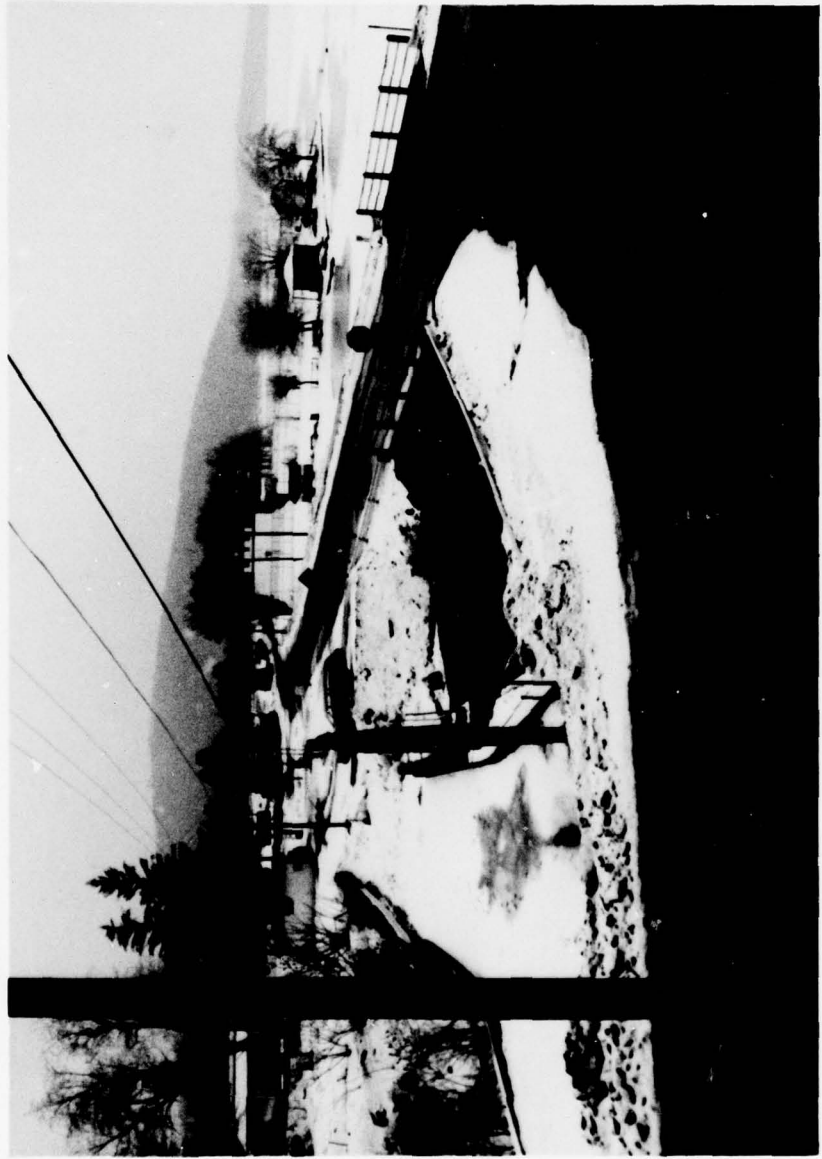
Photo #1

OVERVIEW OF SWAN LAKE DAM

The abandoned spillway bridge which covers the entire spillway is reducing the spillway flow (see photographs #1, 2 & 14). In addition, the bridge slab is cracked and deteriorated. The slab exhibits signs of calcification and appears to have contracted relative to the abutment walls which form the walls of the spillway. The limited spillway capacity and the deteriorated condition of this bridge may necessitate its removal.

- a. The abandoned spillway bridge and the utility lines suspended beneath the bridge must be removed to increase spillway capacity.
- b. The spillway stoplogs should be replaced with flashboards which collapse at a specific reservoir level.

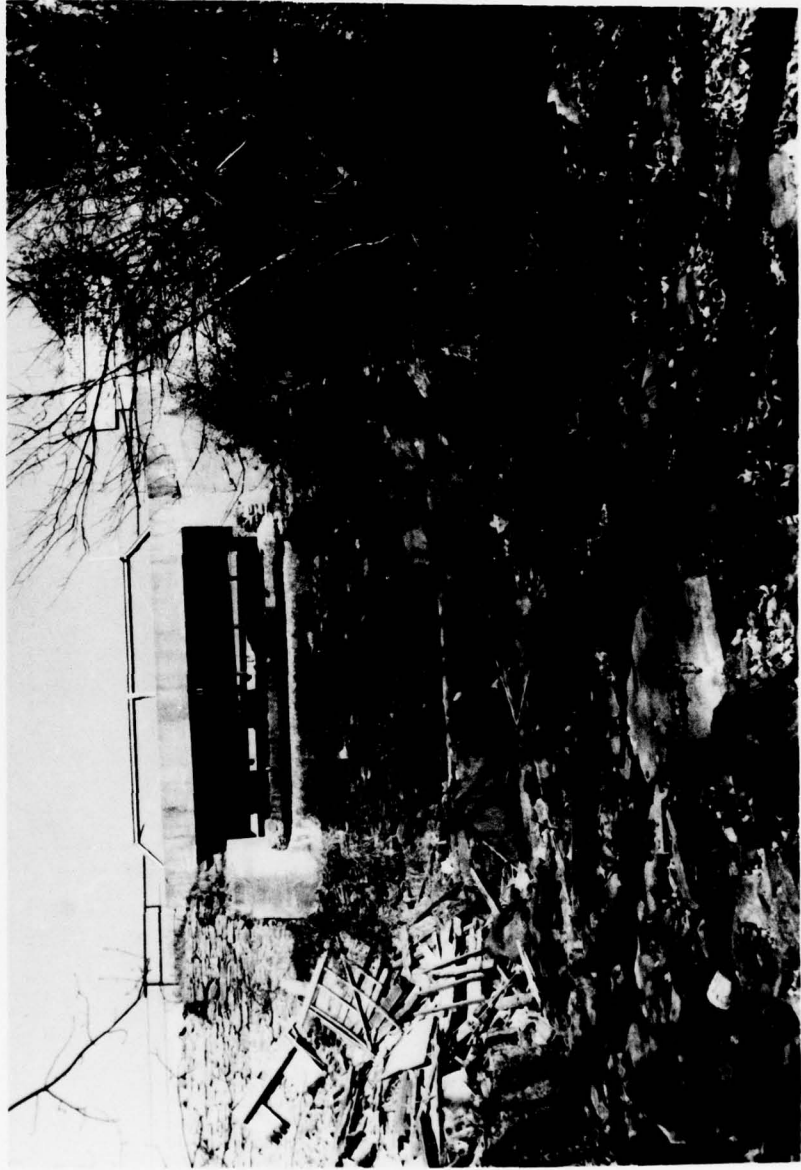
Photo #2

SWAN LAKE DAM
DOWNSTREAM FACE

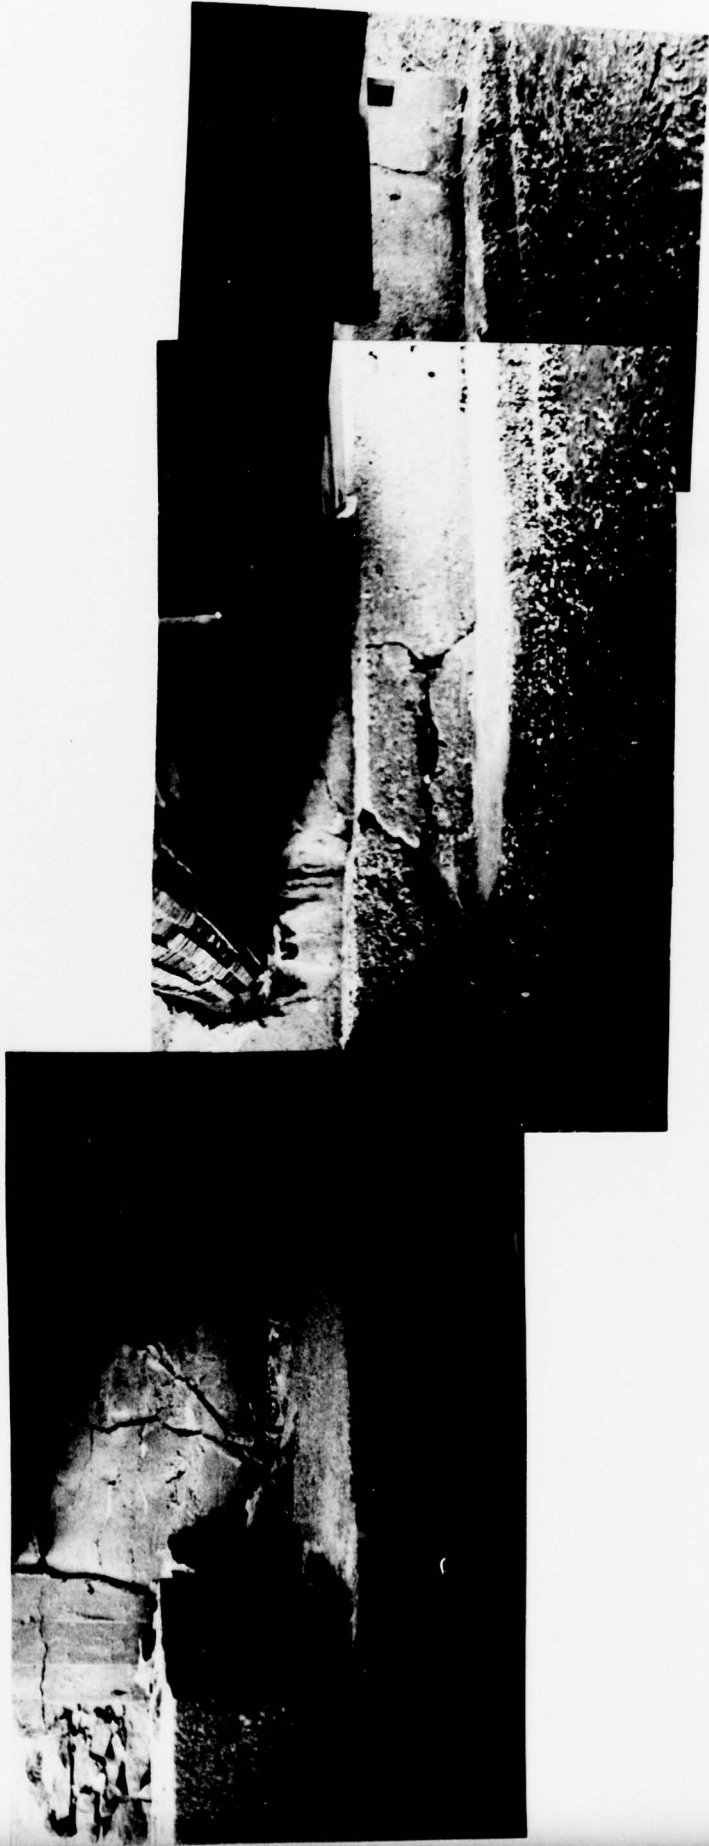
Photos #3A, B & C

EAST ABUTMENT WALL
NOTE CRACKING & DETERIORATION

- b. Structural Cracking Numerous structural cracks observed on
both east & west abutment walls of spillway + southeast wingwall
Bridge deck: observed extensive cracking & calcification

- c. Erosion at the base of the metal bin wall near the southeast corner of the spillway must be repaired.
- d. Cracking and deterioration of the spillway slab and walls must be repaired.
- e. Periodically monitor the bulge on the downstream masonry face in the vicinity of the penstock to determine if further movement is occurring. Periodically monitor the seepage from the penstock and the reservoir drain to ascertain changes in flow.
- f. Provide a reservoir drain to lower the lake level for future maintenance and repair work.
- g. Initiate a program of periodic inspection and maintenance of the dam and appurtenances. Document this information for future reference. Also, develop an operations manual.

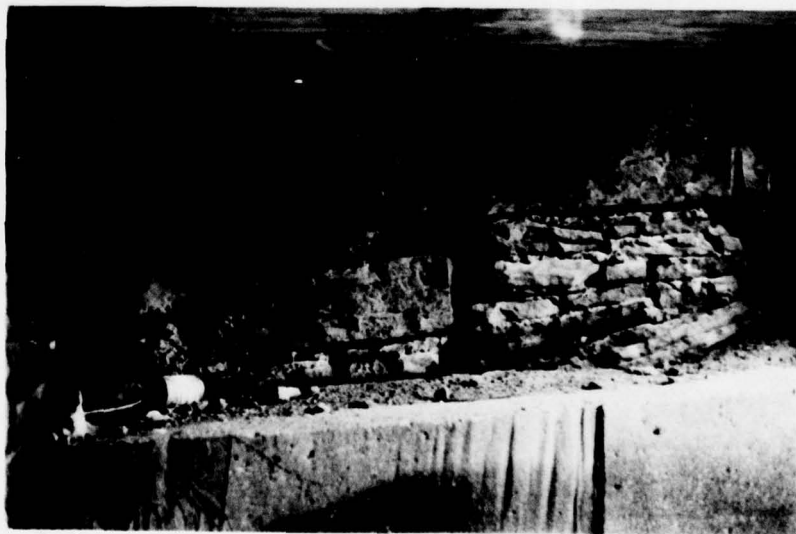
Photo #6

WEST ABUTMENT WALL
NOTE DETERIORATED MASONRY

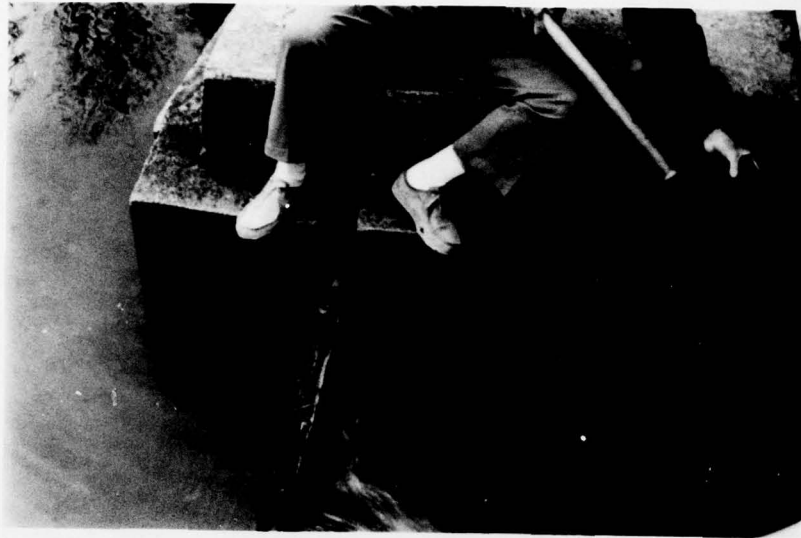
Photo #7

STOPLOGS

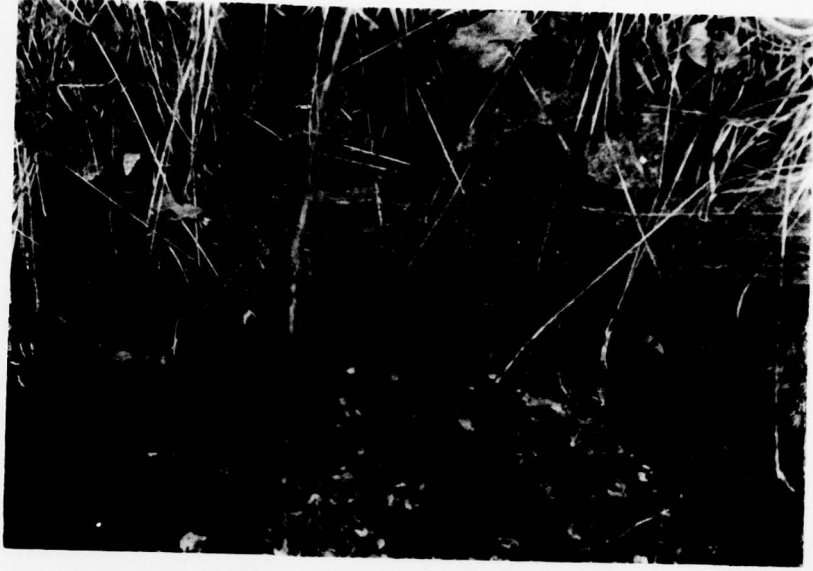
Slight bulging was observed in the stone masonry on either side of the penstock for a total distance of approximately 16 feet. No recent movement was observed in this 2 to 3 inch bulge. This bulge may have been the result of mis-alignment during construction.

PENSTOCK AS VIEWED FROM TOP OF DAM
NOTE: SLIGHT BULGE IN MASONRY
Photo #10

6. At bi-monthly intervals, monitor the bulge on the downstream masonry face in the vicinity of the penstock and the seepage from the penstock and the reservoir drain.

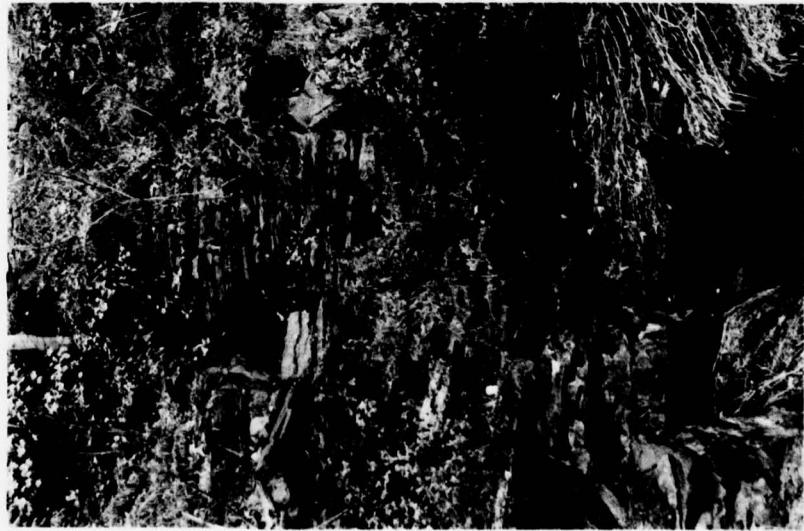
PENSTOCK AS VIEWED FROM BASE OF DAM
Photo #9

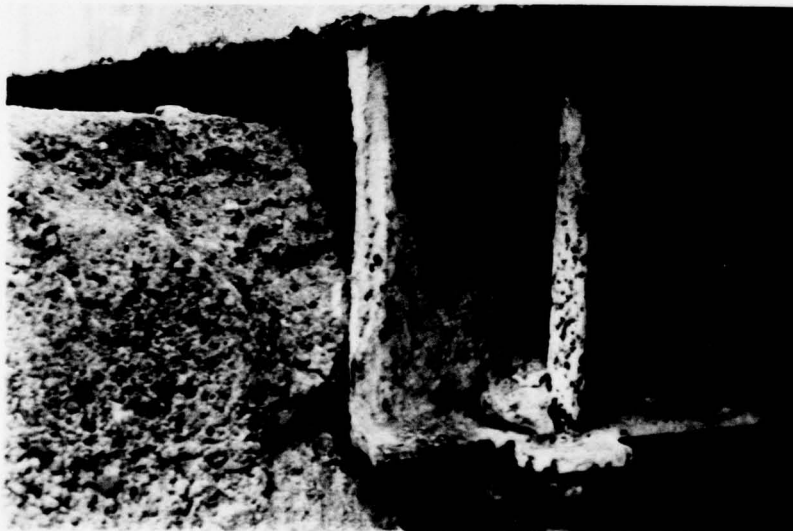
Photo #15

SPILLWAY BRIDGE DECK I - BEAM
NOTE DETERIORATION OF CONCRETE STOPLOG SUPPORT

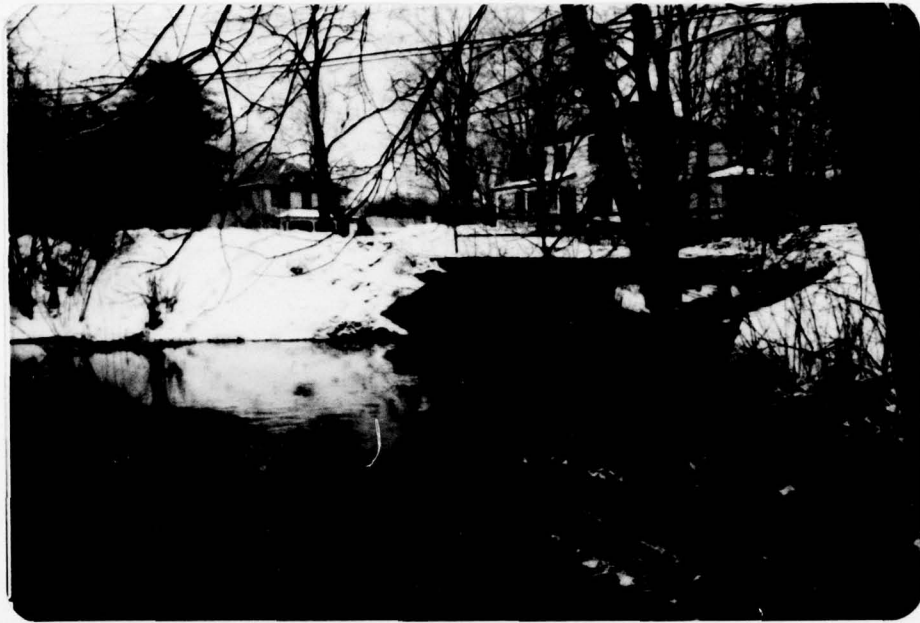
Photo #16

DOWNSTREAM BRIDGE AND CHANNEL

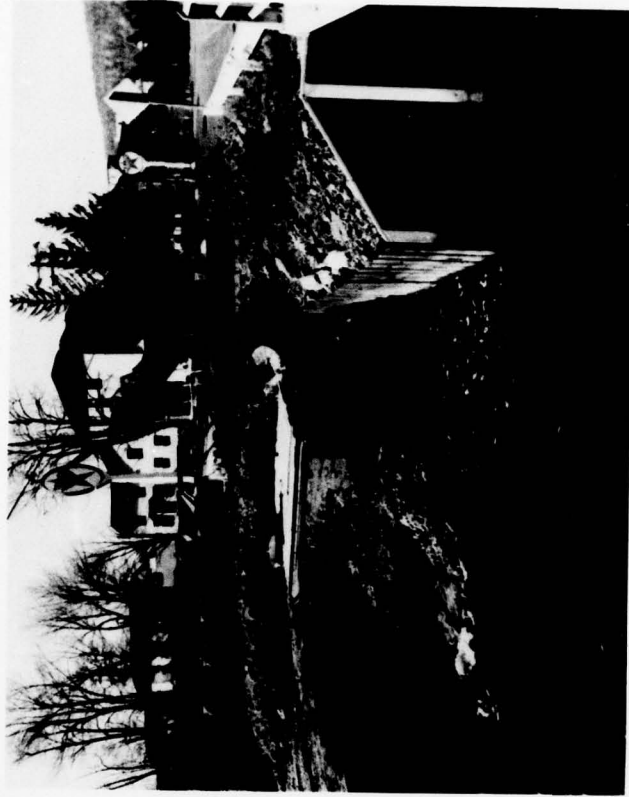
Photo #19

INTAKE AREA FOR PENSTOCK (1962)
NOTE: THIS AREA IS NOW FILLED IN
