IRVING POND DAM

**FULTON COUNTY, NEW YORK
INVENTORY NO. N.Y. 174**

**PHASE I INSPECTION REPORT
NATIONAL DAM SAFETY PROGRAM**

PHASE 1 INSPECTION REPORT
NATIONAL DAM SAFETY PROGRAM
IRVING POND DAM I.D. No. 174
DEC #476
MOHAWK RIVER BASIN
FULTON COUNTY, NEW YORK

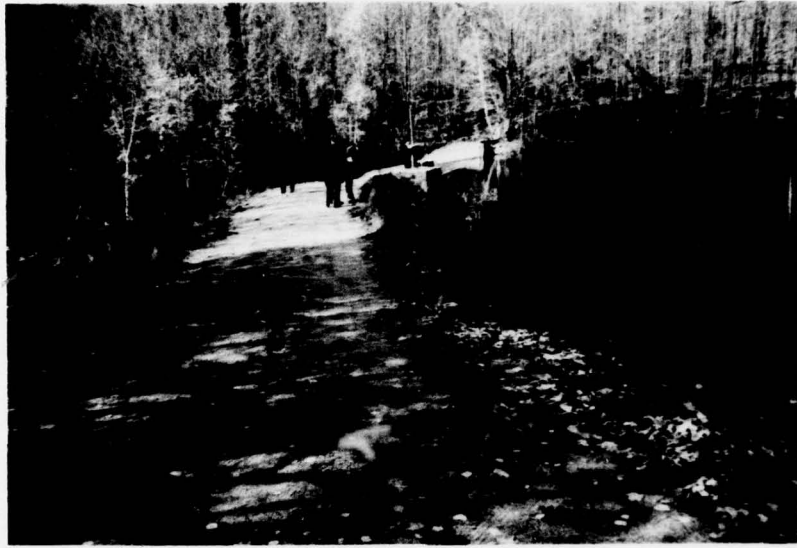
The earth embankment shows no sign of distress. The vertical and horizontal alignment of the crest appears to be good with no visible cracks on the embankment slopes or crest. There is no evidence of sliding, sloughing and depressions. The top of the south embankment is exposed earth while the same on the north embankment is heavily riprapped. Slopes are also protected by heavy riprap. There is considerable growth of vegetation on the upstream side of embankment and there is debris and trees around the walls of the low-level outlet and at both abutments. The two abutment walls have cracked exposing sheet piles. Seepage was observed at different locations at the toe of the spillway. However, the seepage water was clear and there was no evidence that fine materials were being carried away. The spillway and the toe of the dam should be observed under no flow conditions to determine the source of the observed seepage. The seepage could be related to spillway flow since the grouted riprap downstream face also serves to transport spillway flow.

Top of Dam Looking North

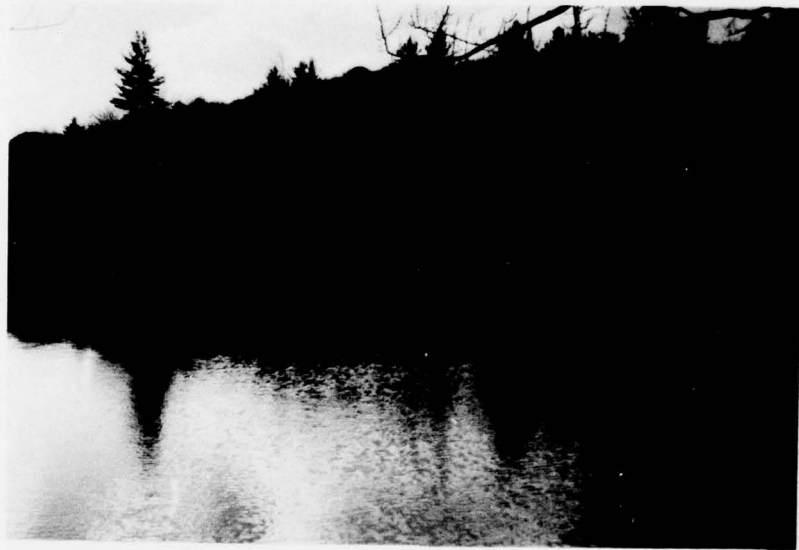
Upstream face of dam

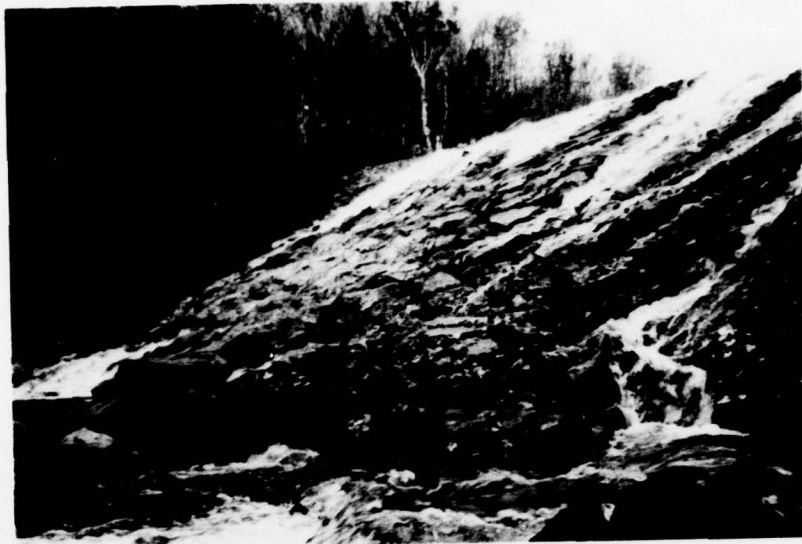
Downstream face of dam
Looking North

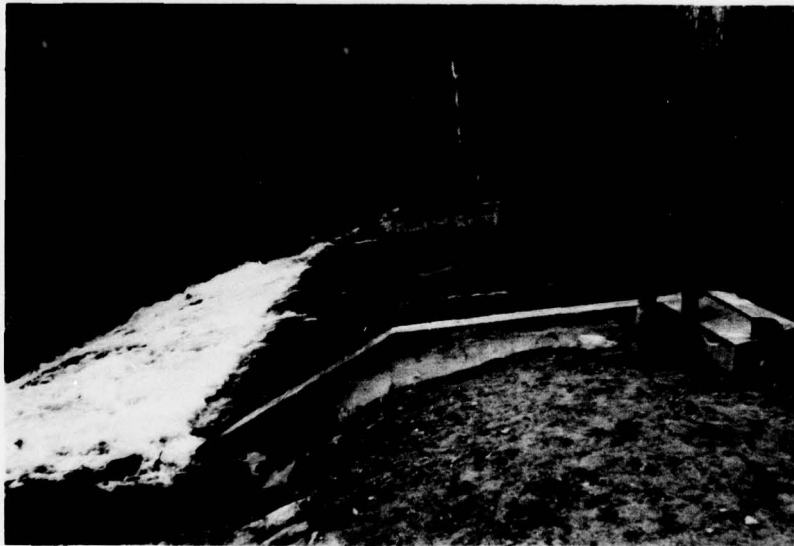
The visual observations did not indicate any sign of major distress in connection with earth embankment. The spillway, however, is in poor shape. The spillway slab cracked and spalled in many places exposing reinforcement bars. Cracks separated the two end walls and the spillway slab from the sheet pile along the entire width of the spillway. There are a number of voids underneath the spillway, the biggest one is about 4 feet in diameter and 5 feet deep. Water flowing through the cracked south end wall is scouring the embankment.

Spillway Looking North

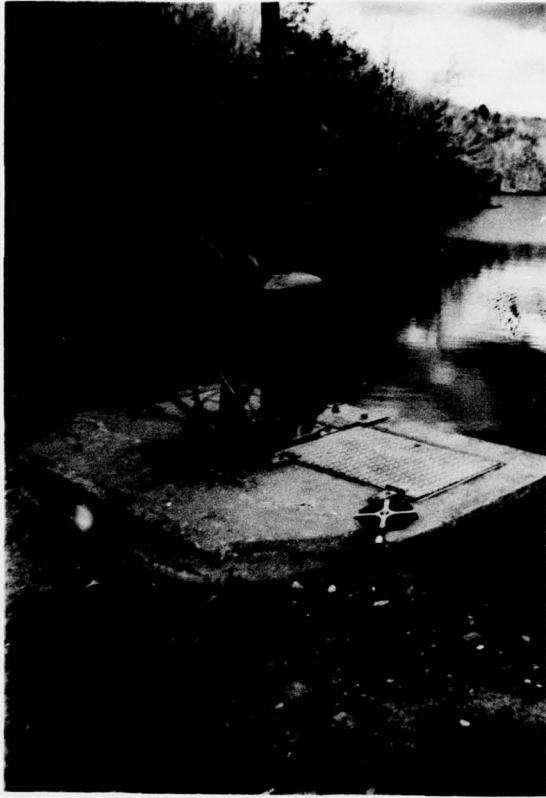
The low-level drain pipe is distorted and rusted. The joint between valve section and the pipe has been displaced approximately 1/2 inch. Some seepage was noticed at this junction. The distortion of the pipe is probably due to the placement of heavy stones on top of the pipe. The flow to the low-level drain is controlled by a sluice gate connected to a manually operated control mechanism placed on the upstream side of the south embankment. The control mechanism is operational.

Sluice Gate Mechanism

There are several minor deficiencies which require remedial action. The joint between the reservoir drain valve and the outlet pipe should be sealed within 6 months of notification.

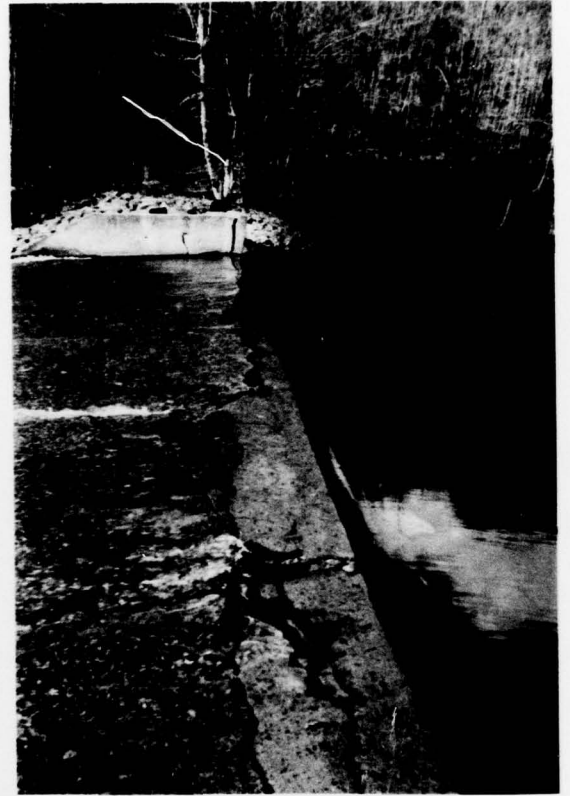
Spillway Looking North
note cracked and spalled concrete
resulting from sheet piling

b. Principle Spillway SEPERATION OF R.C. SPILLWAY SLAB AND
STEEL SHEET PILE FACING IS COMPLETE. BOTH THE
ABUTMENTS CRACKED OPEN EXPOSING SHEET PILES. REBARS
EXPOSED THROUGH CRACKS IN SPILLWAY. WATER FLOWING
THROUGH BROKEN ABUTMENT WALL SCOURED EMBANKMENT.

b. Structural Cracking some cracking & spalling of low level outlet wing walls
cracking of spillway slab & return walls due to expansion & contraction
(differential) from cut-off sheeting (steel-interlocking)

The spillway is not considered unsafe at this time. However, a thorough investigation of the spillway foundation should be conducted to determine the extent of the voids and the stability of the spillway.

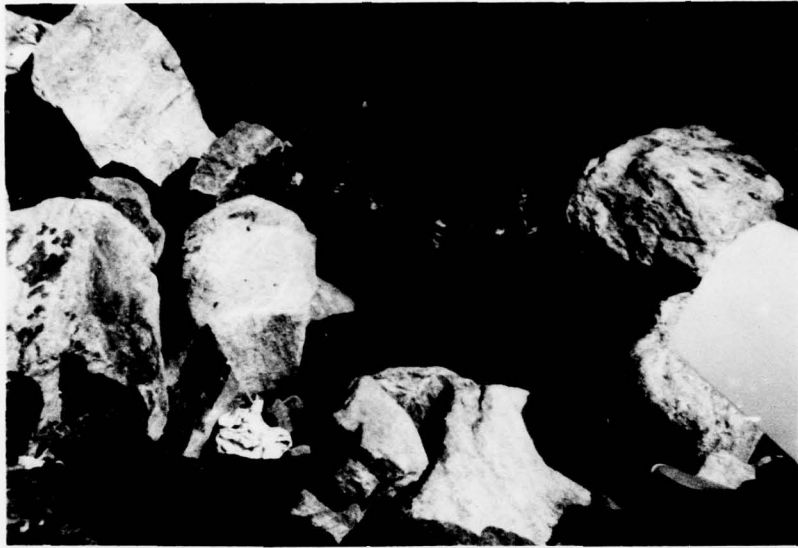
The spillway is in poor shape and needs repairs. It is possible that the timber crib has deteriorated, resulting in the displacement of stones and creation of voids underneath the spillway slab.

Void under north wall of spillway

a. General SPILLWAY IN BAD SHAPE. THE BROAD CRESTED REINFORCED
SLAB
CONCRETE SPILLWAY IS BROKEN AND CRACKED IN MANY
PLACES. VOIDS UNDERNATH THE SPILLWAY. ONE VOID ABOUT
4' DIA AND 5' DEEP.

Subsurface investigations of the spillway and its foundation are required to perform a complete stability analysis of the spillway. An additional investigation should also be undertaken to determine the exact nature and cause of the seepage through the spillway.

to spillway wall (west) - no problem with spillway or wall above -
recommend backfill with stone & observe

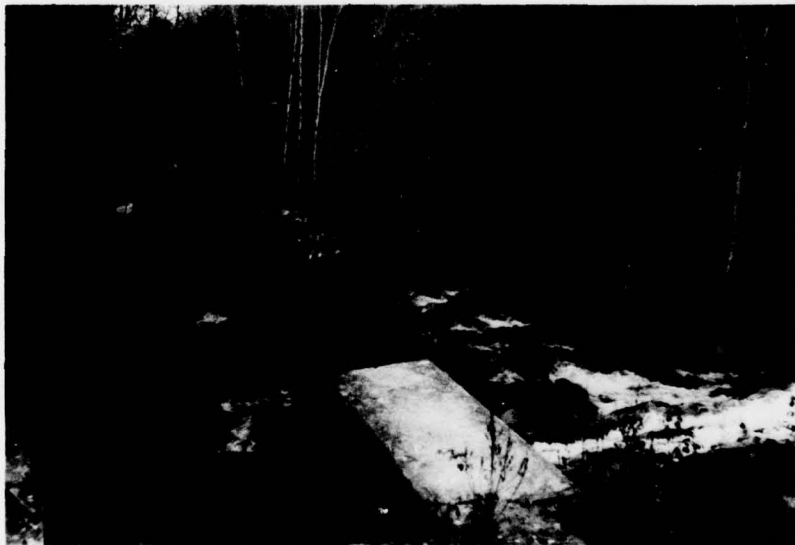
Downstream area looking west

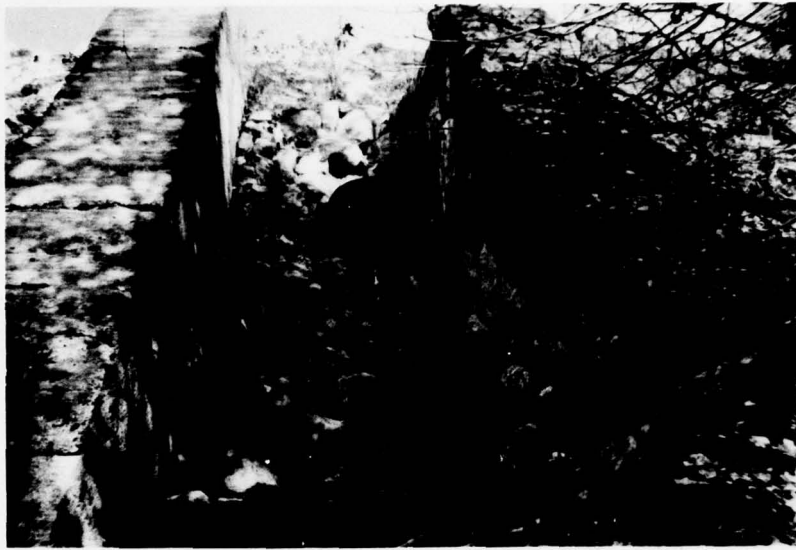
Low level outlet looking east

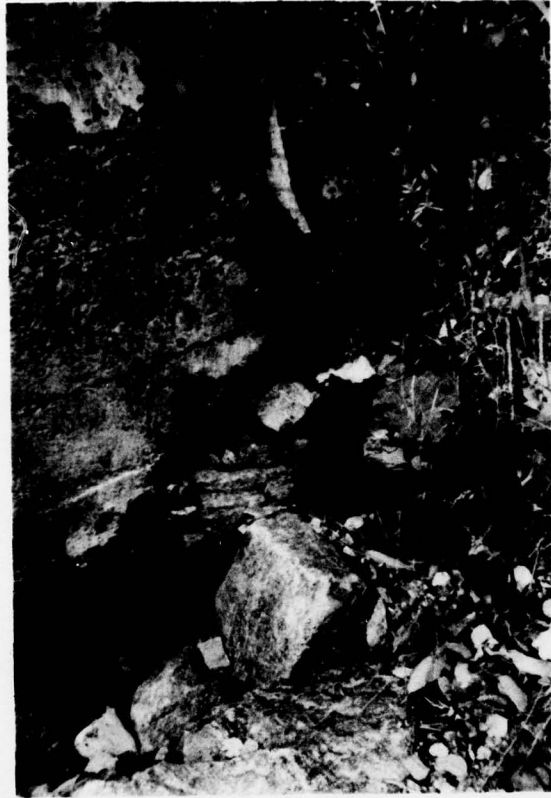
North wall of low level outlet channel
note cracking of concrete

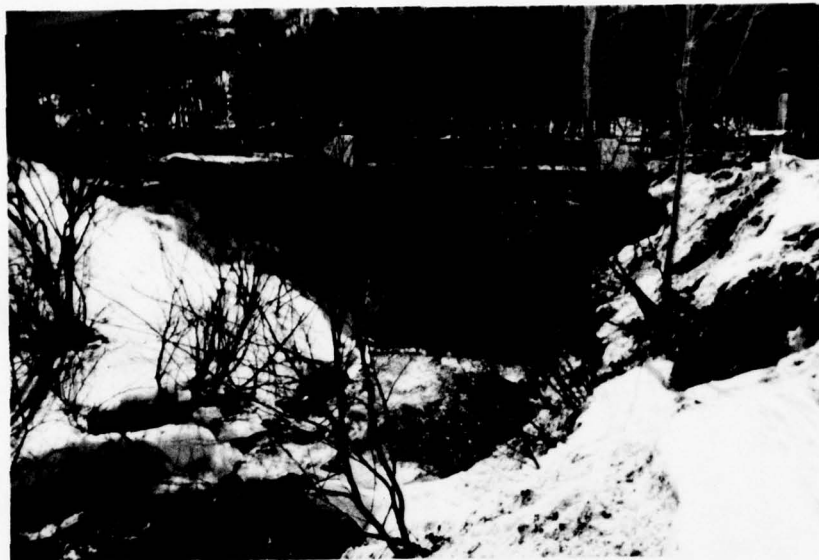
Downstream Channel - Bridge NY Rts 10 & 29A

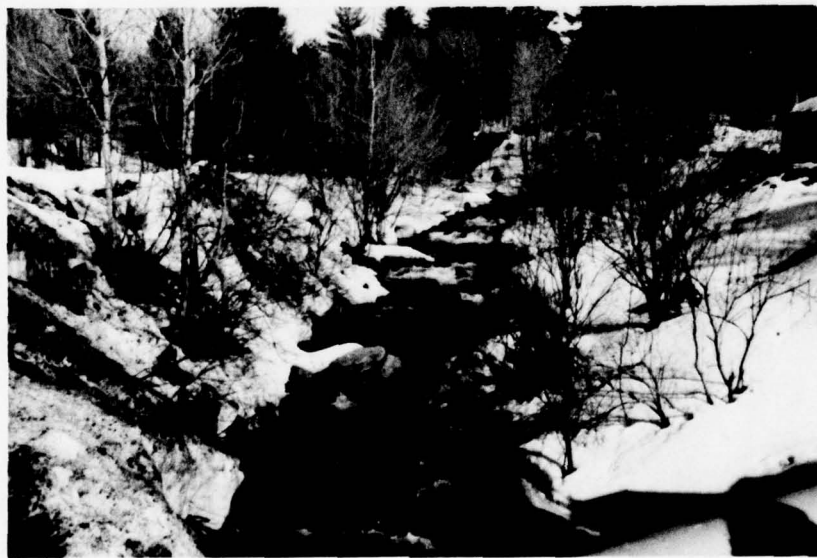
The downstream channel is riprapped and no debris was observed in the channel other than some displaced stone.

Downstream Channel
Looking Upstream from Bridge
