MISCELLANEOUS PAPER SL-79-25

INVESTIGATION OF LIGHTWEIGHT CONCRETE AND MATERIALS, EAST LOS ANGELES COMPREHENSIVE HEALTH CENTER BUILDING

A. D. Buck and T. C. Liu

Structures Laboratory

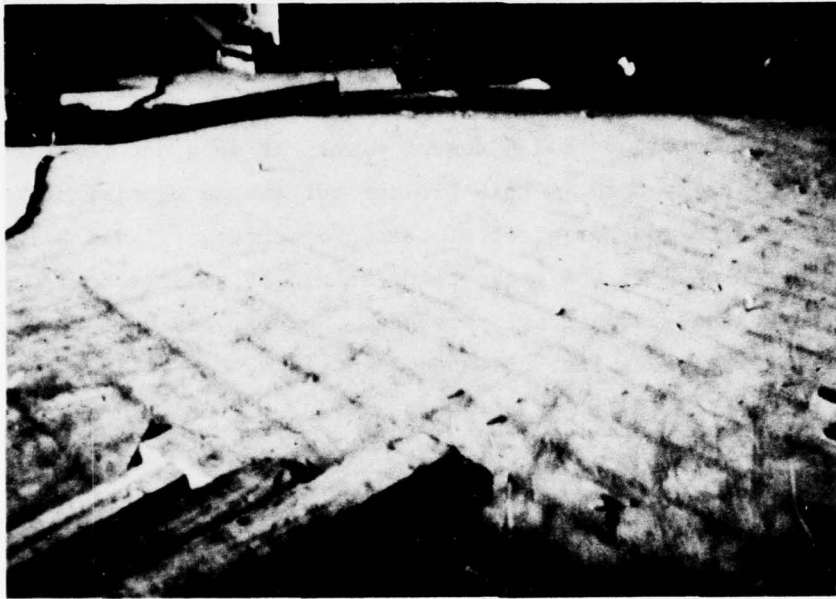
1. It was observed during construction of the building that an unusual effect developed on the upper surfaces of four of the floors. The effect was that of a square grid pattern with the sides of the squares being 1/4 to 1/2 in. lower than the rest of the squares (Figure 1). Since each square was about 8 in.* on a side, it was apparent that the pattern was outlining the upper layer of reinforcing steel bars which were intended to be 3/4 in. below the surface of the concrete. Visually this surface looked like a waffle with the ribs being low instead of high.

Figure 1. Typical grid pattern in the hardened lightweight concrete floor slabs.

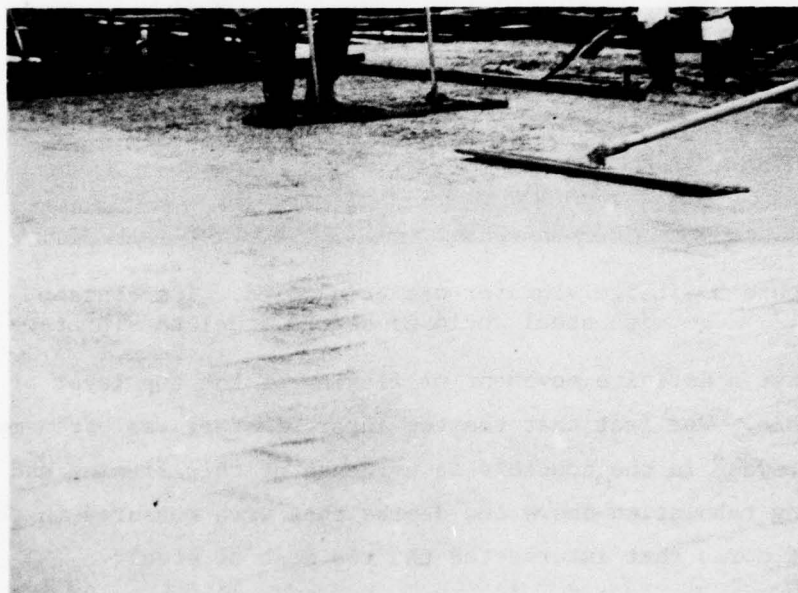
21. Study of the jobsite photographs showed that the waffle effect was clearly visible soon after the initial bull floating operation and long before the final finishing was done (Figure 2). This meant the effect was occurring somewhere between 30 minutes to 75 minutes after the concrete was batched. The short elapsed time between smoothing of the freshly placed concrete and appearance of the waffle effect made it unlikely that pronounced effects of gas generation from aluminum contamination would be seen so soon.

Figure 2. Waffle effect was visible on concrete surface almost immediately after placement.

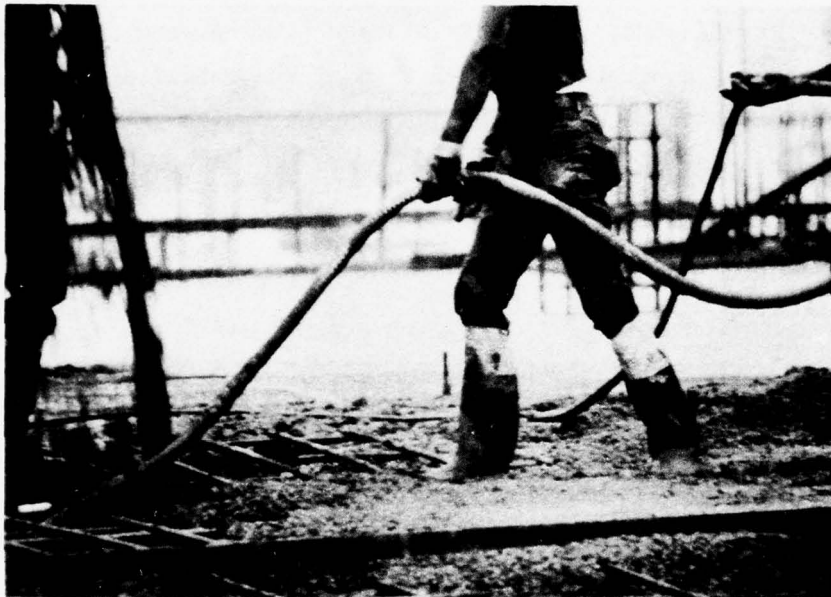
22. The photographs show that the early waffle effect or a large part of it was probably due to flexing of the top layer of steel during placement and strike-off activities adjacent to freshly smoothed areas.

One slide shows individual bars sagging beneath each foot of a worker. Another slide shows that it was almost a certainty that the vibrator being used would hit some of the top steel, causing it to transmit vibrations along its length (Figure 3). The sequence of photographs

Figure 3. Large vibrator was being used. Its contact with steel would cause the steel to vibrate.

37. The way to avoid a repetition of this problem would probably involve several steps. These would include lowering the level of the steel mat, increasing the rigidity of the upper steel mat to eliminate or reduce its ability to sag or flex, reducing the slump of the concrete, and immediate finishing (smoothing) of concrete surfaces to remove any grid pattern that might develop. The elimination of aluminum contamination might also be desirable.

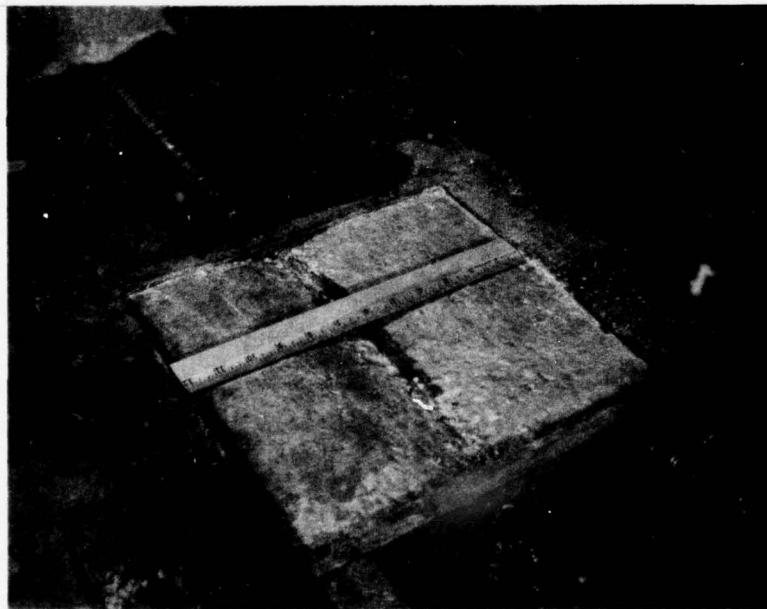
Figure 5. Typical concrete surface condition after the reinforcing steel was lowered. The indentation above the bar is visible.

26. In one of the specimens made from Batch 1, the reinforcing bar was forced down at approximately 1 hour after finishing. (Some concrete set has occurred.) In this case, a void space around the bar was developed, but no surface indentation was formed. These tests demonstrated that movement of a near-surface reinforcing bar in fresh concrete will cause a depression to form on the concrete surface.

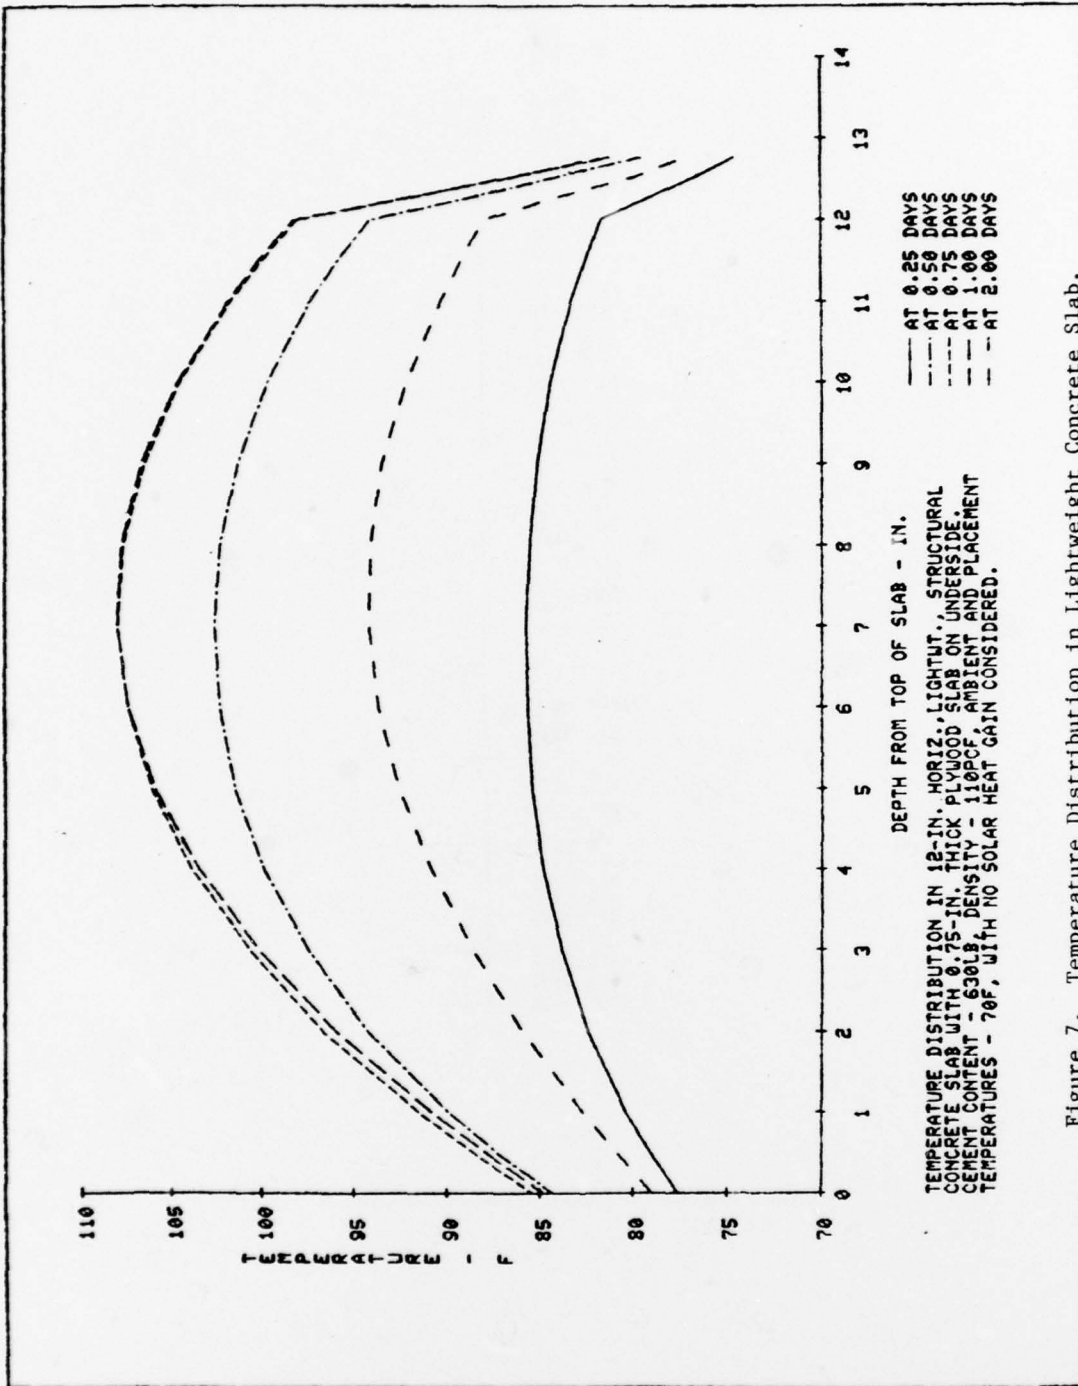
31. The calculated temperature distribution in the lightweight concrete slab is shown in Figure 7. It can be seen that peak temperatures of approximately 108°F were attained at about 19 hours after placement. The temperature history at 7 in. from the top surface (position at which peak temperature is reached) is shown in Figure 8. This temperature information was transmitted to Osborne Laboratories, Inc. through County of Los Angeles Facilities Department on 13 September 1978.

Figure 7. Temperature Distribution in Lightweight Concrete Slab.

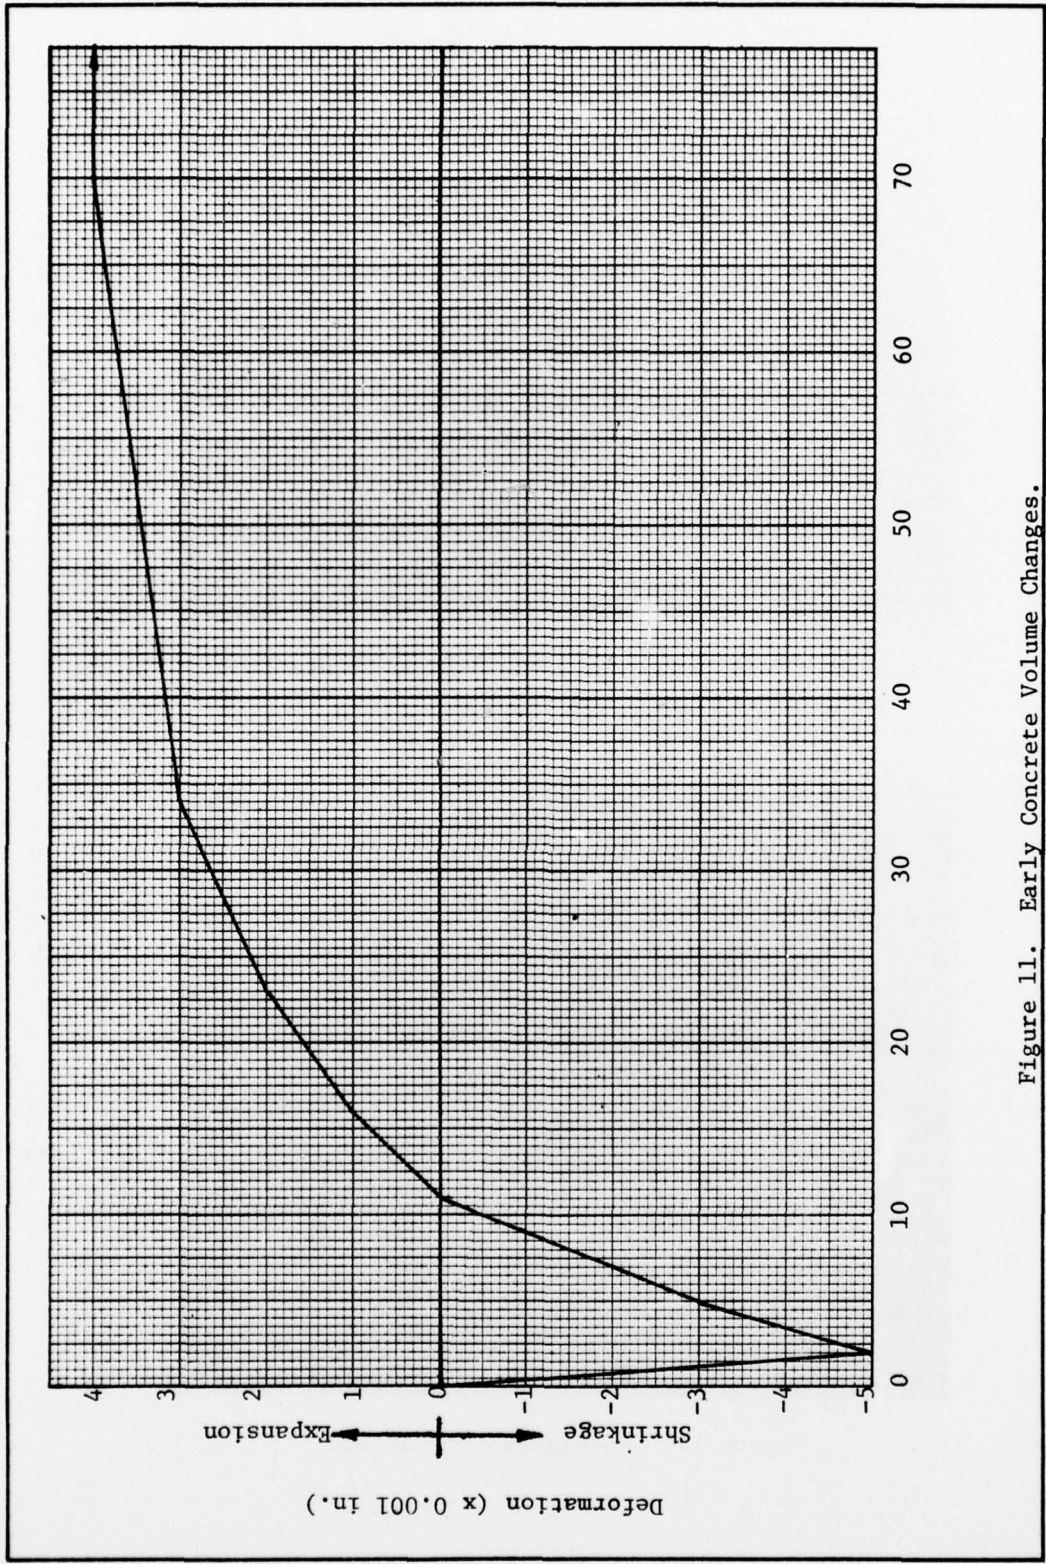
34. The test results are shown in Figure 11. It can be seen that during the first two hours, the concrete underwent a contraction (total vertical subsidence) whose magnitude was of the order of 0.005 in. Following this initial contraction, the concrete expanded due to temperature rise in the concrete. The magnitude of expansion was about 0.009 in. or a net of 0.004 in. based on the initial volume at 70 hours after casting and remained essentially constant thereafter. This recorded

Figure 11. Early Concrete Volume Changes.

expansion is approximately one one-hundredth of the relative difference in elevation of the high and low places as observed in the waffle pattern in the structure where it is most fully developed.

35. Based on the results of this test, it may be concluded that early volume growth of the lightweight concrete was not the main contributing factor for the undulation problem.
