NRL Memorandum Report 4128

Shock and Vibration Performance of an Epoxy Chocking Compound

E. W. CLEMENTS

NAVAL RESEARCH LABORATORY
Washington, D.C.

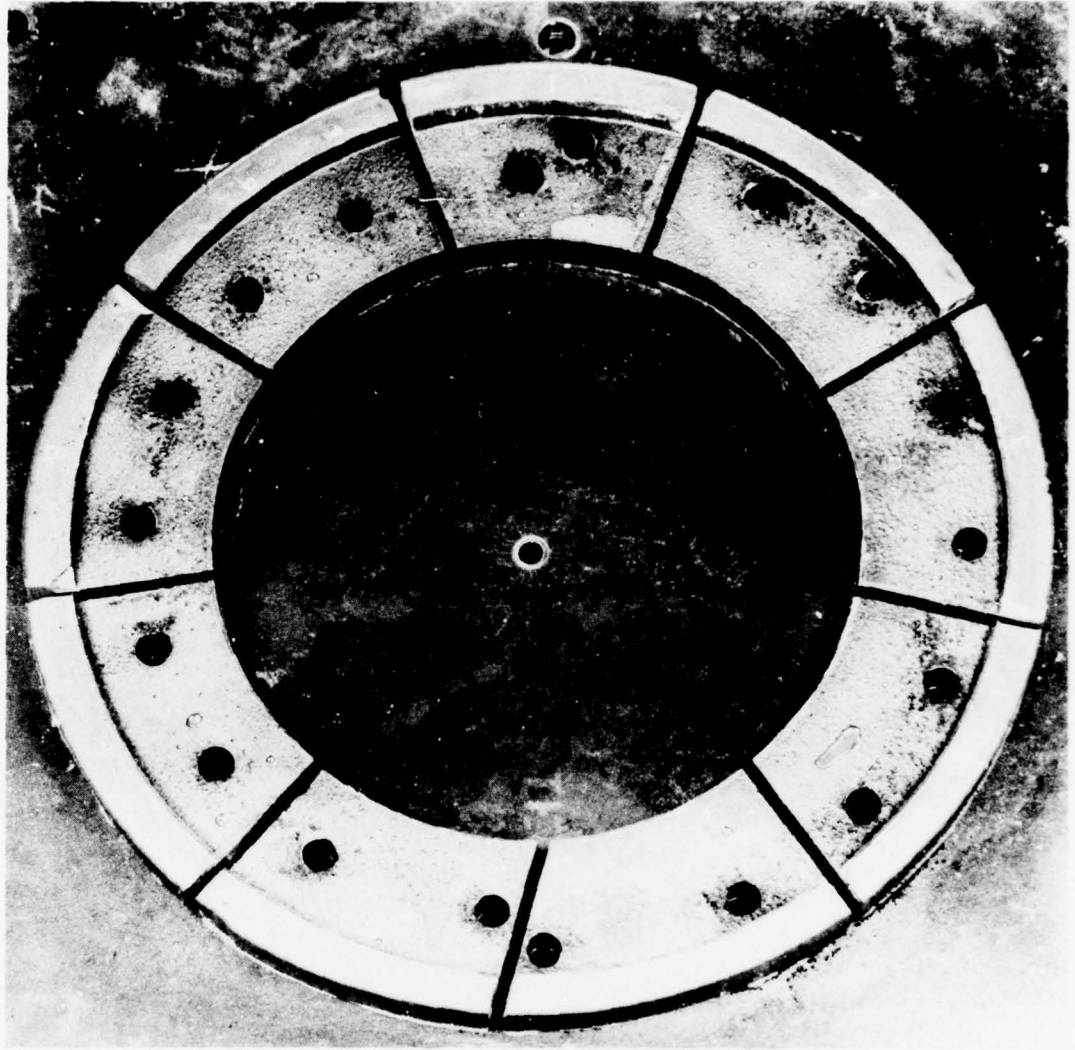
Following the vibration test, the test assembly was taken apart for inspection of the chocks. As may be seen in Figure 9 (top) and Figure 10 (bottom), no change was found in their condition, save that their bearing surfaces were somewhat grimmer. The test assembly was then put back together and mounted on the MWSM for shock tests.

Fig. 9 — Top surface of the chock pads of Test Structure No. 1 following vibration test

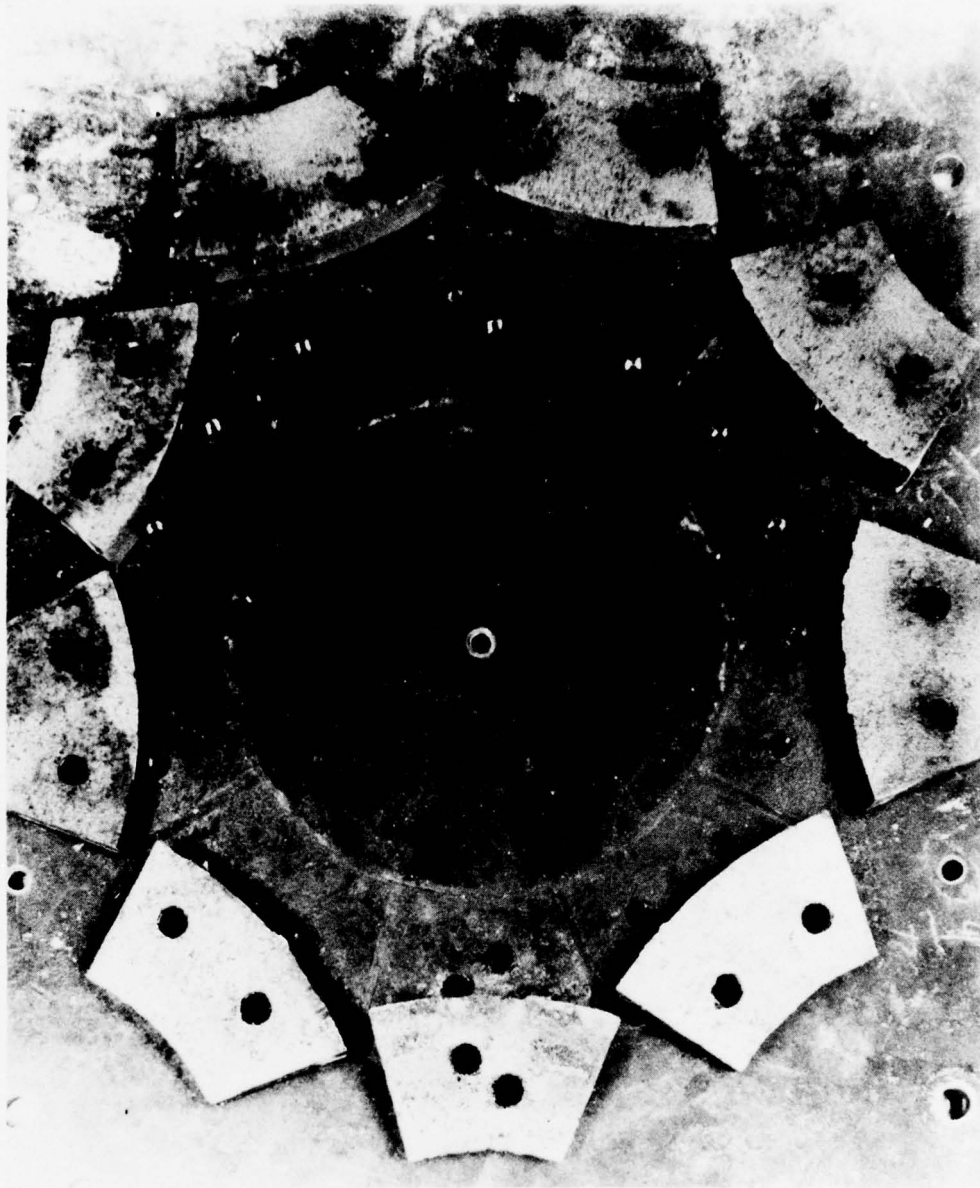
Fig. 10 — Bottom surface of the chock pads of Test Structure No. 1 following vibration test

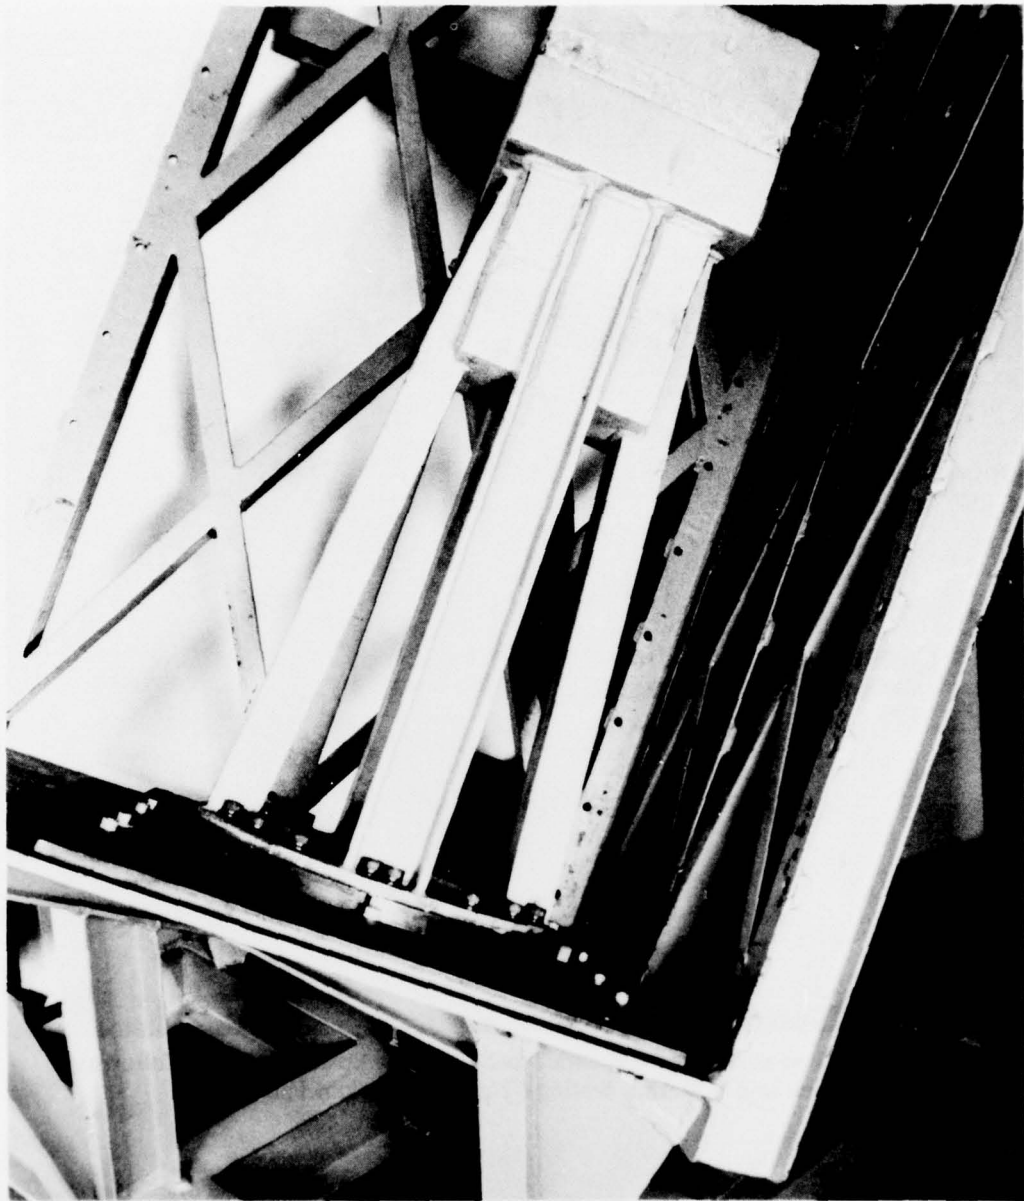
It was observed that the overpour ridge of Pad No. 3 at the end adjacent to Pad No. 4 had moved outward from the edge of the mounting ring. Closer inspection revealed a crack in the bearing section of Pad 3 at this end just outside the mounting bolt. No similar crack was found at the other end of the pad, but as the overpour was visibly separated from the edge of the mounting ring for a third or more of its length, it would be safe to assume that the observed crack extended at least as far.

Fig. 13 — Damage from shock. After the regular shock test of Test Structure No. 1 had been completed, two additional blows were delivered with the mounting bolts loosened. A section of Pad No. 3 broke off and slid out from under the mounting ring. It may be seen resting against the heads of the row of bolts securing the mounting plate to the 30°-Corner Bulkhead.

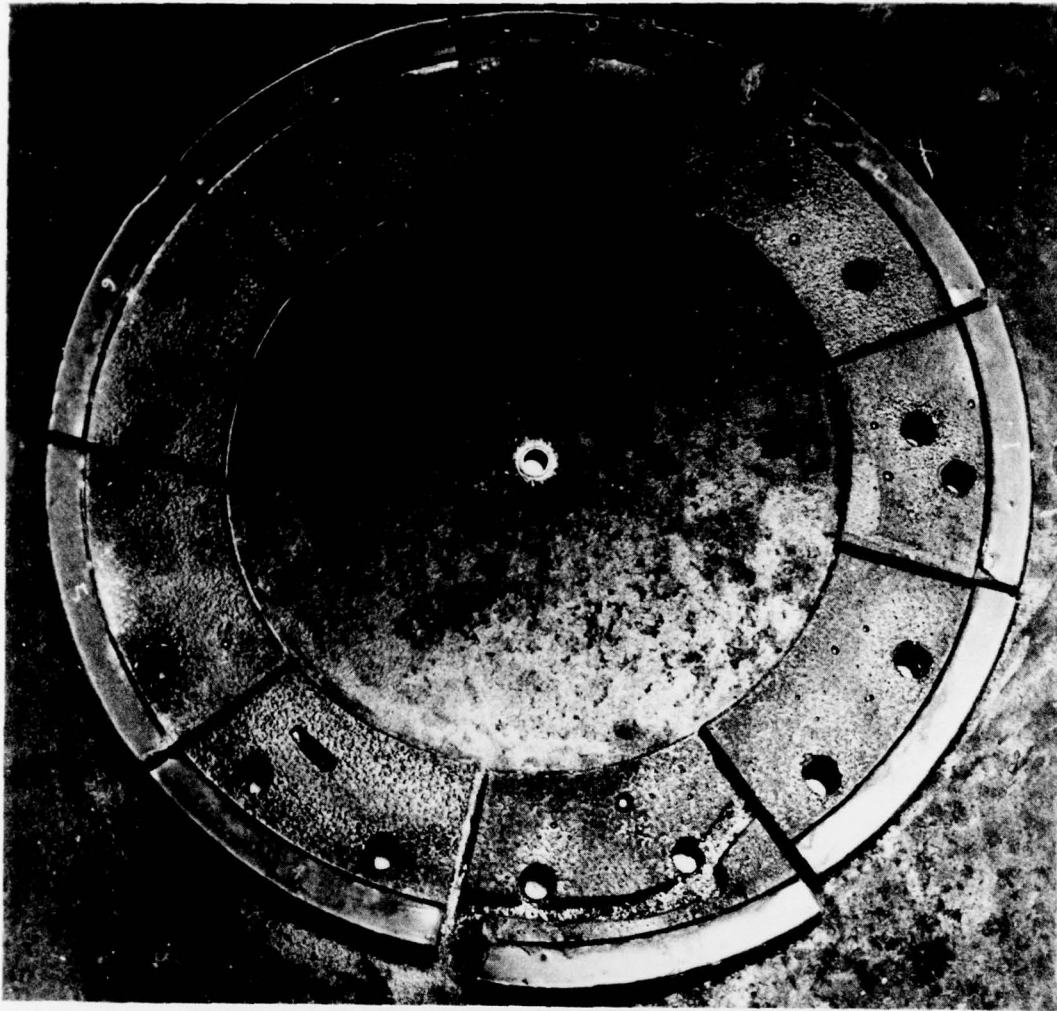
The test assembly was then removed from the MWSM and disassembled. The top and bottom views of the chocks are shown in Figures 14 and 15, respectively. As may be seen, the loss of the broken-off portion of Pad No. 3 did not entail much reduction in its load bearing area, and would not have impaired alignment of the mounted item. Note, however, that while the circumference of one bolt hole (the upper in Figure 14) is substantially intact, that of the other is about half gone. As it exists, this crack might allow the remaining portion of the pad to pivot on the upper bolt until its ends bound against those of the adjacent pads, which would cause little additional loss of bearing area and still no effect on alignment. A slightly different crack trajectory could easily have split both bolt holes, and perhaps allowed the pad to be lost completely. Given the overall chock configuration, it is questionable if even this event would lead to significant loss of bearing area or alignment in practical situations.

It should be noted that there can be no absolute certainty that the cracking of Pad No. 3 did not occur, or at least initially, on an earlier blow. A crack in that location would be extremely difficult to detect without disassembly. Blow 7, in the inclined orientation with loosened mounting bolts, was the first which would be likely to allow the separation of pieces which led to the detection of the crack. By the same token, it was the first blow which would be likely to cause such a crack, as the loosened bolts would allow the Test Structure to shift down the slope during the upward acceleration of

Fig. 14 — Top surface of the chock pads of Test Structure No. 1 following shock and vibration testing. Note the broken Pad No. 3.

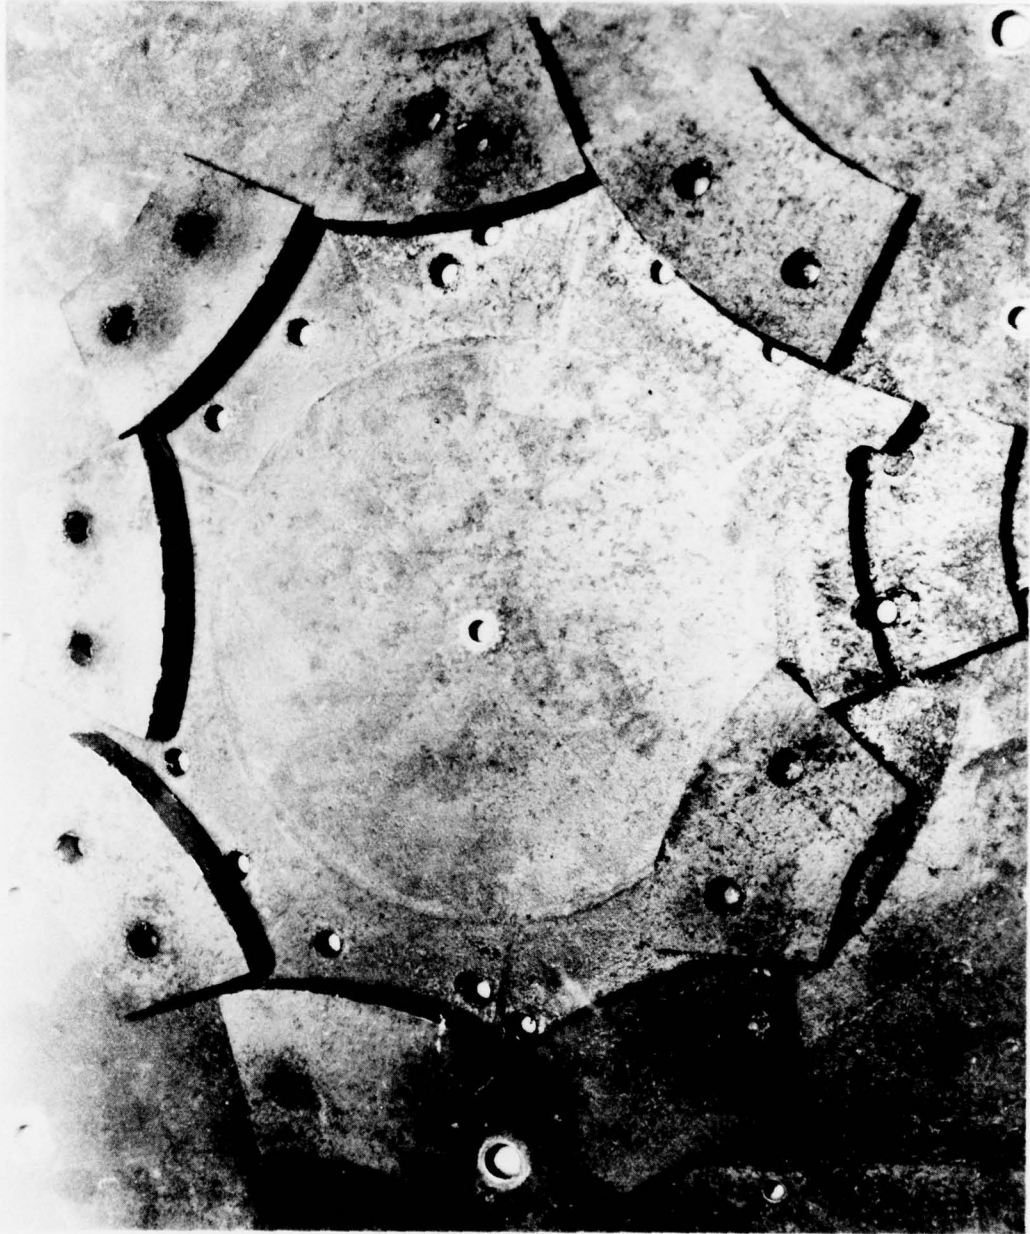
Fig. 15 — Bottom surface of the chock pads of Test Structure No. 1 after shock and vibration testing

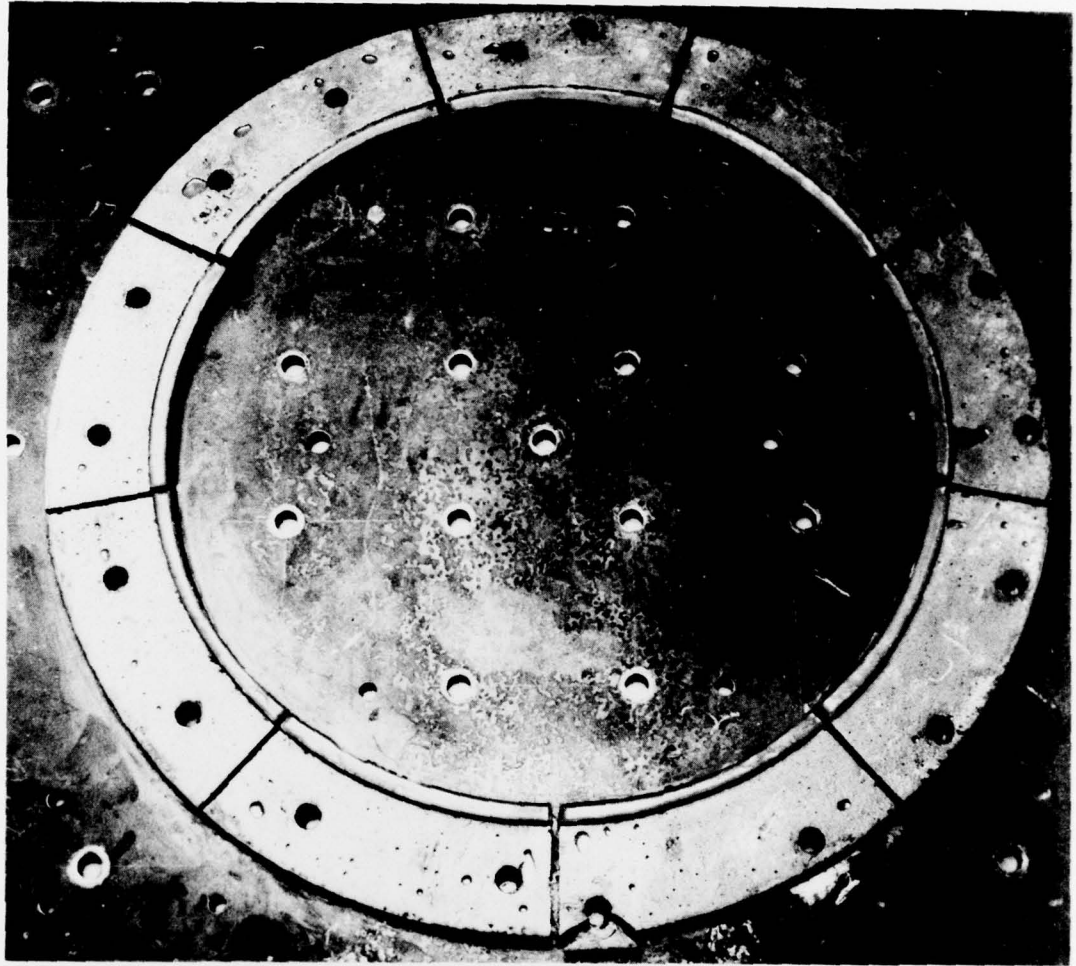
For this blow, the mounting bolts were loosened completely, then tightened finger-tight. With this condition, a triangular segment chipped out of Pad No. 2 from the outside of the bolt-hole adjacent to Pad No. 3 (Figures 23, 24).

The test assembly was then taken apart and the top (Figure 23) and bottom (Figure 24) surfaces of the chock pads photographed. With the exception of the small piece chipped out of Pad No. 2, the condition of the pads seems little changed by the shock test. The

damage noted would cause a miniscule decrease of load-bearing area, and would not be likely to impair alignment of a mounted item. The affected pad conceivably could rotate about the bolt through the intact hole, but with this chock pad configuration could do so only to a small degree.

Fig. 23 — Top surface of chock pads of Test Structure No. 2 after shock and vibration tests. Note chip broken out of Pad No. 2 during extra blows

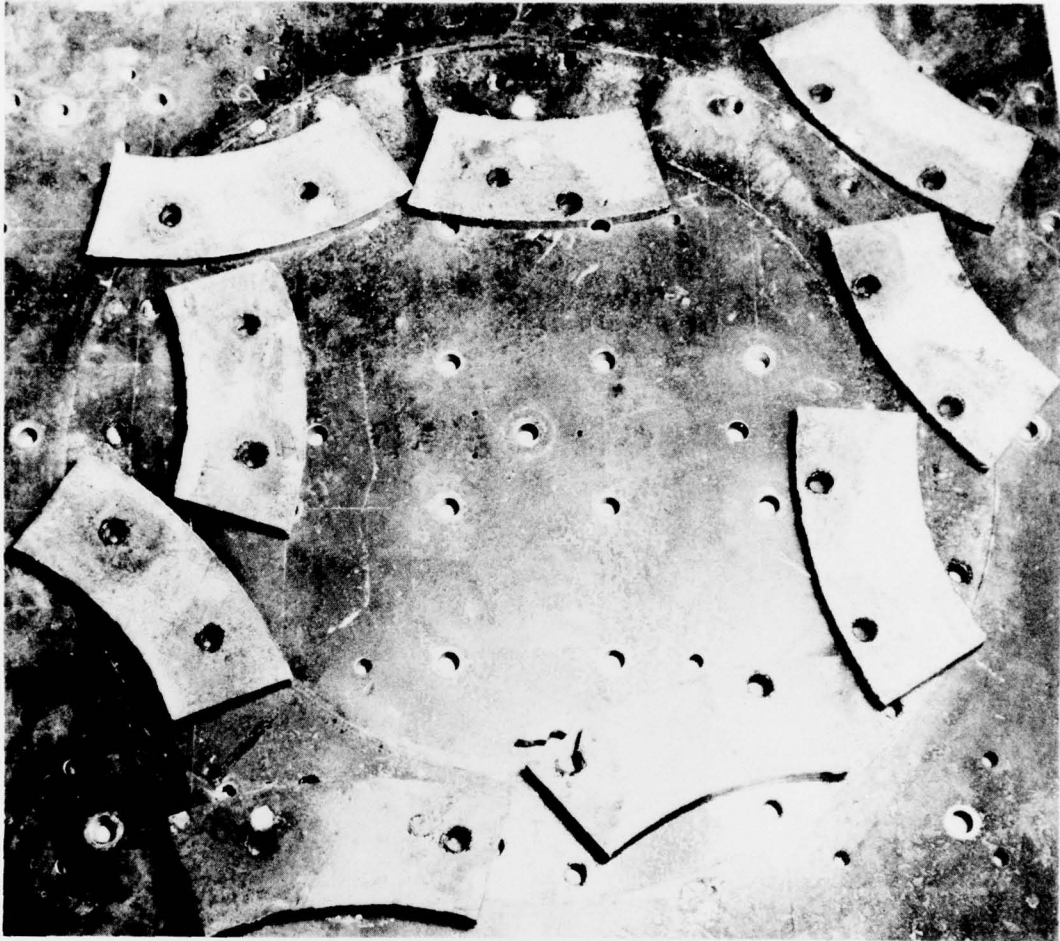
Fig. 24 — Bottom surface of chock pads of Test Structure No. 2 after shock and vibration tests
