HOT ISOSTATIC PRESSING REJUVENATION OF DISKS

AiResearch Manufacturing Company of Arizona  
111 South 34th Street  
Phoenix, Arizona 85010

July 1979

TECHNICAL REPORT AFML-TR-79-4093

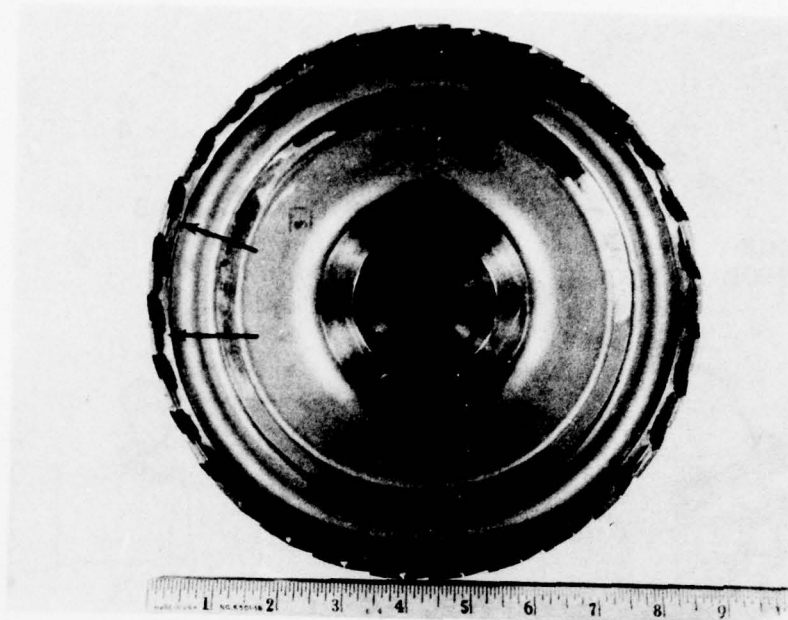
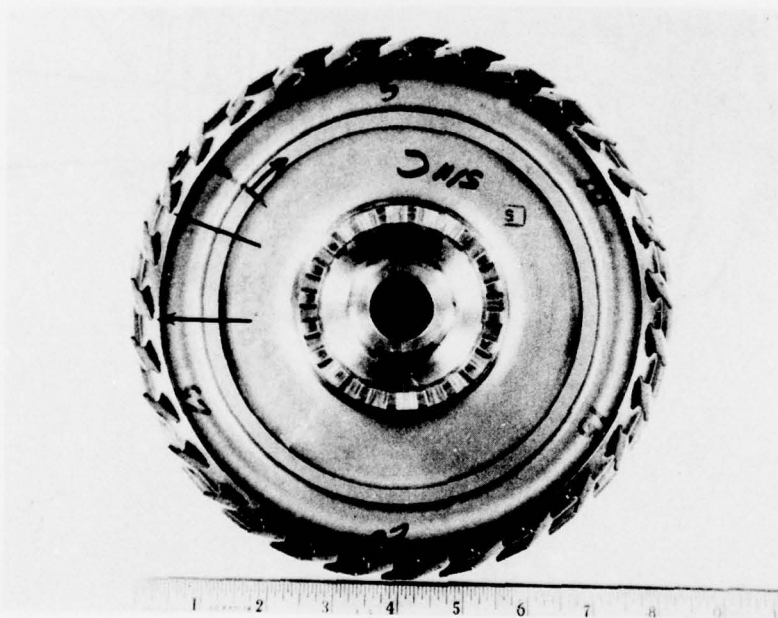
Figure 2. Retired First-Stage Compressor Disk from an AiResearch Model TSCP700 APU. Arrows Show Typical Locations of Fatigue Cracks.

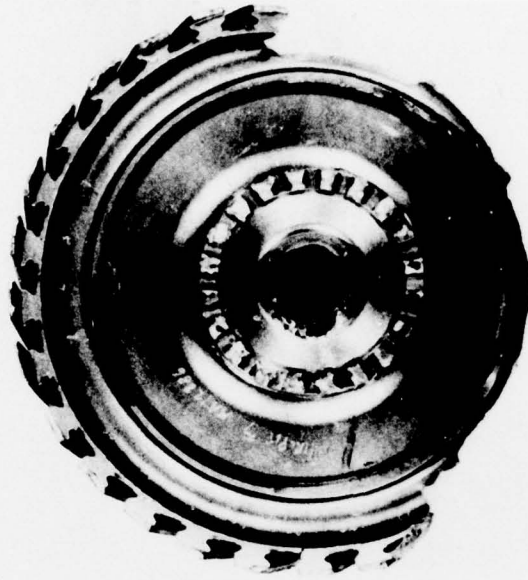
Figure 8. Ti-6Al-4V Compressor Disk Showing a Relatively Large Crack which has Propagated to the Surface (Left, Arrow) and the Result of Prolonged Cycling with a Crack Evident (Right) on the Surface.

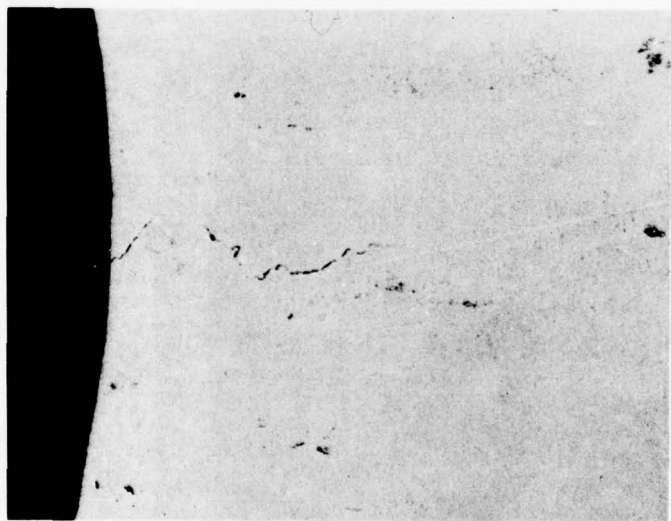
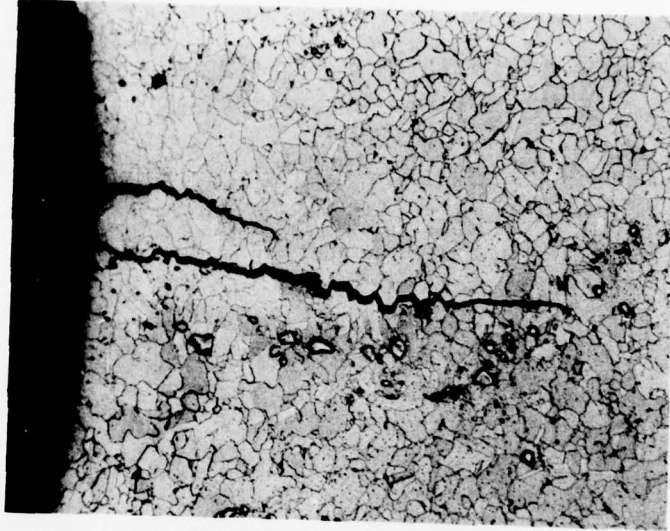
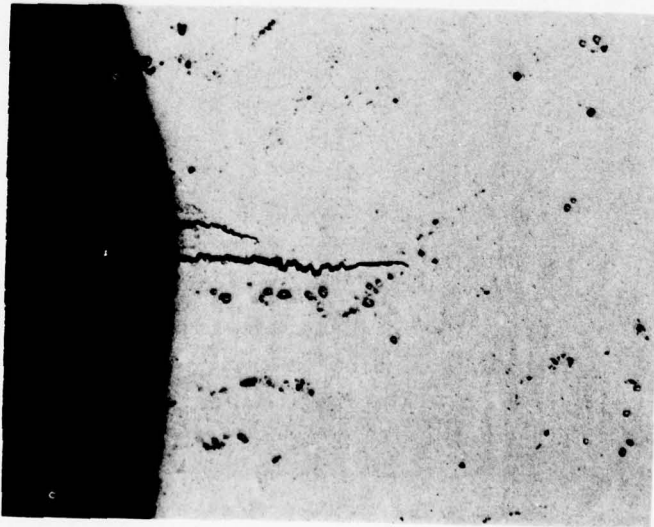
Figure 23. Low-Cycle-Fatigue Cracks Detected in Field-Service Disk Serial No. 90149A.

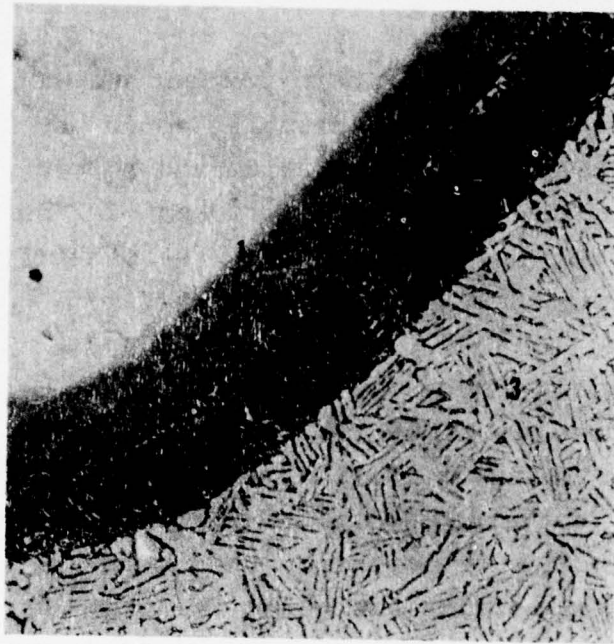
DISK NO. 4829 DOVETAIL NO. 16

The layer was identified, using TEM thin-film techniques, as stabilized beta with a fine distribution of small alpha and/or  $Ti_2Cu$  precipitates. Copper is a strong beta stabilizer. This beta layer was present on the internal surfaces of the dovetails but changed on the outside diameter of the disk. It appeared to be replaced by a white etching layer, as shown in Figure 42. Figure 43 shows Scanning Electron Microscope (SEM) images of the corner of a dovetail showing this transition from stabilized beta to the unidentified layer. X-ray analysis in the SEM detected a slightly higher copper content in the OD layer than in the beta, but was unable to detect other chemical differences due to the

Figure 40. Microstructure of HIP Rejuvenated Ti-6Al-4V Compressor Disk Dovetail Corner.

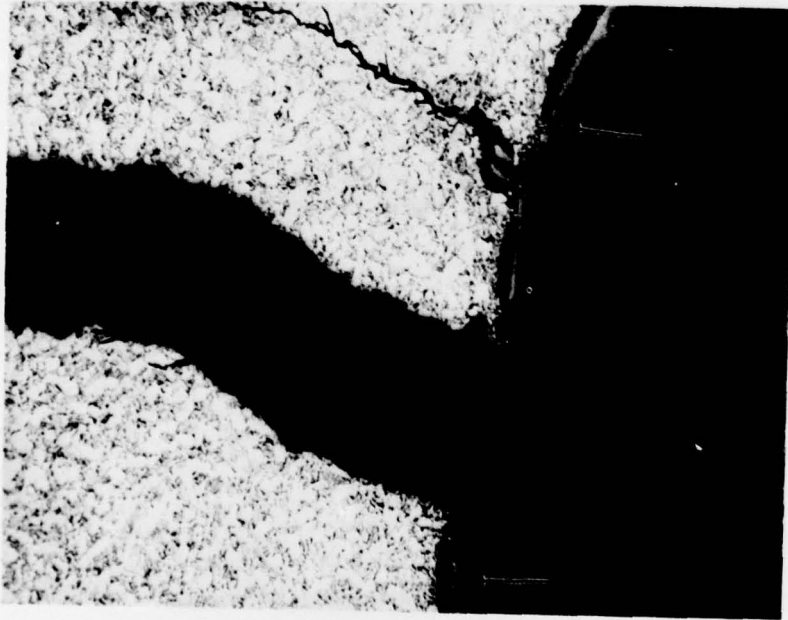
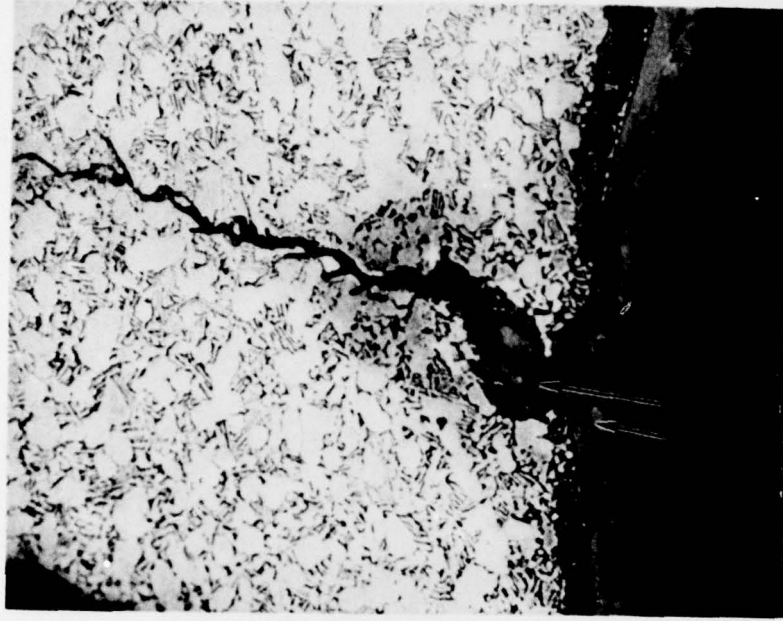
Figure 44. Cracks in Ti-6Al-4V Alloy Compressor Disk.  
A - Large Crack that was not Bridged Plus Small Crack.  
B - Small Crack from A with Bridge Material Forced into Crack.  
- Arrows Show Bridge Material.

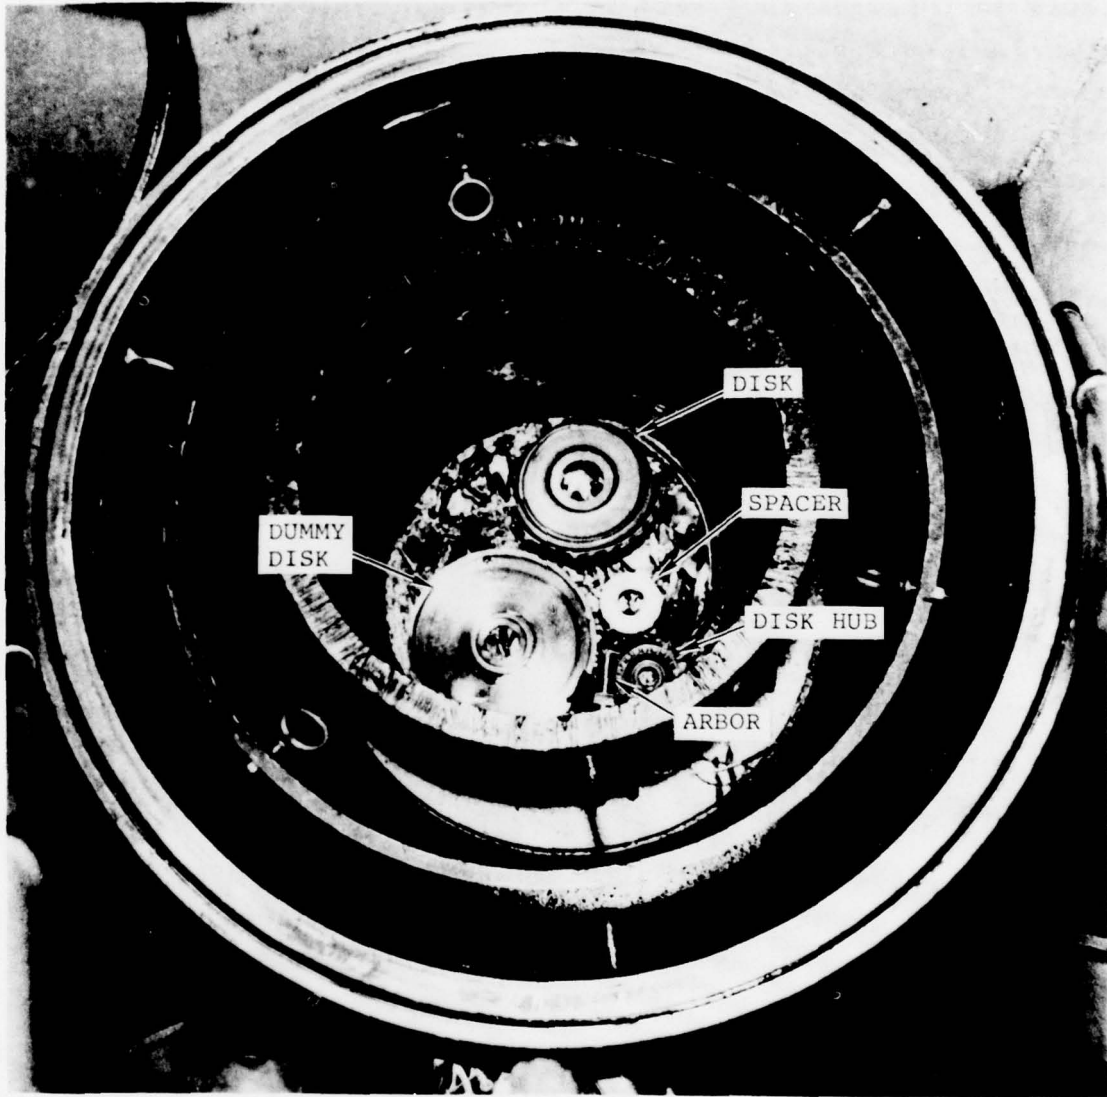
Figure 52. Ti-6Al-4V Alloy Compressor Disk S/N 717 Failure After 1410 Cycles in the Cyclic Whirlpit.

Prior to additional spin testing, the decision was made to attempt to remove the brittle stabilized beta layer by either chemically milling or utilizing a heat treatment that could possibly homogenize the microstructure. However, solution treatments at 1650°F and 1825°F were not successful in diffusing the copper out of the beta layer and the resultant microstructure

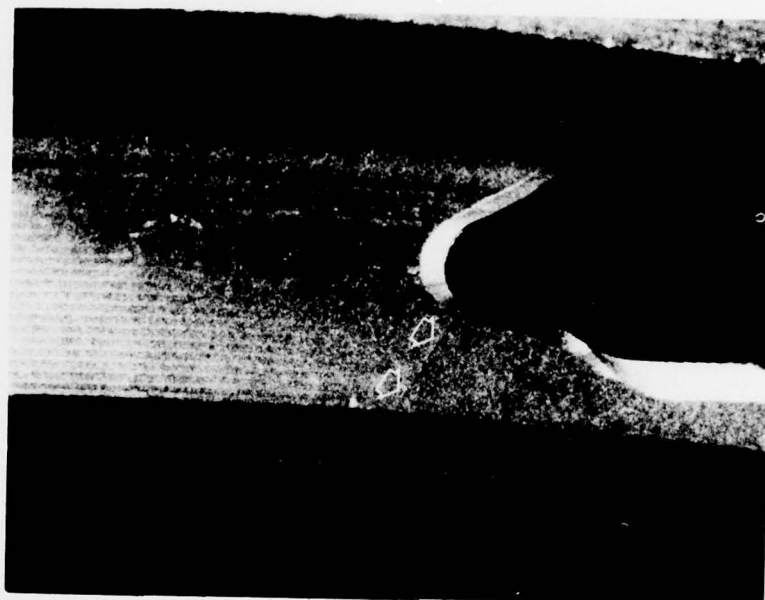
Figure 53. Crack Extending from the Dovetail on the Face of HIPped Compressor Disk S/N 4843. (Arrows Show Crack) MAG: Approx. 3X.

The early crack initiation could have been caused by a number of conditions; (1) surface contamination during HIP, (2) chemistry changes on the surface, and (3) relaxation of the residual stresses caused by the original machining and broaching of the disk dovetails. To investigate these possibilities, detailed Scanning Electron Microscope (SEM) analyses, Auger Spectroscopy,

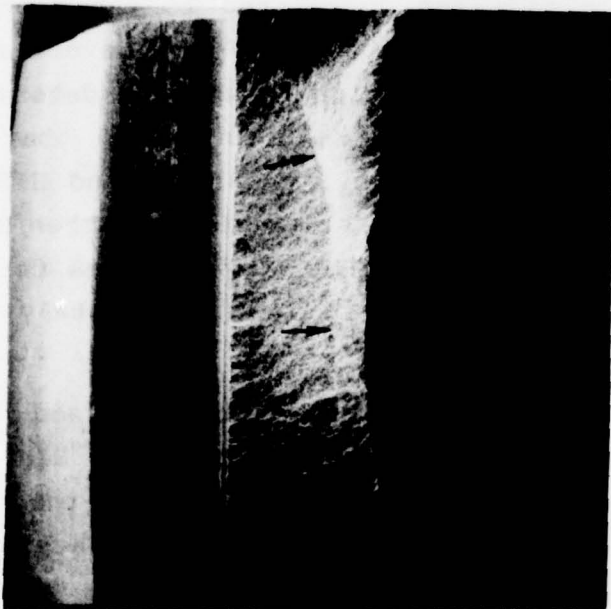
IMAGE 1

Crack in Dovetail No. 15.

Arrows Show Progression of  
Fatigue Crack.

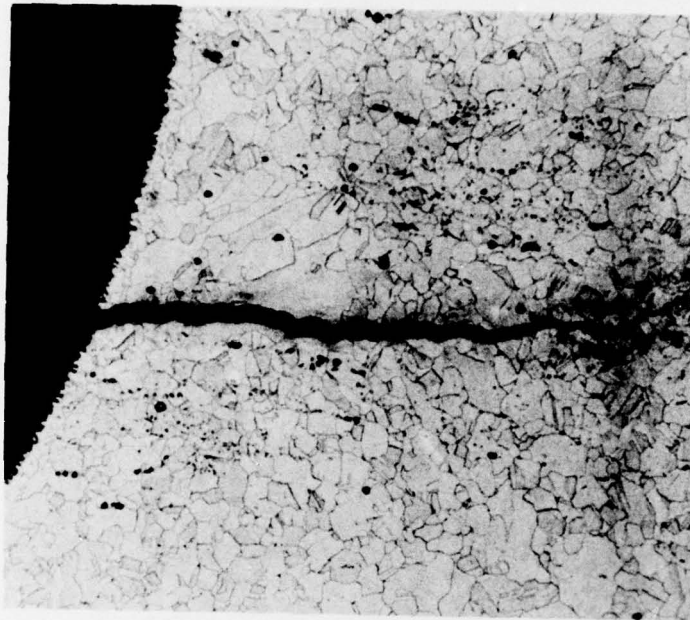
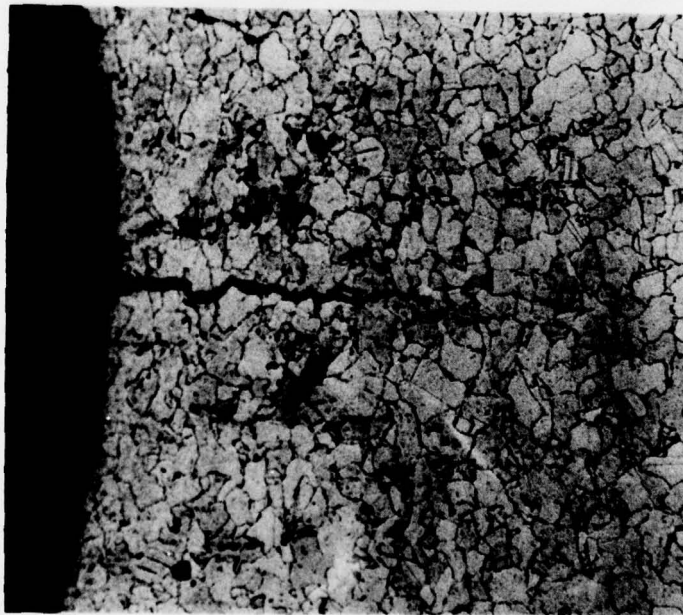
Figure 57. Appearance of Fatigue Cracks at the Base of Firtrees in Field-Service Disk Serial No. 90149A and in Cyclic-Spin Tested HIPped Disk Serial No. 2909. Mag.: 200X
