**EVALUATION OF AIRCRAFT WINDSHIELD MATERIALS  
IN A SIMULATED SUPERSONIC FLIGHT ENVIRONMENT**

J.B. HOFFMAN  
Douglas Aircraft Company  
McDonnell Douglas Corporation  
3855 Lakewood Boulevard  
Long Beach, California 90846

JUNE 1979

TECHNICAL REPORT AFFDL-TR-79-3058

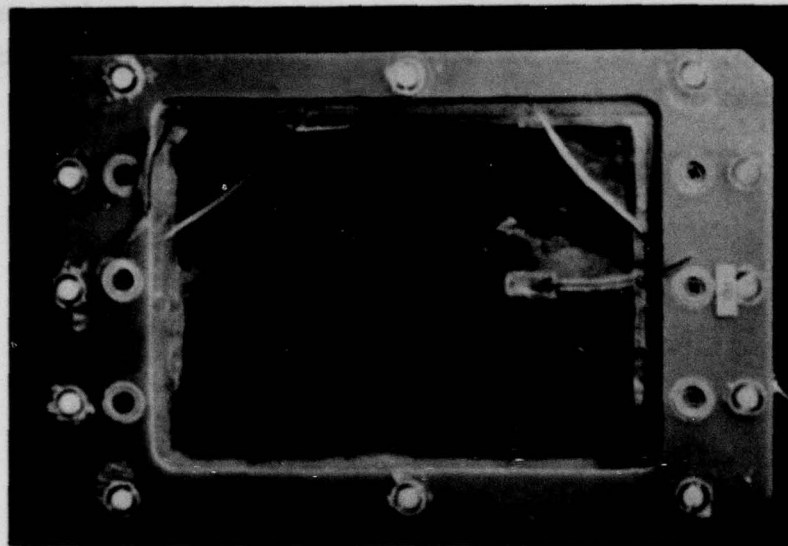
Figure 37. Post-Test Photo of Specimen GY21.

The acrylic face ply of GY21, shown in Figure 37, had been cracked in two places during fabrication. These cracks expanded during the Mach 2.4 tunnel injection and precipitated face ply delamination.

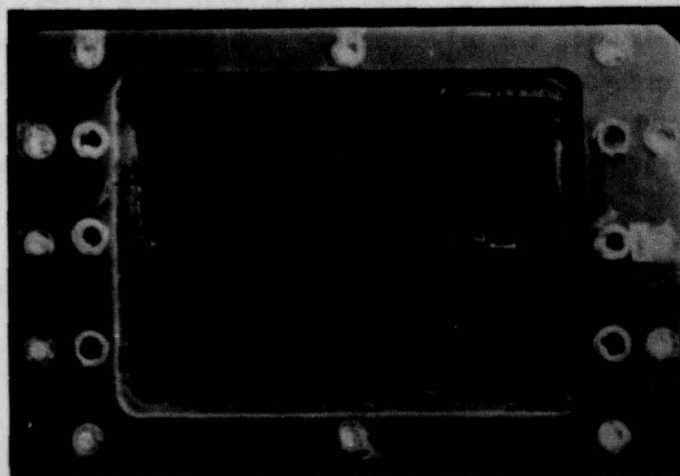
Figure 38. Post-Test Photo of Specimen GY22.

The rabbeted area of GY22, Figure 38, ruptured along the aft edge during the Mach 2.6 exposure and exposed the interlayer. Face ply delamination spread across most of the surface. The fiberglass filled polycarbonate bushings (part of the edge attachment system) melted and flowed around the screws.

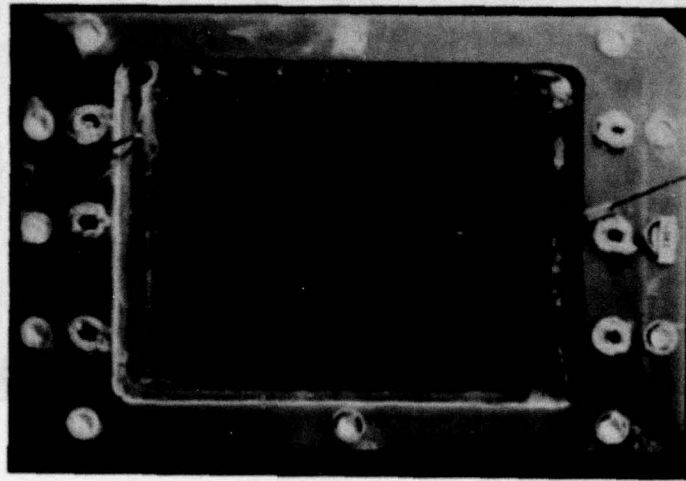
Figure 39. Post-Test Photo of Specimen GY23.

GY23, Figure 39, reacted similarly to GY22. Holes were burned in the rabbeted area of the face ply and the bushings melted during a Mach 3.0 exposure. This specimen also had a cracked face ply due to fabrication procedures. The face ply became very rough. Delamination occurred only around the edges of the face ply.

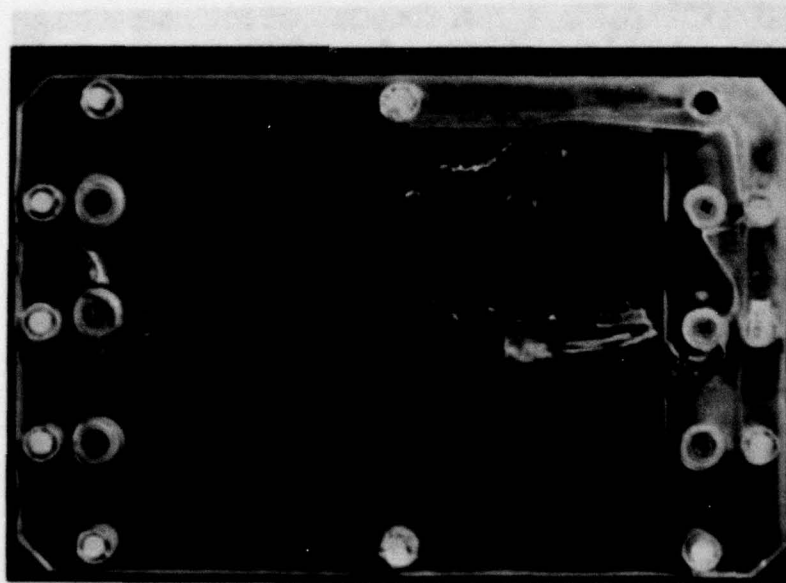
Figure 40. Post-Test Photo of Specimen GY24.

Specimen GY24 is shown in Figure 40. After the first Mach 2.4 injection slight delamination was visible in the area of the bolts. During the second

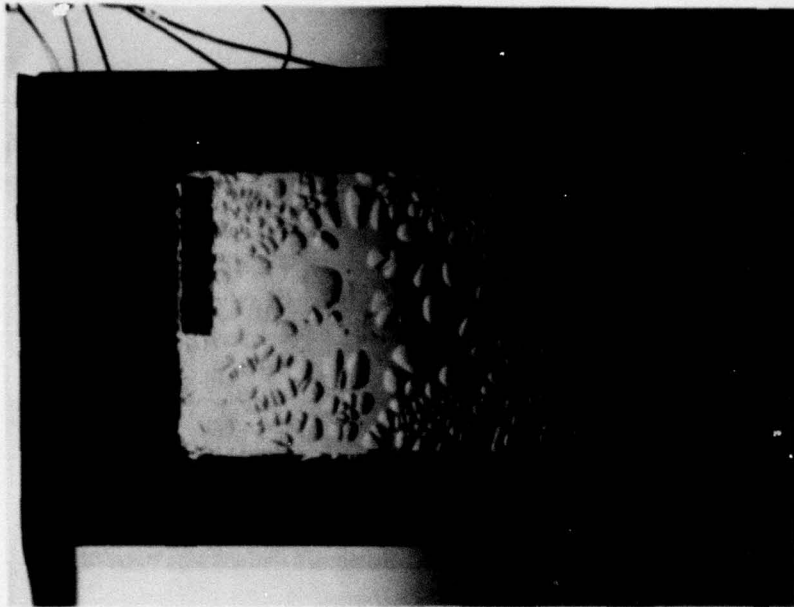
Figure 45. Post-Test Photo of Specimen PPG22A.

Specimen PPG22A (identical to PPG22) sustained severe interlayer bubbling during its initial tunnel injection at Mach 2.6 and was retracted early. The flat shaped bubbles are apparently at the face ply/interlayer interface, and are shown in Figure 45.

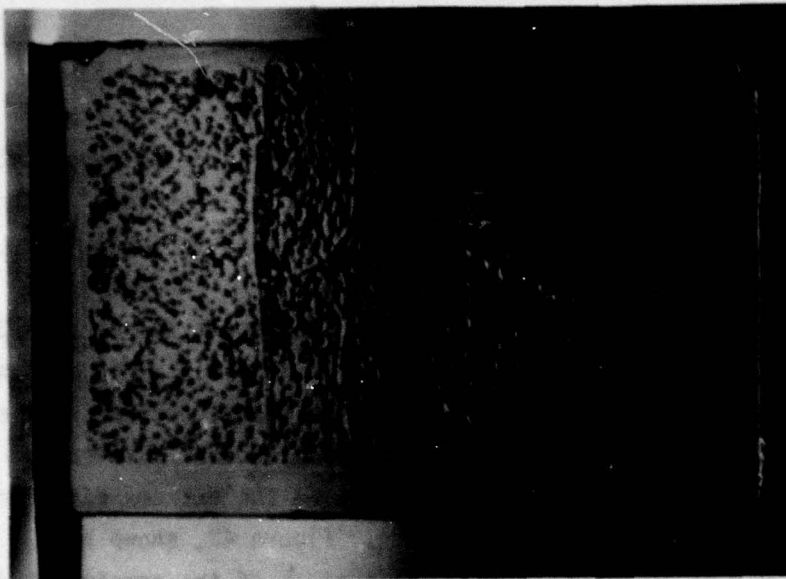
Figure 47. Post-Test Photo of Specimen TEX21.

SPECIMEN	EXPOSURE TIME (MIN.)			DESCRIPTION OF SPECIMEN DAMAGE	EDGE DEFORMATION
	2.4	2.6	3.0		
TEX21	5			Hazing occurred at 1 minute on right hand side (looking forward). No change after 1.5 minutes.	Slight
	10			No Change.	
			1	Severe bubbling of outer surface occurred immediately.	
TEX21A		5		Slight bubbling occurred on outer surface. Aft corner deformed and bubbles in polycarbonate. Approximately 5 cracks appeared in outer surface, 3 to 4 inches long, resembling "dry mud" cracks. Very fine ripples occurred on surface along forward and aft edge where frame ended.	Yes
