Forest
Products
Laboratory

Research
Paper,
FPL 342
1979

**Structural Sandwich Performance
After 31 Years of Service.**

Structural Sandwich Performance After 31 Years of Service

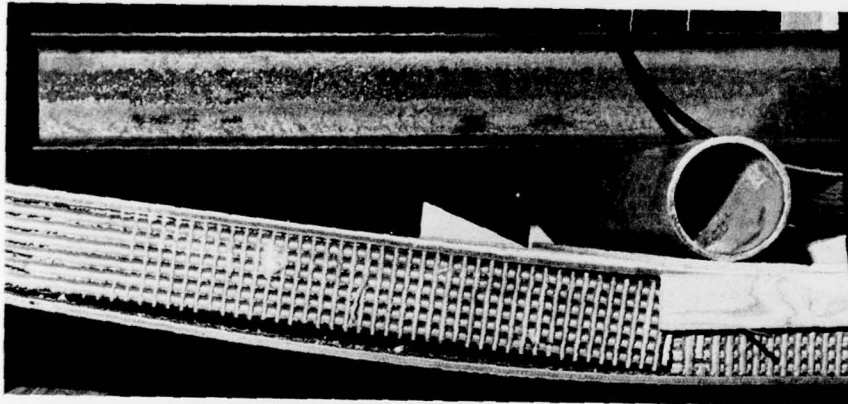
sandwich panels failed as a result of shearing in the core material. Particularly in plywood-faced panels with corrugated paper honeycomb core, shearing would occur in the core material alongside the glue line (fig. 14). Only in one pair of plywood panels (7N1, 7S1) was there evidence of failure in the glue bond itself (fig. 15).

Figure 14.—View of shear failure in the paper honeycomb core material along the glue line in a panel faced with plywood (panel No. 1N1). (M 147 103-7)

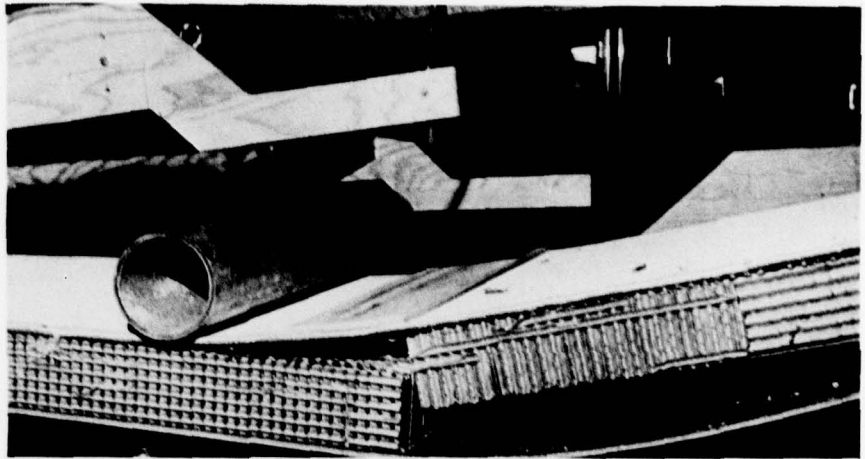
Figure 15.—View of shear failure in a panel with corrugated paper core and plywood facing. Some failure in glue bond was evident. Note that the shearing surface changes from lower inside facing to top at the point of interface between two sections of core material (panel No. TN1). (M 147 104-1)

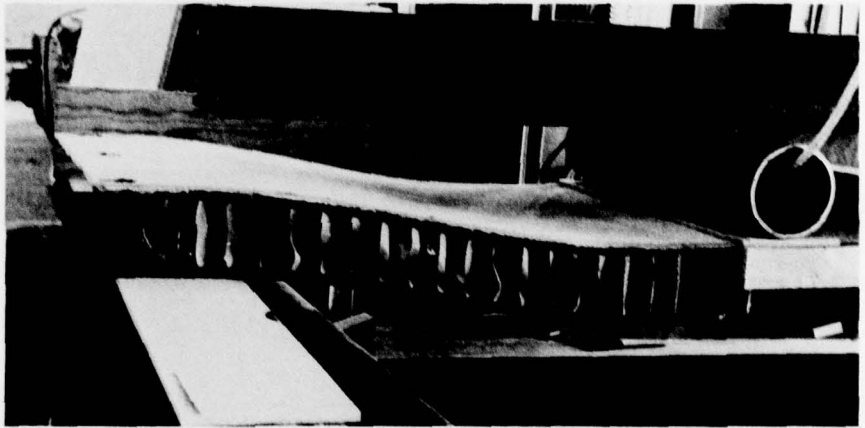
In the fiberboard-faced panels (3N4, 3S4), a layer of fiberboard had pulled away, with the bond between glue and fiberboard completely intact. Failure in these two panels was accompanied by wrinkling of the core material (fig. 16), which was frequently the case with the expanded type of paper core.

Figure 16.—View of failure due to shear in a panel with fiberboard facings and expanded type of core (Panel No. 3S4). (M 147 139-11)

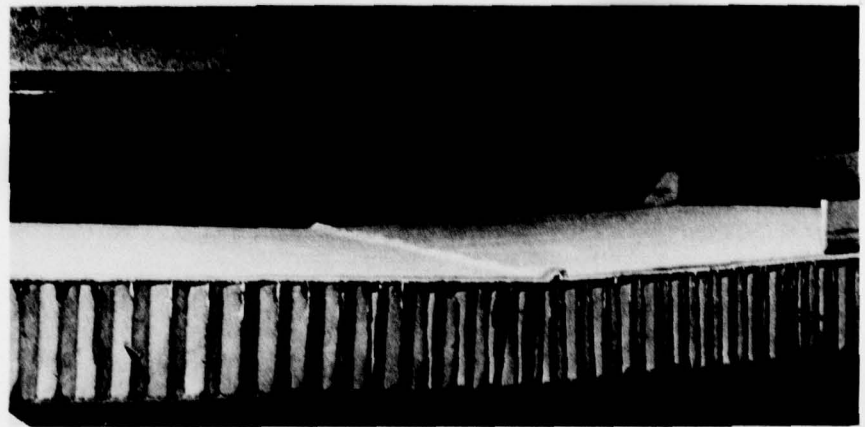
Aluminum-faced panels failed in local buckling in the top compression facing by suddenly bulging out from the core. Close observation revealed that when the facing had separated from the core, the adhesive had not adhered to the aluminum surface. Paperboard-faced panels also failed in compression of the top facing that resulted in local buckling (fig. 17).

Figure 17.—View of failure in paperboard facing due to local buckling on compression side (Panel No. 1N2). (M 147 103-1)

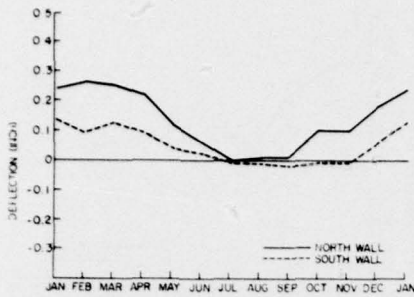
Among panels faced with wood-based products, plywood panels with paper cores bowed the least with a maximum outward bow of about 1/4 inch during the winter months. However, plywood-faced panels with polyurethane and polystyrene cores bowed much more, perhaps due to a greater moisture content differential between inside and outside facings. The average bowing throughout the year is minimal in aluminum-faced panels.

Figure 18.—Seasonal bowing of plywood-faced panels with paper cores (15-year average).

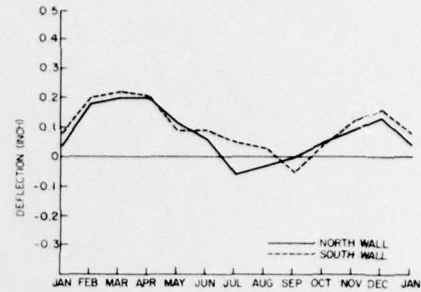
Paperboard-faced panels (4 inches thick).—Bow of north and south panels was almost identical with maximum outward bow during the winter months

of 2/10 inch and with a slight inward bow in late summer (fig. 24).

Figure 24.—Seasonal bowing of paperboard-faced panels (4-year average).

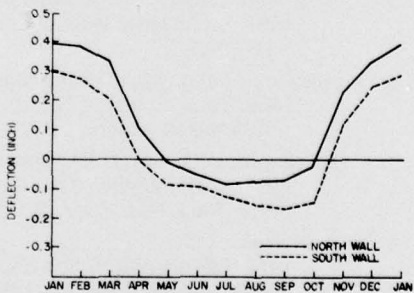
Particleboard-faced panels (8N3, 8S3).—North and south panels bowed in similar patterns, the north panel reaching a maximum at 4/10 inch and the south panel at 3/10 inch in January (fig. 23). Both panels bowed inward slightly during the warmer half of the year.

Figure 23.—Seasonal bowing of particleboard-faced panels (8N3, 8S3) (3-year average).
