CALIFORNIA BLACK OAK DRYING PROBLEMS AND THE BACTERIAL FACTOR.(U)

Research
Paper
FPL 344
1979

6 **California Black Oak
Drying Problems and
The Bacterial Factor.** 12

10 James C. Ward
Dell Shedd

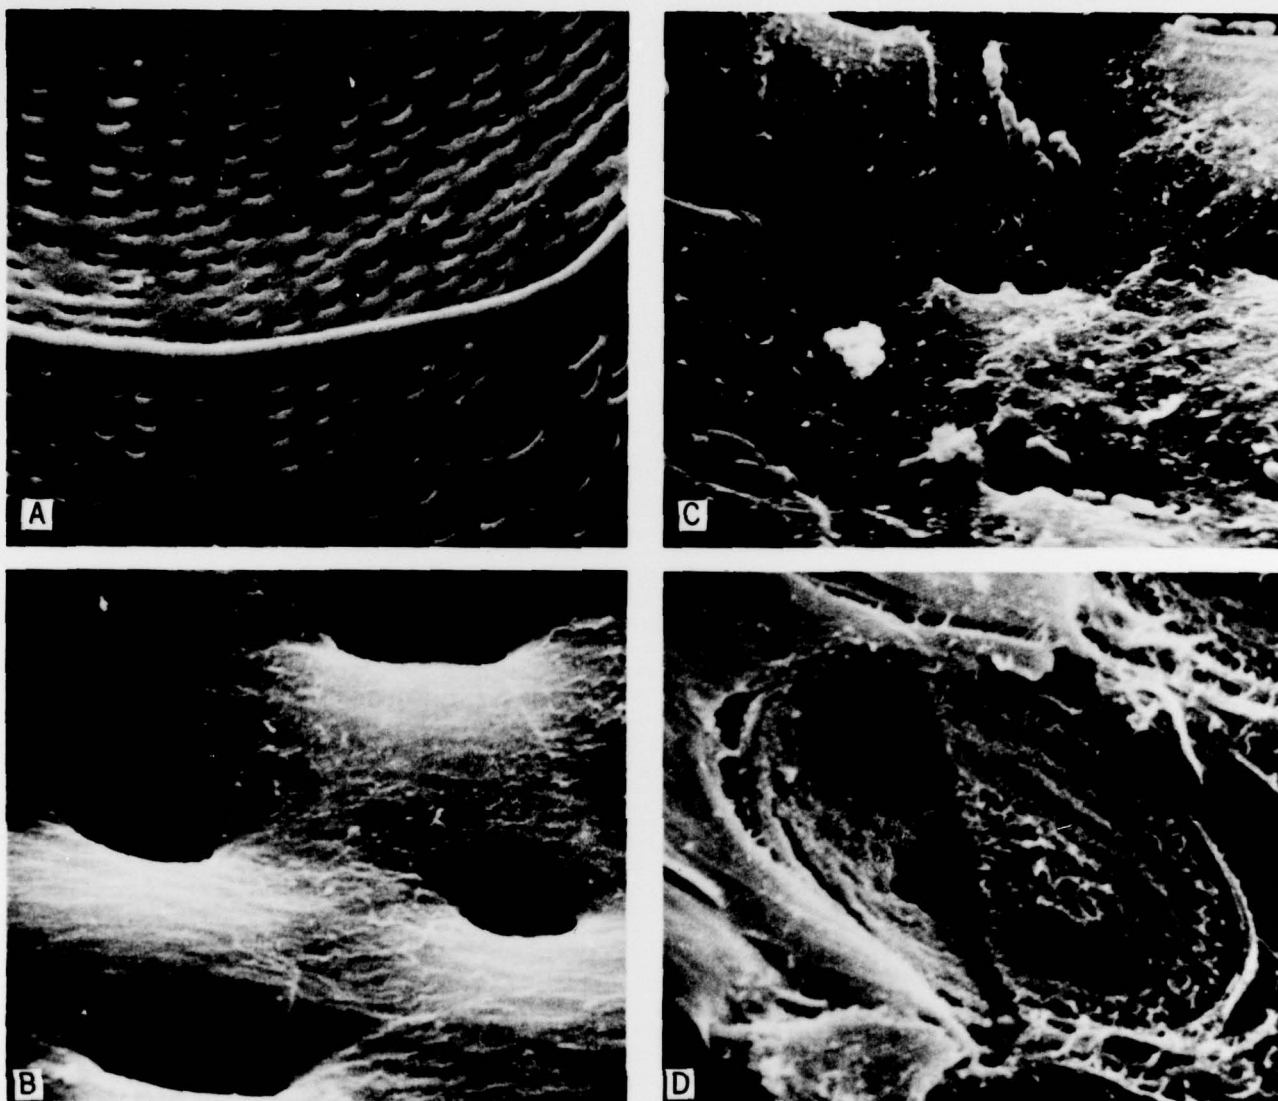
Figure 1.—Scanning electron micrographs of noninfected sapwood (A-B) and bacterially infected heartwood (C-D) from living California black oak trees. Spore of *Clostridium* sp. within the bordered pit in D. (M 147 430, M 147 428, M 147 429, M 147 428)

California black oak trees can be infected by anaerobic bacteria in a manner similar to that reported for eastern red and black oaks (Ward 1972, Ward *et al.* 1972). Results from both the large-scale mill study and the FPL laboratory study indicate that the bacterially infected heartwood can be related to the unexpected occurrence of drying degrade from honeycomb, ring failure, and collapse.

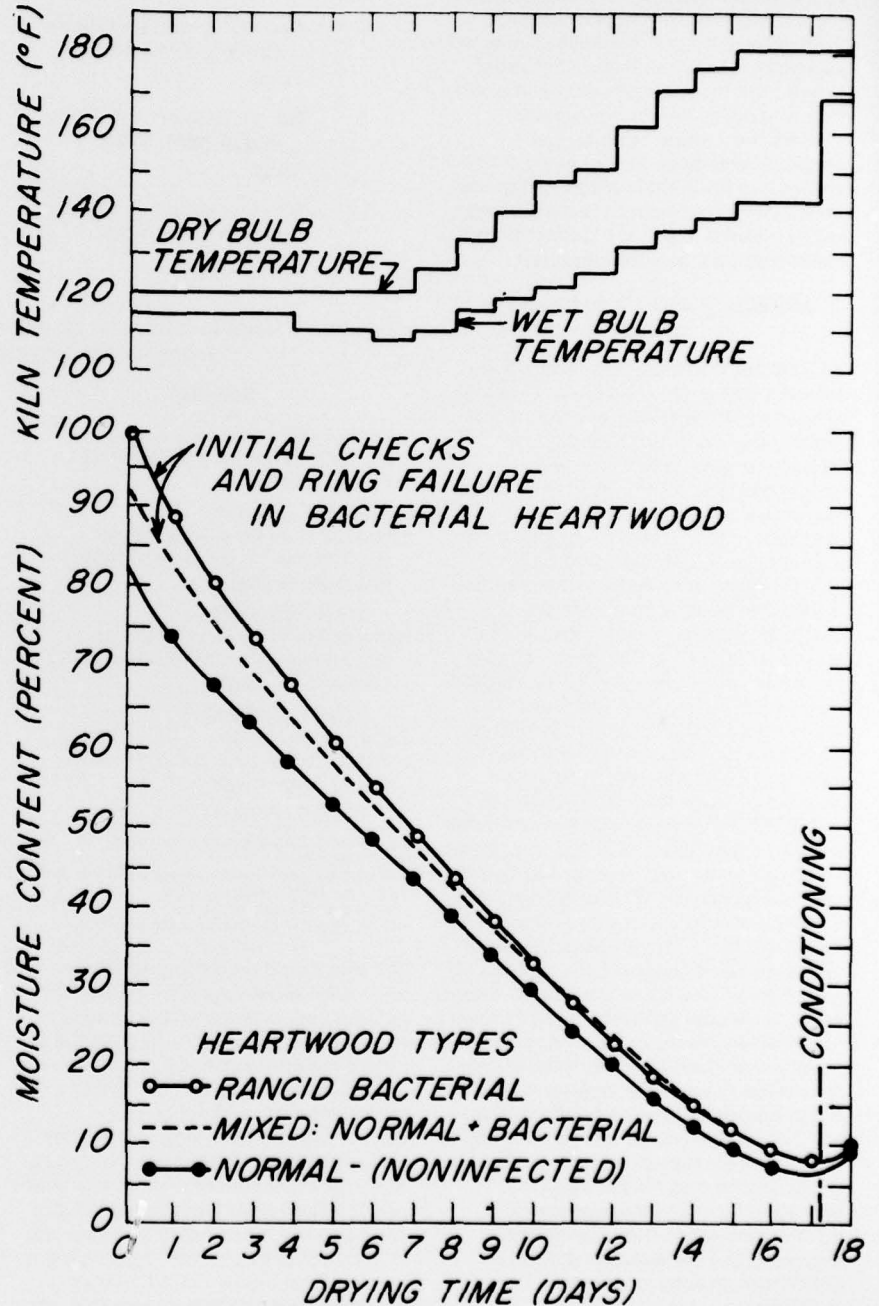
Experimental drying conditions and moisture loss curves for the green boards shipped to FPL are shown in figure 2 for simulated kiln drying and in figure 3 for air drying. Under both drying conditions, surface checking started in about 24 hours in bacterially infected heartwood of the rancid sample and the mixed wood sample. The initial air drying conditions were quite mild but not enough to prevent surface checking in bacterial heartwood. Normal, noninfected heartwood did not develop surface checks under either air drying or kiln drying. Ellwood (1959b) observed that most surface checking occurred in green flatsawn California black oak on the first day of kiln drying.

Figure 2.—Experimental kiln conditions and drying curves for 4/4 California black oak. (M 146 707)

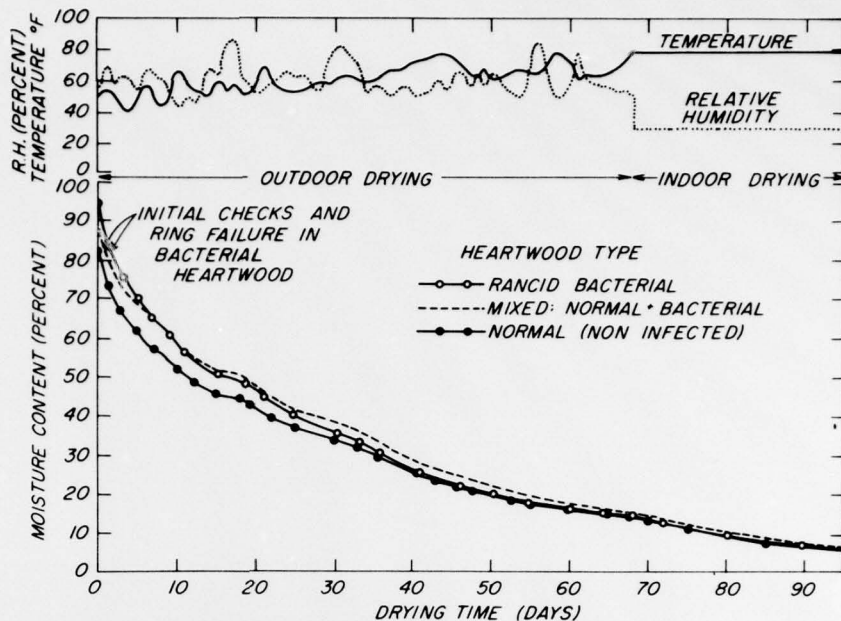
Figure 3.—Atmospheric conditions and air-drying curves for 4/4 California black oak. (M 146 705)

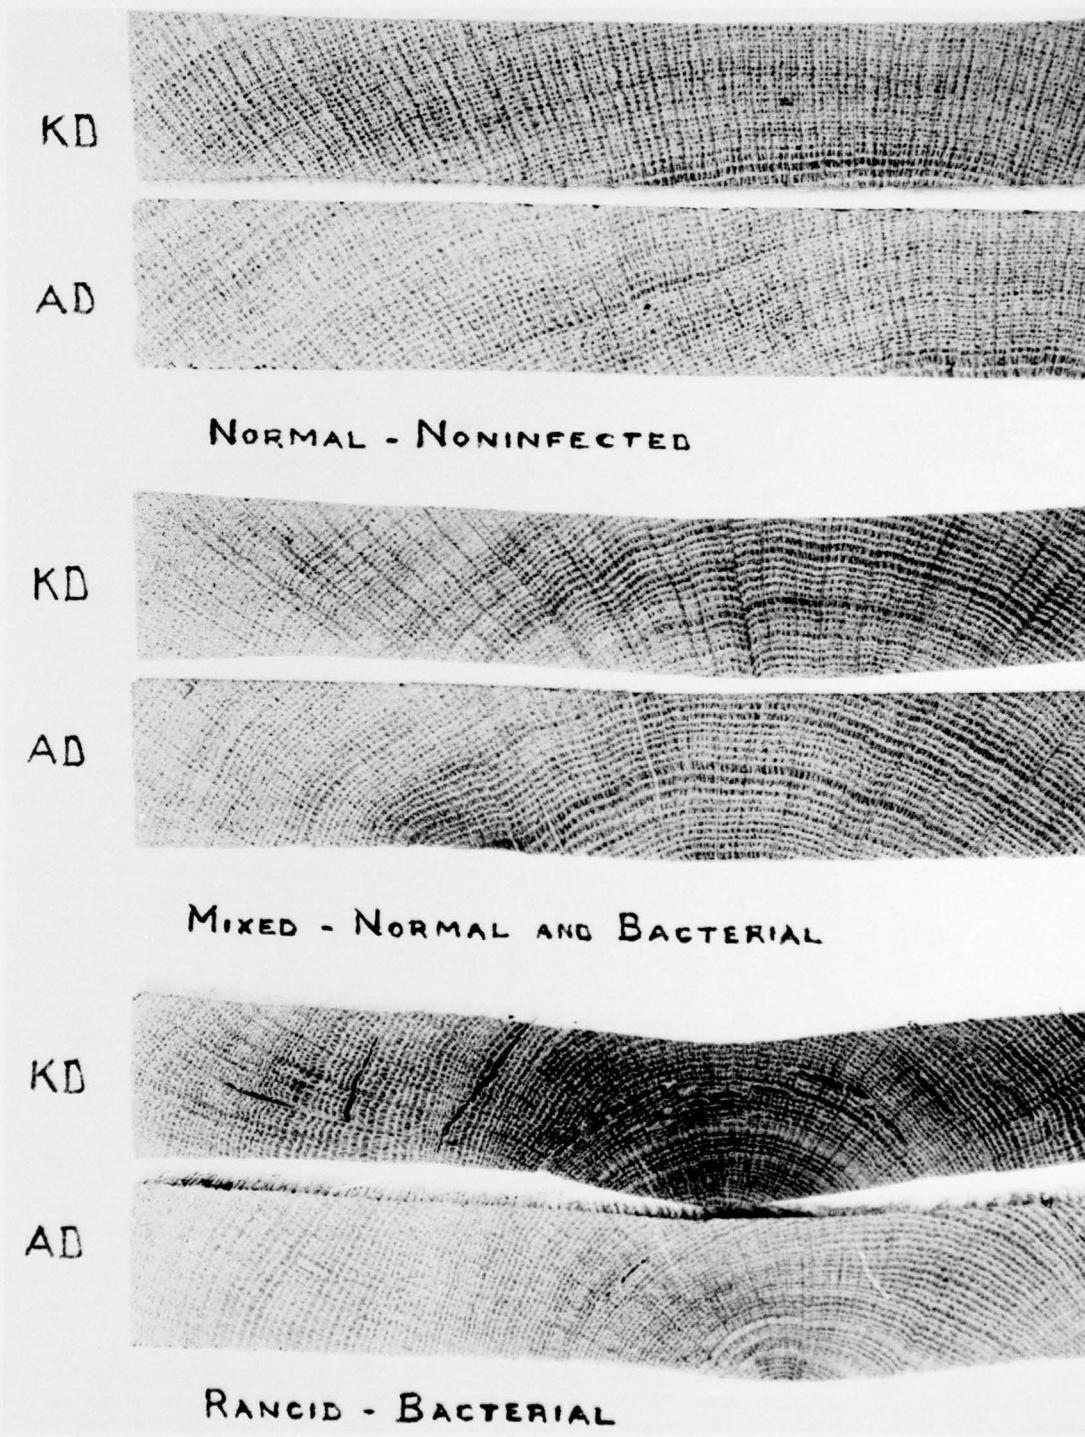
Ring failure was present in cross sections cut from both the kiln- and air-dried samples of the rancid board, but ring failure was more severe under kiln-drying conditions (fig. 4). Ring failure did not develop in normal, noninfected heartwood or in the infected heartwood of the mixed sample. Honeycomb developed in the kiln-dried rancid sample, but could not be detected in the air-dried sample. The mixed heartwood sample developed a few internal hairline checks in the bacterial heartwood under kiln drying but not air drying. Neither the surface checks which closed during the final drying stages nor the hairline internal checks are visible in

Collapse or excessive shrinkage in thickness is evident in all samples containing bacterial heartwood when compared with cross sections from normal, noninfected heartwood samples.

Figure 4.—Cross sections from matched sample boards of 4/4 California black oak—dried under laboratory conditions to 6 percent moisture content. KD = kiln dried, AD = air dried.
(M 147 113)

The absence of honeycomb in air-dried boards containing bacterial heartwood substantiates Smith's (1961) recommendations that California black oak in general should be predried under temperatures that do not exceed 100° F. However, our laboratory experiments also indicate that some bacterially infected heartwood, particularly the rancid-odor type, cannot be dried defect-free even under the mildest commercial conditions. This is substantiated by the third test of the mill study where over half of the kiln charge was degraded from checking and collapse, even though drying was done in the winter with initial temperatures that did not exceed 100° F.

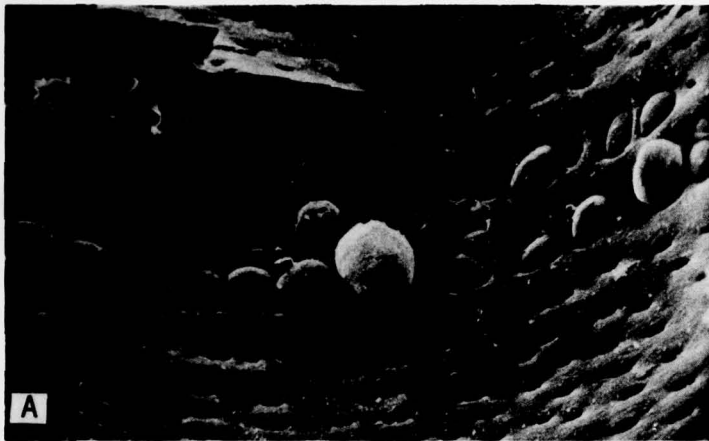
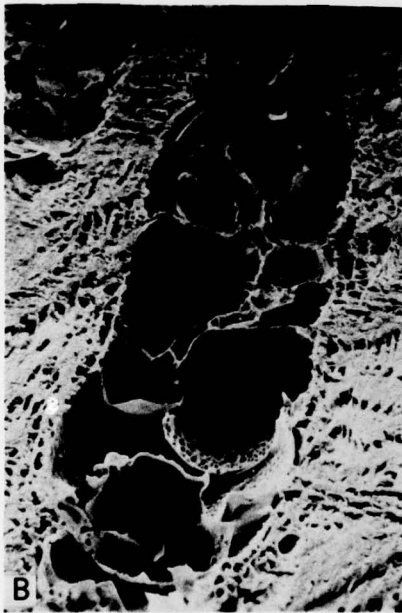
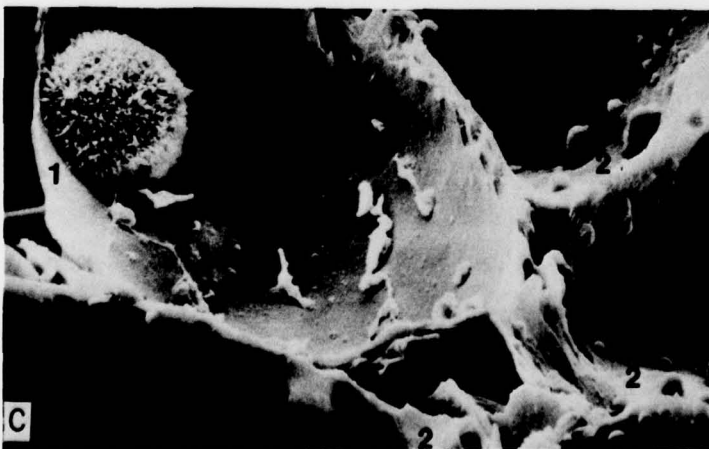
The presence of tyloses is generally considered a diagnostic characteristic of white oaks rather than the red and black oaks. But California black oak is an exception. All heartwood, both normal and infected, that was examined in this study contained an abundance of tyloses. Furthermore, a comprehensive study of the anatomy of American oaks by Williams (1942) found that tyloses are the rule rather than the exception in California black oak.

Figure 5.—Scanning electron micrographs of tyloses in living California black oak. A. Vessel from sapwood to heartwood transition zone showing initial tyloses development from ray pits. B. Vessel from noninfected heartwood showing abundant tyloses growth. C. Closeup of tyloses in B showing: (1) Crystal inclusion inside one tyloses and (2) Secondary burgeoning from membranes within adjacent tyloses.

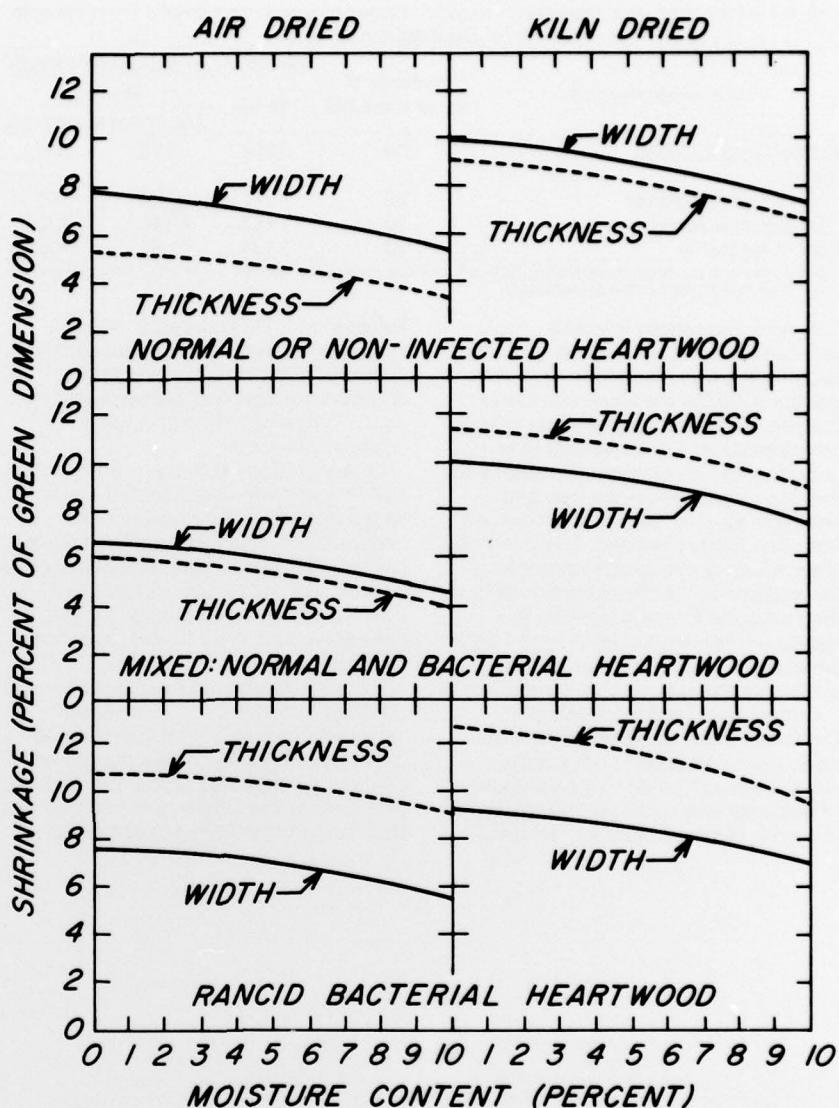
The greater shrinkage of bacterially infected California black oak is largely associated with collapse, especially across the thickness of the board. Collapse seems to be more prominent in California black oak than in most of the eastern red and black oaks. The deep collapse zones in California black oak can be attributed to relatively severe drying conditions, bacterially weakened wood, and plugging of the vessels or pores with tyloses. Moisture movement through the vessels is retarded by the tyloses and bacterial debris. Tensile stresses that are set up are sufficient to cause collapse of the weakened wood tissue.

The influences of bacterial weakening of the wood and of drying conditions on the dimensional shrinkage of California black oak are illustrated in figure 6.

Figure 6.—Effect of drying conditions and bacterial tree infections on the dimensional shrinkage of flatsawn 4/4 California black oak boards. All heartwood contained tyloses.
(M 146 706)
