FRACTOGRAPHIC ANALYSIS OF OPTICAL FIBERS

J.J. Mecholsky, S.W. Freiman and S.M. Morey  
Naval Research Laboratory  
Washington, D.C. 20375

November 1977

Interim Technical Report 1

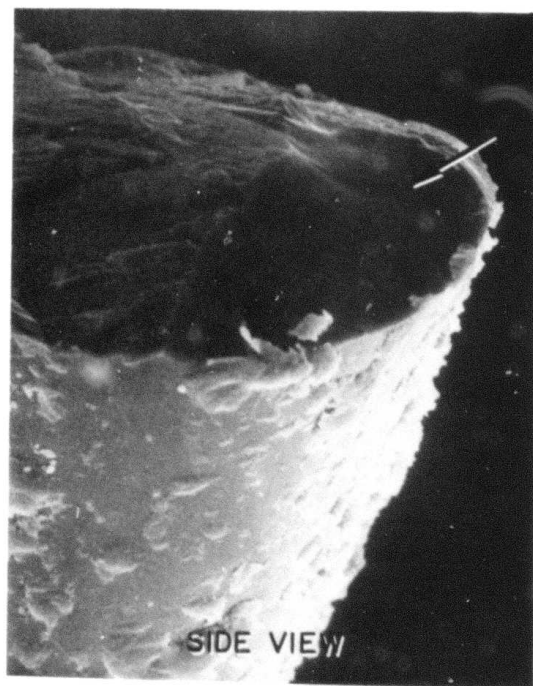
Observation of fracture surfaces on brittle materials and in particular on fibers can be misleading unless one can determine that the origin is real and is primary, that is, the main cause of failure. For example, if one observes the top view in Fig. 2 it could be concluded erroneously that a relatively large somewhat irregular mirror exists surrounding the origin. However, if care is taken to get another angle of observation (side view) one sees that in reality a chip out of the fracture surface is being observed. A true fracture mirror in most cases would not deviate from the total plane of fracture as much as indicated in the figure.

Fig. 2. SEM fractograph of a Hughes fiber (770209- H-SS-3) after removal of metal coating. Top view shows appearances of irregular "fracture mirror" around "origin" (arrow). Side view shows this to be really a chip that is missing from the surface (arrow) giving the false appearance of a fracture mirror. From the fracture markings beyond this lost area, one can conclude that a surface defect initiated the fracture. (The silica fiber is nominally 120  $\mu\text{m}$  in dia.).

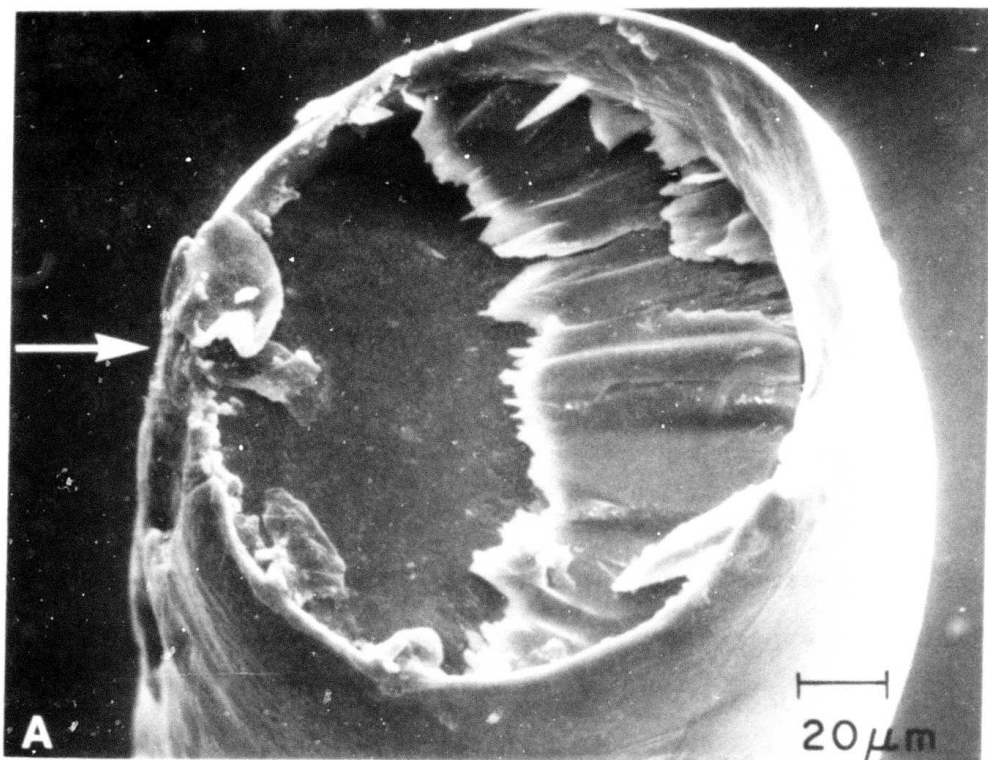
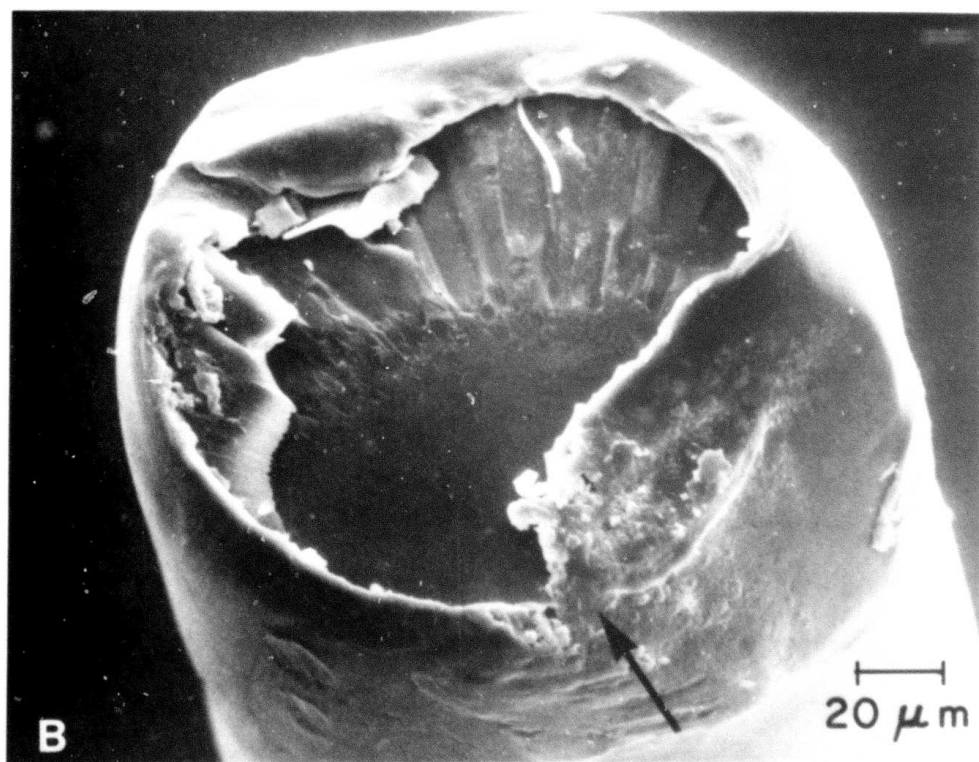
Fig. 3. Matching halves of a SEM fractograph of Hughes fibers  
(A-770725-37b; B-770725-37a). These show that fracture features  
"point" back to the origin (arrows) at the surface even though  
the exact cause is unknown.

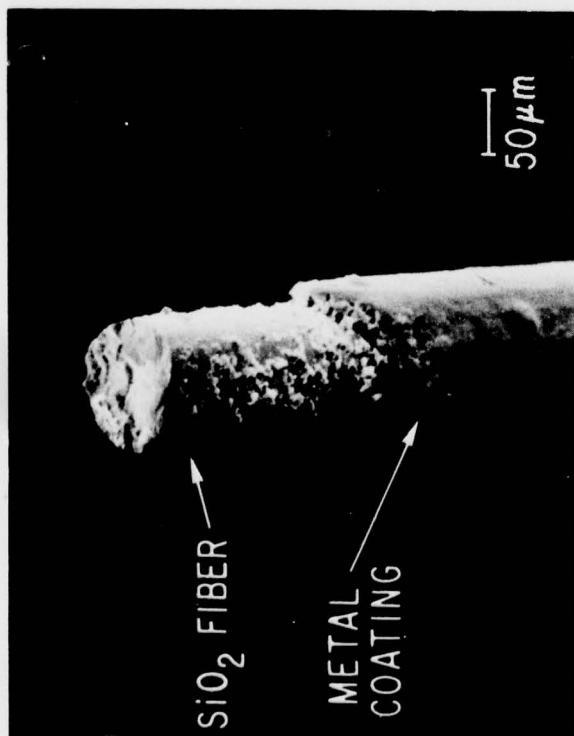
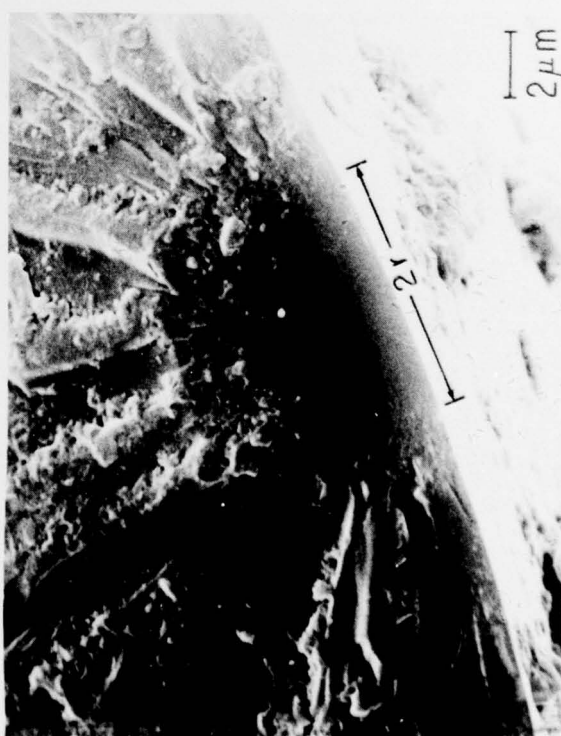
| Designation | Fracture Stress | | Measured Flaw Size | | a/b | | r, $\mu\text{m}$ | | Calculated Fracture Stress | | Comments |
|---|---|---|---|--|---|--|---|---|---|---|---|
| -2 DF | 200 | 1400 | | | | | | | 160 | 1100 | Corrosion product; surface origin |

Fig. 4. SEM fractograph of a Hughes fiber (770209 - H-SS-2) showing fracture demarcations surrounding the fracture origin (most likely a sharp crack-not visible on the surface).

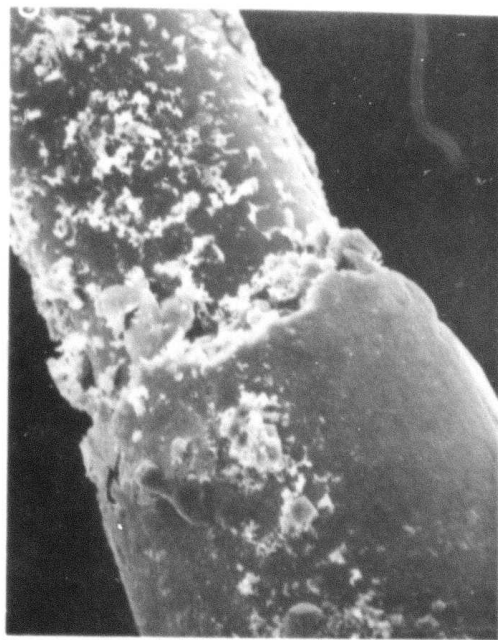
| Designation | Fracture Stress | | Measured Flaw Size | | a/b | | r, $\mu\text{m}$ | | Calculated Fracture Stress | | Comments |
|---|---|---|---|--|---|--|---|---|---|---|---|
| H-SS-1 DF | 200 | 1400 | | | | | | | | | Corrosion product; pitting in Al |

Fig. 6. SEM micrograph of the corroded surface of metal and fiber as a result of failure in salt water. (Hughes fiber 770209-H-SS-1). Notice the cracks in the metal tend to follow grain boundaries (C and D).

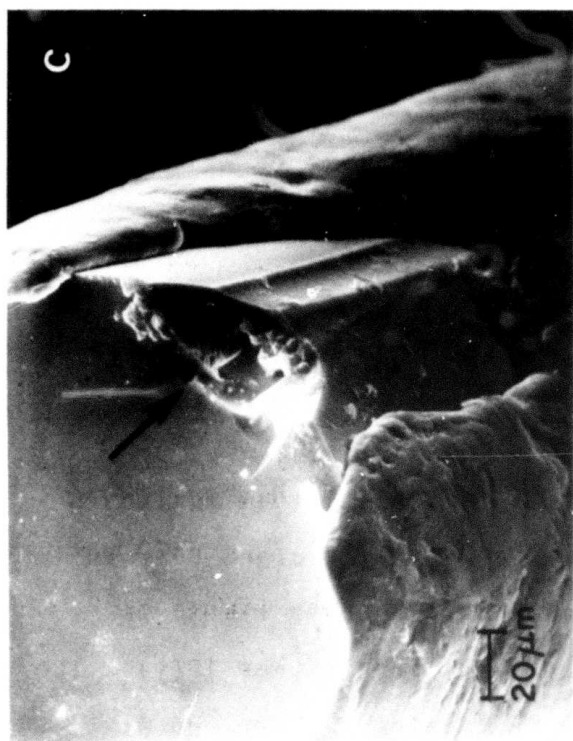
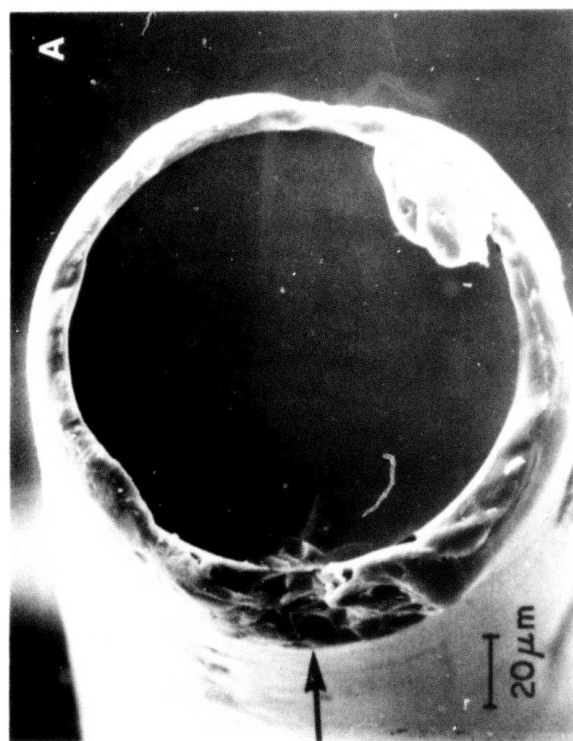
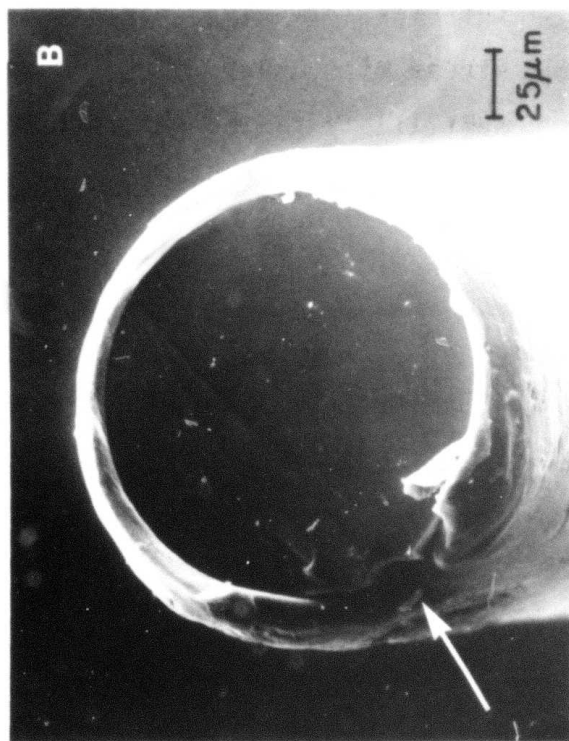
Several low strength fibers were sent from Hughes for identification of fracture origins. Although the analysis is not complete, it is quite evident that a semi-elliptical ridge on the surface of most of the fibers examined is consistently the cause of failure (Fig. 7). Because the ridge along the fiber surface is relatively smooth it would appear that this defect is being caused in the drawing process when the fiber is relatively hot. One would expect a rough gouge if some object were pulled across the surface. Further communication between NRL and Hughes will hopefully trace the exact cause of this defect and thereby eliminate it.

Fig. 7. SEM fractograph of four Hughes fibers failed in proof test at relatively low strengths. Notice that all fibers indicate surface failure from an elliptical cut with ridge. The smoothness of the depression in B and C would indicate this occurred while the fiber was soft. Also, most likely the metal is debonded from the fiber in the area around the defect in B and C. (770725-: A-4a; B-2a; C-1a; D-3)

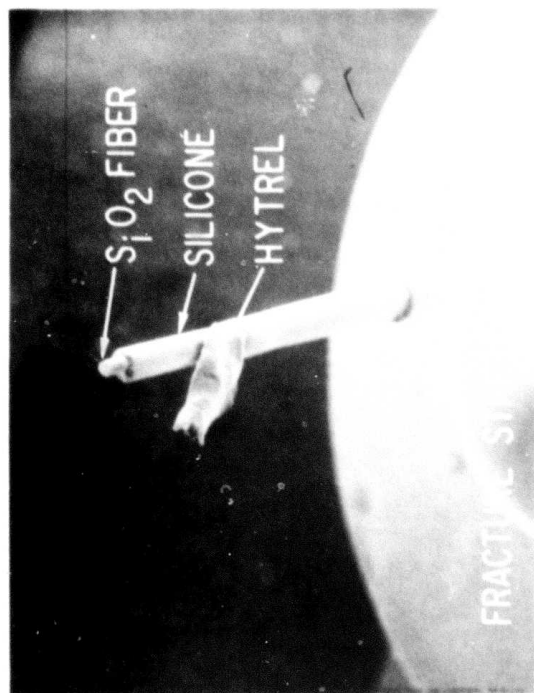
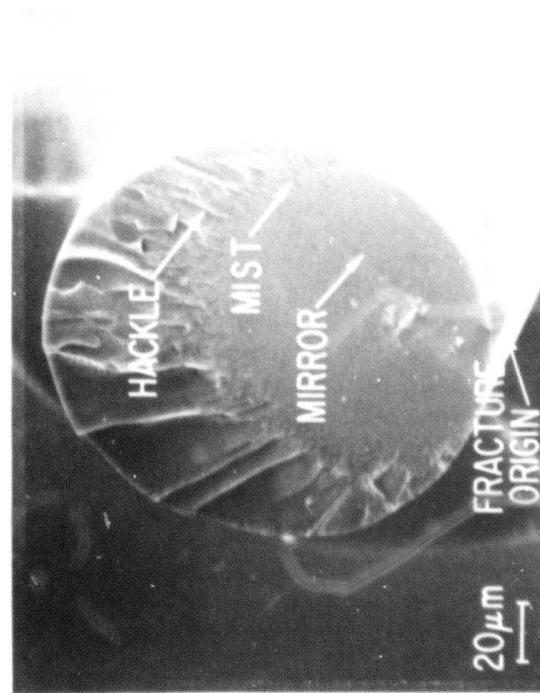
A foreign particle is shown attached to the silica in Figures 8 and 13. The particle was analyzed using an electron microprobe; the results indicated the presence of magnesium and iron as well as silica (Fig. 13). This type of failure can be avoided by filtering (clean room). This "dust" particle which attached to the fiber during drawing caused a small (approximately 1.5  $\mu\text{m}$ ) crack, most likely upon cooling, which subsequently lead to failure. The size of this crack (2  $\mu\text{m}$ ) is in

Fig. 8. SEM fractograph of an ITT fiber (761221-4) that failed in a proof test (200 ksi). The source of failure (crack between foreign particle and bulk  $\text{SiO}_2$ , as shown in lower right) is shown surrounded by the fracture demarcations (lower left). The foreign particle is identified as containing Mg, Fe, and Si (cf Fig. 13). The 'mirror' size measurements indicate a failure stress of  $\sim 315 \text{ MN/m}^2$  ( $\sim 45 \text{ ksi}$ ). This means that this fiber most likely failed before the full proof stress was achieved, i.e. around the edge of the drum.

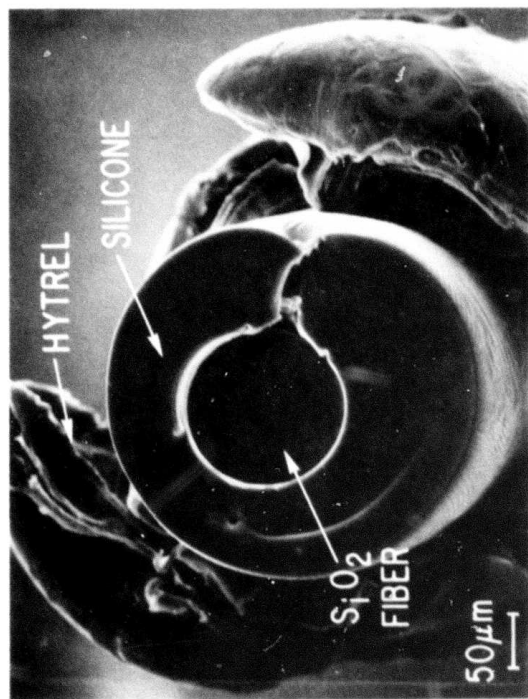
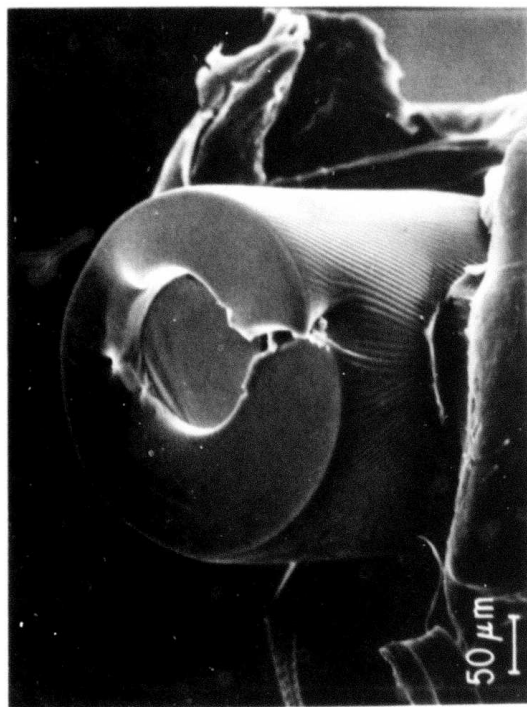
Fig. 9. SEM fractograph of an ITT fiber (761221-3) that failed from a sharp crack at the surface (dotted line in lower right). As in Fig. 8, this fiber failed well below the proof stress of  $1400 \text{ MN/m}^2$  indicating failure on the edge of the drum before full stress was achieved.

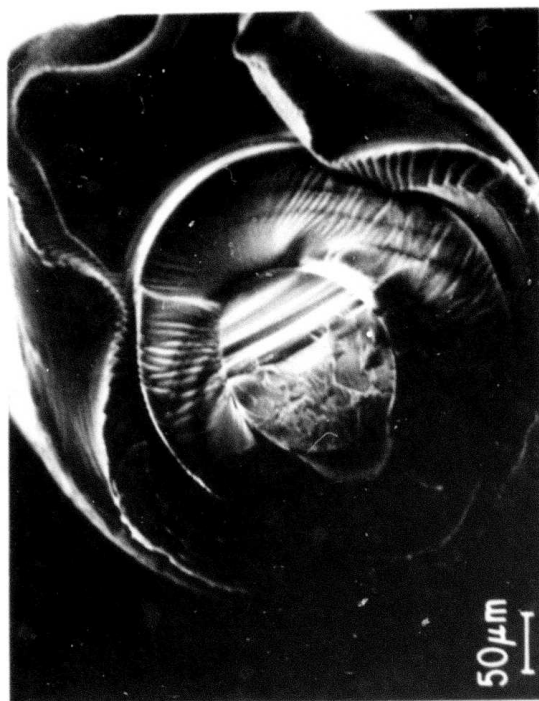
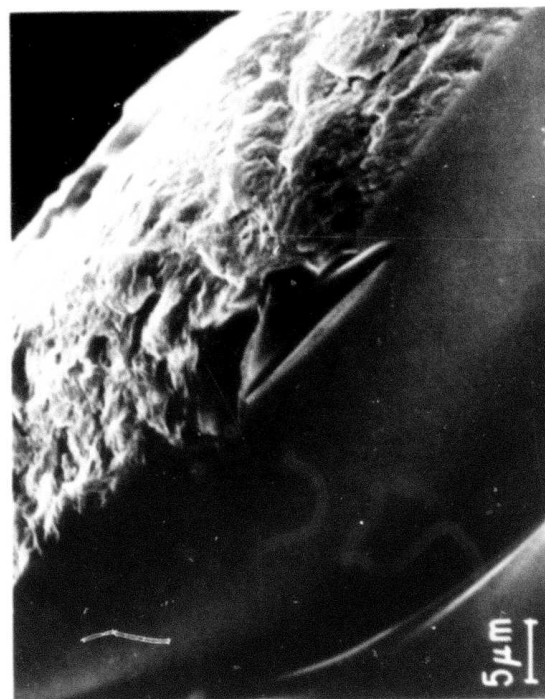
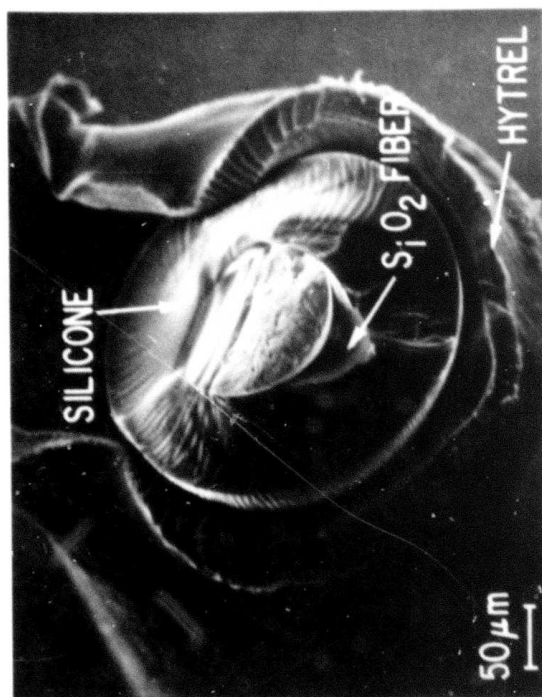
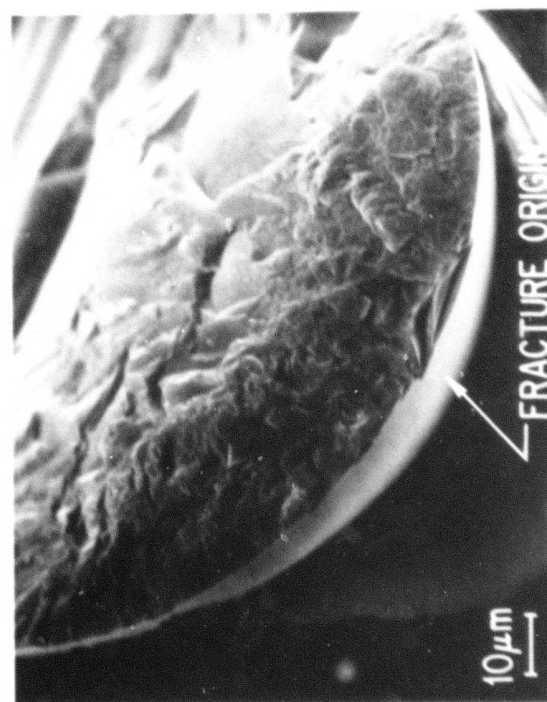
Fig. 10. SEM fractograph of an ITT fiber (761221-5) that failed from a mechanically induced crack. Although the crack is relatively large, it is probably not sharp, and thus, this fiber most likely achieved the  $1400 \text{ MN/m}^2$  proof stress.

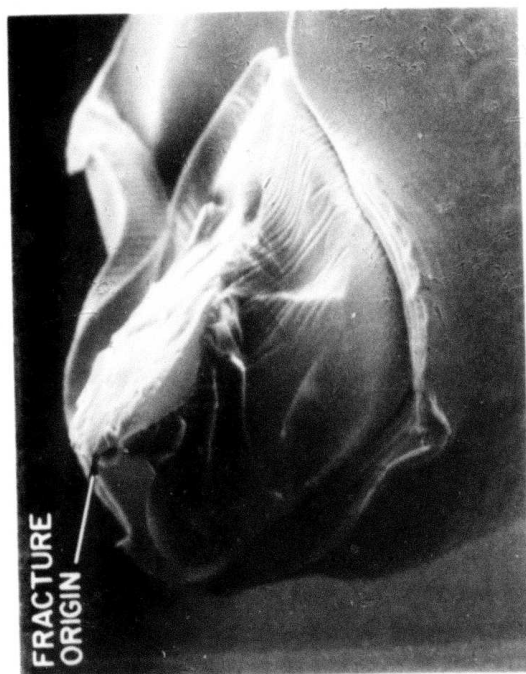
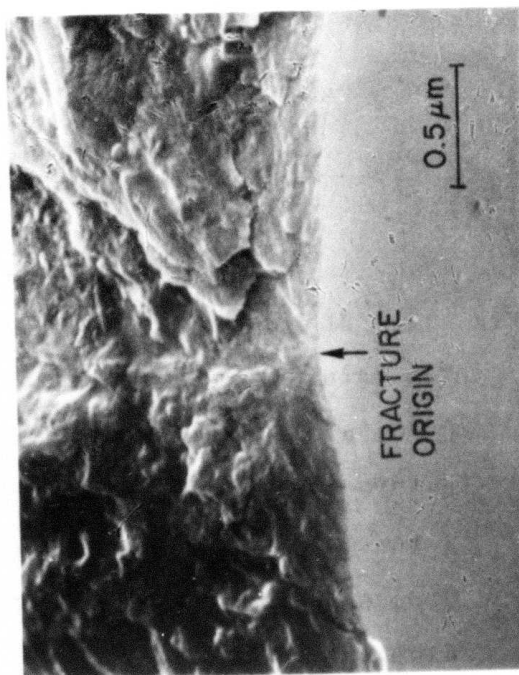
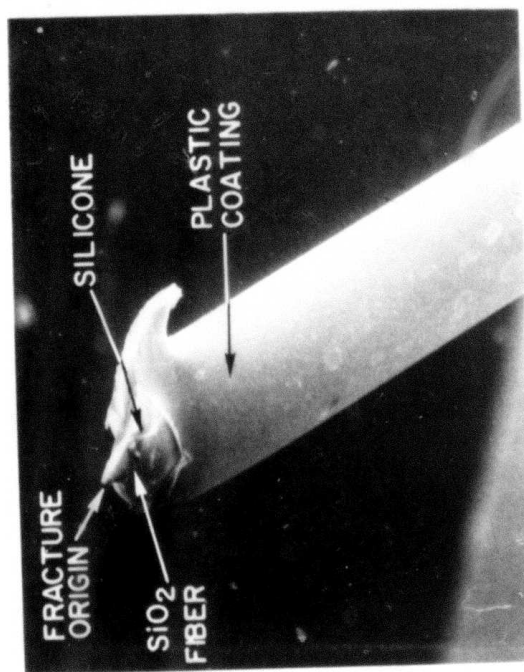
Fig. 11. SEM of an ITT fiber (770209-A) failing from the surface. The nature of the fracture origin and surrounding area (rough surface) indicates a high stress ( $> 2100 \text{ MN/m}^2$ ). The exact source of failure is unknown.

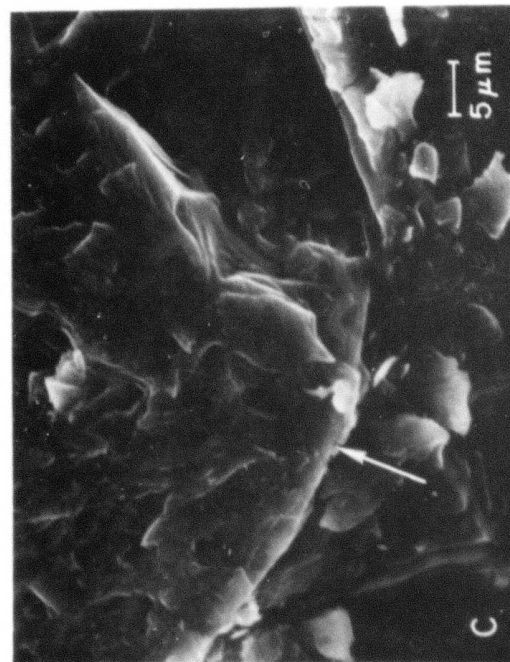
Fig. 12. SEM of an ITT fiber (770209-1) failed from the surface.

The nature of the rough area surrounding the origin (arrow in B, C, and D) indicates a high stress ( $\sim 2070 \text{ MN/m}^2$ ). The exact nature of the fracture origin is unknown, but could be due to a thermal expansion mismatch between two phases (i.e. glassy  $\text{SiO}_2$  and crystalline  $\text{SiO}_2$  or crystalline metal or crystalline alumina).

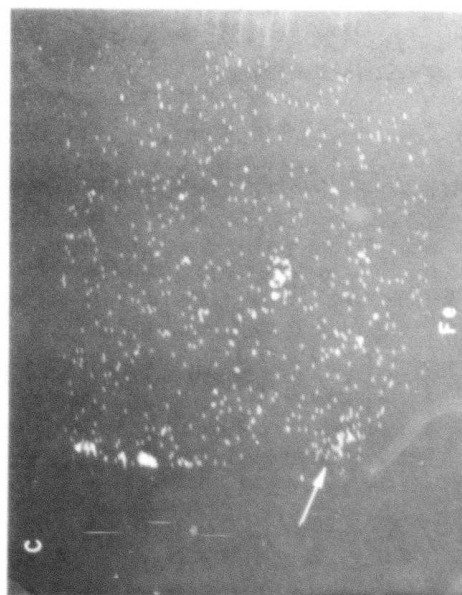
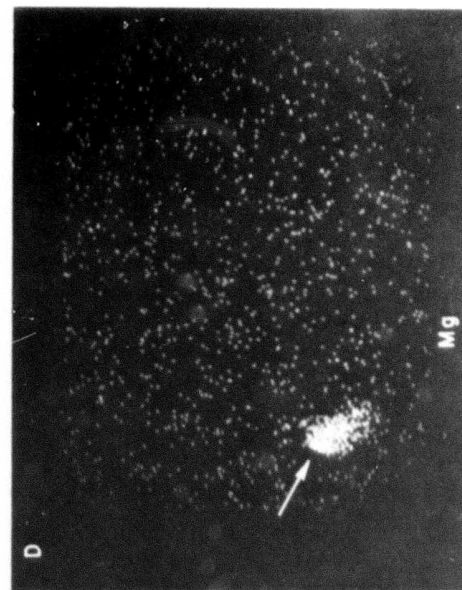
Fig. 13. A) SEM fractograph of Fig. 8 for reference. B) Real image of A as given by microprobe unit. C and D) Microprobe electron images showing relative concentrations of Fe and Mg, respectively. Arrows indicate fracture origin for reference.

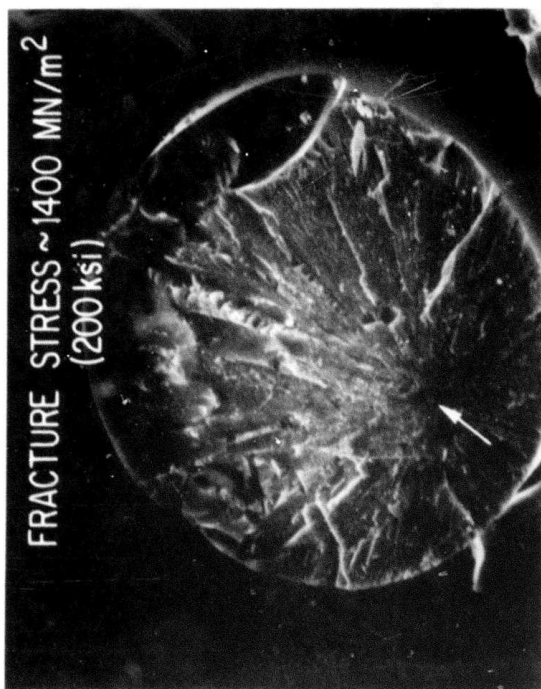
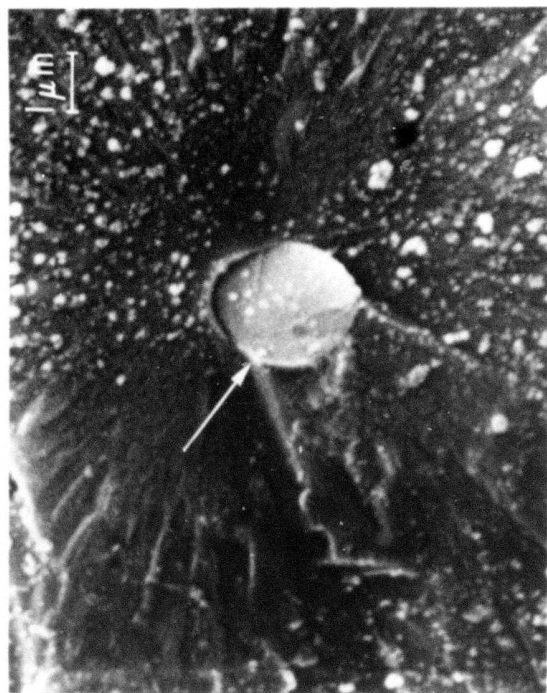
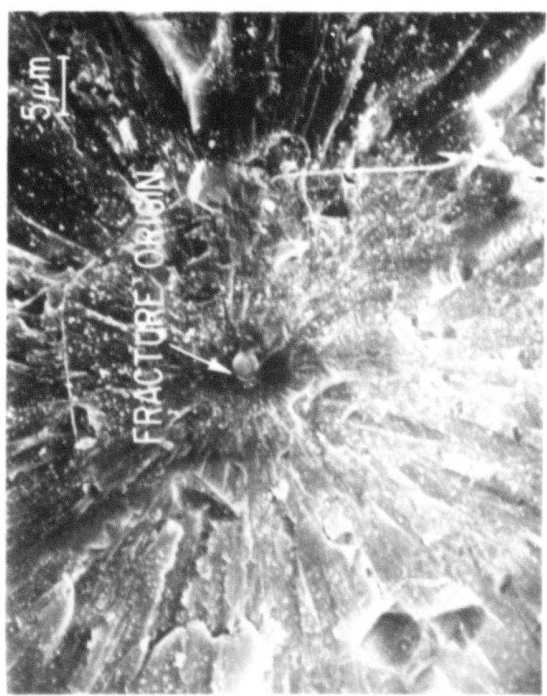
Although most fractures were from surface origins, there are seven cases where internal origins occurred. One internal origin was an inclusion containing rare earth elements (Nb and La) Fig. 14. This failure occurred due to a ( $0.2\text{ }\mu\text{m}$ ) crack formed between the inclusion and bulk  $\text{SiO}_2$ . Failure from inclusions related to natural forming elements can most likely be eliminated by using synthetic quartz material rather than the natural quartz. This also applies to preform manufacture used in the CVD process. If the outer tube or preform material is natural quartz, then defects such as bubbles and inclusions will be transferred to the final silica fiber. Closer examination is planned to determine the source of these internal failures. Higher magnification is required to determine the source of these failures because the size of the defect, in most cases, is less than  $0.2\text{ }\mu\text{m}$ , and consequently detailed analysis is difficult.

Fig. 14. SEM fractograph of an ITT fiber (761221-2) showing failure from a crack at the interface between a rare earth (Nb and La) inclusion and the bulk  $\text{SiO}_2$  fiber. The size of the fracture "mirror" region surrounding the origin agrees with the  $1400 \text{ MN/m}^2$  proof stress recorded.

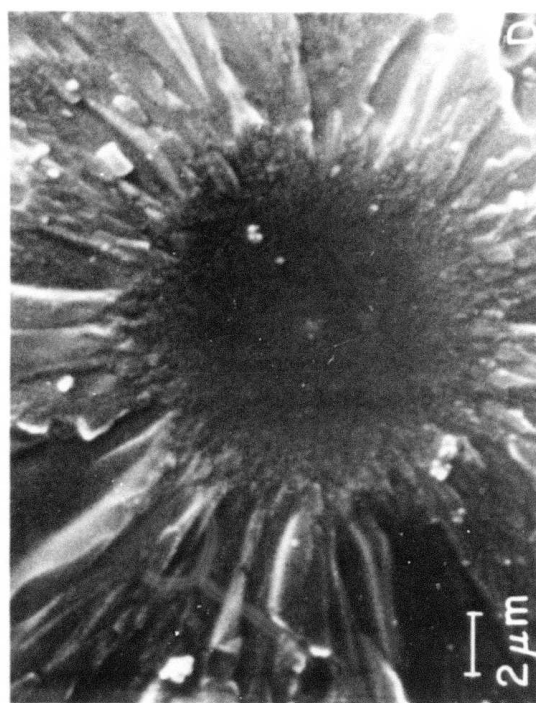
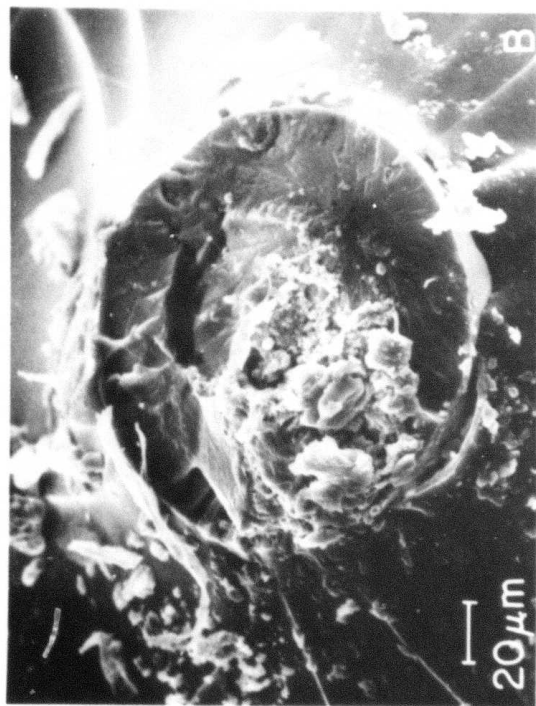
Several fibers were sent that were known to have low strength values. Fracture surface analysis determined that the low strength (approximately 200,000 psi) failures were probably occurring due to a defect that existed in the preform and was drawn out during the pulling of the fiber. This is concluded because there were several internal failures in the same general location in the plane of the fracture (cf Fig. 15a and b).

Fig. 15. SEM fractographs of three ITT fibers failing from internal sources. (A=770708-4; B=770708-3; C and D=770510-9.) The location of the origin in A & B and the other fibers of this set (Table II) indicate that the same type of source is probably causing failure. Although not certain, the white dot evident in D could be a small microcrystallite of silica.

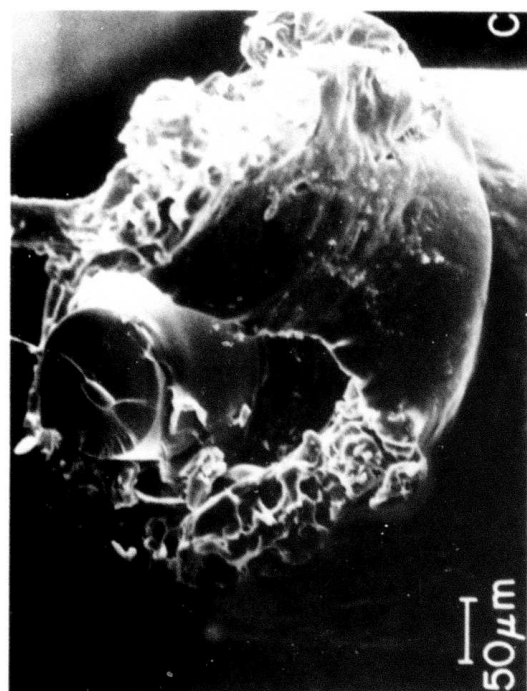
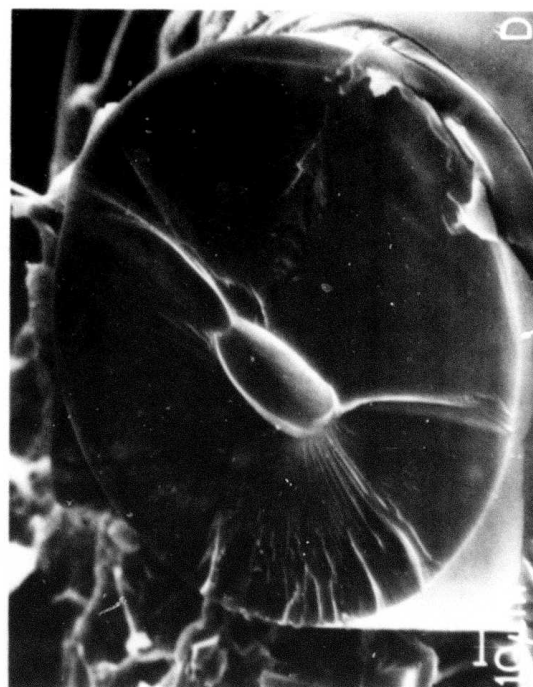
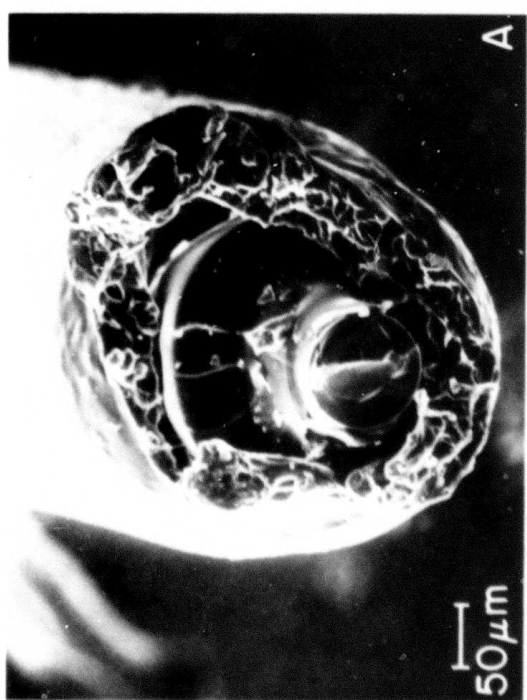
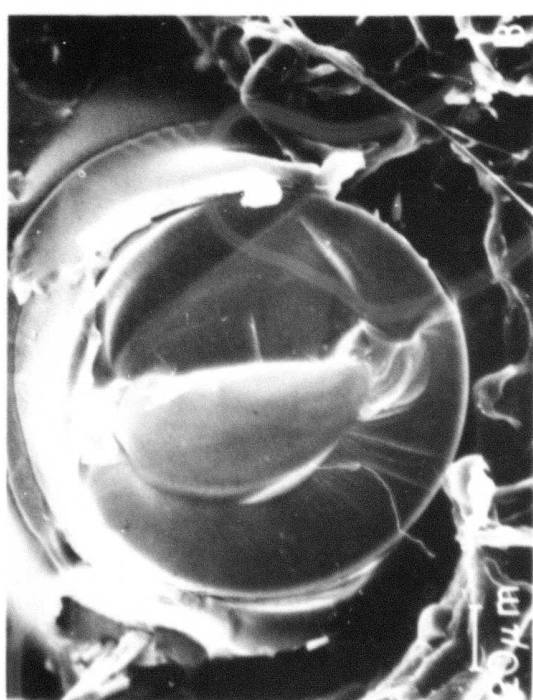
Of all the fibers observed (28 pairs) which were sent from NOSC, only two origins were found. The low yield is due to the fact that these fibers all had a relatively high strength since the pretest proofing at 300 ksi eliminated the weak fibers. These high strengths > 500 ksi mean that fracture origin determination is very difficult, if not impossible. However, two of the three fracture surfaces were similar in appearance (Fig. 15) to each other but not to any other fibers observed, either from ITT or Hughes. The large semi-elliptical sections in the interior of the fibers observed in Fig. 16 should have caused low strength breaks. The reported strength is  $\sim 3500 \text{ MN/m}^{3/2}$  ( $\sim 500 \text{ ksi}$ ), indicating that these fractures are probably secondary, rather than primary breaks. However, the question arises of why these large inhomogeneities did not cause failure at lower stresses as the primary break. Perhaps, because these inhomogeneities are  $\text{SiO}_x$  of a slightly different composition than  $\text{SiO}_2$ , they were not high stress concentrators leading to low strength failure. The composition and identity of these anomalies is unknown but further research is being performed.

Fig. 16. SEM fractograph of an ITT fiber tested (at  $3500 \text{ MN/m}^2$ ) at NOSC. A and B - 4-8; C and D- 2-6. These very large defects are unidentified, but would be expected to cause low strength ( $< 700 \text{ MN/m}^2$ ) fractures. One would suspect, then, that these are probably secondary failures and do not reflect the primary break, or that the inhomogeneity is not a high stress concentration.
