OHIO RIVER BASIN
CHERRY RUN, INDIANA COUNTY
PENNSYLVANIA
CHERRY RUN DAM

PHASE I INSPECTION REPORT
NATIONAL DAM INSPECTION PROGRAM.

Source LGAI CONSULTANTS, INC.
570 BEATTY ROAD
MONROEVILLE, PENNSYLVANIA 15146

11 AUGUST 1979

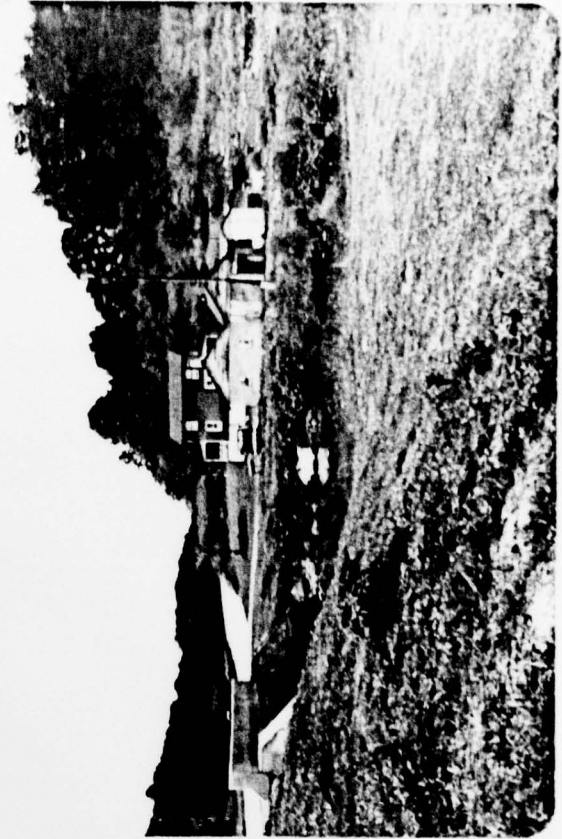
PHOTOGRAPH 12 View of a bridge and low lying house located less than one mile downstream of the embankment.
