KELSEY CREEK DAM

NDI ID No. PA-00031
DER ID No. 59-64
SCS ID No. PA-600

PHASE I INSPECTION REPORT
NATIONAL DAM INSPECTION PROGRAM

AUGUST 1979

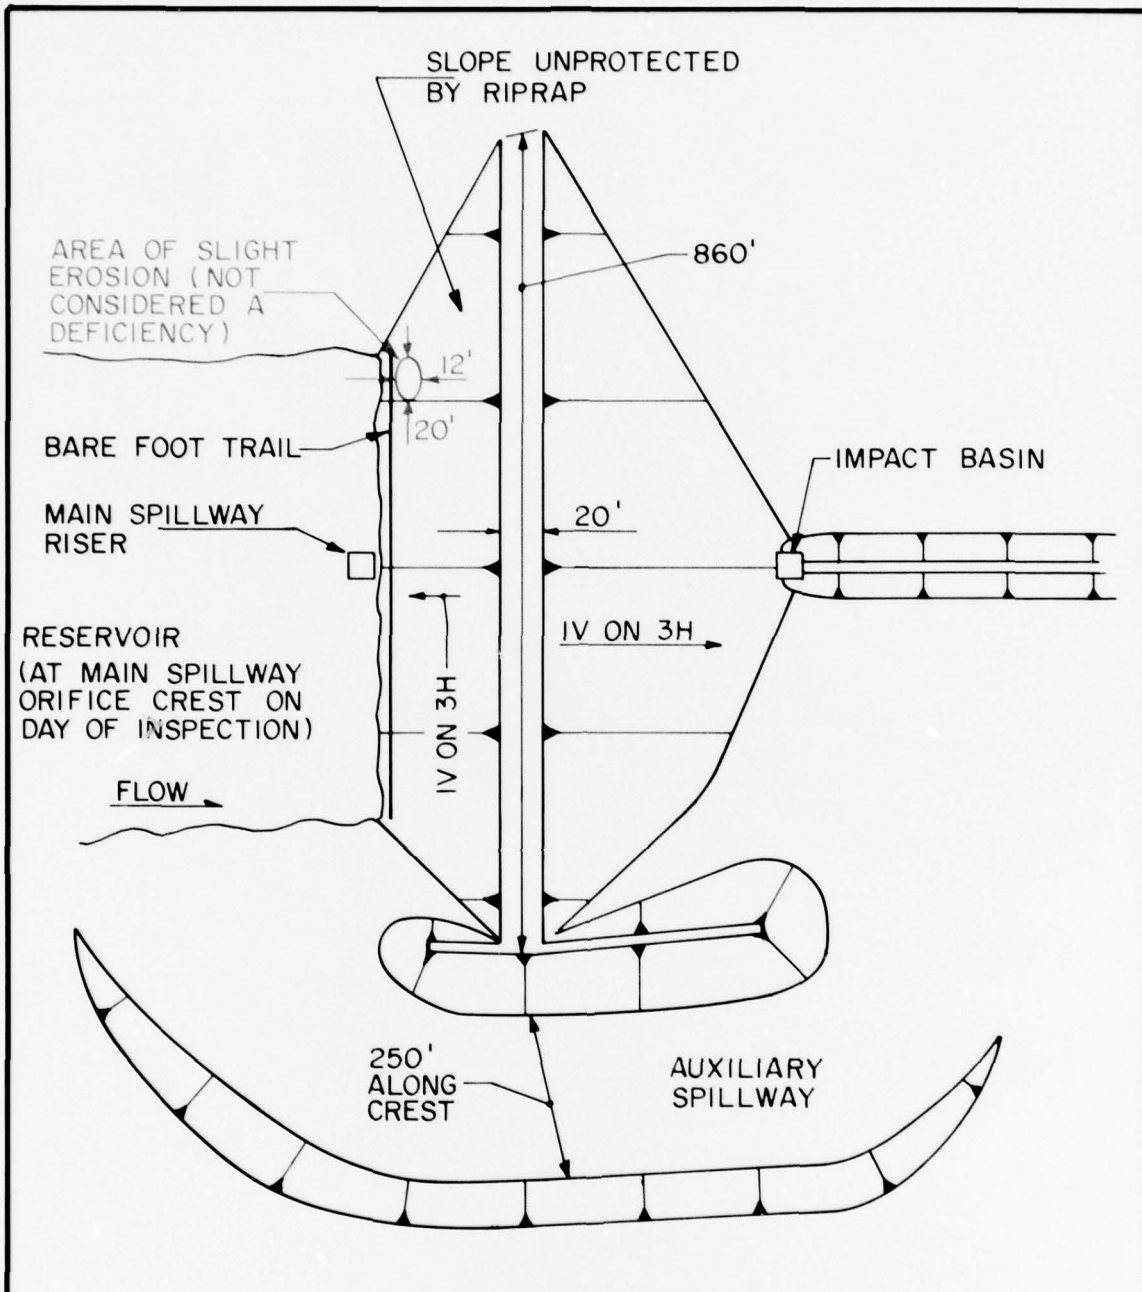
PHASE I INSPECTION REPORT
 NATIONAL DAM INSPECTION PROGRAM
 KELSEY CREEK DAM
 BOROUGH OF WELLSBORO
 RESULTS OF VISUAL INSPECTION
 AUGUST 1979
 PLATE B-1

a. General. The overall appearance of the dam is good with a few deficiencies as noted herein. The locations of deficiencies are shown in Appendix B on Plate B-1. Survey data acquired during this inspection are presented in Appendix B. On the day of the inspection, the pool was at the crest of the orifice in main spillway riser.

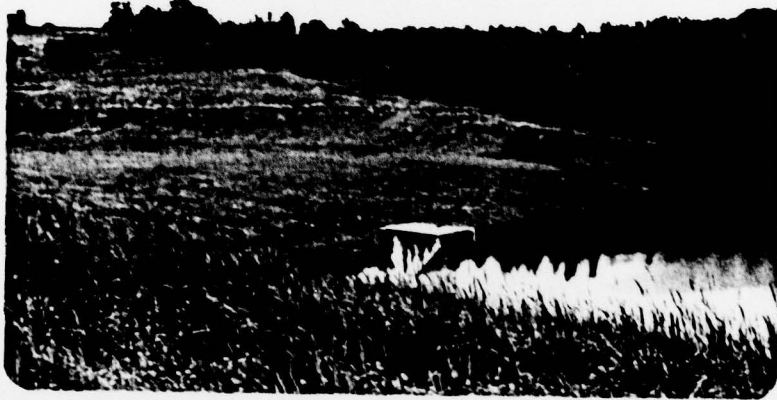
C. Main Spillway and Auxiliary
Spillway Approach Channel

The main spillway riser is in good condition. The conduit beneath the embankment could not be inspected because it was flowing about one half full. A minor amount of debris was at the orifice of the main spillway riser. The impact basin is in good condition. Very minor spalling, of no concern, was observed at a few localized areas of the concrete. Because of the high tailwater, it was impossible to determine if the drain

The conduit has not been inspected since the dam was completed. As the joints of concrete conduits founded on earth tend to spread apart, an inspection would be prudent. However, since the as-built information indicates that each conduit joint has an allowable elongation of at least 3 inches, the concern is only minor.

(1) Implement an inspection of the main spillway conduit and riser to determine if separation of the conduit joints and cavitation damage to the riser have occurred. If pool conditions prevent the

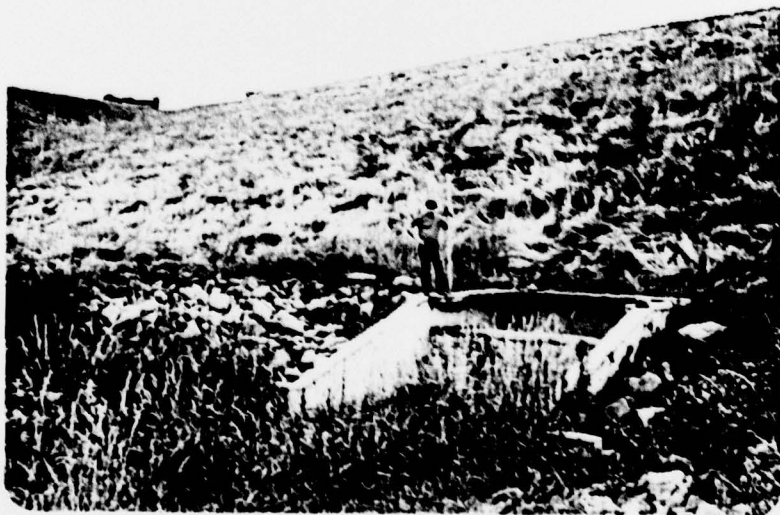
D. Impact Basin

pipes, which extend to the embankment toe drain, were discharging. The riprap downstream from the impact basin is in good condition. It appeared that someone had piled some of the riprap across the impact basin sill to create a pool at the impact basin.

(3) Appurtenant Structures. The gate for the outlet works is located sufficiently far upstream to be considered an upstream closure facility. The riprap at the endsill of the impact basin raises tailwater slightly. This is not a hazard to the dam, but it does hinder visual inspection. The crest elevation of the auxiliary spillway indicates that the spillway capacity is slightly greater than the design computations indicate.
