6 National Dam Inspection Program.  
Bryant Pond Dam

SUSQUEHANNA RIVER BASIN,  
HARVEYS CREEK, LUZERNE COUNTY  
PENNSYLVANIA.

Phase I Inspection  
Report,

PHASE I INSPECTION REPORT  
NATIONAL DAM INSPECTION PROGRAM

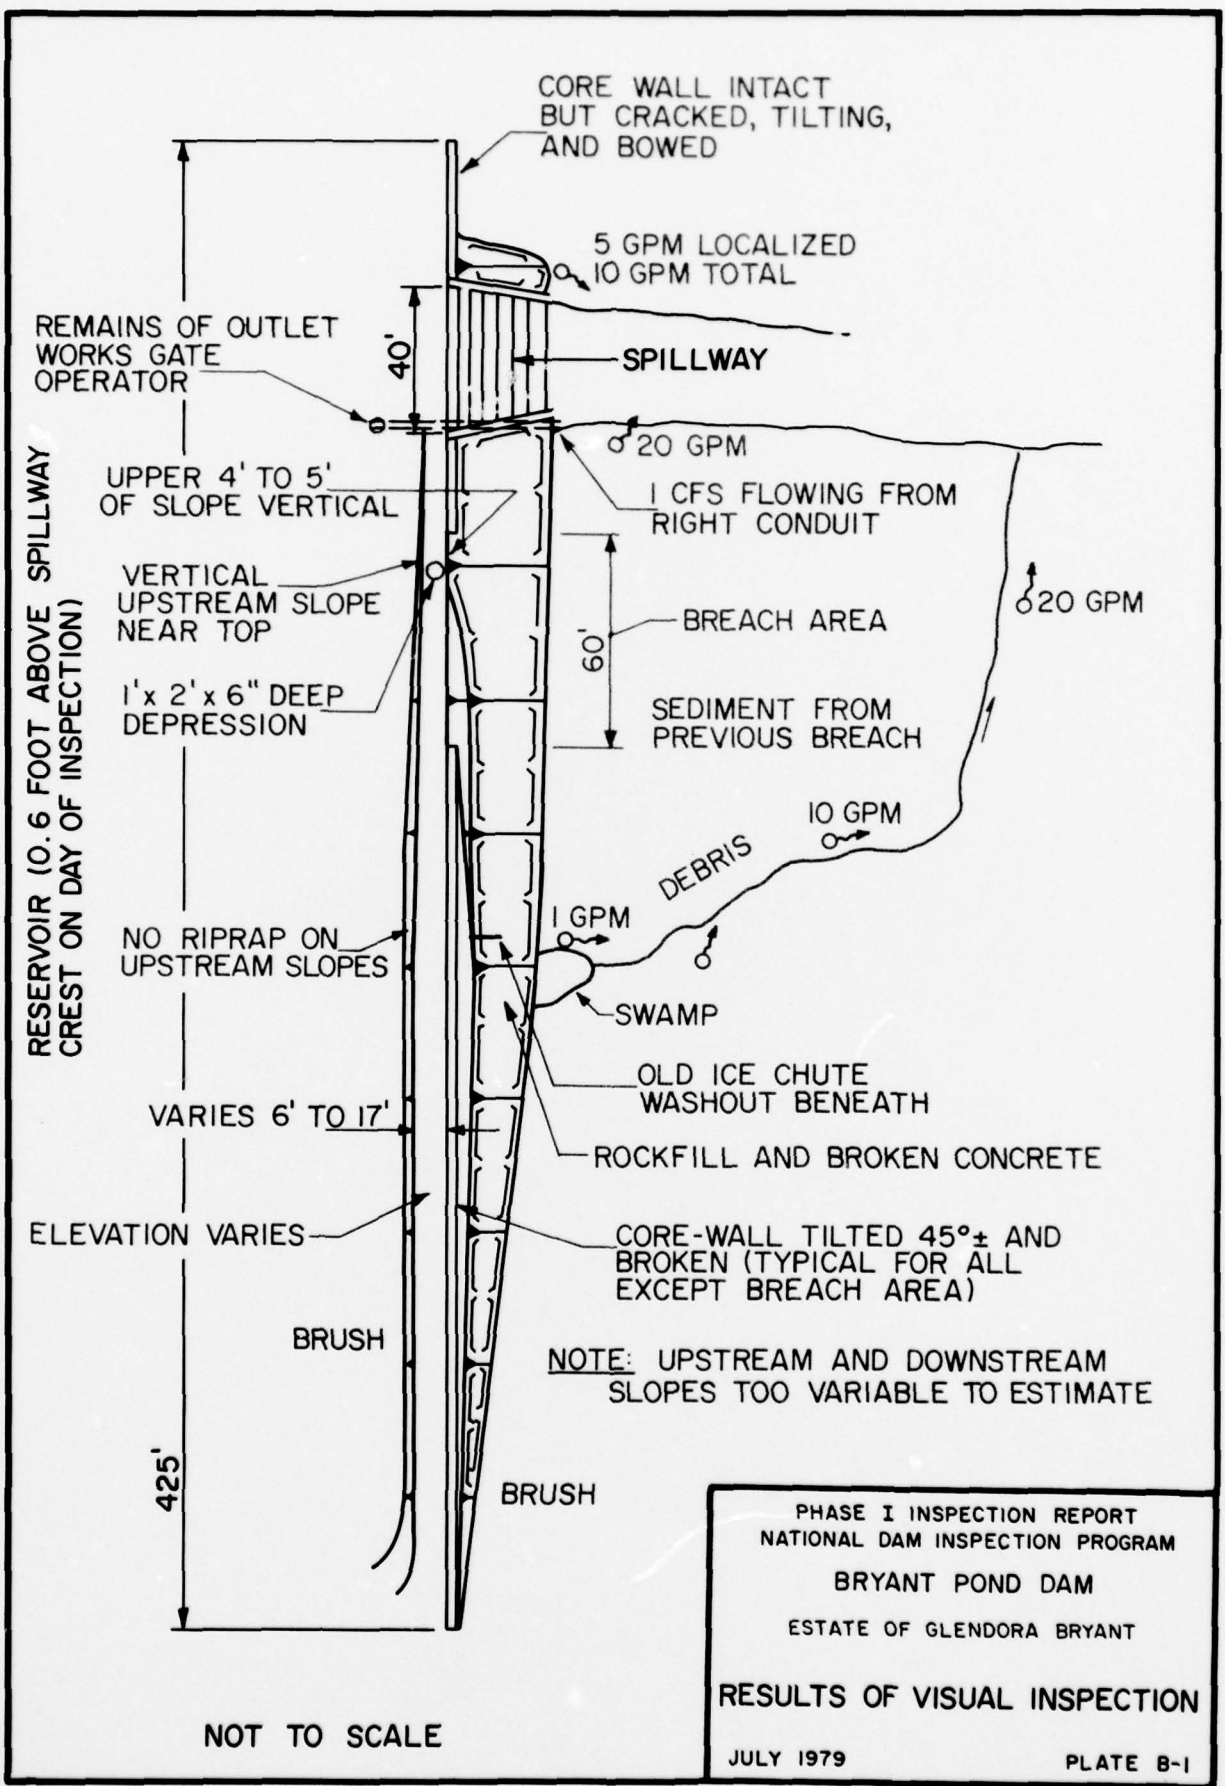
PHASE I INSPECTION REPORT  
 NATIONAL DAM INSPECTION PROGRAM  
 BRYANT POND DAM  
 ESTATE OF GLENDORA BRYANT  
 RESULTS OF VISUAL INSPECTION  
 JULY 1979  
 PLATE B-1

a. General. The overall appearance of the dam is very poor. Deficiencies were observed as noted below. A sketch of the dam with the location of deficiencies is presented in Appendix B on Plate B-1. Survey information acquired for this report is summarized in Appendix B. On the day of the inspection, the pool was 0.6 foot above spillway crest. The design main spillway is termed the spillway hereafter.

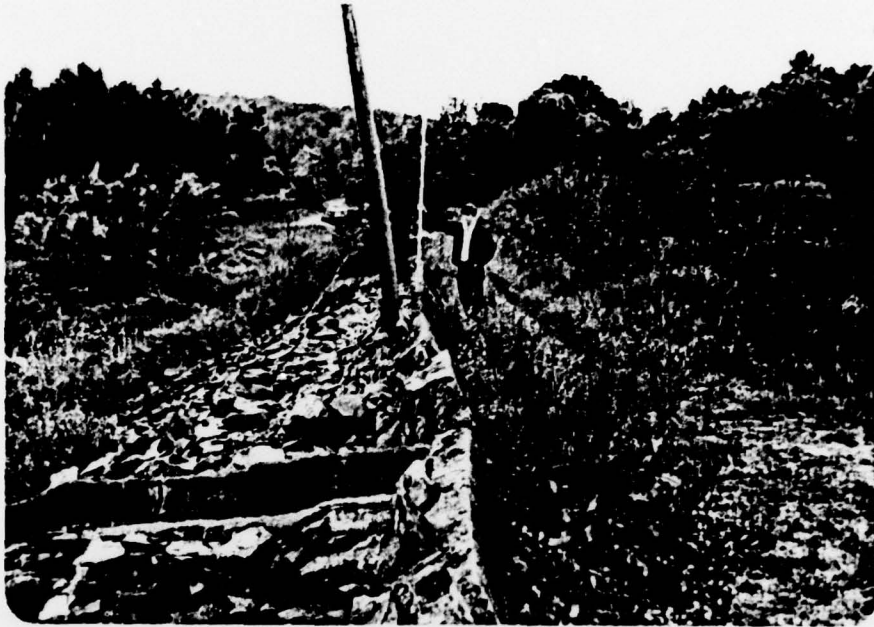
The top of the core-wall is visible along the top of the dam, except in the breach area. It tilts about 45° downstream along the entire top of the dam except in the breach area, where it has been washed away, and in certain other areas, where it has broken off and is lying on the downstream slope. The top of the earthfill on the upstream side of the core-wall is uneven. It is a maximum of 1.6 feet below its design elevation except adjacent to the spillway, where it is 2.7 feet below its design elevation. The top of the core-wall, except at the breach area, is a maximum of 2.3 feet below its design elevation. The existing profiles are shown in Appendix B.

A. Top of Dam

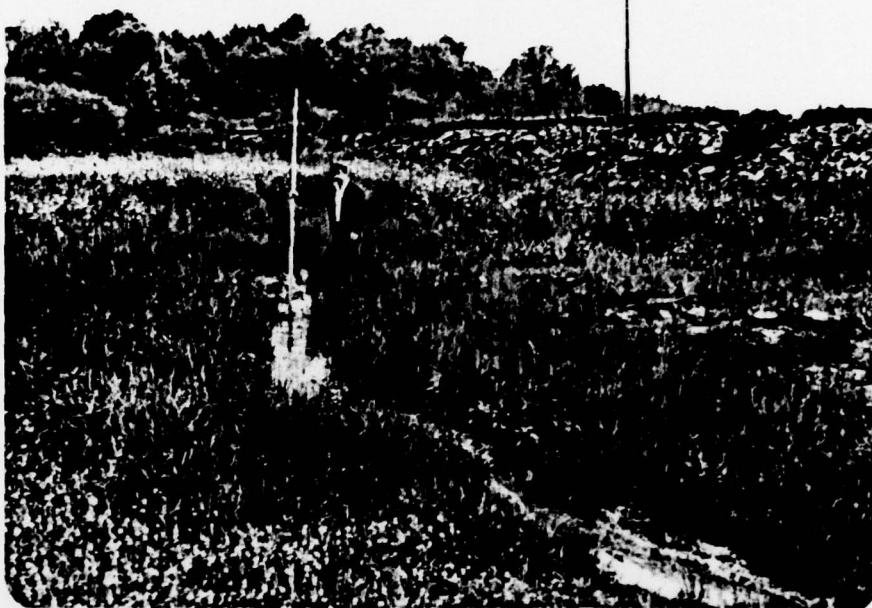
The rockfill on the downstream side of the core-wall is very uneven. Beneath one of the ice chutes it is washed out. The rockfill is covered with large, broken pieces of concrete. Some of these are part of the core-wall. The Owner reported that others are the remains of an old ice house that he used in lieu of rockfill to repair the embankment. Seepage was observed downstream from the embankment. Directly at the toe of the embankment a seep estimated at 1 gpm was flowing from a 200 square foot wet area. About 50 feet downstream the seepage increased to about 10 gpm at a localized area. This seepage then flowed to the creek. At the creek, the total seepage was estimated at 20 gpm. As a result of the previous overtoppings, the entire area downstream from the dam is covered with sediment and debris. Additional seepage was observed near the outlet works, as described hereafter.

C. Downstream Slope and Seepage

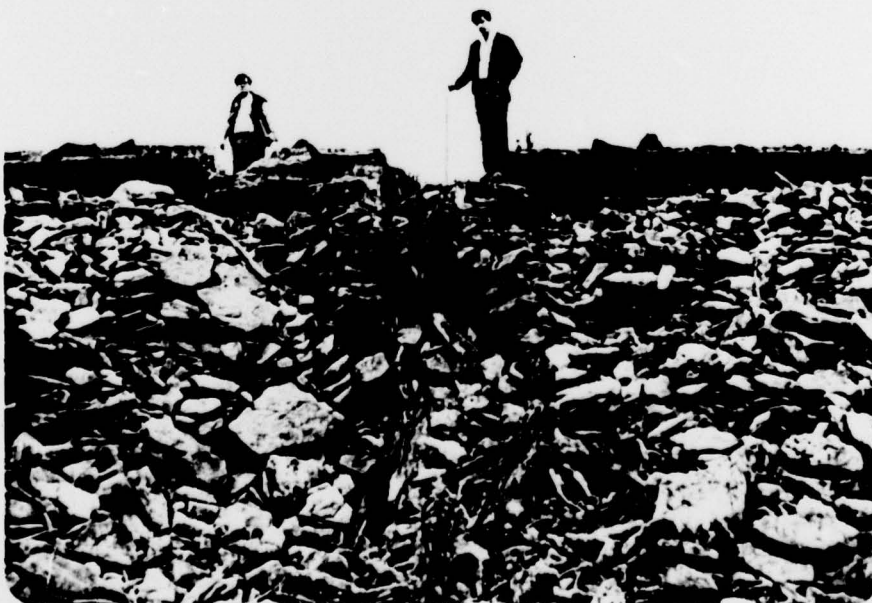
D. Washout Near Ice Chute

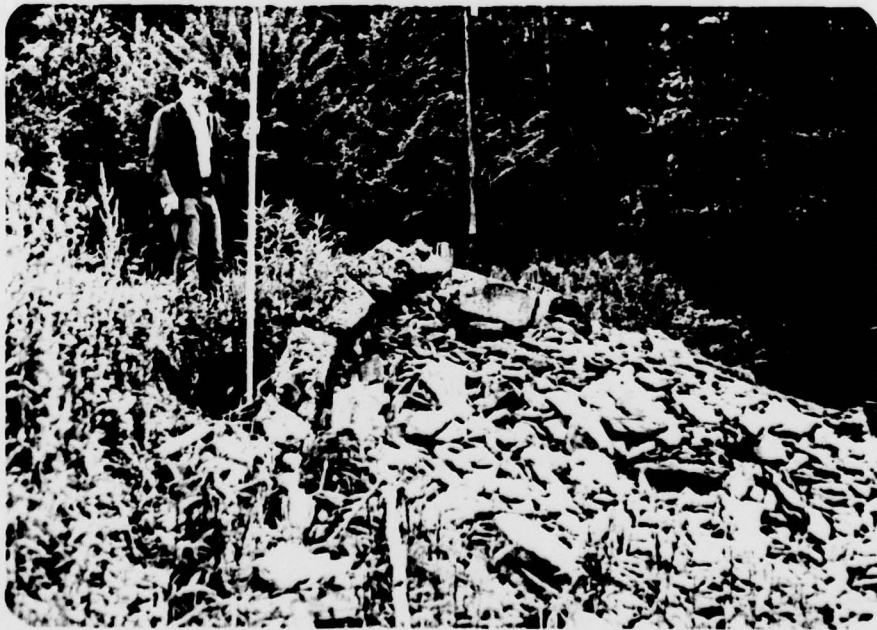
F. Breach Area

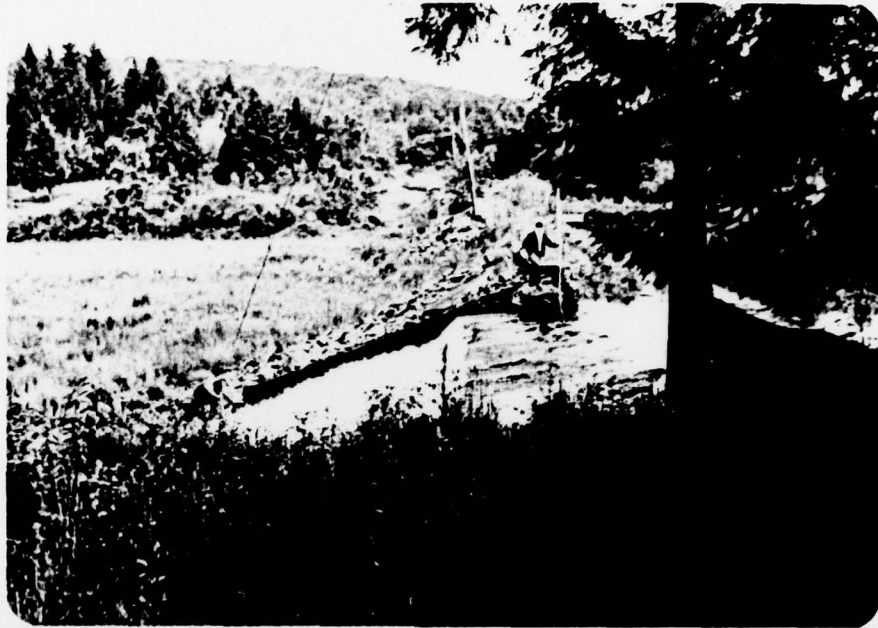
c. Appurtenant Structures. The spillway is in fair condition. As water was flowing over it, a detailed visual inspection was not possible. It was noted that the downstream edges of the cascades were jagged and eroded. Cracks were observed in the cascade slabs. The spillway walls along the cascade are low. The top of wall is 0.6 foot above the cascade at one point. The area to the left of the left spillway wall is rockfill covered with poorly placed concrete. At the downstream toe of this area, seepage estimated at 10 gpm, including a localized seep of 5 gpm, was observed. The core-wall to the left of the spillway is intact. Cracks, which extend entirely through the structure, were observed at 4 locations. The wall is tilted forward near its center; it is also bowed.

G. Spillway

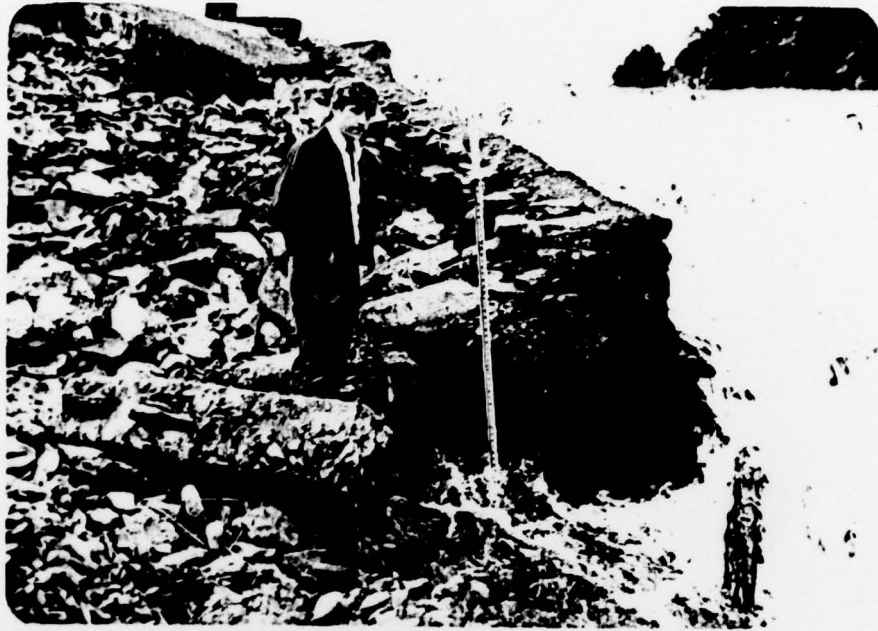
The outlet works is in very poor condition. The remains of the gate operator were observed immediately upstream of the spillway. At the downstream end, a flow of about 1 cfs was discharging from the right conduit. No flow was visible from the left conduit. Although the conduits were reportedly constructed of concrete, they appear to be dry masonry covered with concrete. It is possible to see daylight through the left side of the left conduit. Seepage estimated at 20 gpm was observed

I. Outlet Works

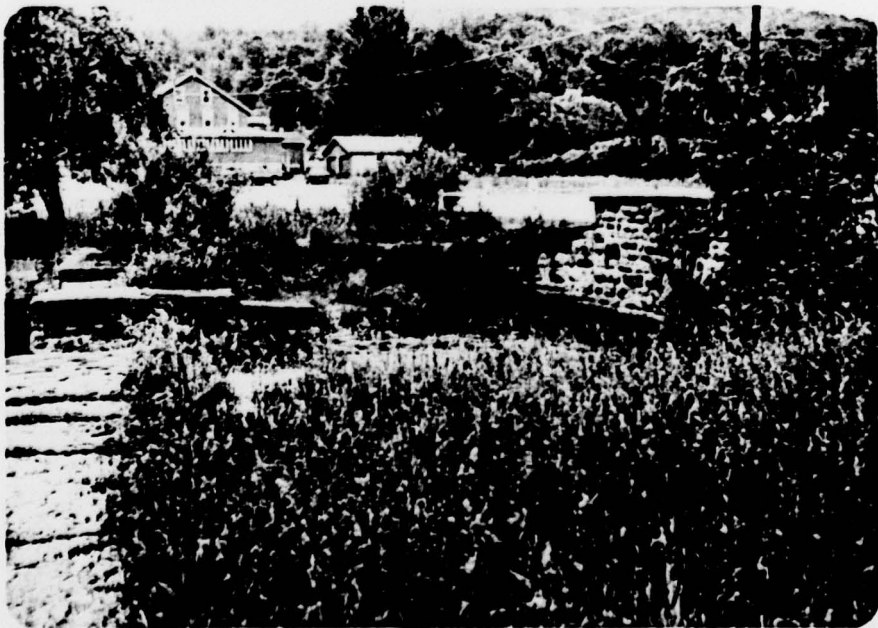
J. Harveys Lake Dam -  
Upstream From Bryant Pond Dam
