NORTH FORK DAM

NDS ID NO. PA-28

PHASE I INSPECTION REPORT
NATIONAL DAM INSPECTION PROGRAM

L. ROBERT KIMBALL & ASSOCIATES
CONSULTING ENGINEERS & ARCHITECTS
EBENSBURG, PENNSYLVANIA
15931

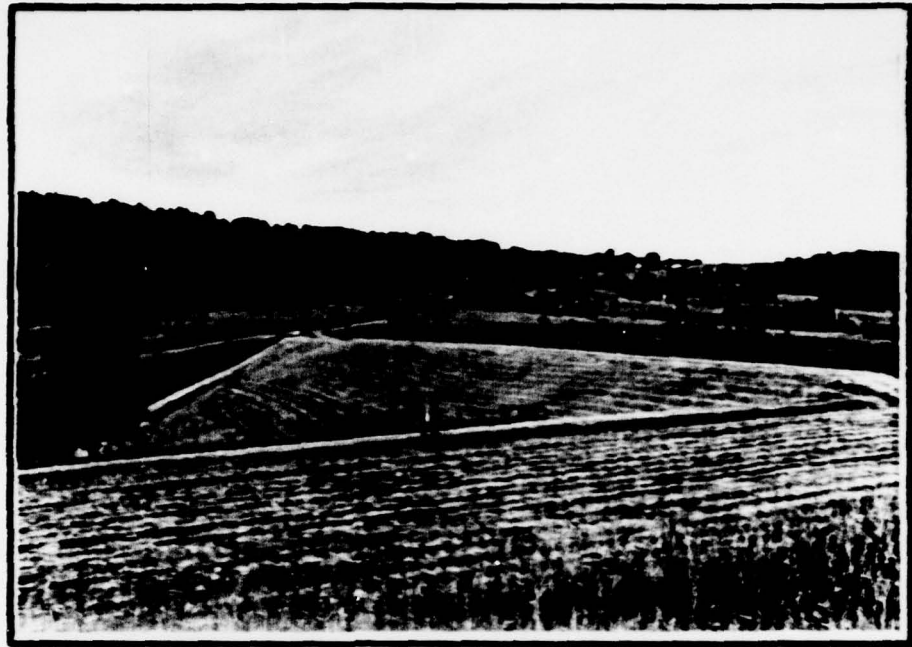
Overview of downstream slope of dam.

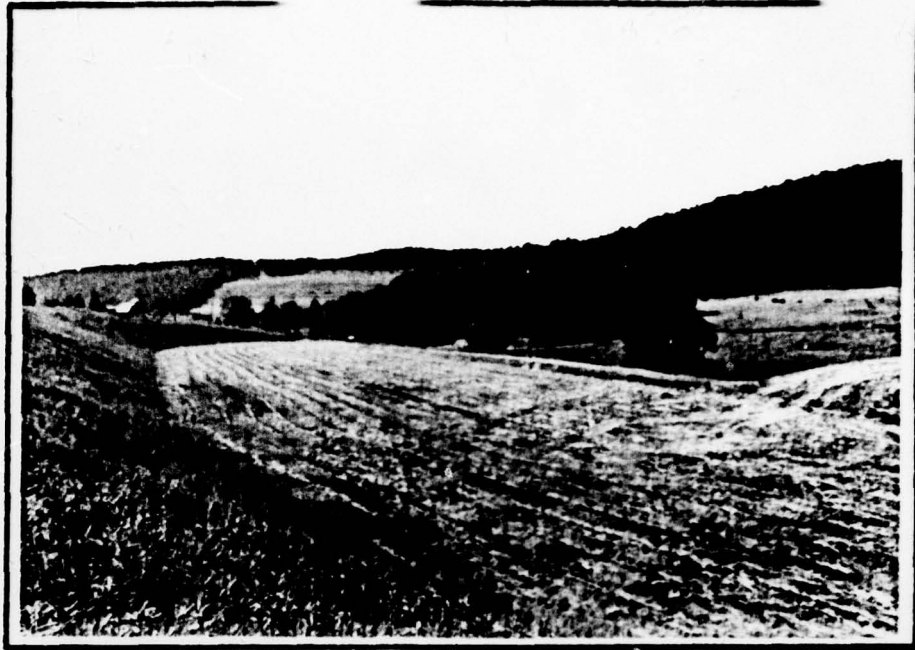
c. Visual Observation. Principal spillway and emergency spillway facilities appeared to be in good condition. However, the earth berm on the right portion of the emergency spillway discharge channel is approximately 5 feet lower than the top of dam. During flooding conditions, flow over this berm will cause erosion of the embankment abutment contact.

The spillway and reservoir are capable of controlling approximately 60% of the PMF without overtopping the embankment. However, because of the low earth berm on the spillway exit channel, flow over the berm will cause erosion of the embankment/abutment contact. The earth berm will overtop with approximately 25% of the PMF.

Emergency spillway discharge channel.
Note low spot on right berm.

1. Raise the earth berm on the right spillway discharge channel to top of dam elevation.
2. The wet area at the bottom of the right rock gutter should be regraded to provide positive drainage.
3. The wet area on the left cut slope of the emergency spillway has shown a minimal amount of movement in the past. This area should be watched closely and drainage provided.
4. A warning system should be instituted to warn downstream residents of large spillway discharges or failure of the dam.
5. A safety inspection should be conducted by a registered professional engineer knowledgeable in dam design in accordance with Commonwealth of Pennsylvania regulations.

3.2 Evaluation. In general, the embankment and appurtenant structures appear to be in good condition and well maintained. The wet area at the bottom of the rock gutter should be corrected by providing positive drainage from the gutter to the scour basin. In addition, the earth berm on the right portion of the spillway discharge channel should be raised to the top of dam elevation.

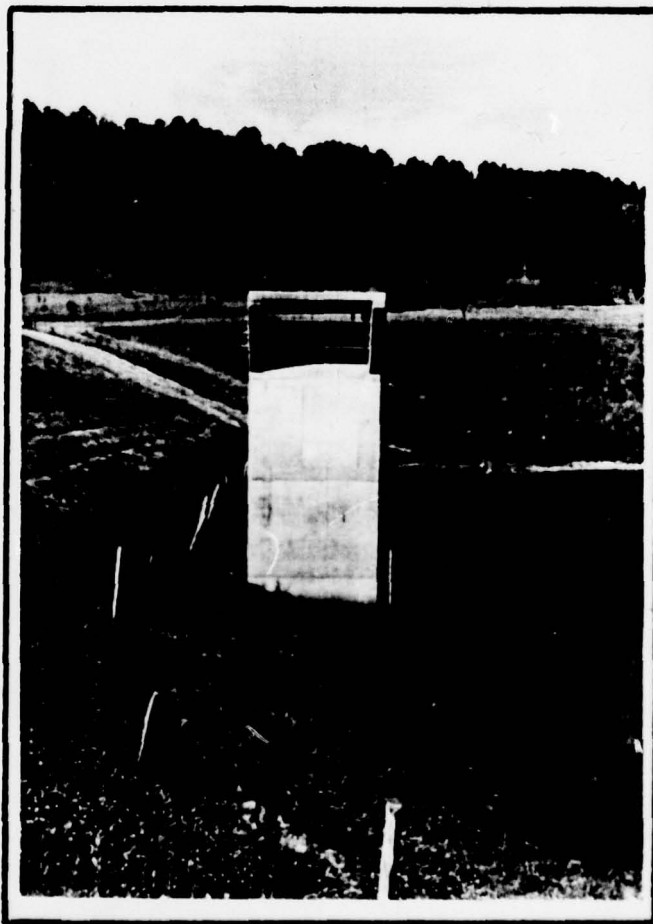
Principal spillway.

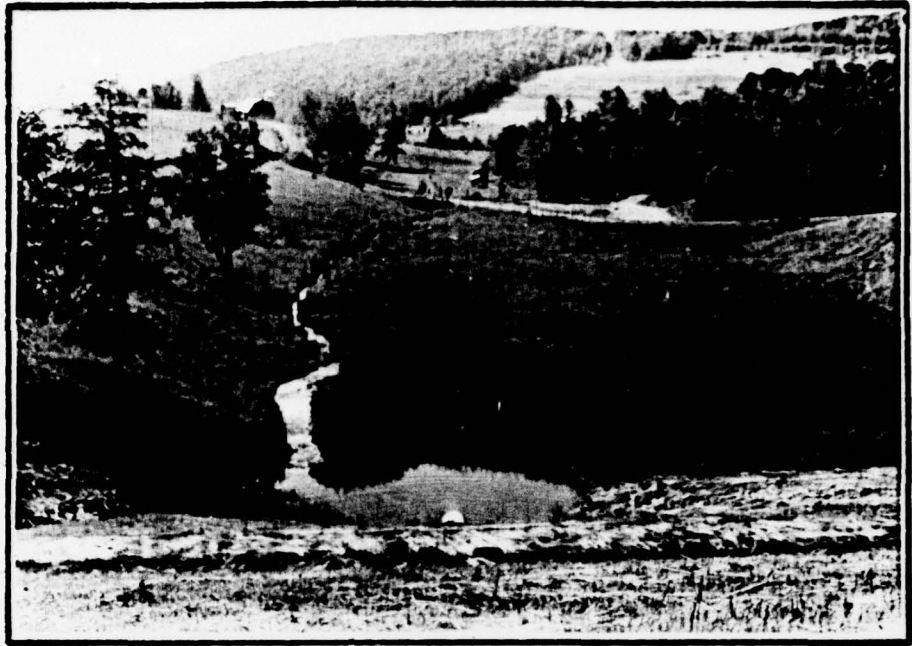
Immediate downstream channel.

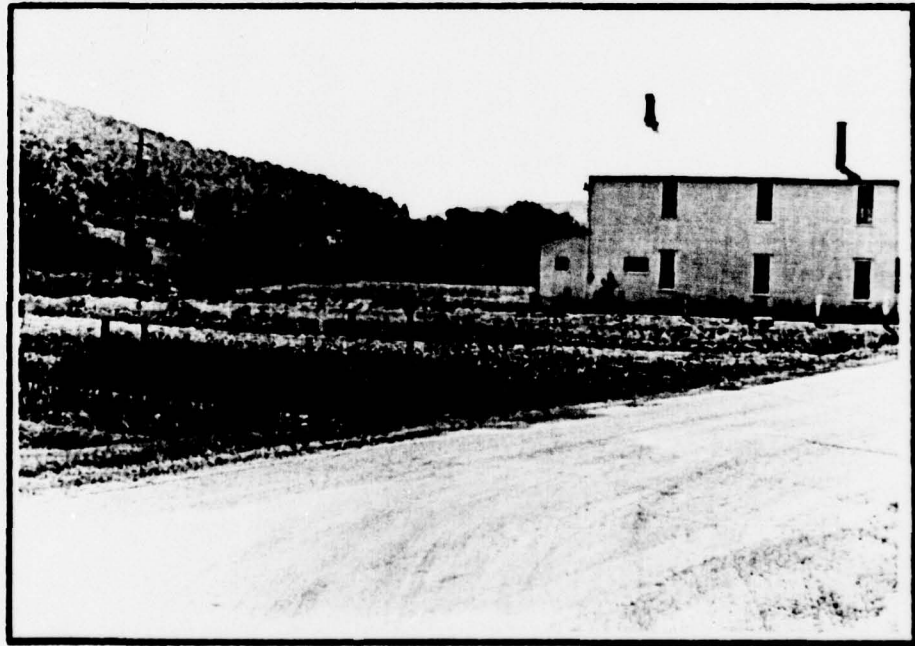
Residence in village of North Fork.
