6 National Dam Inspection Program.

SUNRISE LAKE DAM
(NDI ID Number PA-00556
DER ID Number 40-216)

WHITE HAVEN POCONOS OWNERS ASSOCIATION, INC.
PHASE I INSPECTION REPORT,
NATIONAL DAM INSPECTION PROGRAM

11 JULY 1979

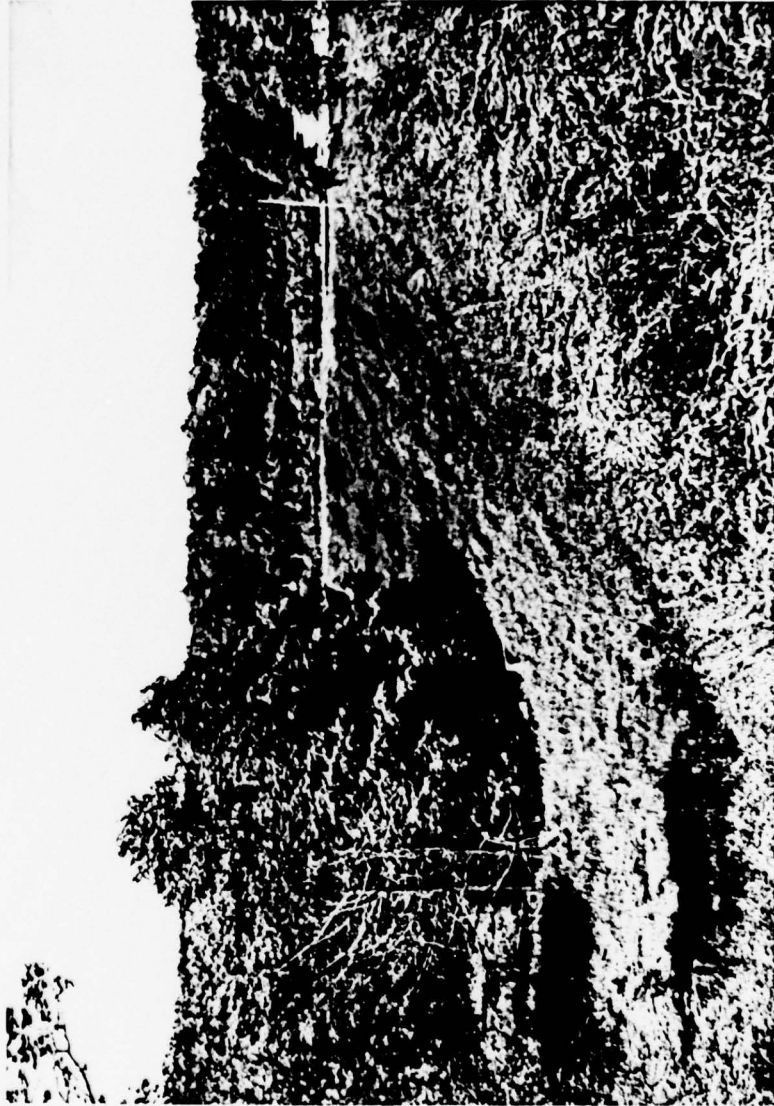
Overview

b. Embankment. The riprap on the upstream slope is generally in good condition (Photograph A), but riprap was missing at each side of the spillway. Crownvetch covers some areas of the riprap, and there were a few small shrubs on the upstream slope. The measured topwidth varied from 7 feet to 8.5 feet. The top of the dam and the downstream slope are covered with crownvetch about 30 inches high (Photograph B). The downstream slope appeared to be in good condition except along the right wall of the spillway chute, where there has been some surface erosion along a footpath (Photograph C). In this area, from the right wall of the spillway chute to the right abutment, the vegetal cover on the downstream slope is sparse (Photograph C). There are some large trees and brush growing just beyond the toe of the embankment to the left of the spillway (Overview and Photograph D).

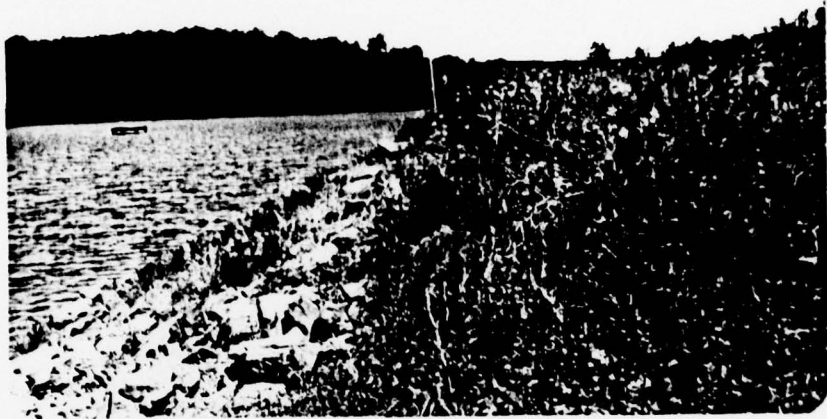
A. Upstream Slope

- (1) Replace riprap missing at each side of spillway.
- (2) Replace headwall at conduit outlet with a structure that is structurally adequate.

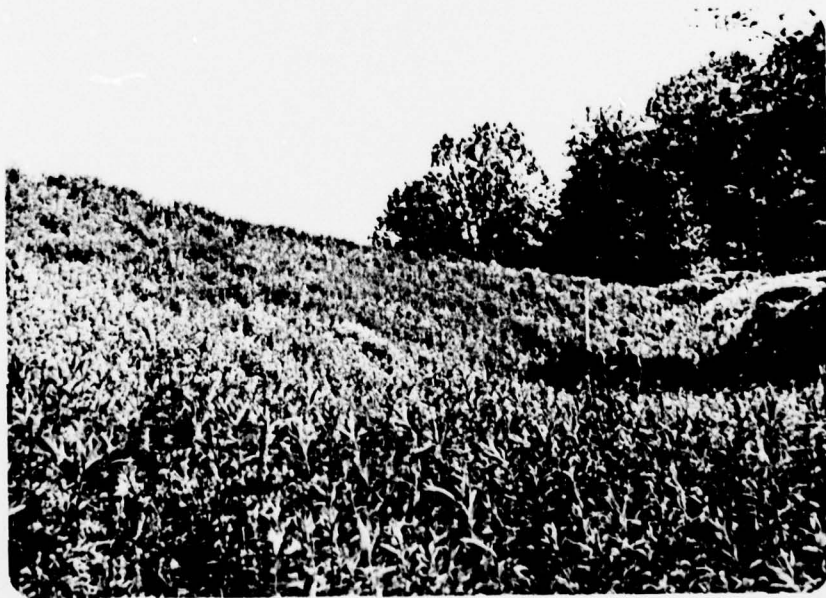
B. Downstream Slope and Left Abutment.

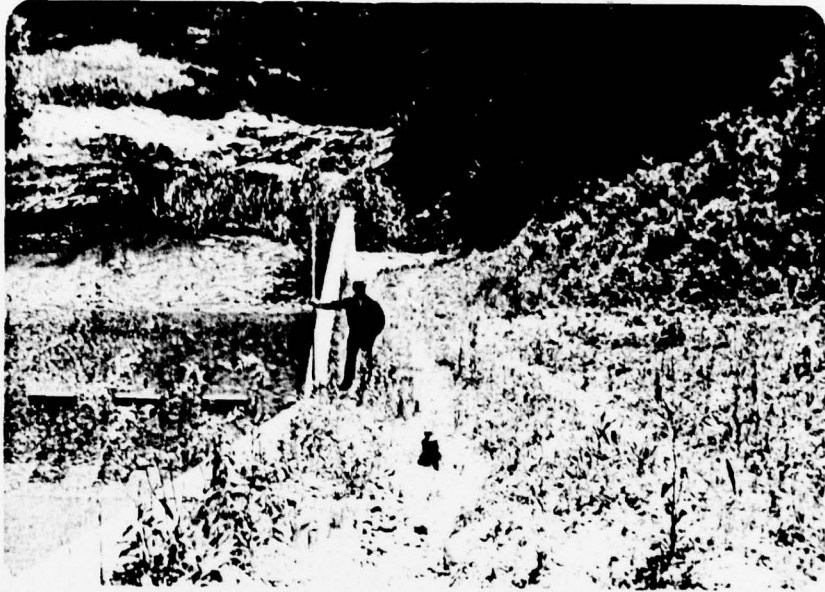
(2) Embankment. Riprap missing at each side of the spillway is an erosion hazard. The sparse vegetal cover on the downstream slope to the right of the spillway is inadequate and creates a potential for surface erosion. Where pedestrian traffic has been frequent, substantial surface erosion has already occurred. The brush on the upstream slope and the trees and brush that are at the downstream toe are undesirable. Although no signs of sloughing or embankment instability were evident at the time of the visual inspection, the downstream slope, which averages 1V on 1.7H, is considered to be too steep without stability computations to show that there is an adequate factor of safety. The design slopes and slope stability computations were not available for the Phase I Inspection Report.

C. Downstream Slope and Right Spillway Wall.

(4) Repair eroded areas on surface of downstream slope and establish adequate vegetal cover at all areas.

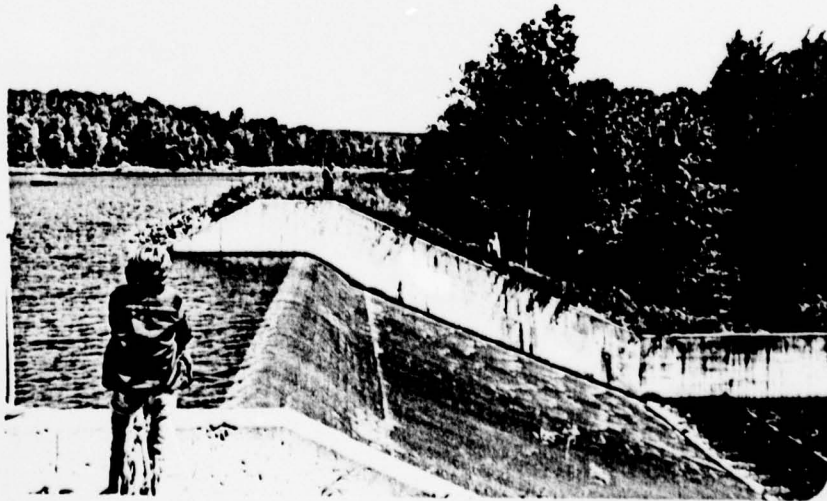
The spillway weir, chute, and stilling basin appeared to be in generally good condition (Photographs D, F, and G). The weir had some minor surface scaling (Photograph F), and the right chute wall was cracked at its downstream end. Some of the expansion joint filler in the chute was deteriorated slightly. There were stones and minor amounts of debris in the apron area of the stilling basin (Photograph F). Downstream from the end sill of the stilling basin, the channel bottom and side-slopes are protected by grouted stone riprap (Photograph G and H). Some of this protection had local areas of deterioration, which allowed water to enter at one point and exit farther downstream. A grouted stone obstruction about 4 feet high is located about 60 feet downstream from the stilling basin (Photograph H). Its purpose appeared to be for tailwater control in the stilling basin.

D. Embankment and Spillway.

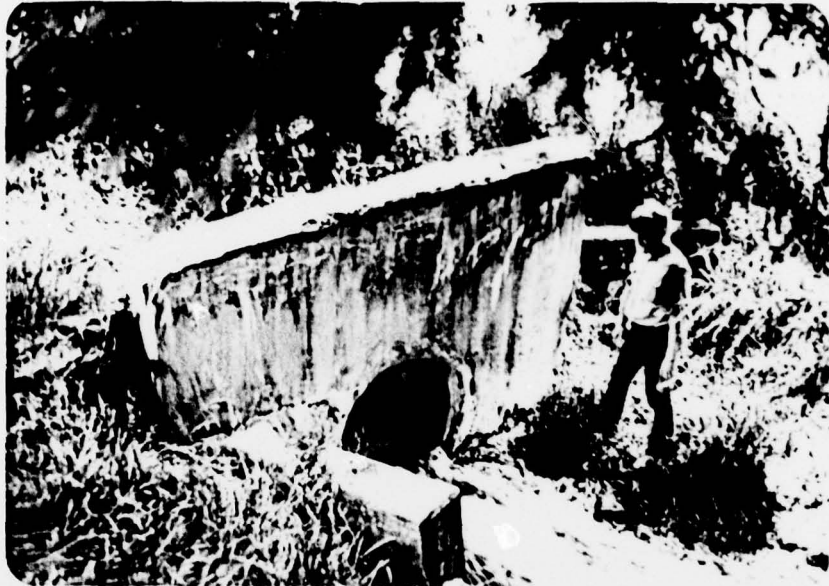
(3) Appurtenant Structures. The tilting of the concrete headwall at the conduit outlet is a stability problem. As noted in Section 5, failure of this headwall could create a serious condition.

E. Headwall at Conduit Outlet.

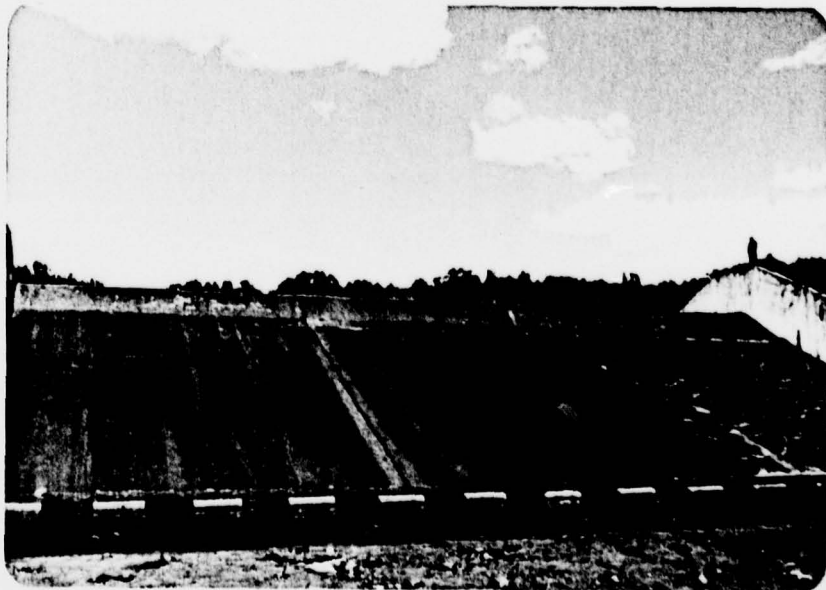
F. Spillway Chute and Stilling Basin.

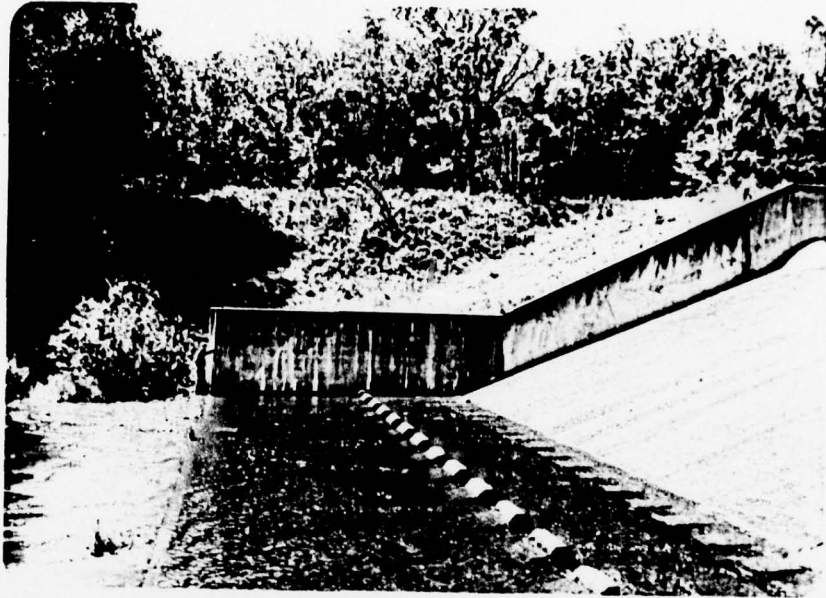
G. Stilling Basin and Right Abutment.

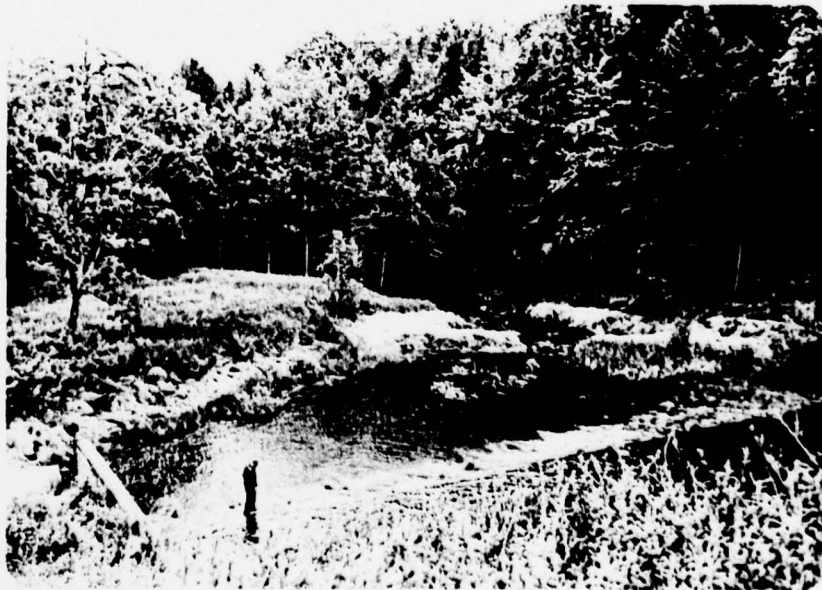
H. Area Downstream from Stilling Basin.
