GLEN BROOK NO. 4 DAM

Number
CNDI NO. PA-00650
DER NO. 19-8

PHASE I INSPECTION REPORT.

Berger Associates, Inc.
Harrisburg, Pennsylvania

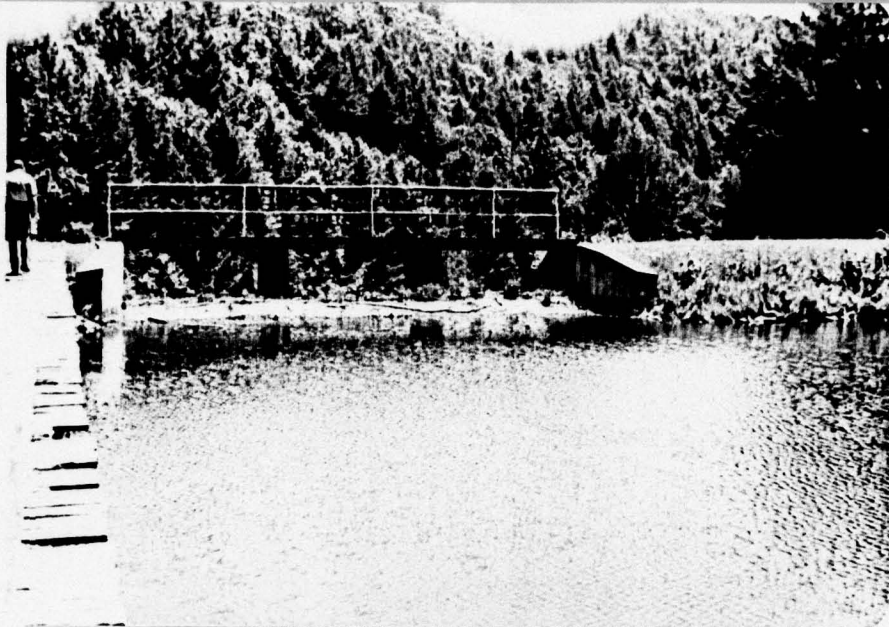
Upstream Slope
& Footbridge
Across Spillway

4. That the bridge decks across the spillway and to the intake tower be repaired and that a handrail be placed on the bridge to the tower.
5. That the source of seepage from the weepholes on the spillway chute slab be identified and that the cavity beneath the chute slab at the location of the lowest weephole be investigated and repaired.

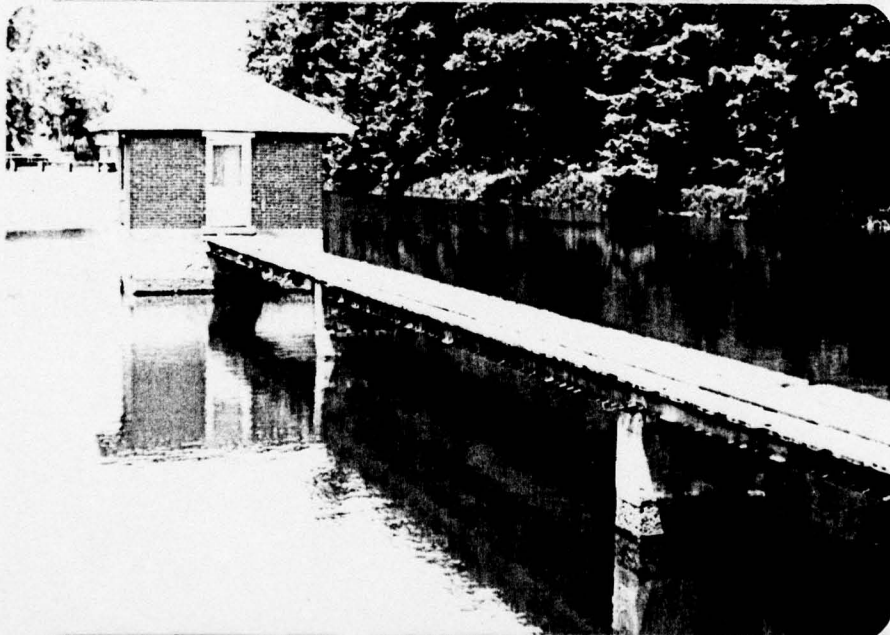
Access to the intake structure is by means of a wooden footbridge on steel beams. This bridge has no handrail and is in fair condition. The deck needs improvement.

The intake structure appears to be stable. The steel beam wooden deck footbridge is usable but it does not have a handrail. Installation of a handrail for safety purposes should be considered. Repairs to the wooden deck should be included in the regular maintenance program.

Footbridge to
Intake Structure

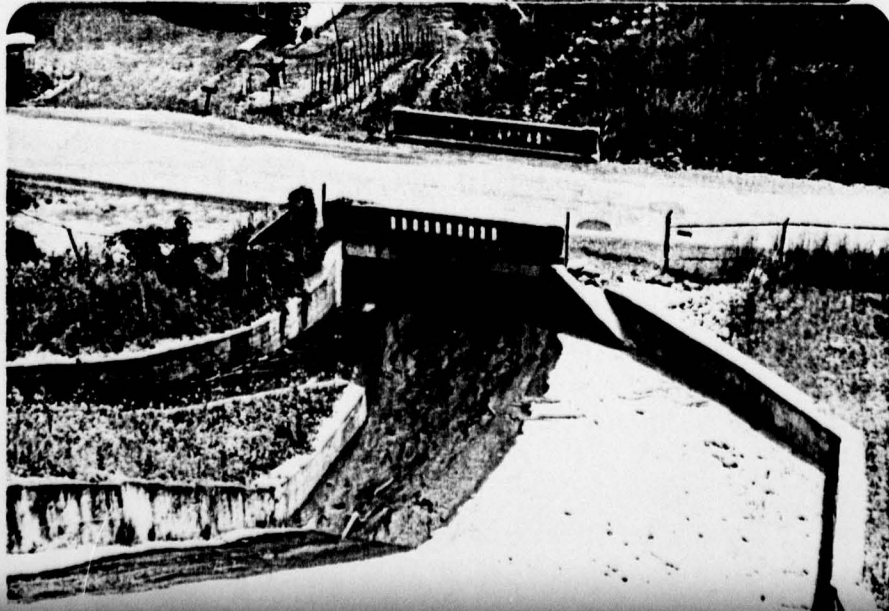
The spillway chute continues nearly horizontally to its termination beneath a roadway bridge. Refer to Appendix F, Plate No. III for plan view. The end of the slab shows some undermining but is not observed to be critical as the slab is sufficiently thick at this location. The drawdown or blowoff pipe discharges to the stream under the roadway bridge.

Downstream Spillway
Discharge Chute
& Highway Bridge

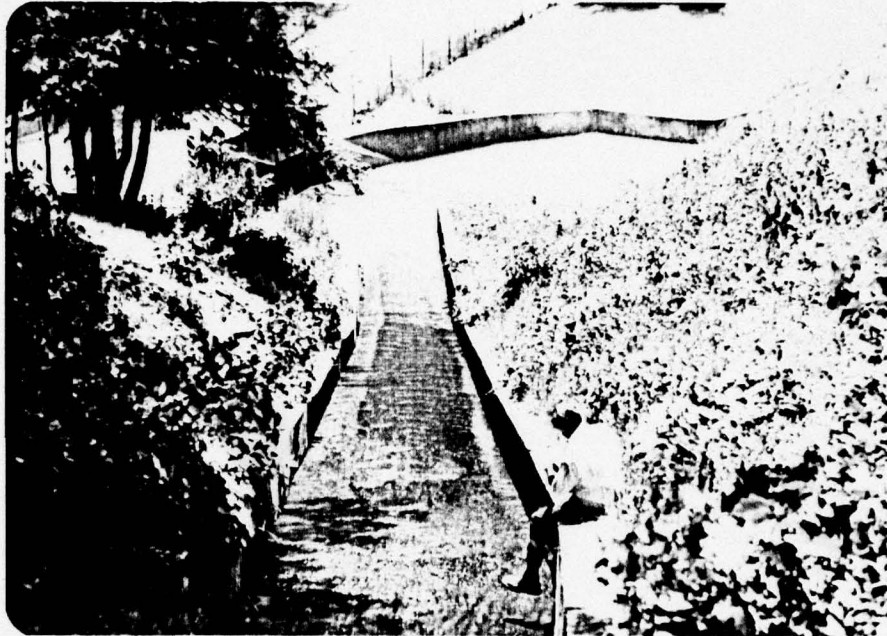
Bypass Conduit Discharge Channel

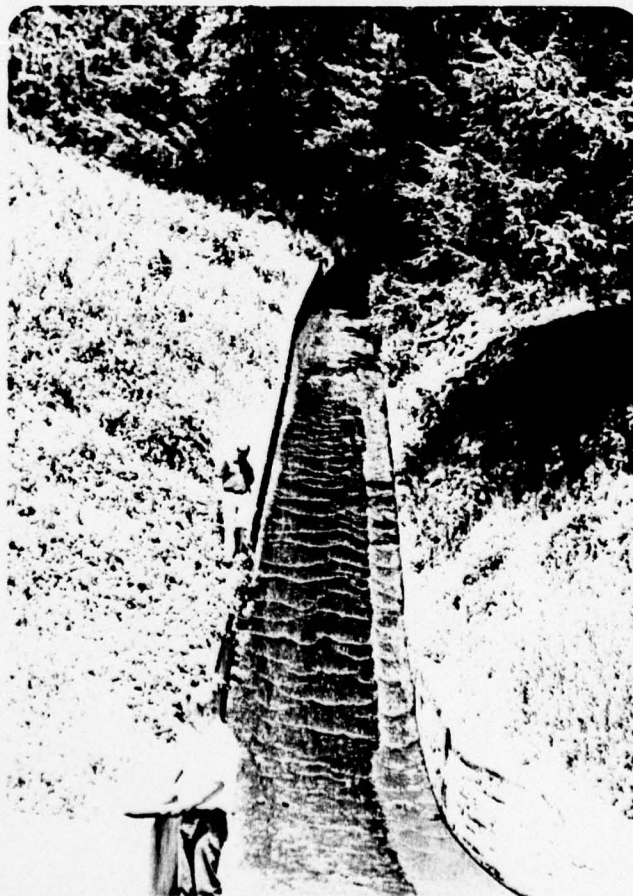
Bypass Conduit Outlet

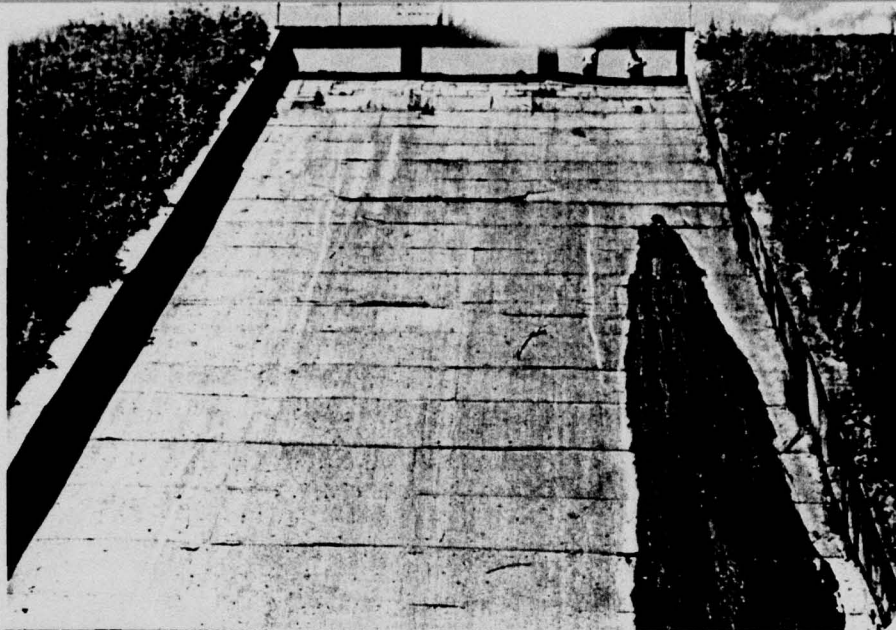
be in reasonably good condition. The spillway chute, at a 1.5H to 1V slope ratio, is bounded by concrete walls. The wall sections are tilted slightly inward creating small projections into the channel between sections. This does not appear to be a serious condition, but it should be closely observed on a regular basis for possible progressive movement in the future.

The spillway chute slab contains four six-inch diameter weep-holes located about 10 feet from the left wall and at vertical distances of about 13 feet between holes. The lowest hole is approximately 18-inches from the bottom of the chute slope. Three of the holes were discharging water. The top hole was dry. The estimated flow from the three holes is about 40 to 50 gallons per minute. A section of downspout was inserted into the bottom hole and extends about three feet out from the surface. Close examination of this hole observed that the section of downspout was loose and can easily be removed and that a cavity exists beneath the slab. The discharge was clear.

Spillway Discharge
Chute

3. That maintenance of the flagstone forming the spillway crest be continued to provide a smooth entrance into the spillway chute and that the slight projections on the spillway chute walls be smoothed for better flow characteristics and to minimize further aggravation of the condition.

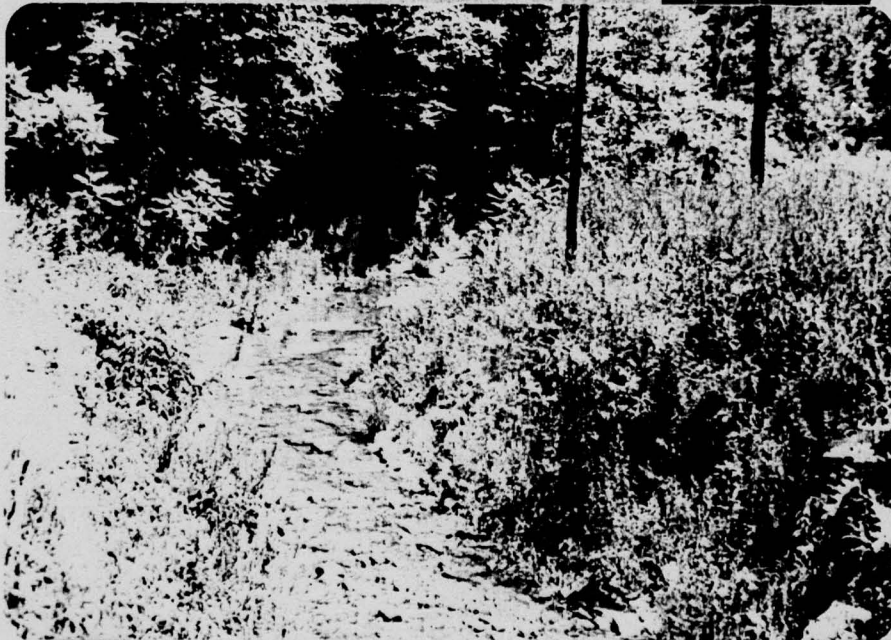
Channel Downstream
from
Highway Bridge

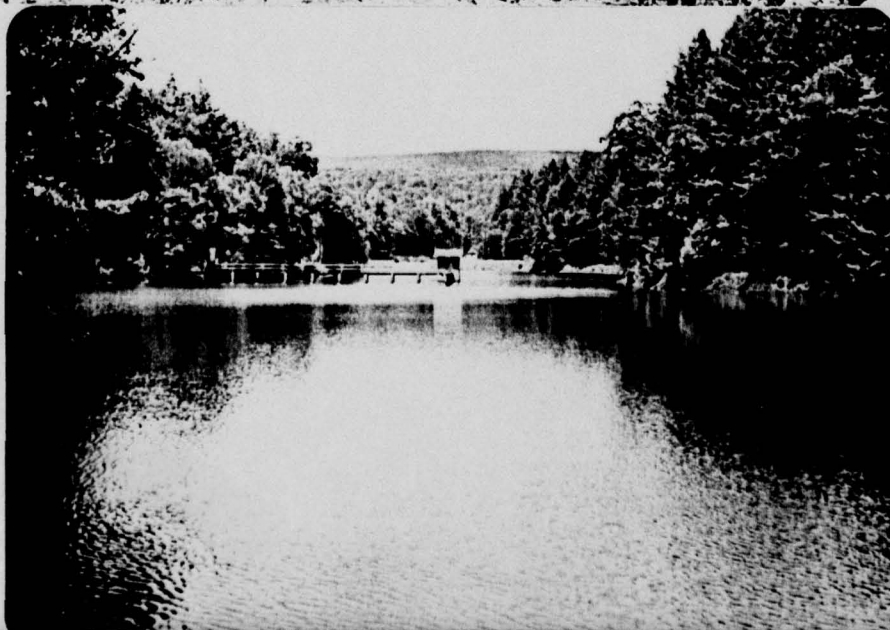
Dam No.4 Reservoir
with
Submerged No.1 Dam
and
No.2 Spillway

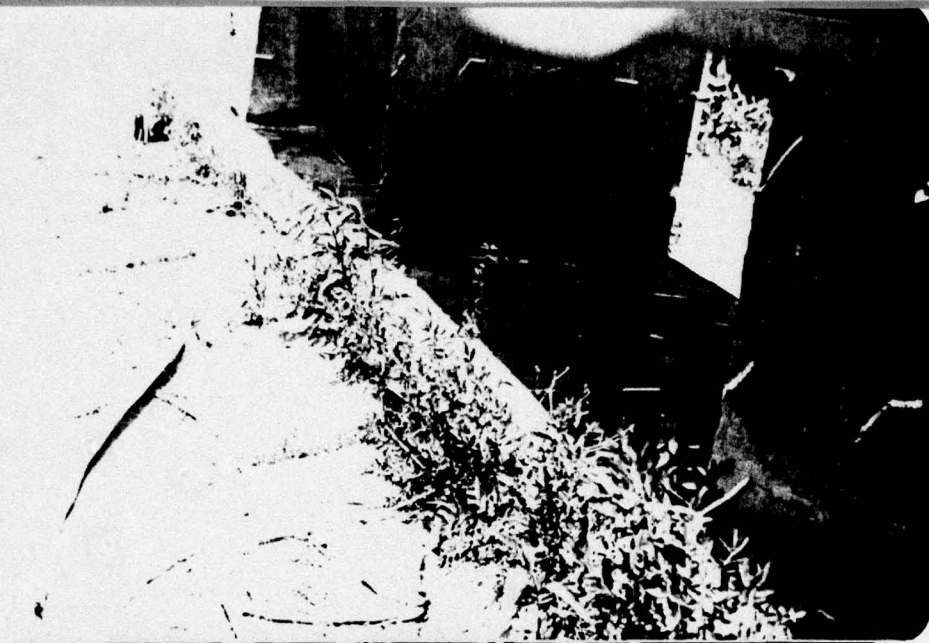
The spillway was observed to be in fair condition. It is a broadcrested weir formed of flagstone slabs with cement mortar in the joints. The slabs appear to have been recently maintained and appear to

The uncontrolled spillway is considered to be in fair condition. The flagstone paving on the crest is reasonably maintained and is sealed with mortar at the joints. The behavior of these slabs under flood or extremely heavy flow is unknown. The outlet channel drops at a rate of 1.5±H to 1V to a nearly horizontal slab at the bottom near the elevation of the natural stream channel. The training wall sections of this channel show evidence of some tilting inward toward the channel. The tilting is not severe, but some slight projections between the sections exist. These projections could possibly aggravate the condition during high flow through the channel. Providing a fillet to create a smoothed surface across the projections would improve the condition. Evidence of other surface repair was observed along the walls on both sides of the channel. The bottom slab and walls below the sloped section appear to be stable and in good condition.

Flagstone Spillway
Weir and Footbridge
Piers

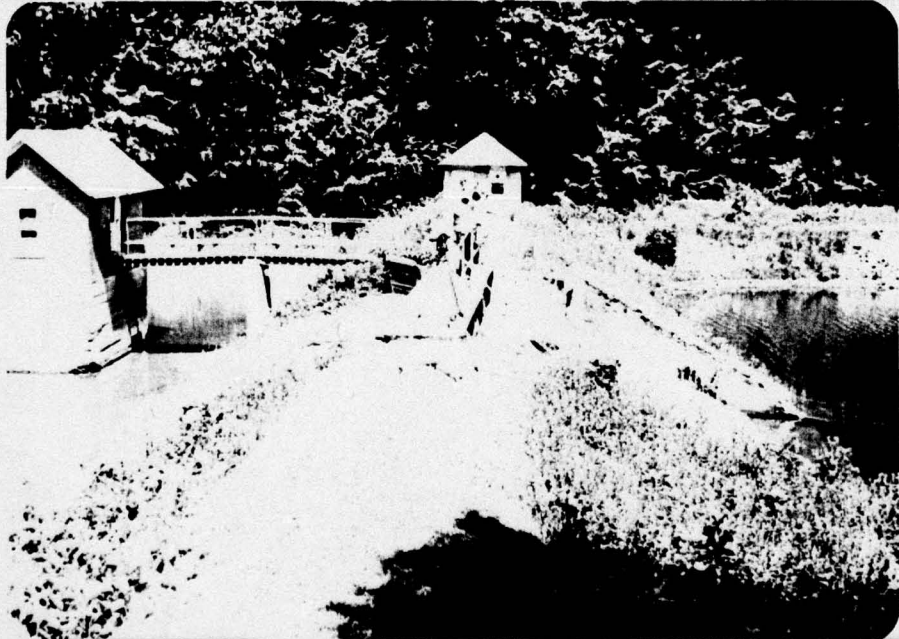
The spillway is severely deteriorated with displaced flagstone slabs, cracked side walls and general deterioration.

The Upstream
Glen Brook
No. 2 Dam

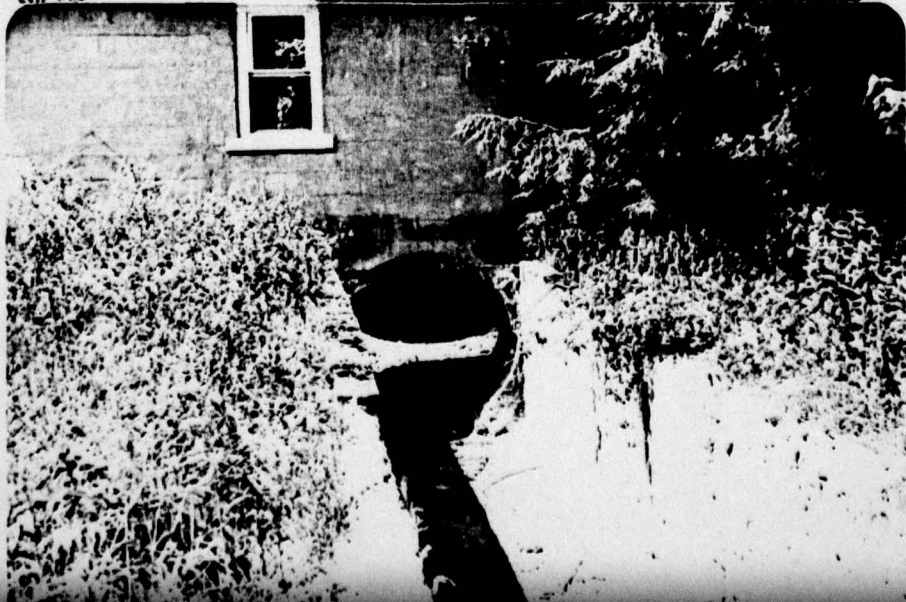
No.2 Dam Reservoir is small. The owners observed this dam closely during heavy storms to prevent water from passing over the main spillway. This is accomplished by opening the 20-inch blowoff pipe and the wooden butterfly gate. The structure, housing the wooden gate is in very poor condition inside.

Bypass Conduit
Gate at No. 2 Dam
