BIG BASS LAKE DAM

NDI ID NO. PA-00368  
DER ID NO. 35-126

PHASE I INSPECTION REPORT  
NATIONAL DAM INSPECTION PROGRAM

JULY 1979

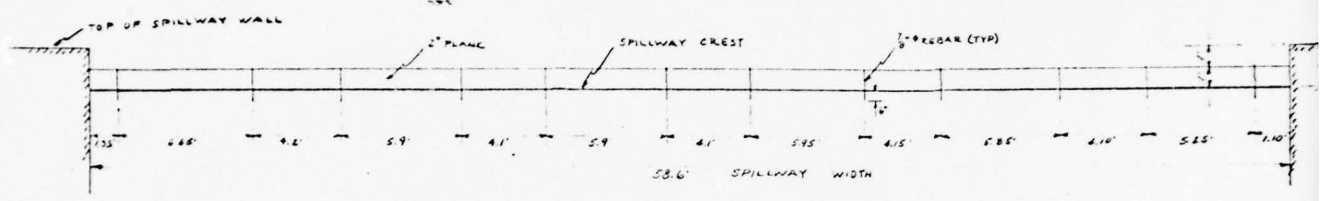
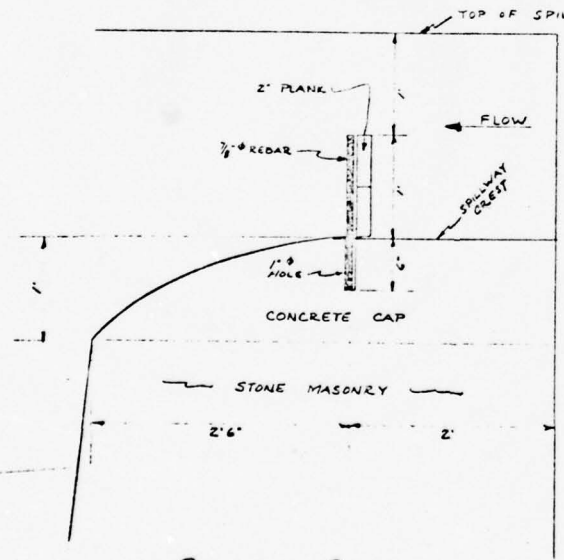
PHASE I INSPECTION REPORT  
 NATIONAL DAM INSPECTION PROGRAM  
 BIG BASS LAKE DAM  
 BIG BASS LAKE, INC.  
 FLASHBOARD DETAILS  
 JULY 1979  
 PLATE 4

The design of the flashboards is presented on Plate 4. The design utilized No. 7 reinforcing bars. The designer assumed that the bars would fail at a yield stress of 36,000 psi. Reinforcing bars are not usually supplied with a yield stress of 36,000 psi. Normally, they are supplied at 40,000; 50,000; and 60,000 psi. Furthermore, yield stress is not the usual criteria used in the design of flashboards because, even if yield stress were exceeded, it would only guarantee a slight plastic deformation but not failure. The usual flashboard design uses hollow pipes. Ultimate stress is usually used to ensure failure. For these reasons, the analysis described hereafter for the existing conditions assumes that the flashboards remain intact.

COMPUTATIONS:  
 AVERAGE SPACING OF BARS = 5"  
 MOM AT 'A' PER BAR =  
 $5 (62.4 \cdot 5 + 67.4 \cdot 33/2) = 24$   
 SECTION MOD OF BAR =  $\frac{7/8}{12} = \frac{0.875}{12}$   
 $f \cdot \frac{M}{S} = \frac{20812}{.066} = 37818$  PSI  
 $> 36000$  YIELD

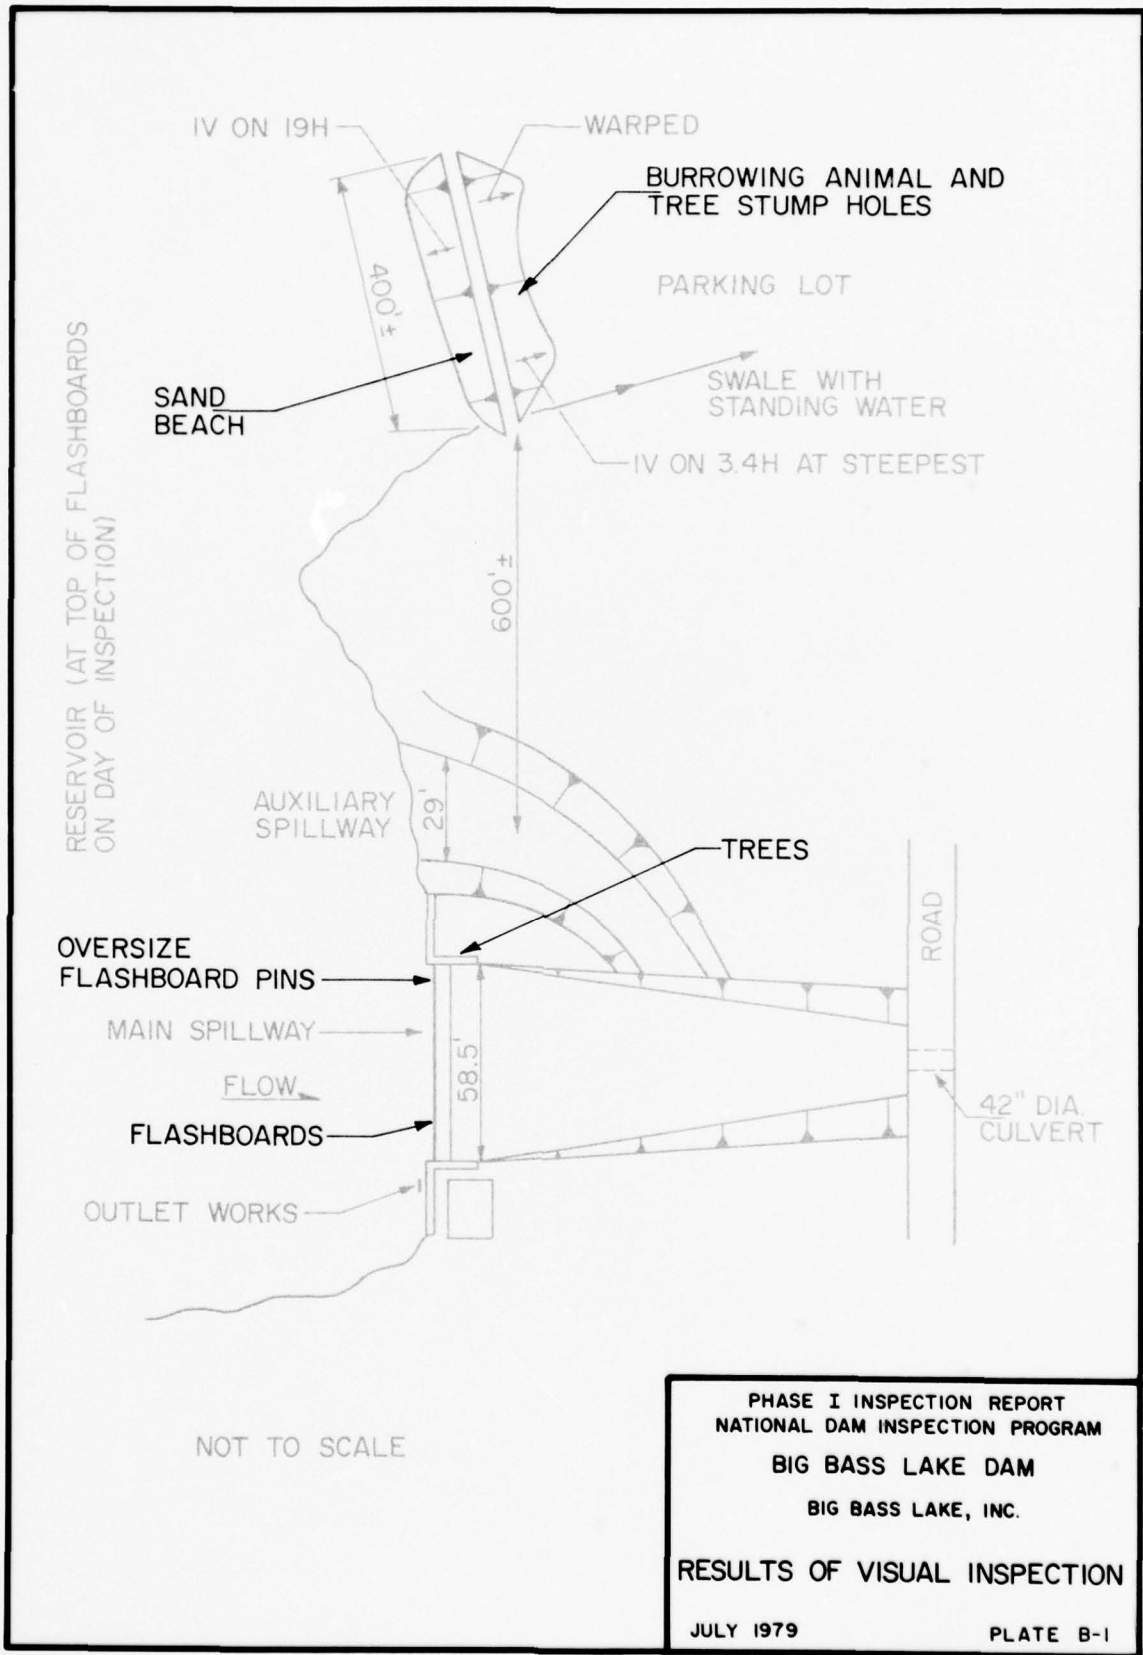
PHASE I INSPECTION REPORT  
 NATIONAL DAM INSPECTION PROGRAM  
 BIG BASS LAKE DAM  
 BIG BASS LAKE, INC.  
 RESULTS OF VISUAL INSPECTION  
 JULY 1979 PLATE B-1

a. General. The overall appearance of the dam is good. Some deficiencies were observed as noted below. A sketch of the dam with the location of deficiencies is presented in Appendix B on Plate B-1. Survey information acquired for this report is summarized in Appendix B. On the day of the inspection, the pool was at the top of the flashboards on the main spillway crest.

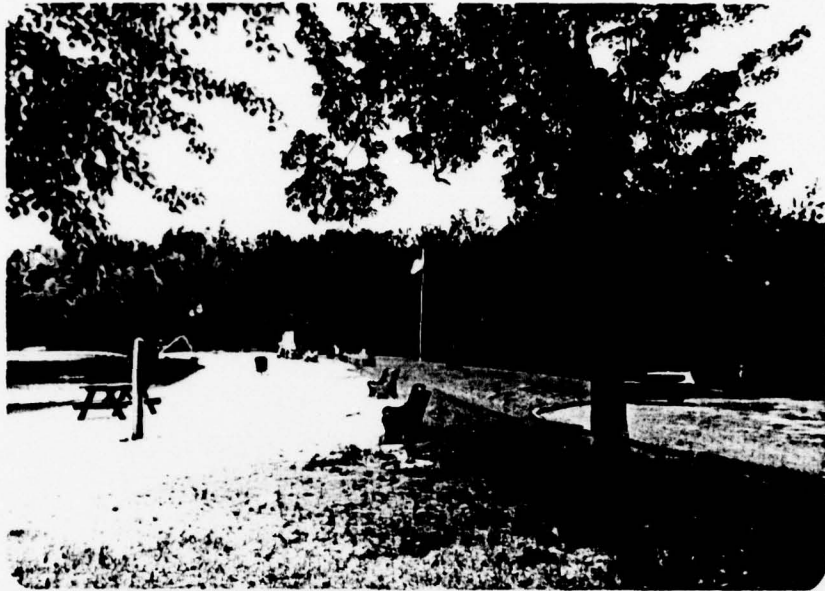
b. Embankment. The embankment is in good condition. The sand beach on the upstream slope is in excellent condition without any evidence of erosion. The grass cover on the remainder of the embankment is in good condition. There are a few holes in the downstream slope. Some holes are caused by decaying tree stumps; others are caused by burrowing animals. None of the burrowing animal holes appeared active. No seepage was observed downstream of the dam. As shown on Plate B-1, a swale was observed extending downstream from the right abutment. The Owner's engineer reported that there used to be a minor amount of seepage in the swale, but that it dried up when the Owner modified the embankment. A few stagnant pools of water were observed in the swale, which does not presently have positive drainage. The drainage in the swale was modified when the area downstream of the embankment was filled to create a parking lot.

A. Embankment

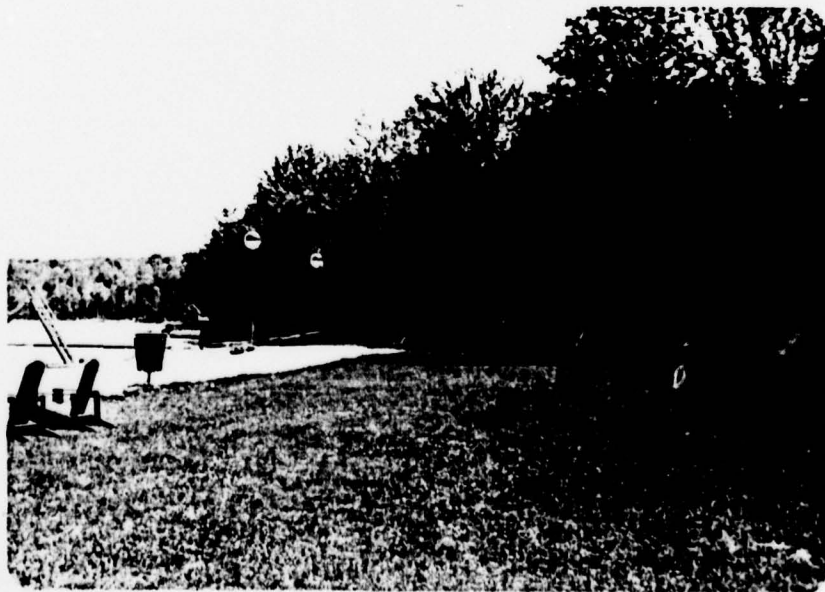
B. Left Abutment of Embankment

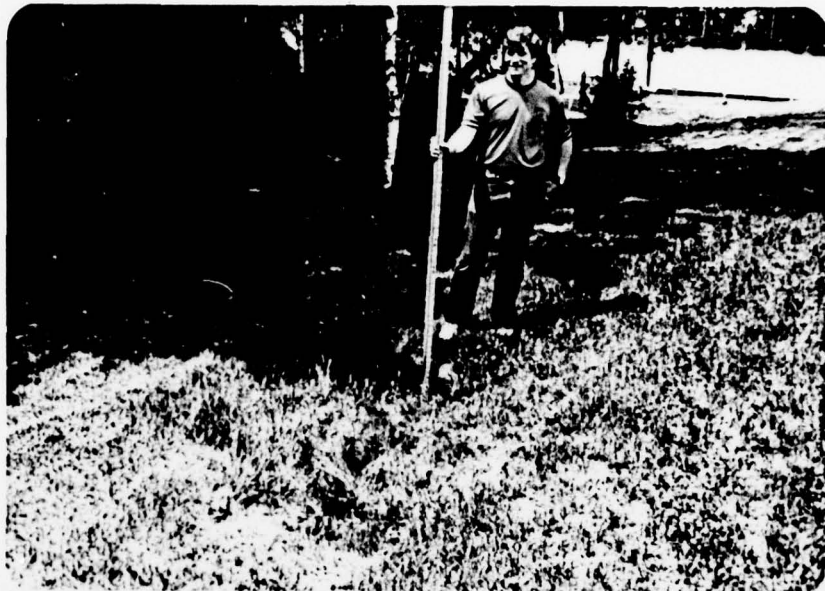
<u>Feature and Location</u>	<u>Observed Deficiencies</u>
<u>Embankment:</u>	
Upstream Slope	Unprotected by riprap but very flat.
Downstream Slope	Burrowing animal and stump holes.
Toe	Dry seepage path.

C. Burrowing Animal and Stump  
Hole in Embankment

(5) As part of the regular maintenance program, remove trees close to the main spillway weir, fill the burrowing animal and stump holes, and monitor the dry seepage path by the right abutment of the embankment. If seepage is noted, have it evaluated by a professional engineer, as noted above. Also, as part of this program, continue observing the upstream slope of the embankment, especially after floods. If erosion is noted, continue the present practice of effecting repairs immediately.

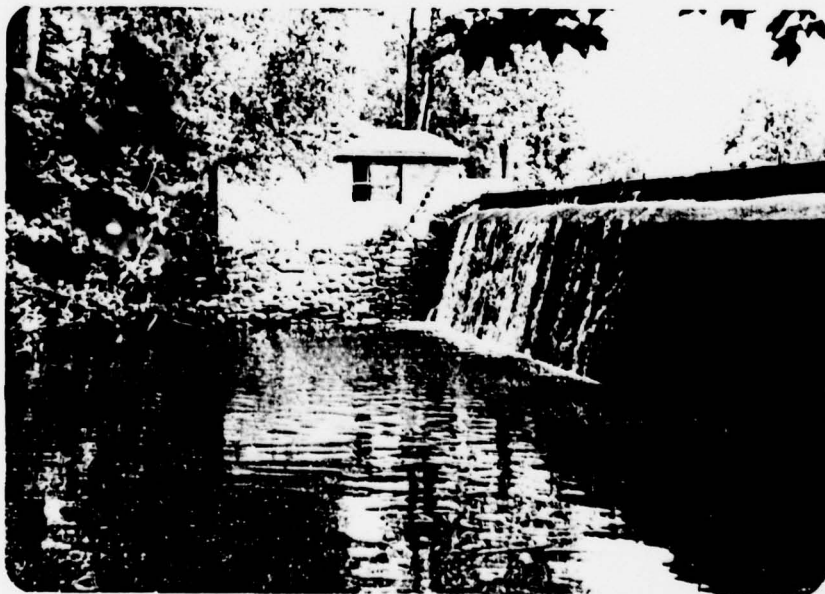
c. Appurtenant Structures. The main spillway is in good condition. No seepage through the masonry was observed; however, a minor amount of flow was occurring over the flashboards, which would have obscured any minor seepage areas. Most of the flashboard pins were No. 7 reinforcing bars. For 20 feet to the right of the left end of the main spillway crest, the flashboards are supported by various pipes and pins measuring from 1 inch to 1-1/4-inches in diameter. The maintenance supervisor reported that these odd size pins had just been put in. He also reported that

The outlet works is in good condition. The sluice gate was opened about 10 percent by one man in about 5 minutes with no apparent problems. The sluice gate is attached to upstream side of the right spillway wall, which is directly exposed to the reservoir.

Susceptible to ice damage.

D. Main Spillway and Outlet Works

(3) Provide protection against ice damage at the outlet works gate.

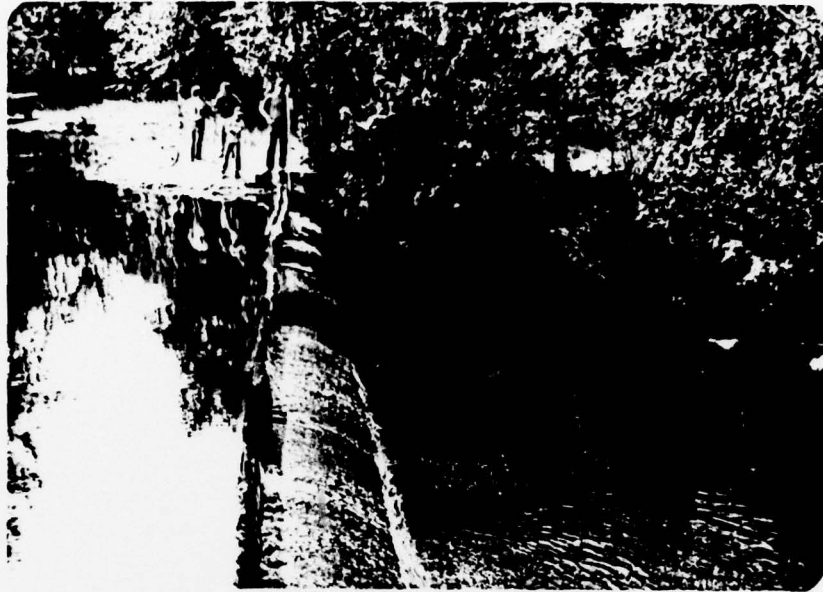
E. Main Spillway and Auxiliary  
Spillway Approach Channel
