6 National Dam Inspection Program  
**TOWAMENSING TRAILS DAM**

(NDI No. <sup>umber</sup> PA-00920  
DER No. <sup>umber</sup> 13-108)

**CARBON COUNTY, PENNSYLVANIA.**

**PHASE I INSPECTION REPORT.**

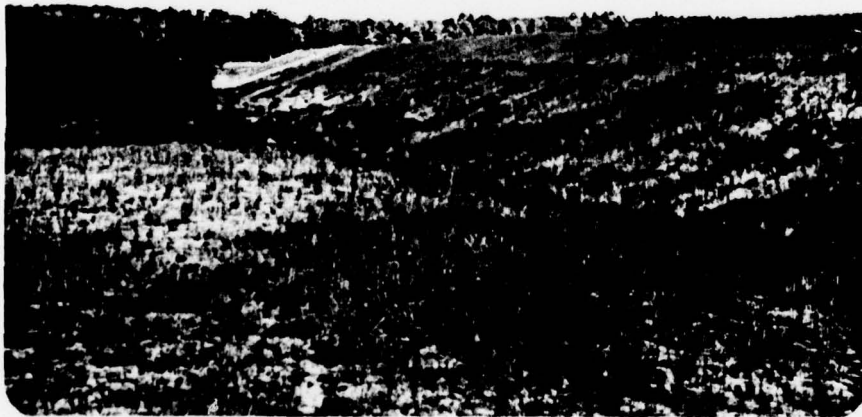
Downstream Slope

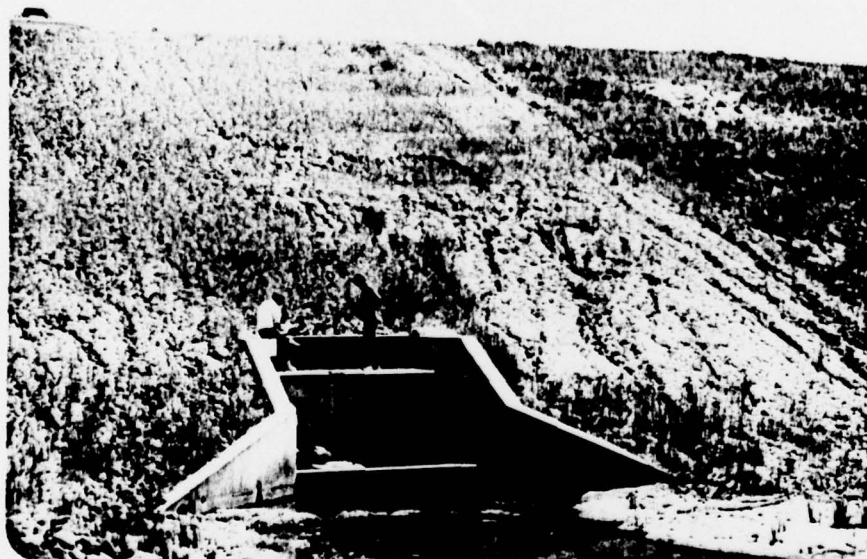
Conduit Outlet  
and  
Slope Erosion

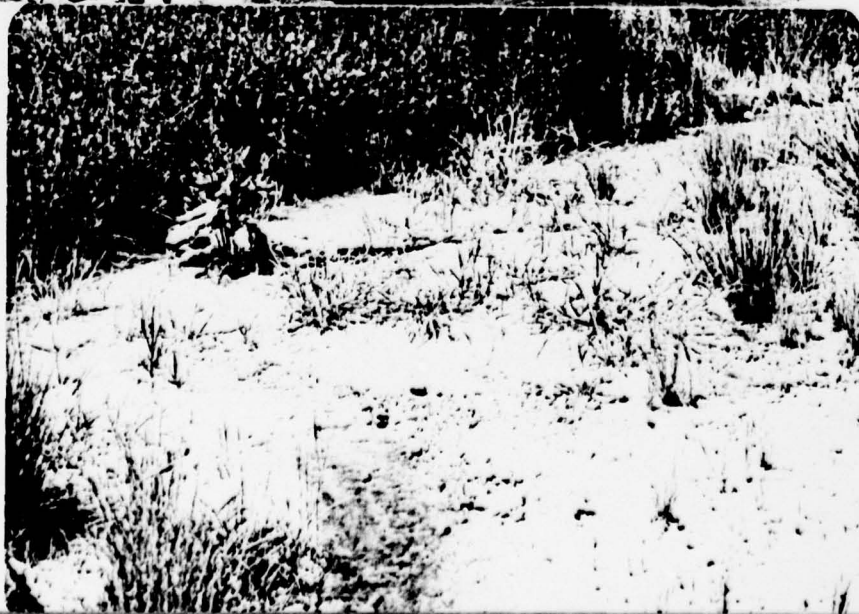
One such bubbling seepage was noted about 50 feet downstream from the toe of the embankment just to the left of the outlet channel. This water was constantly bubbling from the ground creating small mounds of sandy soil at each seepage point. The source points moved at random within a small 4 to 6 foot area during this observation. The water was clean and cold. Because of the number of seepage points, it was not possible to estimate the total flow.

The origin of the seepage condition downstream from the toe of the embankment is uncertain. The geologic report in Appendix D points out the permeable nature of the foundation materials at this site noting that there is opportunity for seepage through the soil overburden as well as through the bedrock. Also that the pressures of the artesian system in the area are in all probability increased due to the added head generated by the reservoir. The seepage points should be located in detail and should be monitored on a regular basis noting and recording flow and clarity. If significant changes are detected, immediate steps should be taken to correct the condition.

Springs Downstream  
from  
Toe of Dam

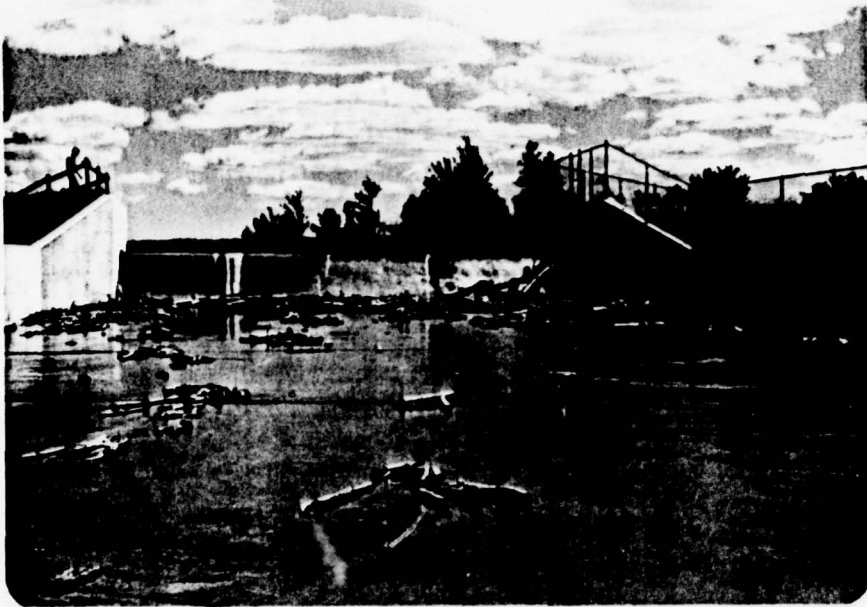
The spillway is a concrete ogee section type weir. There was no evidence of displacement or settlement of this structure. The surface condition is good with no deterioration. This condition applies to the walls, and the spillway outlet channel and walls.

Spillway  
Ogee Section
