DELAWARE RIVER BASIN

POCONO LAKE DAM  
MONROE COUNTY, PENNSYLVANIA

(NDS I. D. No. <sup>umber</sup> PA 00781  
DER I. D. No. <sup>umber</sup> 45-222)

6 PHASE I INSPECTION REPORT  
NATIONAL DAM INSPECTION PROGRAM.  
Pocono Lake Dam  
Delaware River Basin, Monroe County,  
Pennsylvania. Phase I Inspection Report,

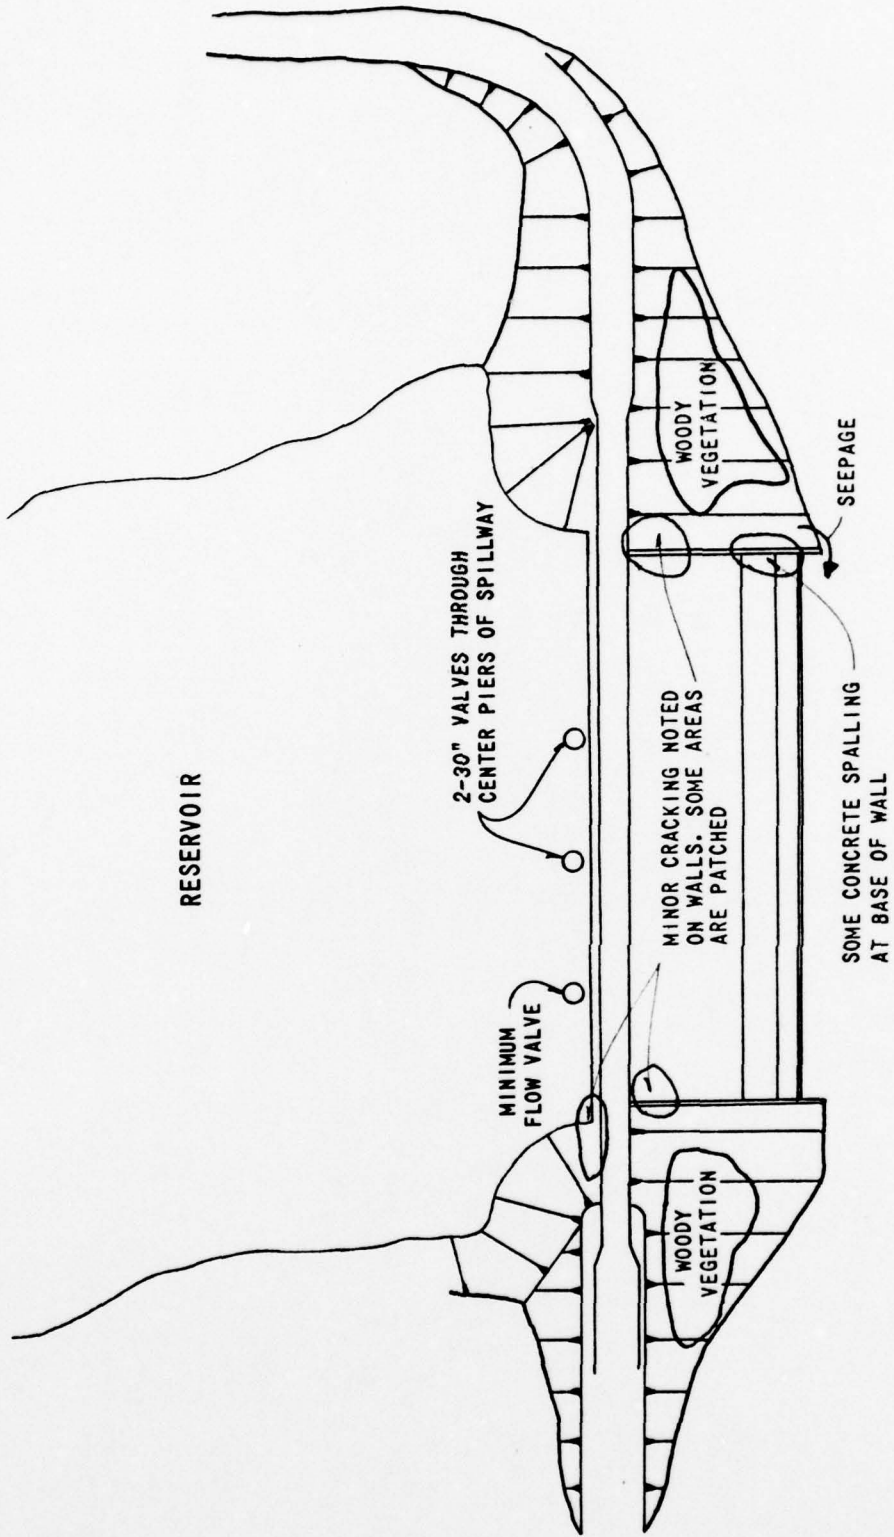
FIELD OBSERVATION PLAN  
POCONO DAM

*Some spalling noted at base of retaining walls as shown on Sheet 5a and photographs. This spalling should be repaired.*

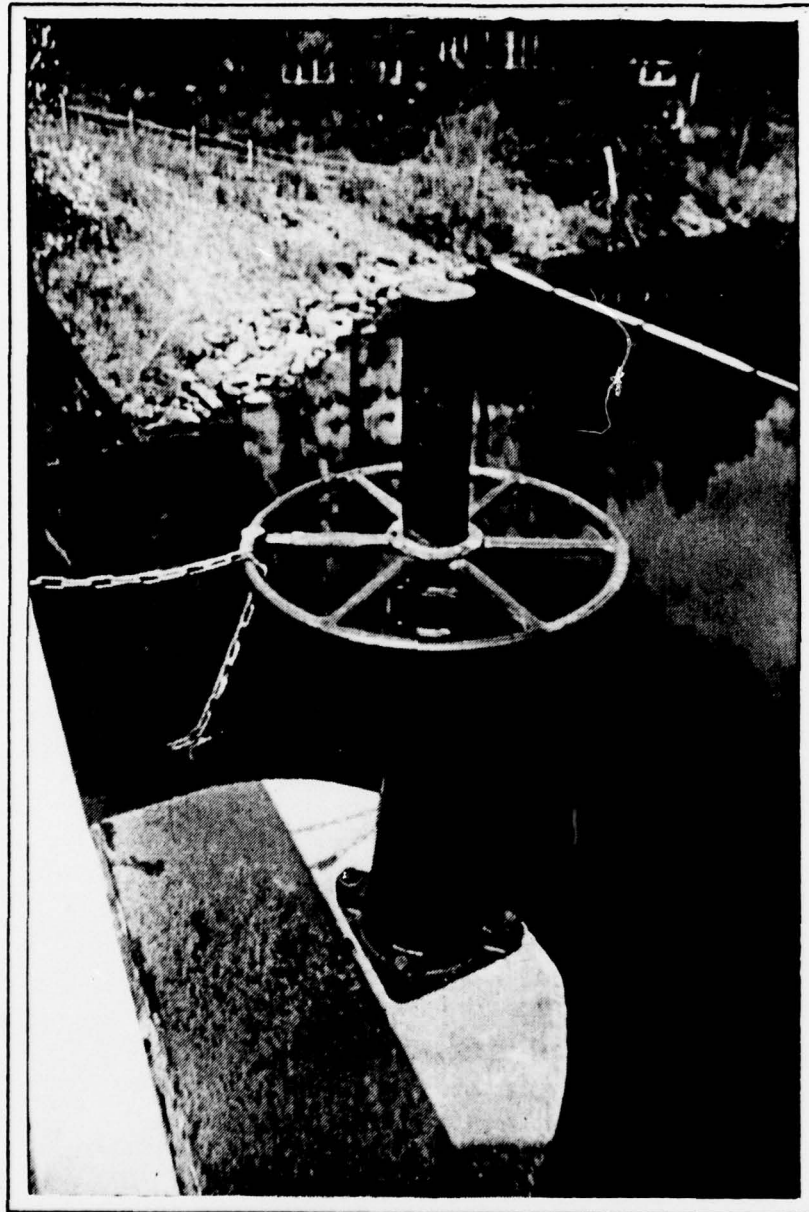
PHOTOGRAPH NO. 1

The minimum flow release gate was exercised and found to operate properly. At the time of inspection, minimum flow was being discharged downstream in addition to excess flow over the spillway crest. Both pond drain gates were exercised and observed to function properly.

VALVE USED TO CONTROL  
MINIMUM FLOW RELEASE.

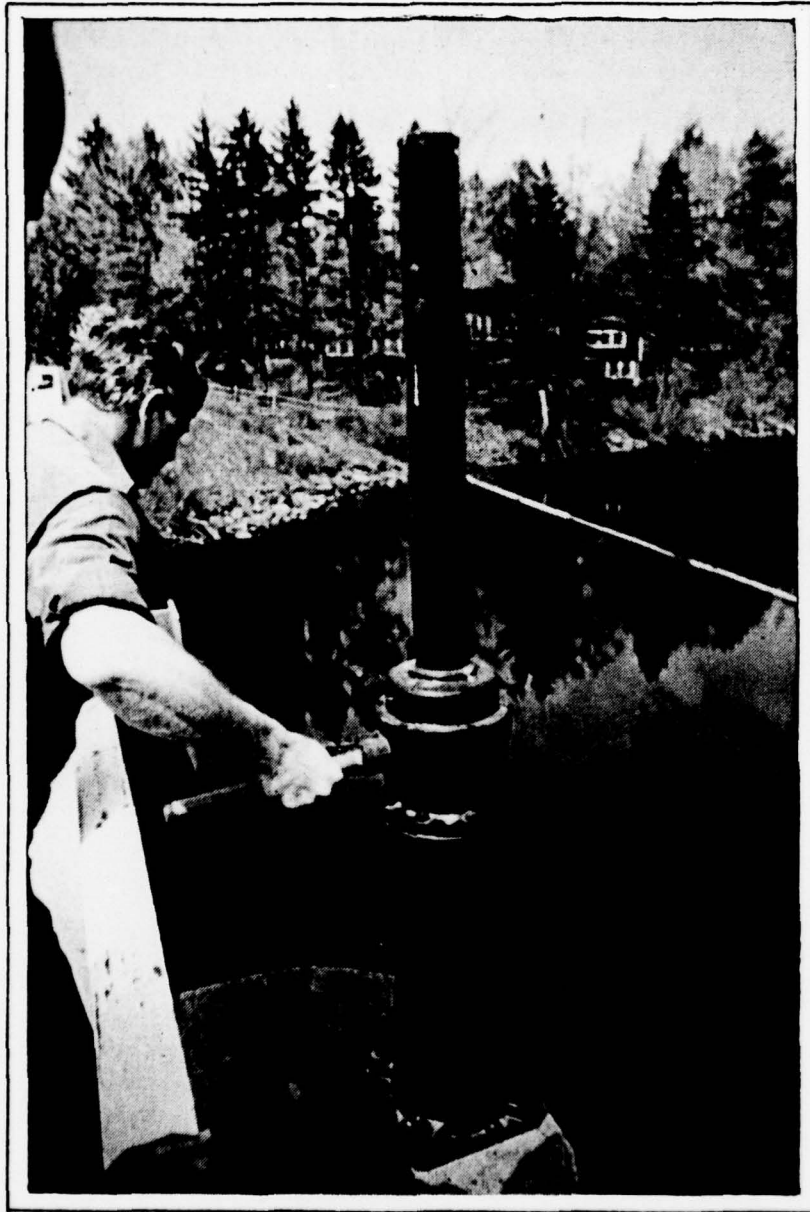
PHOTOGRAPH NO. 2

TYPICAL OUTLET CONTROL VALVE.

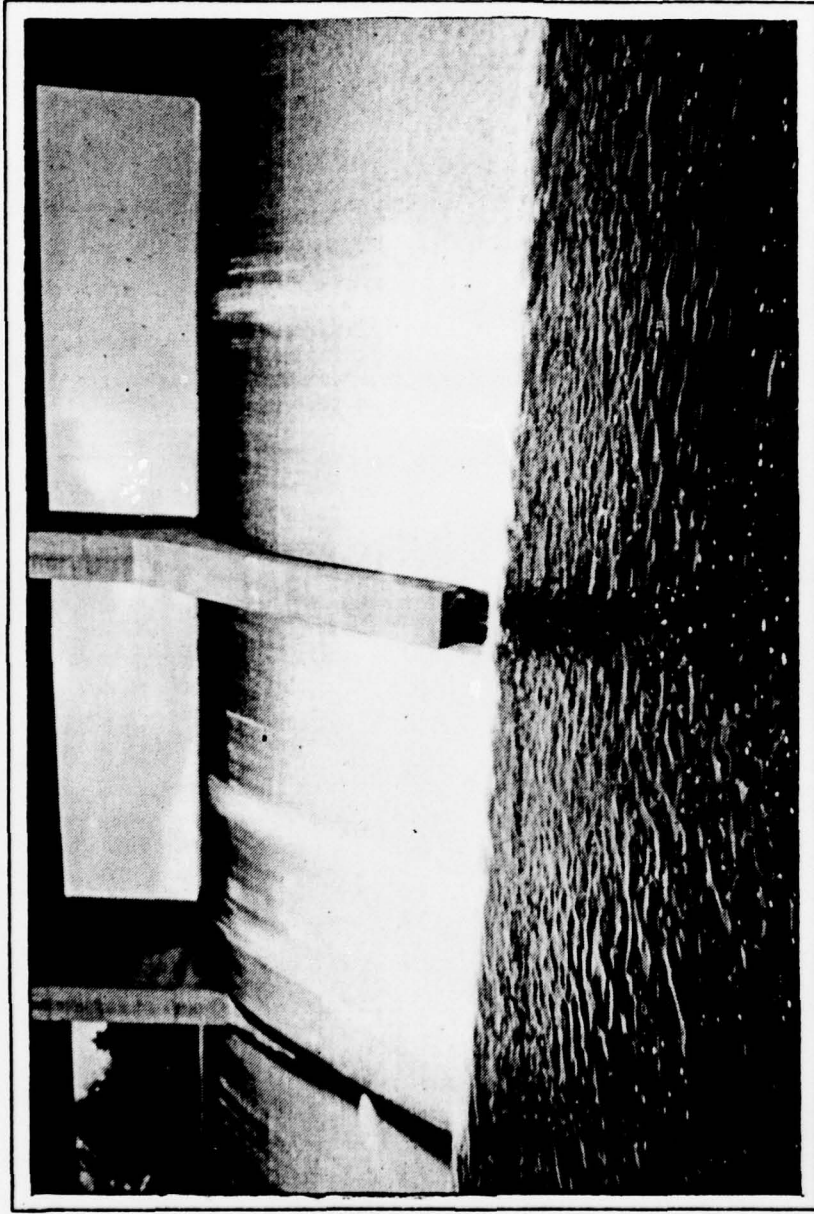
PHOTOGRAPH NO. 3

VIEW OF SPILLWAY. NOTE MINIMUM  
FLOW DISCHARGE OUTLET ON THE LEFT  
OF PHOTOGRAPH.

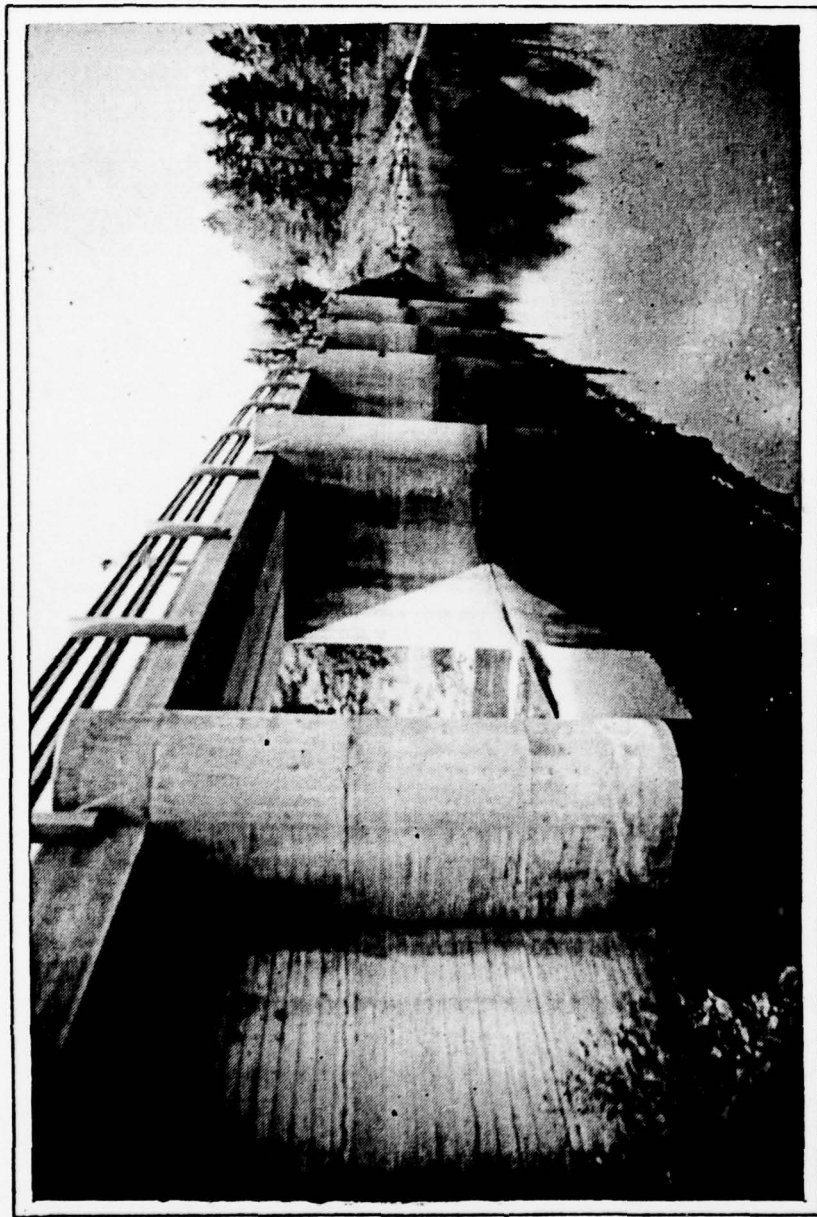
PHOTOGRAPH NO. 4

OVERVIEW OF UPSTREAM SIDE OF  
SPILLWAY.

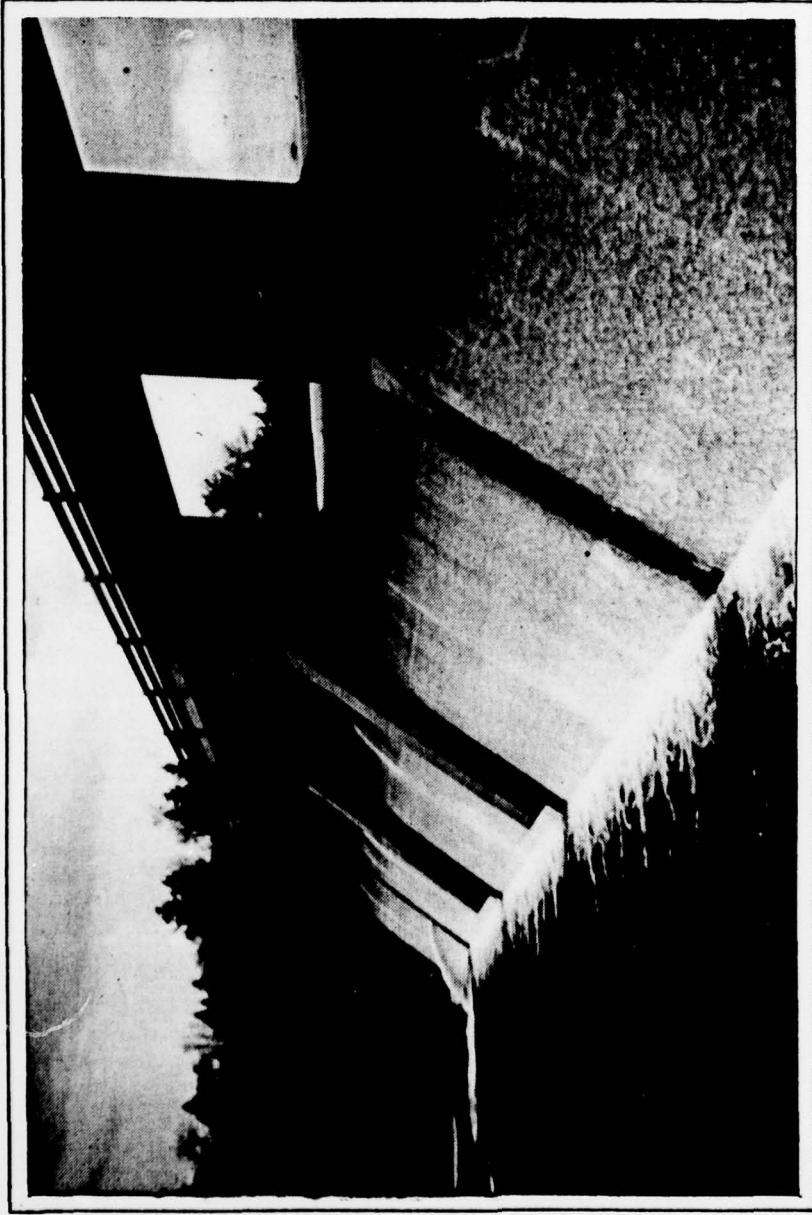
PHOTOGRAPH NO. 5

OVERVIEW OF DOWNSTREAM SIDE OF  
SPILLWAY.

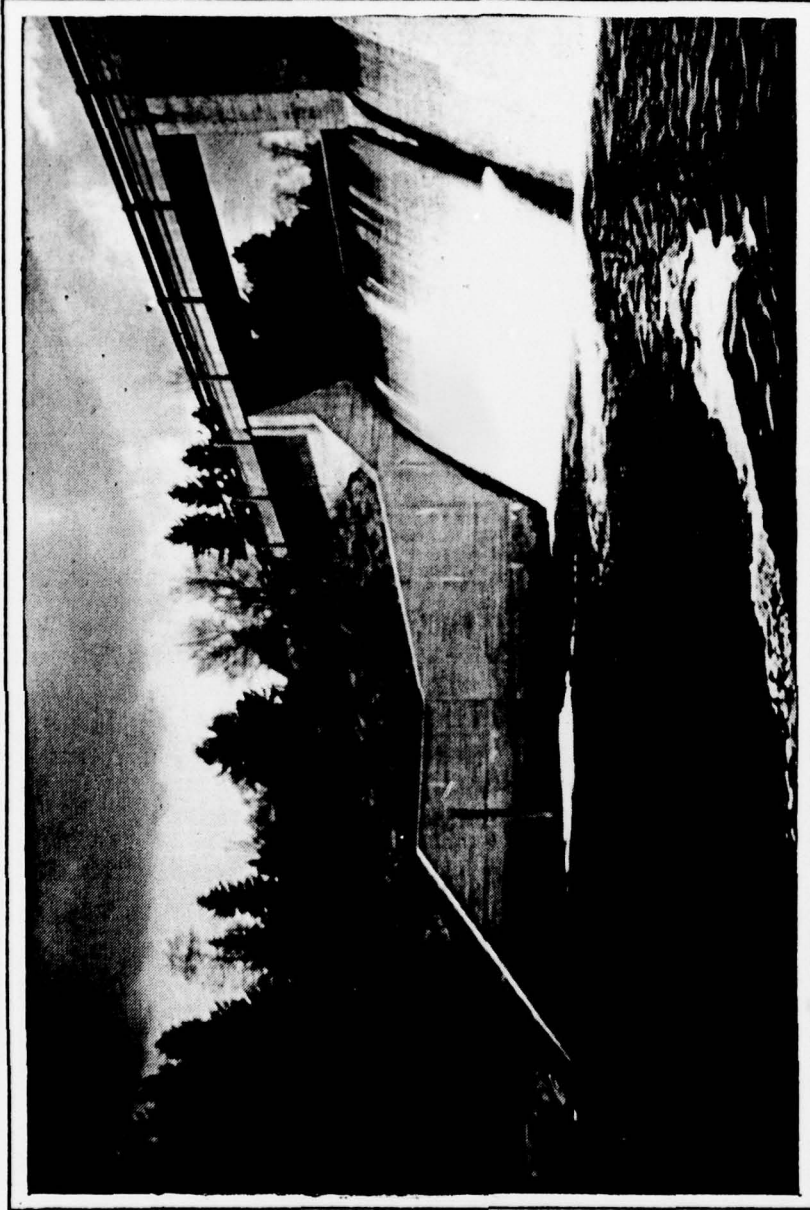
PHOTOGRAPH NO. 6

OVERVIEW OF RIGHT WALL OF SPILLWAY.  
NOTE STAFF GAGE ON WALL.

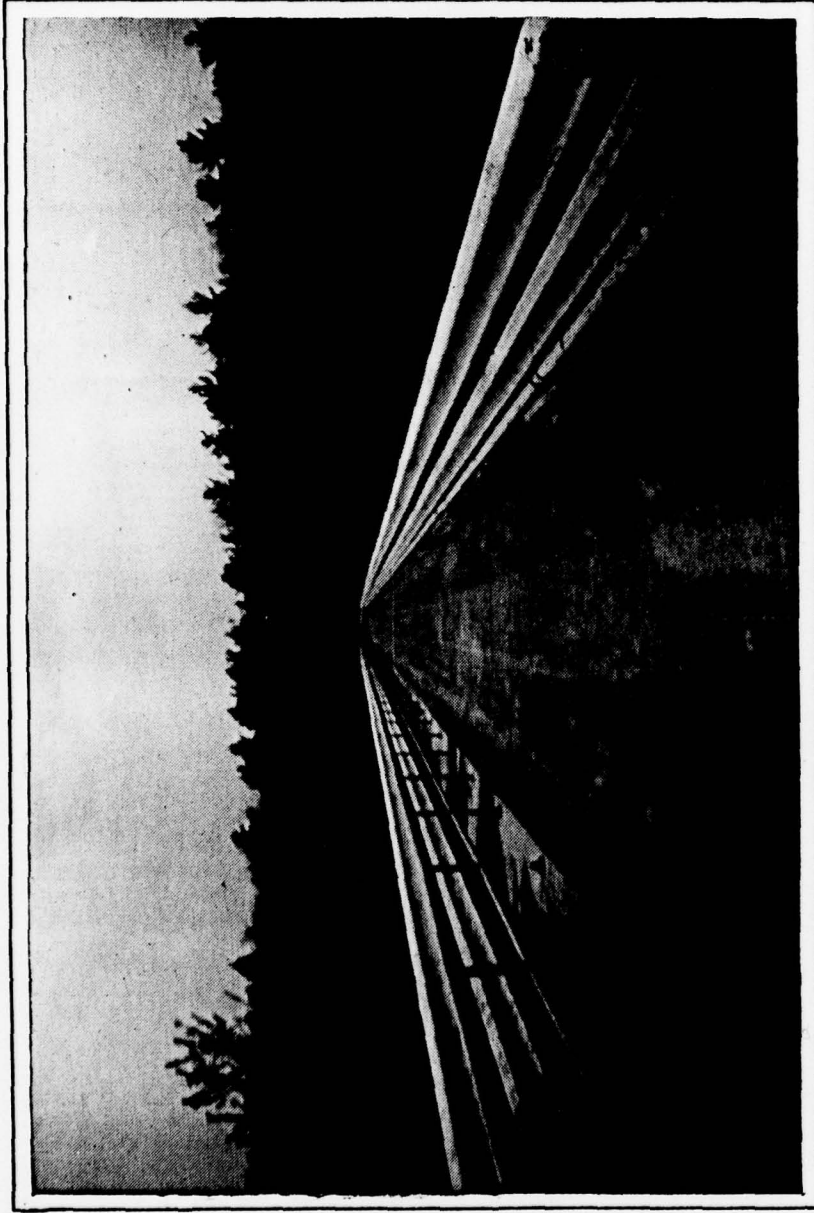
PHOTOGRAPH NO. 8

LOOKING AT ROADWAY ACROSS SPILLWAY  
FROM THE RIGHT ABUTMENT.

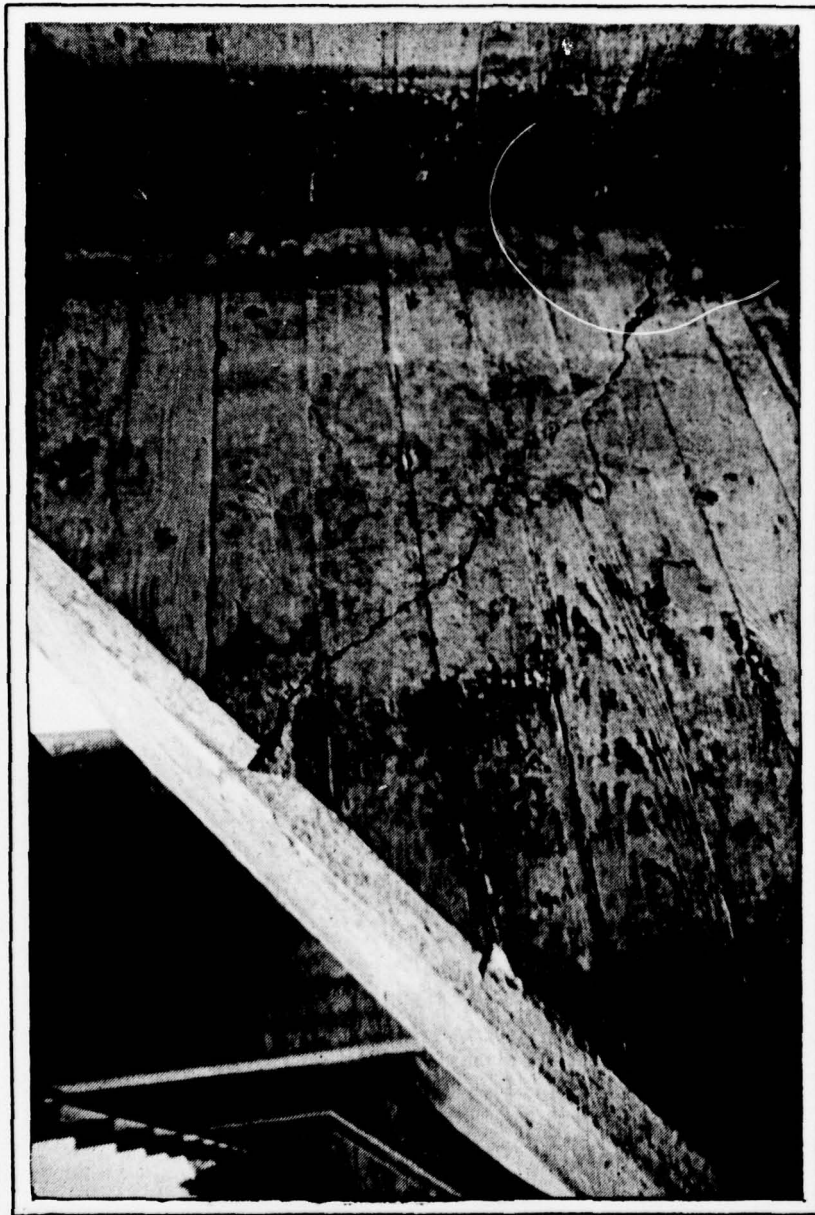
PHOTOGRAPH NO. 9

The concrete ogee spillway section was observed to be in very good condition, with no unusual distortion, cracks or excessive spalling of the concrete. Some minor cracking was observed along the downstream section of the spillway walls, as shown on sheet 5a and on photographs in Appendix D. Vertical and horizontal alignments were checked and found to be satisfactory. The monolith joints were inspected, where possible, and found to be in good condition. Construction joints were also observed to be in good condition. However, some deterioration of the joint sealer was noted beneath the bridge decking joints, resulting in deterioration of pier tops. This should be repaired during normal maintenance.

DIAGONAL CRACKING OF LEFT SPILLWAY  
WALL.

1. Woody vegetation along the downstream slopes of the embankment should be removed on a periodic basis. Once they are removed, the area should be reseeded to establish dense grass/Crownvetch vegetation.
2. Seepage around the end walls of the spillway, which emerges from the toe drain of the embankments, should be monitored, at least visually, for changes in rates or the presence of turbidity. Should either occur, this condition should be inspected by a registered professional engineer experienced in the design of dams.
3. Minor cracking noted along the downstream section of the spillway retaining walls should be monitored annually and, if the cracks increase, they should be repaired.
