BRIAR CREEK DAM

NDI ID No. PA-00651
DER ID No. 19-77
SCS ID No. PA-497

PHASE I INSPECTION REPORT

NATIONAL DAM INSPECTION PROGRAM

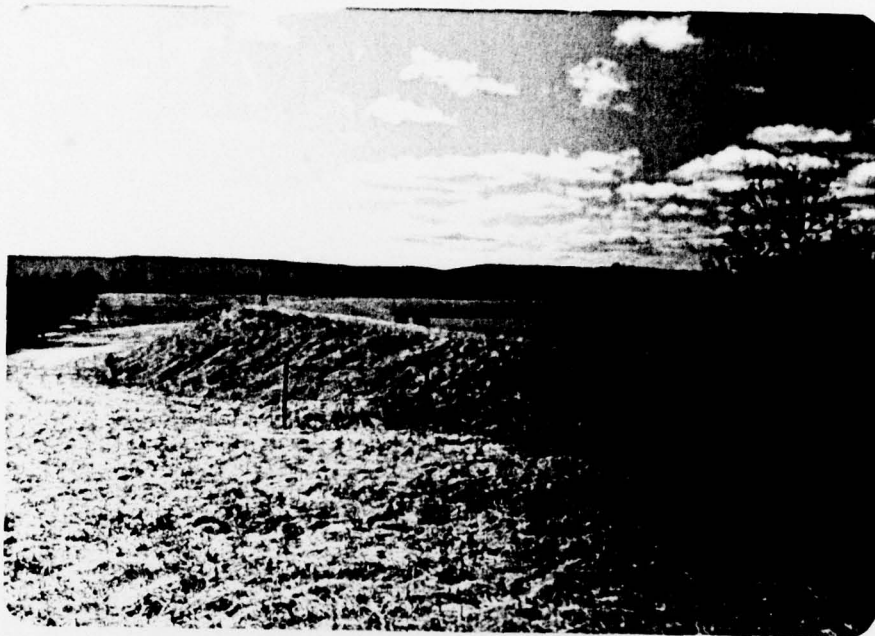
b. Embankment. The embankment is in good condition. The grass cover is in excellent condition except for 4 areas, where foot and trail bike traffic has worn paths in the embankment. The riprap on the upstream slope is in good condition. It extends up to Elevation 603.6, about 15 feet below design top of dam. A survey performed for this inspection reveals that the embankment is at or above the design top elevation and that the slopes are in accordance with the design drawings. An area about 100 feet in length at the downstream toe to the right of the impact basin was wet on the day of the inspection. The caretaker reported that the area is usually dry.

(2) Embankment. The trails on the embankment present an erosion hazard. The problem is minor at present and the caretaker is planning to provide steps to alleviate the problem. He stated that the use of trail bikes on the embankment has been prohibited. The wet area at the toe was probably caused by the heavy rain on the day before the inspection. Therefore, the wet area is not considered a deficiency.

A. Downstream Slope

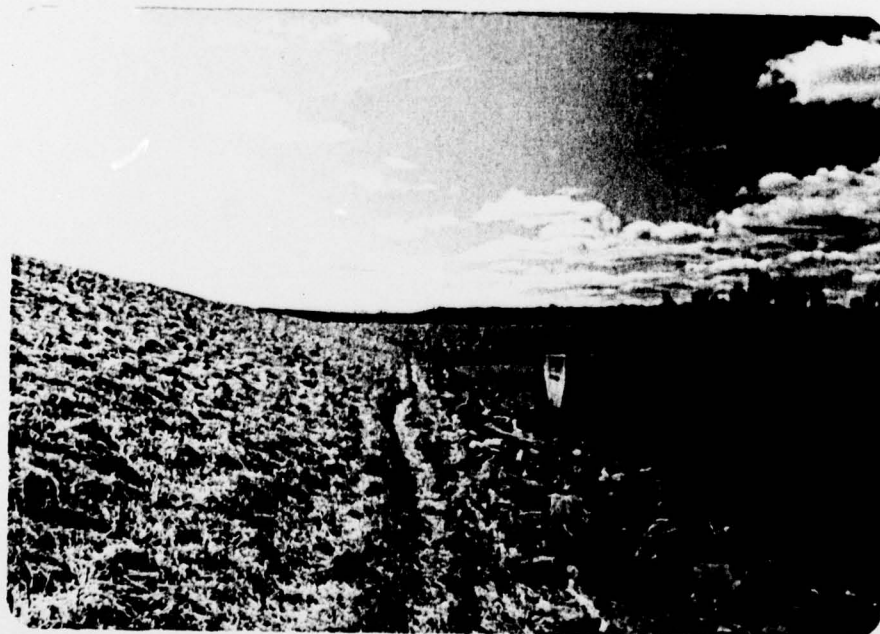
(2) Embankment. The design elevation of the top of the riprap on the upstream slope is El. 603.2, about 2.1 feet below the top of the riser pipe. This is 7.8 feet below the design 100-year pool level. The reason for selecting this elevation is not noted in the design computations. Lack of riprap on the upper portion of the slope creates an erosion hazard during flood conditions. Terminating the riprap below the top of the dam is a standard SCS design criteria. In view of the good

B. Upstream Slope

(2) Extend the riprap on the upstream slope to a reasonable height above the main spillway riser crest. Inspect the upstream embankment after each flood for evidence of erosion. Repair the embankment as necessary.

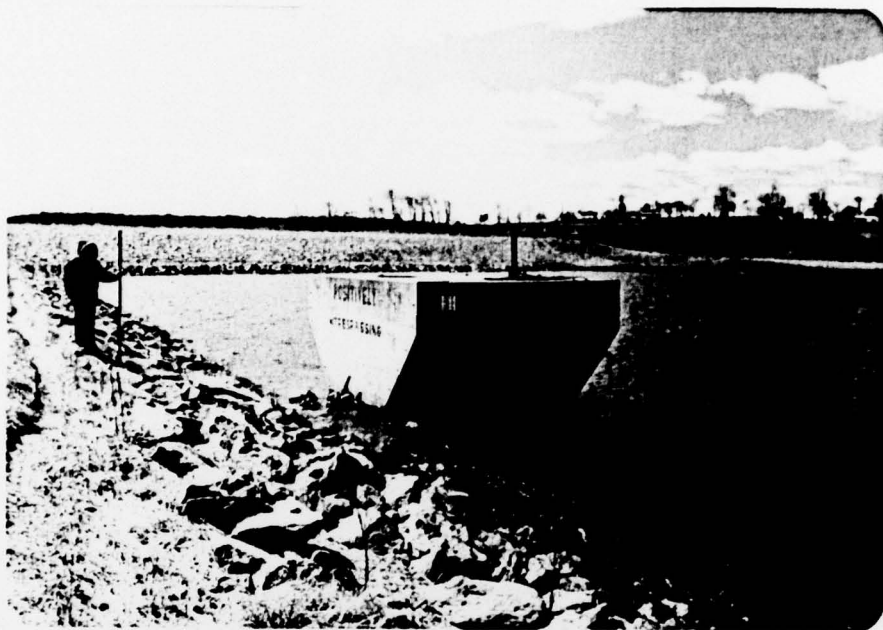
c. Design Considerations. Although the main spillway design has been used successfully by the SCS for many years, it appears that the entrance to the conduit could possibly develop cavitation during certain flow conditions. Other design considerations are discussed in Sections 5 and 6.

C. Riser Intake

(5) Implement the planned inspection of the main spillway conduit and riser to determine if elongation of the conduit and cavitation damage to the riser

have occurred. If pool conditions prevent the implementation of the inspection, the pool should be drawn down as required to provide the opportunity for inspection.

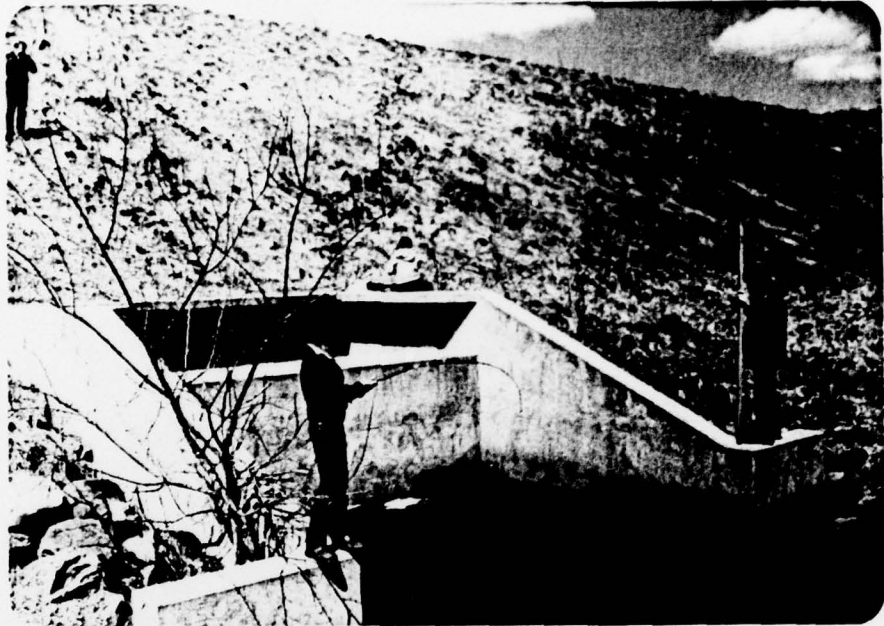
The main spillway riser is in good condition. The conduit beneath the embankment could not be inspected because it was flowing near full. The impact basin is in good condition. Very minor spalling, of no concern, was observed at a few localized areas of the concrete. Because of the high tailwater, it was impossible to determine if the drain pipes, which

(3) Appurtenant Structures. The gate for the outlet works is located sufficiently far upstream to be considered an upstream closure facility. The cause of the uneven riprap below the impact basin is unknown. The erosion hazard is minor. The slide in the auxiliary spillway approach channel is sufficiently far from the control section that it will not affect the hydraulics. Although the exact elevations of the control section are uncertain, it appears that at least part of it is above the design elevation. As the flood routing for the "Freeboard" storm was accomplished using 1V on 1H auxiliary spillway side slopes, and since the final design used 1V on 3H side slopes, the auxiliary spillway crest being slightly above the design elevation does not significantly reduce the design capacity. Other observations concerning the auxiliary spillway are discussed in Section 6.

E. Impact Basin

(6) As part of the regular maintenance program, remove the tree near the impact basin, replace the missing riprap at the impact basin, provide better control of foot traffic on the embankment, and continue efforts to remove burrowing animals.

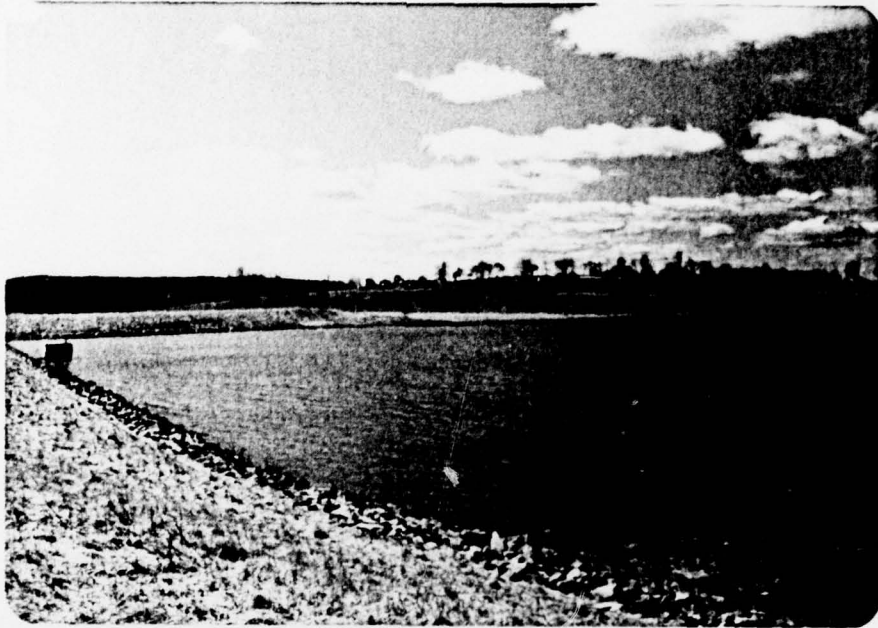
The burrowing animals are not an immediate hazard to the dam because they have not burrowed into the embankment. The caretaker is concerned that they will, and he is trying to eliminate them. The foot trail provides a very minor erosion hazard. The slide in the spillway approach channel right bank is not an immediate hazard to the dam. The area was used for embankment borrow and is indicated as a spoil area on Plate 2. The material that slid may be spoil material. The cut near the control section is on the same slope. The soils analysis indicates that the natural overburden in the slide area and near the auxiliary spillway control section are similar. The slide occurred immediately after Tropical Storm Agnes, and high ground water conditions resulting from the storm were probably a major factor in causing the slide. Any indication of slope movement occurring closer to the auxiliary spillway control section would be cause for concern.

G. Auxiliary Spillway Approach Channel

(3) Continue to monitor the right bank slope near the auxiliary spillway. Any changes should be cause for immediate remedial measures.

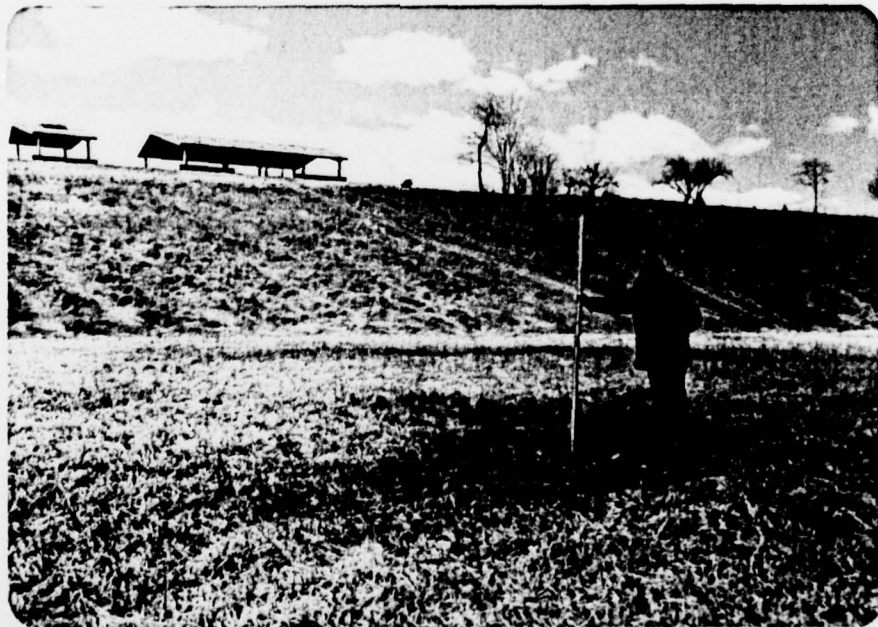
The auxiliary spillway is in good condition, The grass cover is in good condition except at 3 areas, where sinkholes had previously developed. The sinkholes have been filled but the grass cover has not reestablished itself. An area of the spillway approach channel has slid along the right bank. This area is about 400 feet upstream of the control section. A worn foot trail extends down the right bank slope. Burrowing animals inhabit the banks and bottom of the auxiliary spillway. The survey performed for this inspection revealed that the control section invert is between 0.2 to 0.9 foot above the design elevation. Part of the difference between the actual and design elevation may be explained by the uncertain survey datum as noted previously.

The sinkholes in the auxiliary spillway developed immediately after Tropical Storm Agnes. This was the only time flow occurred over the auxiliary spillway. As noted in Appendix E, the geology at the auxiliary spillway is complex. The logs of drill holes performed as part of the foundation exploration indicate that the embankment is not founded on either the fault or the solution-prone limestone. The caretaker is inspecting the sinkhole area frequently. Immediately after Tropical Storm Agnes, the SCS had engineers experienced with dams in limestone areas inspect the sinkholes and recommend repairs. Their report was not available

for review but the conclusions and recommendations were summarized in a letter to the Commonwealth. The recommendations were to backfill the sinkholes with a reverse filter. This has been accomplished. The conclusions were that sinkholes would continue to develop in the auxiliary spillway, that the sinkholes would not be a hazard to the embankment, and that repairing them as they developed is the only economical method of controlling them. There is no reason to doubt the validity of these conclusions.

H. Sinkhole in Auxiliary Spillway

(1) Continue to monitor the filled sinkholes in the auxiliary spillway. Should the sinkholes develop further or should others develop, assess their size, location, and reason for development to determine if the assumption that they are not a hazard to the dam is valid.
