DELAWARE RIVER BASIN  
GRASS LAKE CREEK, CARBON COUNTY  
PENNSYLVANIA  
NDS ID PA. 00615  
DER ID 13-93

# BIG BOULDER DAM

## PHASE I INSPECTION REPORT NATIONAL DAM INSPECTION PROGRAM

JULY 1979

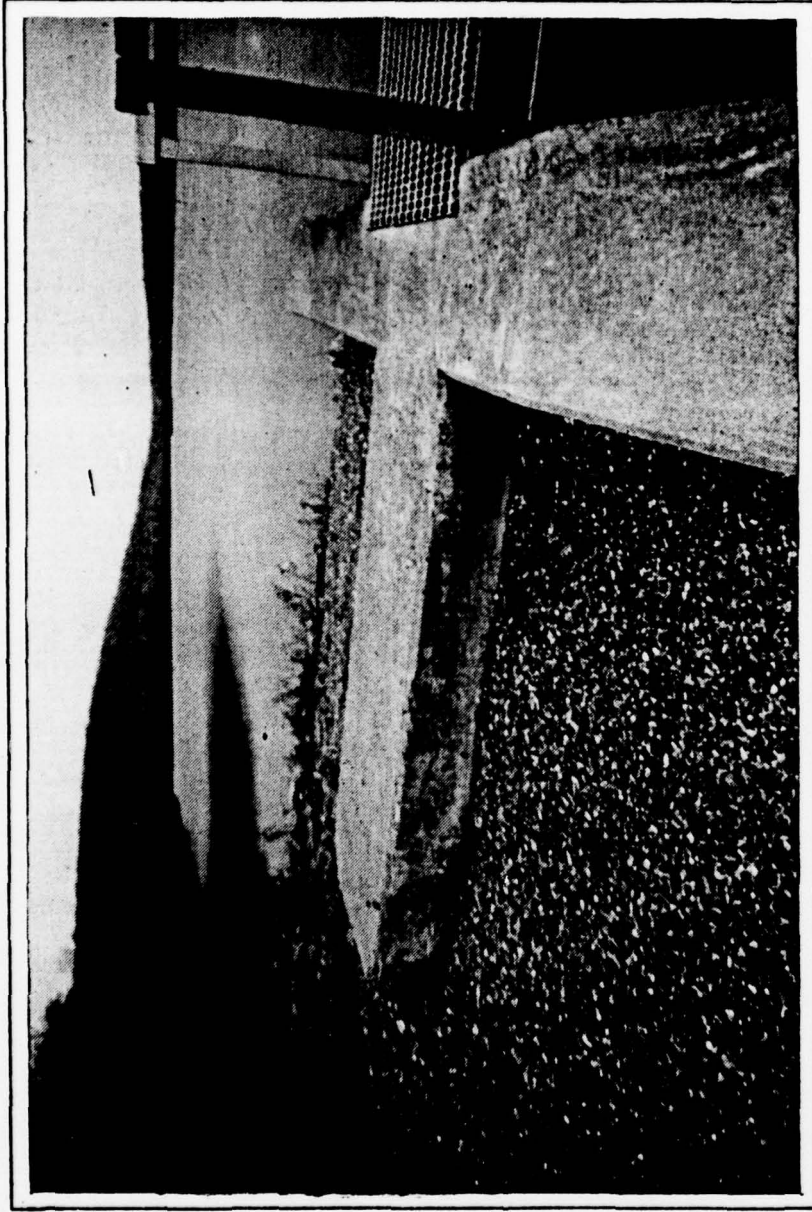
PHOTOGRAPH NO. 8

There are no indications of surface cracks noted on the embankment crest or slopes of Dams A and B. The asphalt roadway across Dam B is in good condition. As shown on Photograph 8, Embankment A has settled approximately four to six inches below the spillway anti-seepage walls. As shown on

c. Visual Observations. On the date of the inspection, the only condition observed that would indicate a reduced spillway capacity (without overtopping the embankment) during an extreme event is settlement of up to seven inches adjacent to the spillway wall. Observations regarding the condition of the downstream channel, spillway and reservoir are located in Appendix B and discussed in Section 3.

TOP OF RIGHT RETAINING WALL OF SPILLWAY.  
NOTE DIFFERENCE IN EMBANKMENT AND WALL  
HEIGHT.

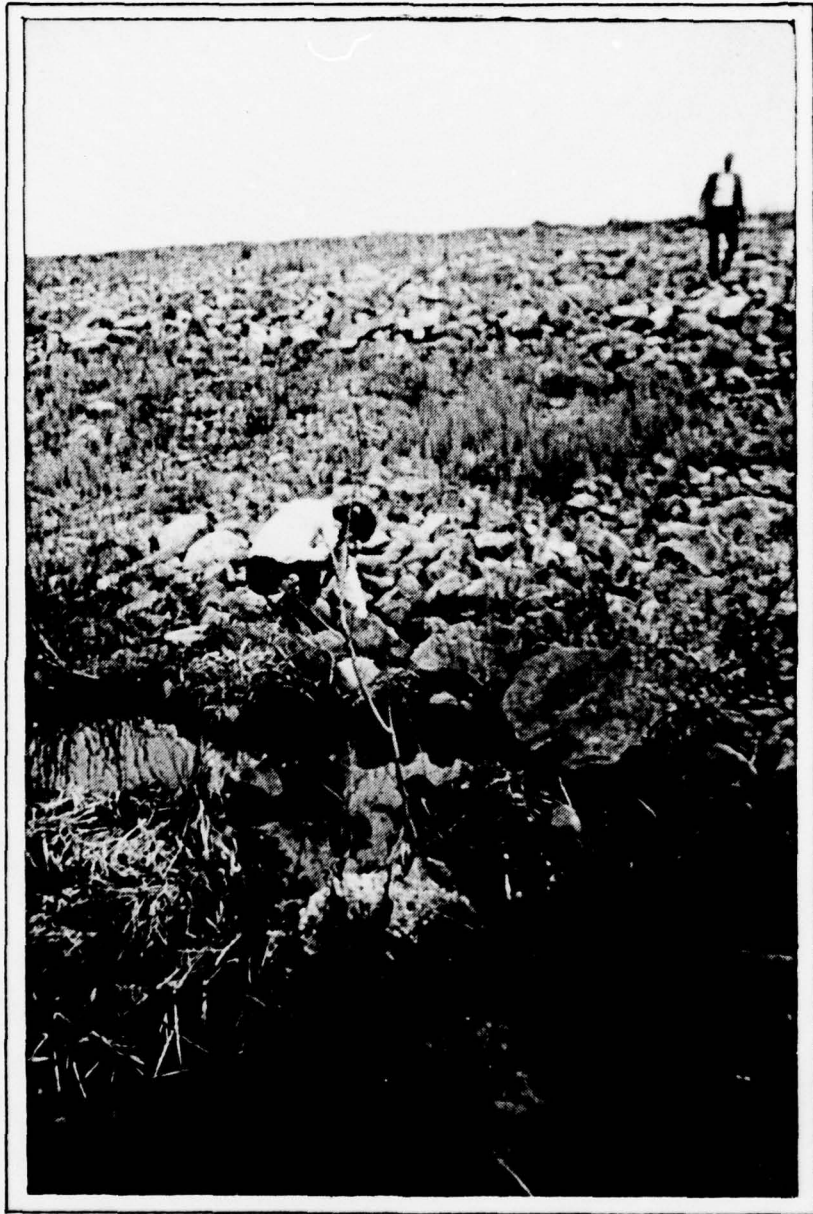
PHOTOGRAPH NO. 10

b. Dam. During the visual inspection, there were no indications of distortion in alignment or grade that would be indicative of movement of the embankment or foundations of either Dam A or B. Inspection of the downstream slope and adjacent downstream area of Dam A disclosed two zones of seepage. The first zone is located adjacent to the right wall of the spillway where seepage, discolored with iron staining, was noted. A photograph of this seepage is enclosed as Photograph 13. As the downstream rock toe does not contain a perforated collector pipe, this type of seepage would be expected. A second form of seepage was noted to the left of the spillway, as shown in Appendix B, sheet 5a, and documented by Photographs 10 and 11 in Appendix D. This seepage was flowing at a rate substantially greater than the seepage at the right spillway wall. It is noted that the Owner has retained Justin & Courtney to evaluate the seepage and recommend a method of control.

OVERVIEW OF SEEPAGE THROUGH  
DOWNSTREAM TOE ON LEFT SIDE  
OF SPILLWAY.

1. Seepage at the downstream toe of Embankment A should be assessed and controlled.
2. The right side of the spillway at Dam A should be monitored for increases in seepage rates or presence of turbidity. In the event either condition occurs, the condition should be reviewed immediately and appropriate action taken, if necessary.
3. Seepage noted along the downstream toe of Dam B should be monitored periodically for turbidity or increases in flow. In the event a change occurs, conditions should be reviewed and appropriate remedial measures taken.

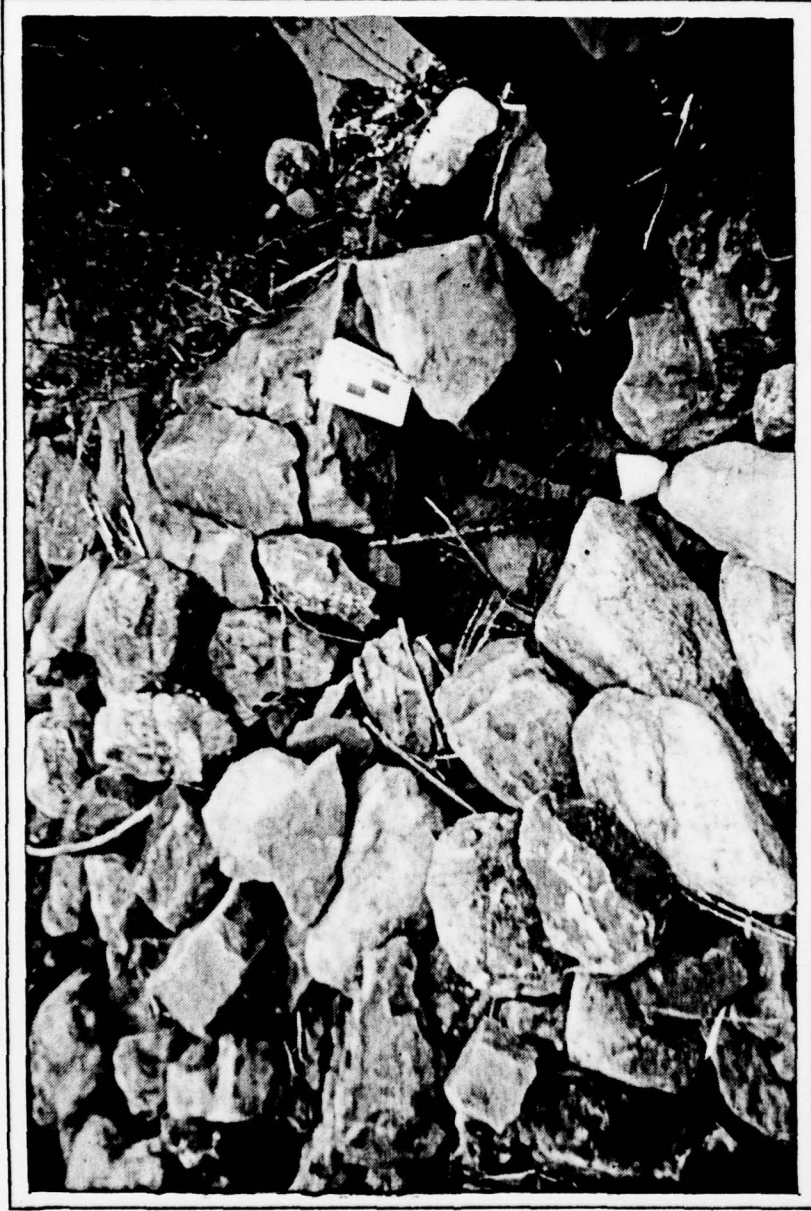
PHOTOGRAPH NO. 11

POINT OF SEEPAGE EMERGENCE THROUGH  
TOE OF DAM.

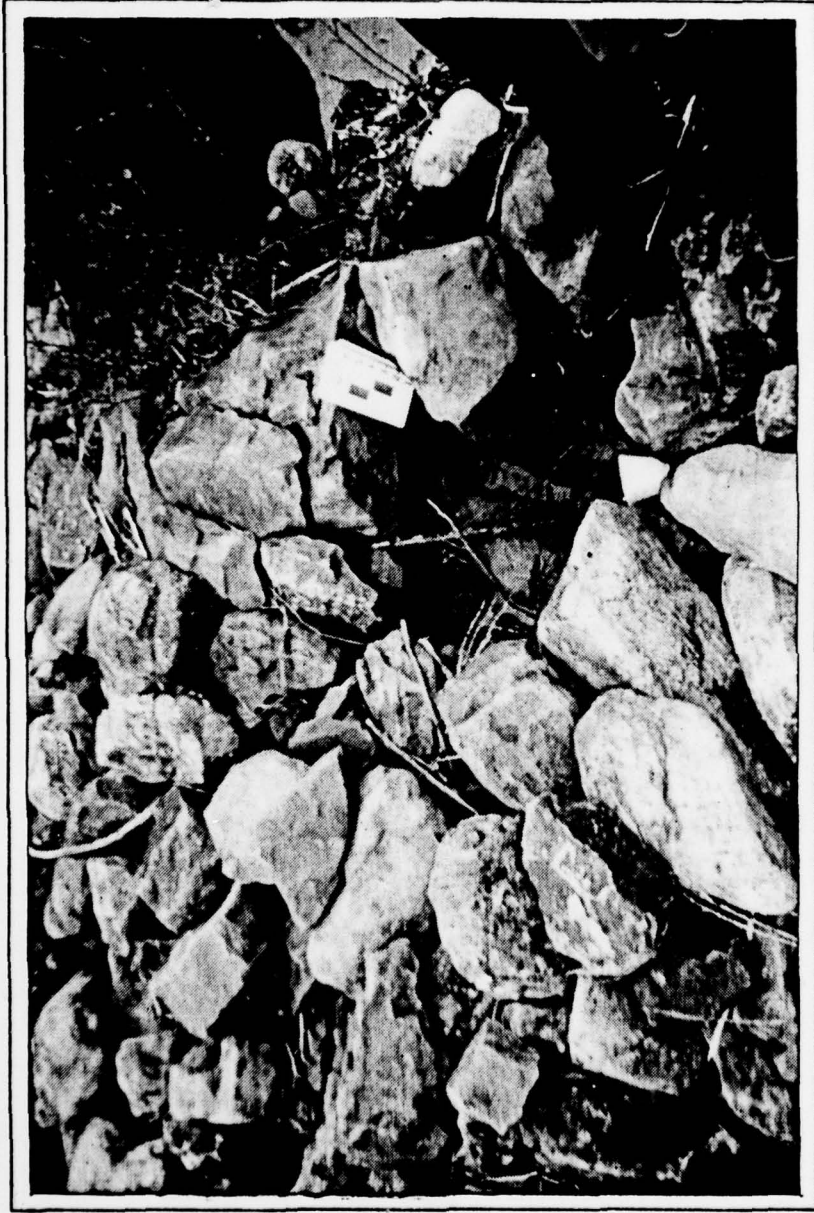
PHOTOGRAPH NO. 11

POINT OF SEEPAGE EMERGENCE THROUGH  
TOE OF DAM.

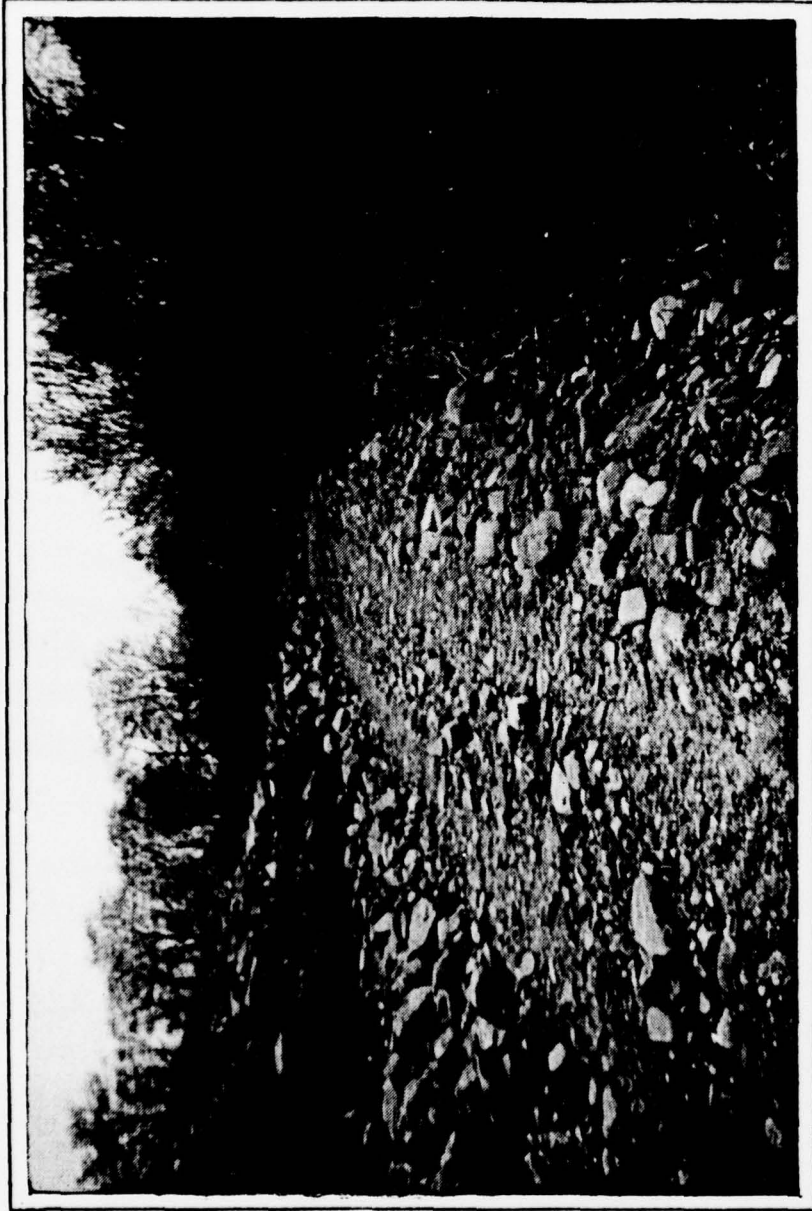
PHOTOGRAPH NO. 12

RECENTLY CONSTRUCTED ACCESS ROAD ALONG  
DOWNSTREAM TOE. ROADWAY USED FOR ACCESS  
TO SEEPAGE ZONE.

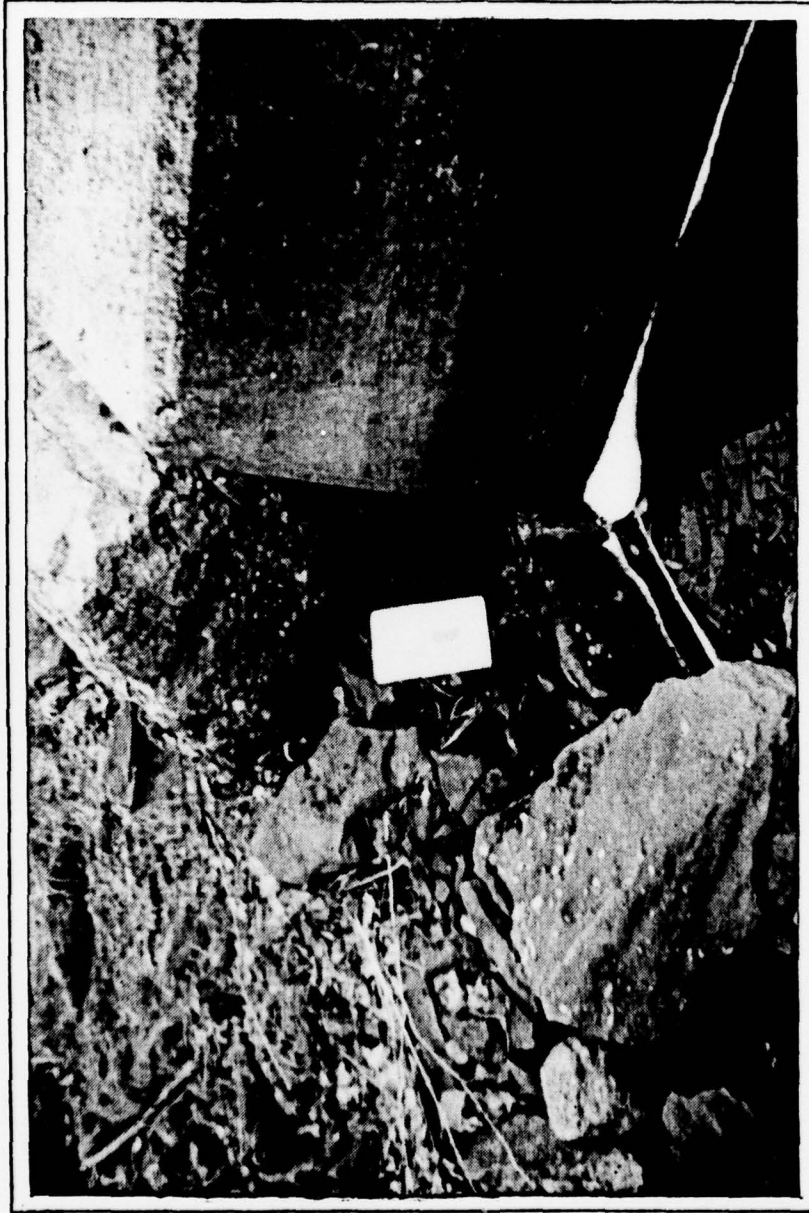
PHOTOGRAPH NO. 13

SEEPAGE THROUGH DAM TOE DISCHARGING  
ALONG RIGHT RETAINING WALL OF SPILLWAY.

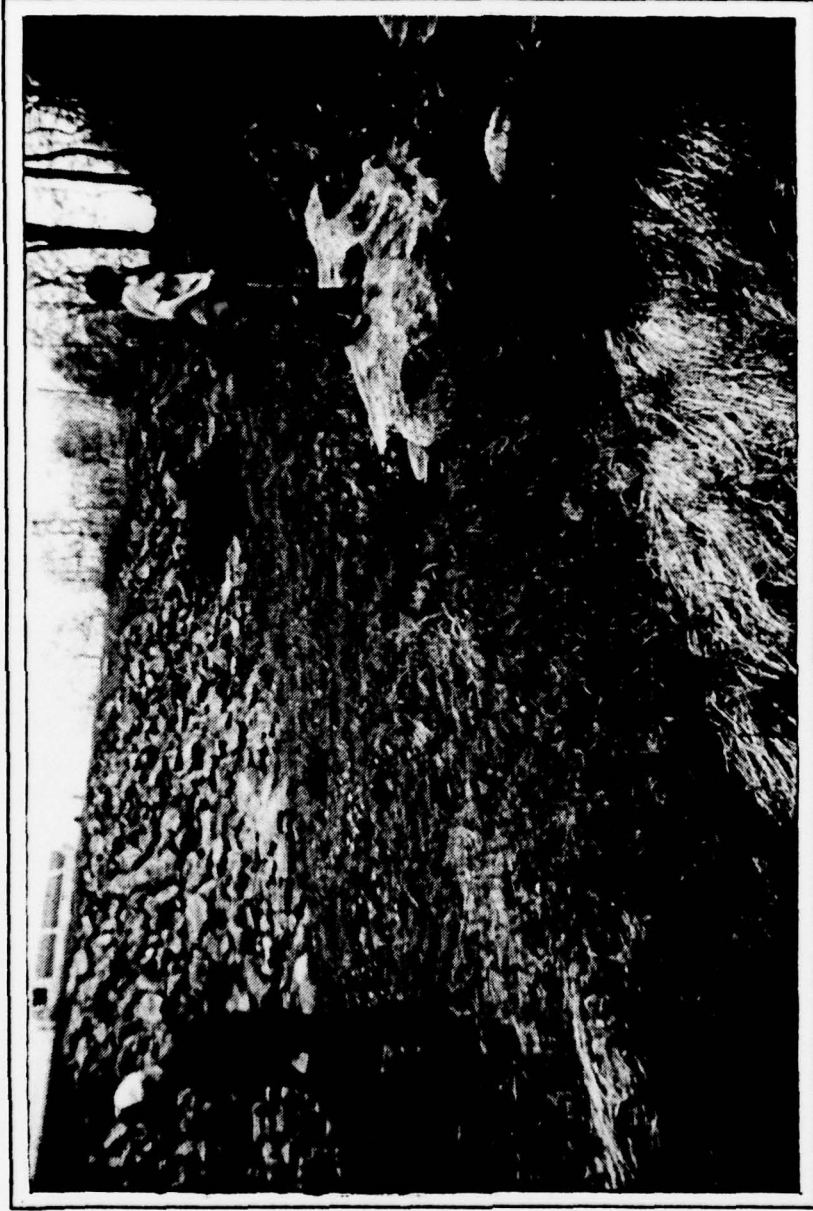
PHOTOGRAPH NO. 17

The downstream area of Dam B was also inspected and some small wet areas were noted, as shown on sheet 5a, Appendix B. However, based on discussions with the Owner's engineer, seepage rates are at least 90 percent less than rates prior to grouting. The engineer concluded this seepage is controlled sufficiently to insure stability of the embankment.

DOWNSTREAM OF DAM B SHOWING LOCATION  
WHERE SEEPAGE OCCURRED UNTIL IT WAS  
CONTROLLED BY MEANS OF GROUTING.
